# FORENSIC STUDIES IN GEOTECHNICAL ENGINEERING

PROCEEDINGS  
*of the*  
TWENTY-SEVENTH  
OHIO RIVER VALLEY SOILS SEMINAR  
(ORVSS XXVII)

October 11, 1996  
Sharonville Convention Center  
Cincinnati, Ohio

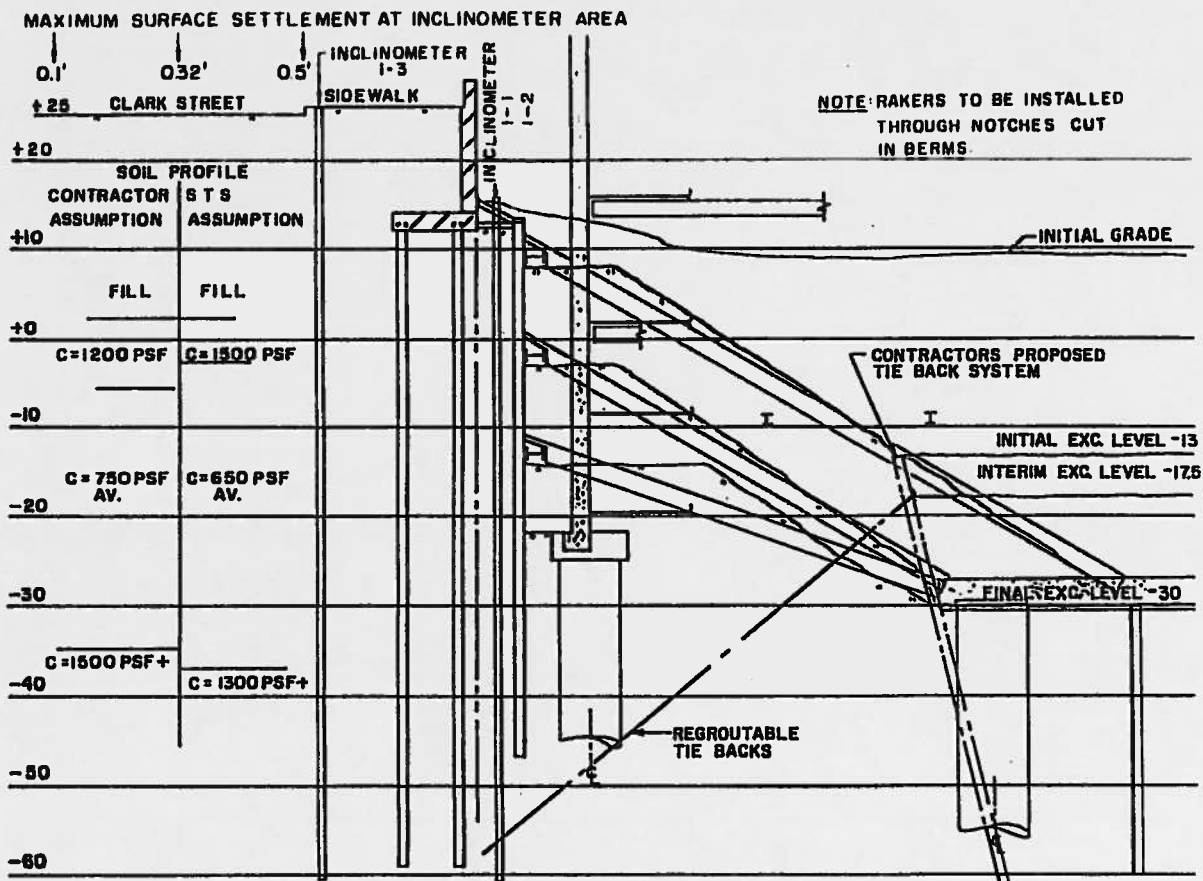
FIGURE 3-FINAL RETENTION SYSTEM

7. Methods for reducing the risk of excessive movements and increasing factor of safety were discussed with the contractor. The geotechnical engineer recommended partial excavation and then cross lot bracing to permit the entire mat construction, installing the top raker through the cross lot braced excavation to the mat, and then proceeding as before. See Figure 2. The contractor countered with replacing the cross lot bracing system with a tied back wall on one side, using regroutable ties and with an open cut on the other noncritical side of the excavation where there was ample room for open cut. The geotechnical engineer agreed and the owner and contractor negotiated a price for the additional work. See Figure 3.

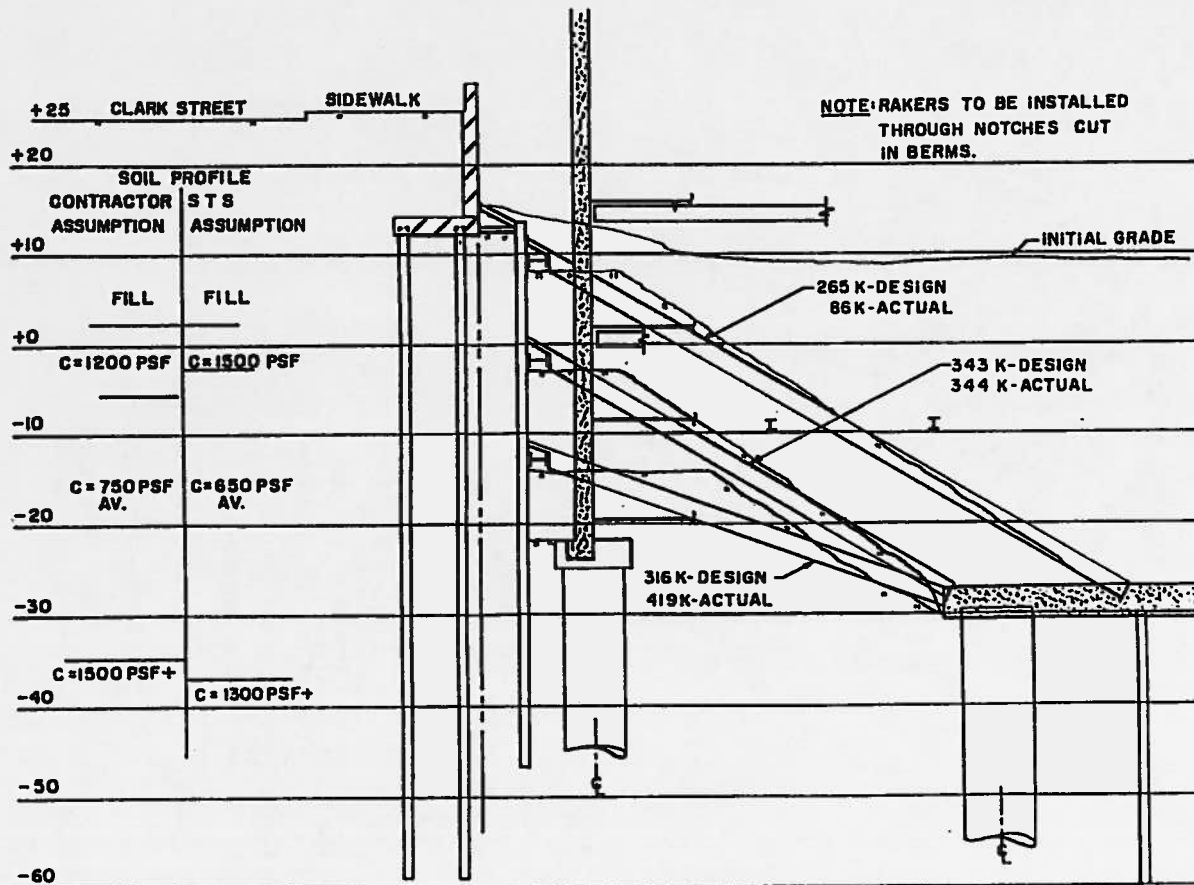
FIGURE 7-RAKER LOADS

inches). An additional 1 to 2 inches occurred during the length of time it took to excavate and pour the mat foundations and install the top raker level. From the time of the first raker installation until completion of the total excavation and three levels of rakers, an additional 2 inches of movement occurred with an additional approximate 1-inch movement during backfilling and raker removal, for a total movement of approximately 5 to 6 inches. While this movement is greater than was desired, it was not sufficient to cause closing of Clark Street at any time during construction.

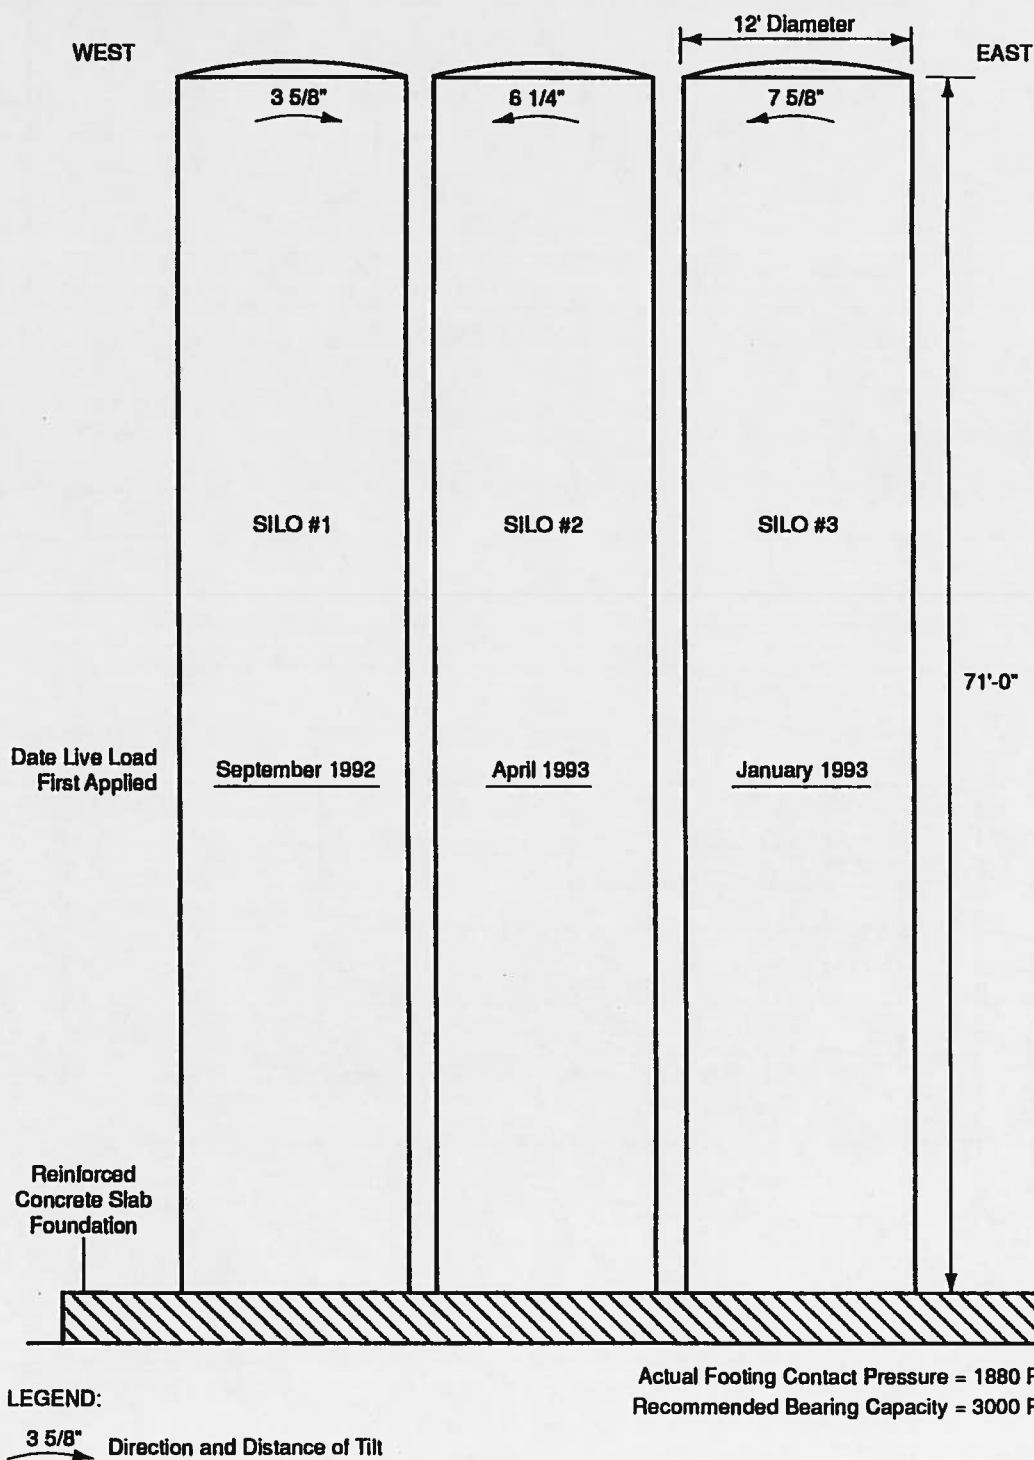
FIGURE 2  
 VERTICAL PROFILE OF SAND SILOS

The failure investigation began by developing a chronology of events and an analysis of the information that affected design. As shown in Figures 1 and 2, all three silos shared a common concrete slab foundation, 17 feet wide by 56 feet long, and 3 feet thick. Each silo was 12 feet in diameter, 71 feet high, and had a total sustained live load of 295 tons. The approximate date each silo was initially loaded is shown in Figure 2. The common concrete foundation slab was founded on compacted structural fill 8 feet deep, constructed over stiff silty clay. So what went wrong?

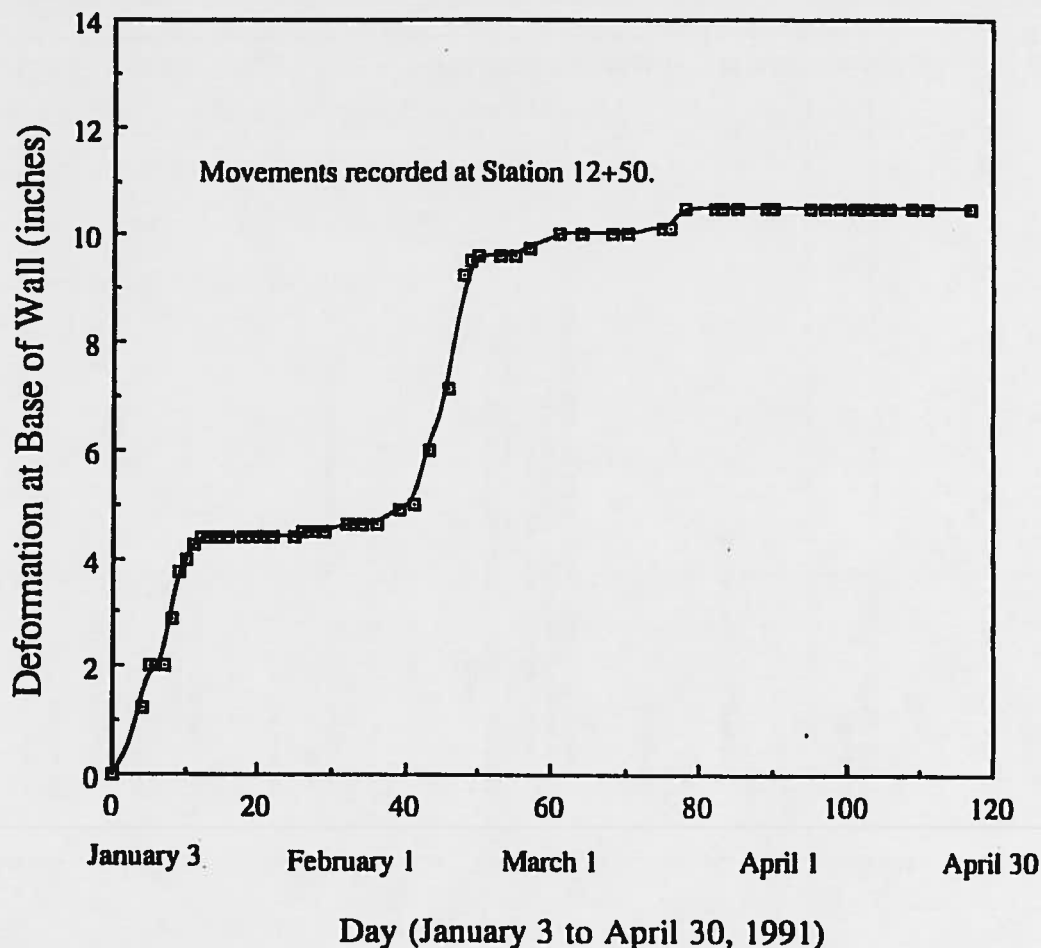
**FIG. 3. Deformation Rate during Initial Period of Distress**

Fig. 3 shows the pattern for the rate of movement at station 12 + 50 at the base of the wall during the period January to April 1991. It can be seen that there were essentially two periods of accelerated movements, along with extended periods of relative inactivity. Fig. 4 shows the rainfall during 5-day periods between October 1990 and April 1991. The timing of major distress in the backfill slope and the periods of recorded accelerated movements of the facing wall have been noted. The close relation between rainfall and observed performance is evident. Major distress in the backfill slope occurred during the heaviest period of rainfall [ $>7.6$  cm (3 in.) per 5-day period for 2 weeks] and subsequent periods of accelerated wall movements

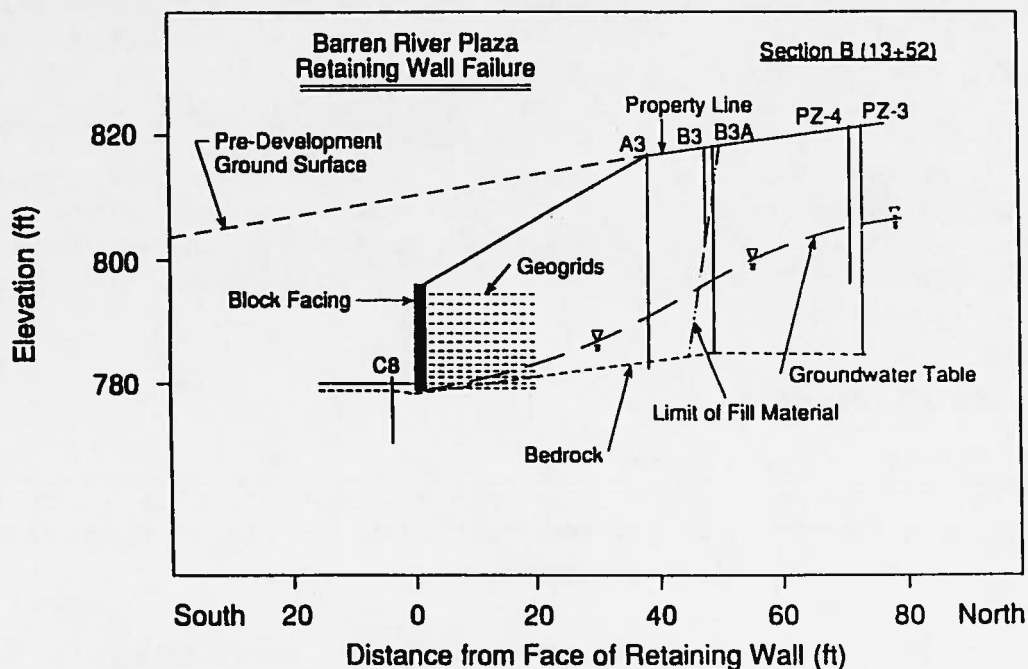
FIG. 6. Cross Section of Retaining Wall at Station 13 + 52

The limits of the fill material were determined on the basis of penetration resistance, density, and moisture content measurement. For example, natural undisturbed soils had blow counts of the order of 15–30 above the water table and 10–15 below the water table. By contrast, compacted fill materials behind the geogrid reinforcement had  $N$  values as low as 2 or 3 and generally less than 10 both above and below the water table. Postfailure density determinations further assisted in delineating fill from natural soils. For example, dry densities above the water table in natural soils were typically in the range of 1,600–1,680 kg/m<sup>3</sup> (100–105 pcf), while corresponding fill soils had densities ranging from 1,360–1,520 kg/m<sup>3</sup> (85–95 pcf) outside the geogrid reinforced zone and 1,490–1,600 kg/m<sup>3</sup> (93–100 pcf) within the reinforced zone.

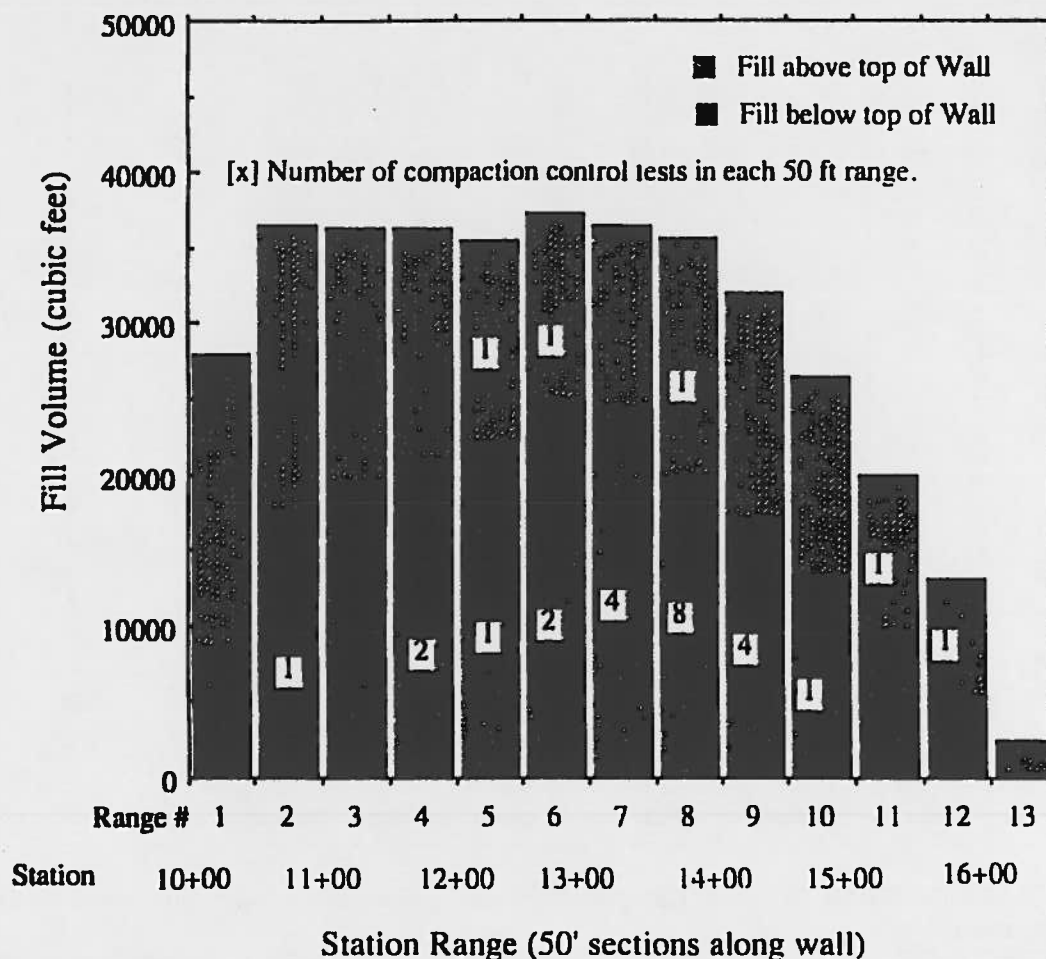
**FIG. 12. Frequency and Distribution of Compaction Control Tests**

In addition to what is considered to be an insufficient total number of tests, the locations of the tests were not well distributed. The solid and hatched areas shown in Fig. 12 correspond to the volume of fill behind and

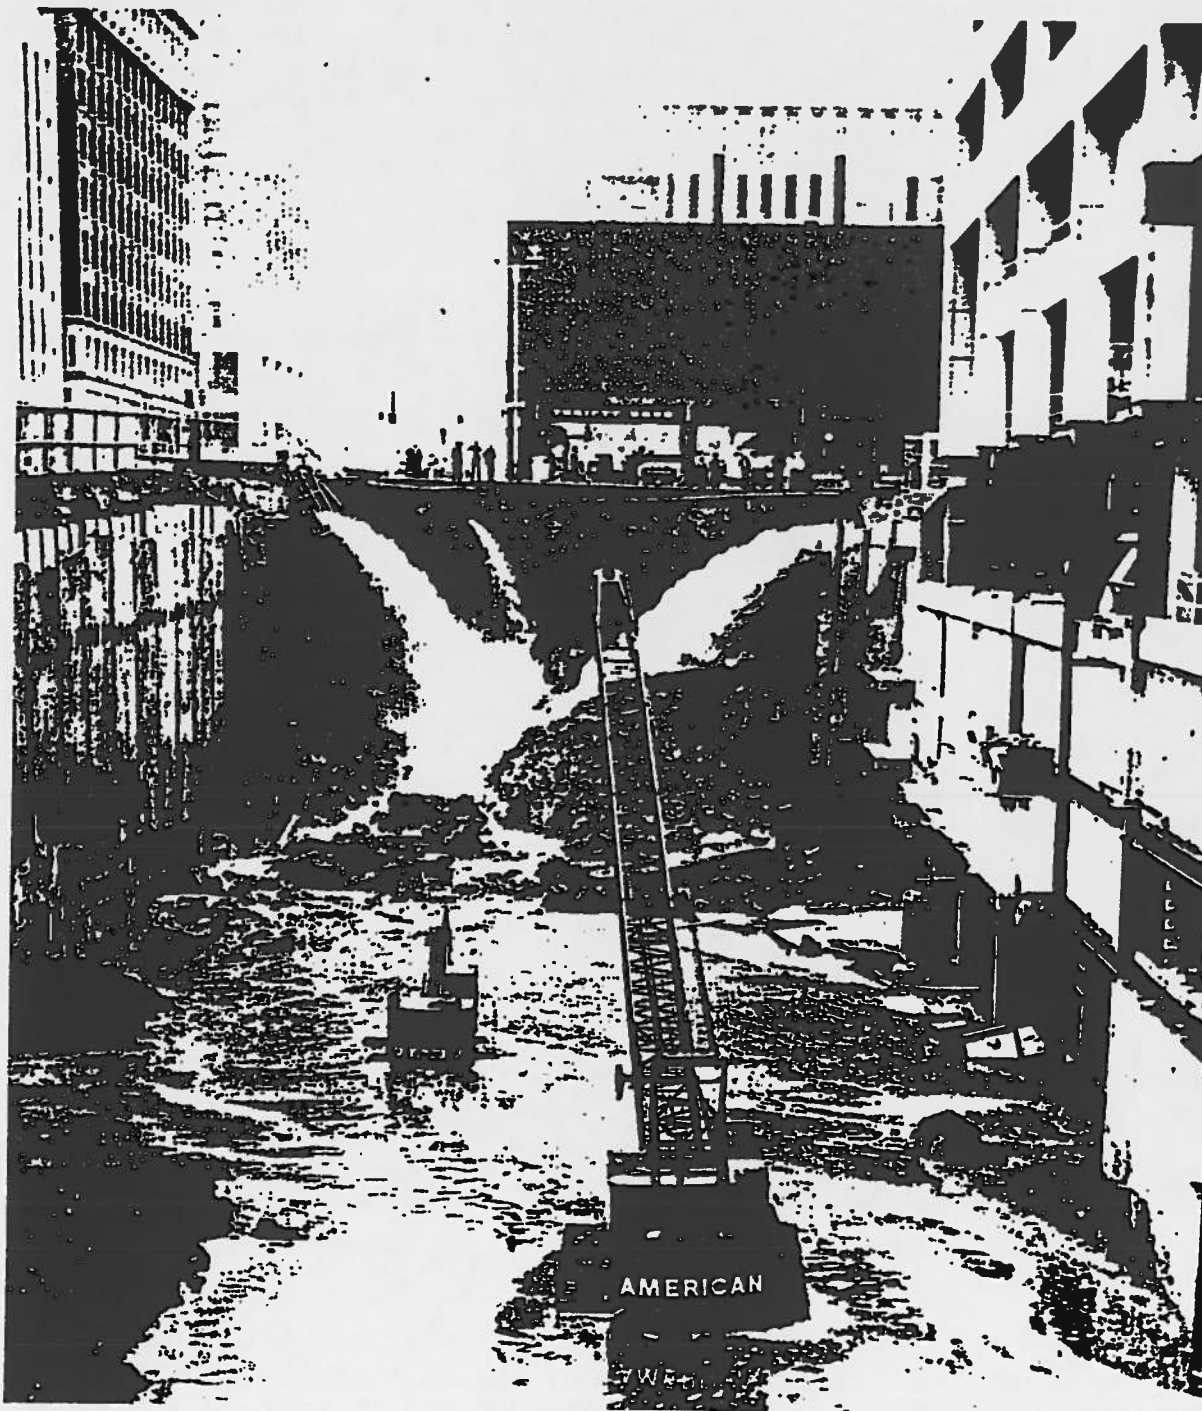
**Figure 5 Excavation Shortly After Wall Failure**

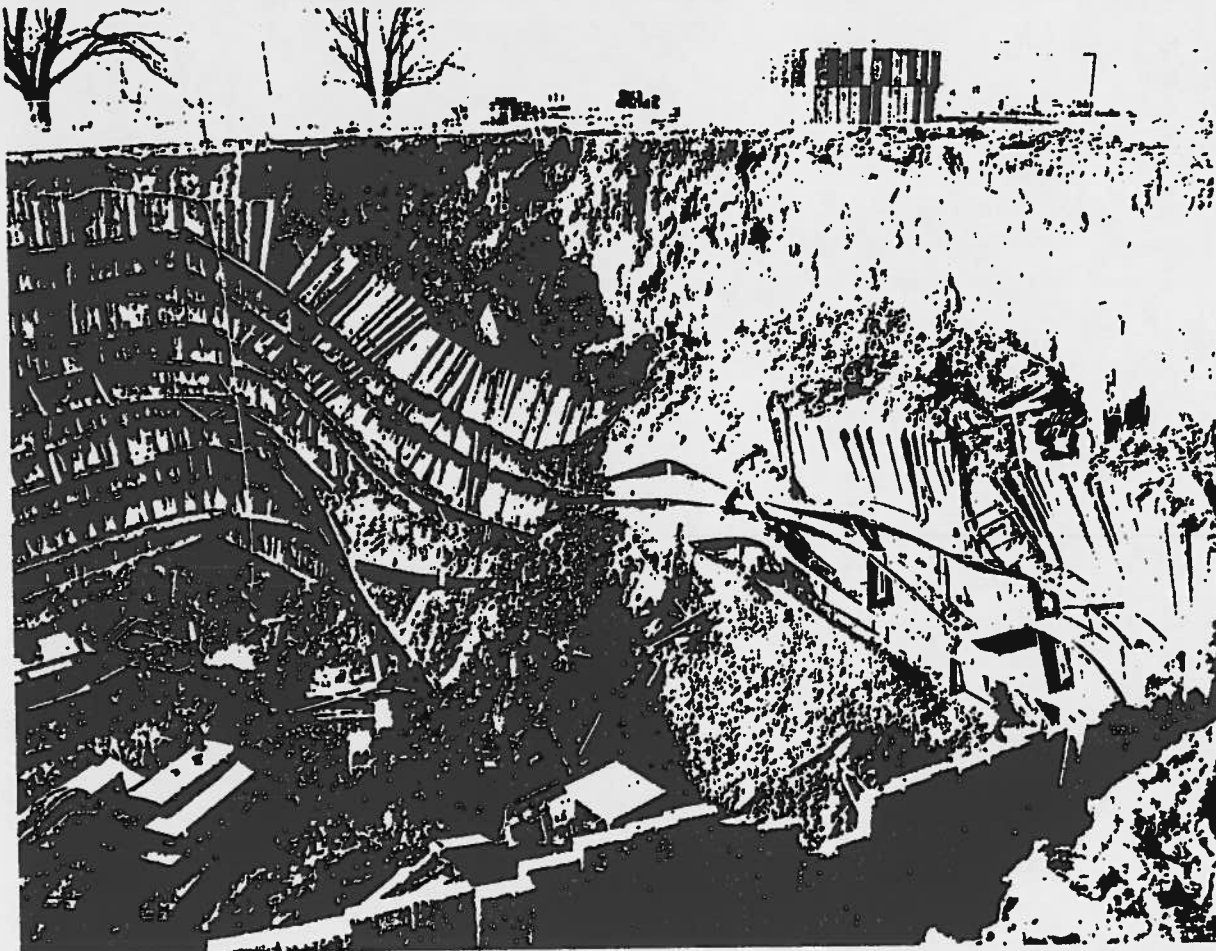
Figure 6 Failure of Circular Wall

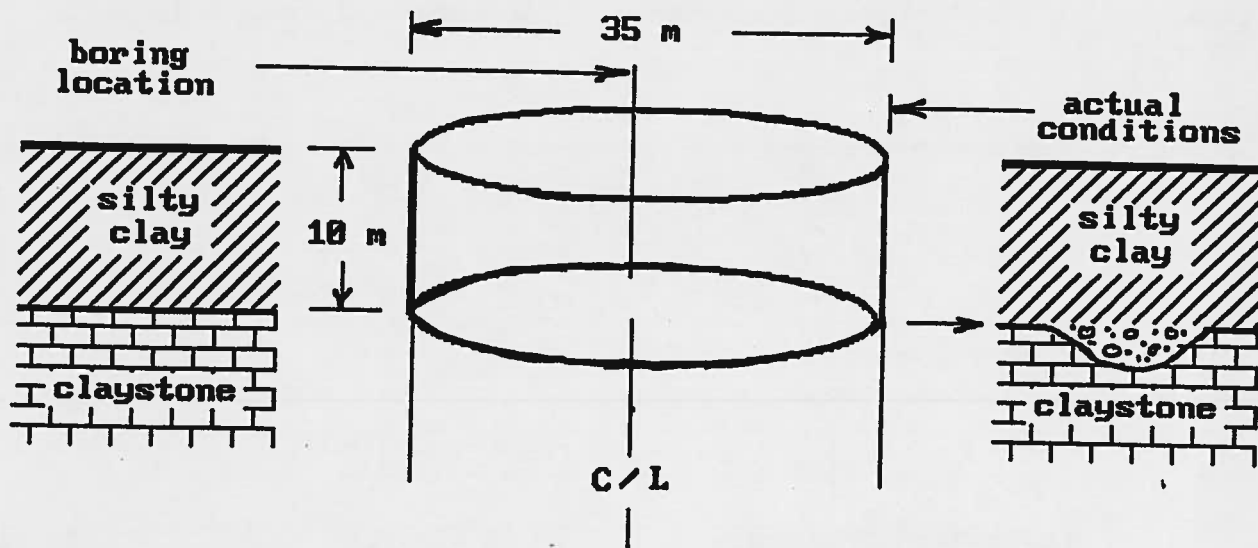
**Figure 7 Profile According to Soil Boring and Conditions as Found - Note Buried Stream Bed**

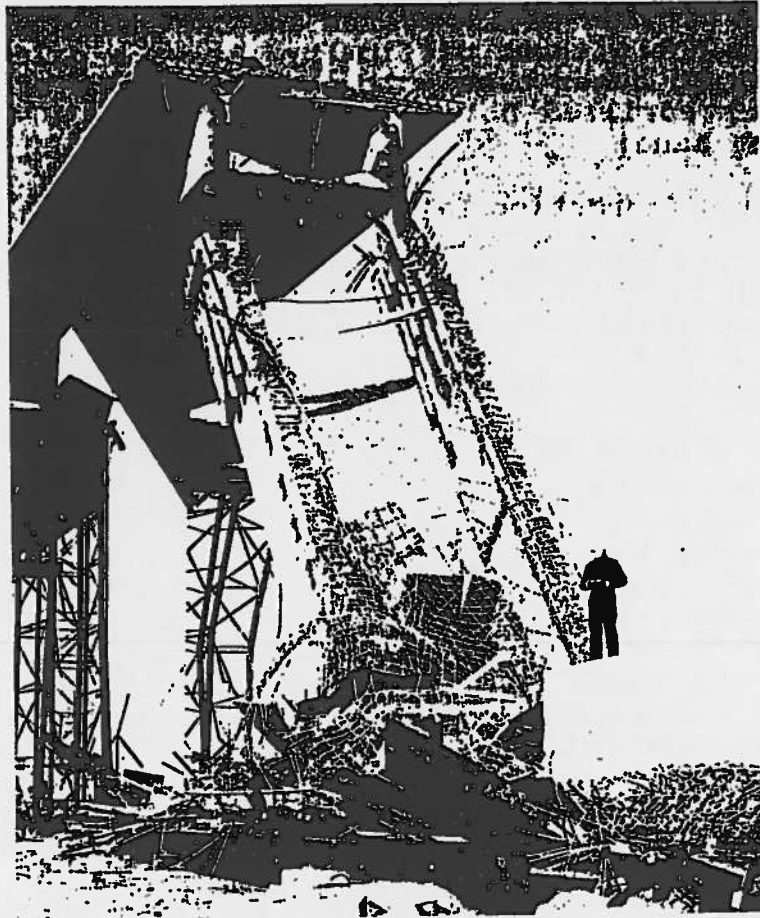
**Figure 9 Collapse of Highway Ramp During Concrete Pouring Operations**

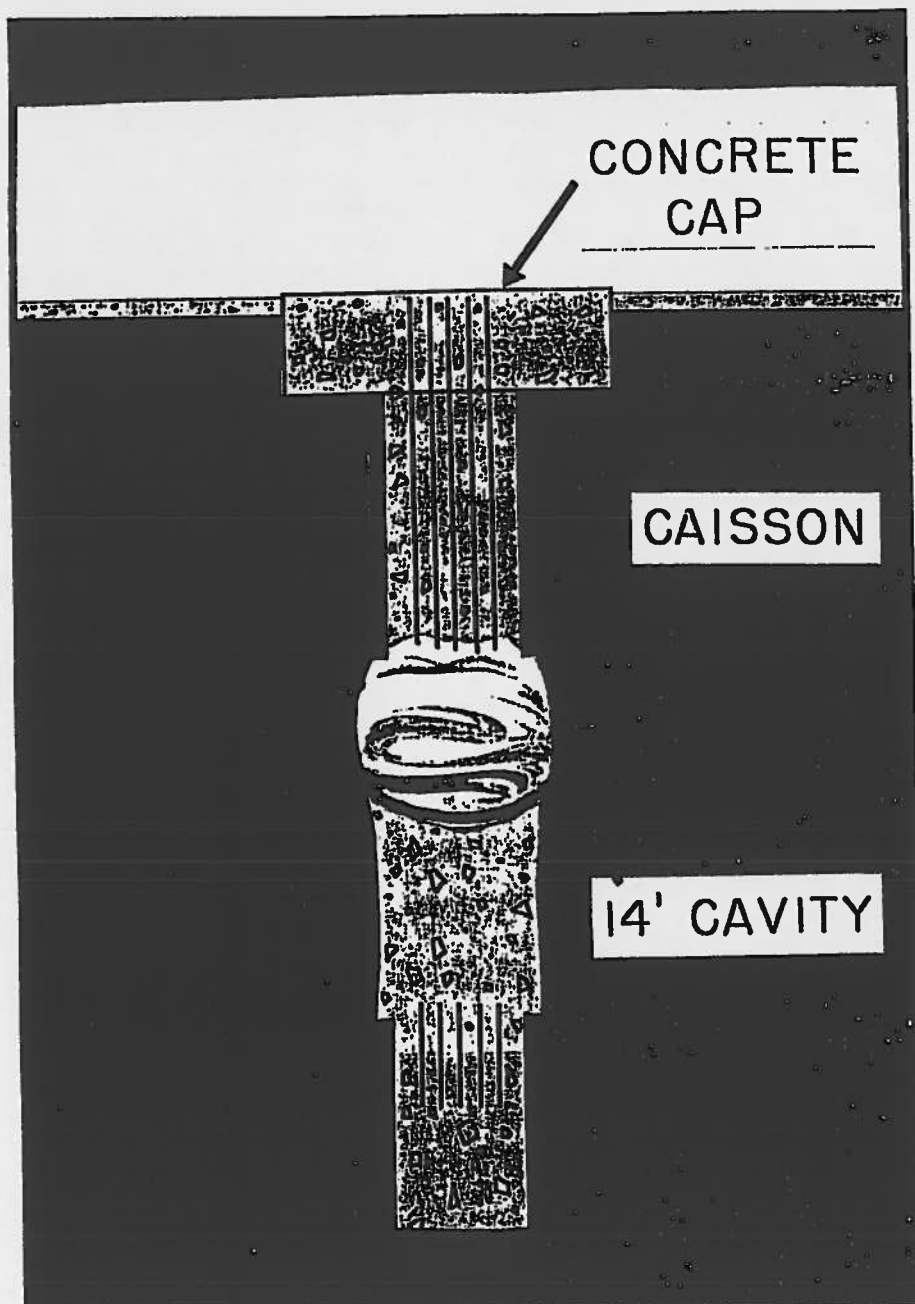
Figure 15 4.3M Void in Bored Pile
