The Kentucky Geotechnical Engineering Group Presents
The 55th Annual Ohio River Valley Soils Seminar

**55th ANNUAL OHIO RIVER VALLEY SOILS SEMINAR
NOVEMBER 12, 2025**

Levee Case Histories: Failures and Incidents Prior to Overtopping

Levee Case Histories: Failures and Incidents prior to Overtopping

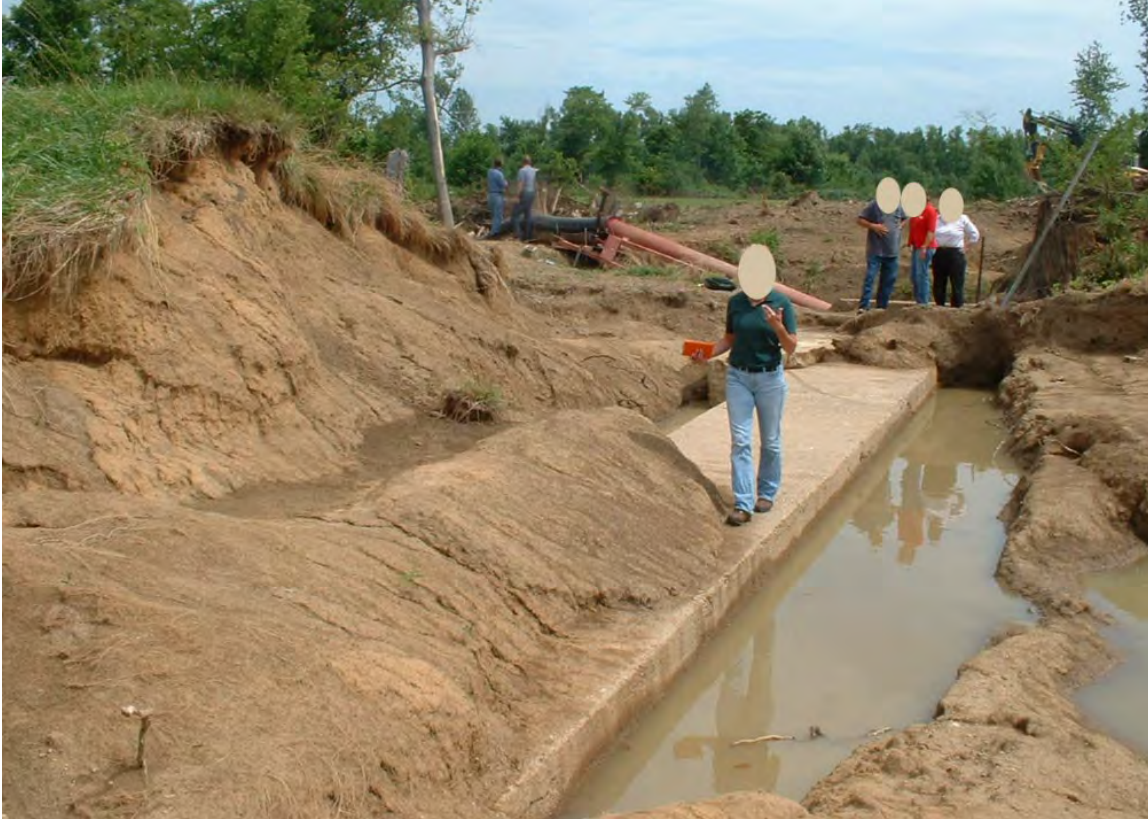
Figure 5. McGinnis Levee Failure looking toward White River

The McGinnis Levee is located on the White River near Edwardsport, IN and experienced three breaches during the 2008 flood. Two overtopping breaches occurred at low spots in the embankment. A third breach toward the downstream end of the project (Figure 4) failed directly over a concrete culvert. Following the flood event, USACE representatives met with the local sponsor at the site to observe the damage. Photos of the breach are seen in Figure 5, Figure 6, Figure 7, and Figure 11.

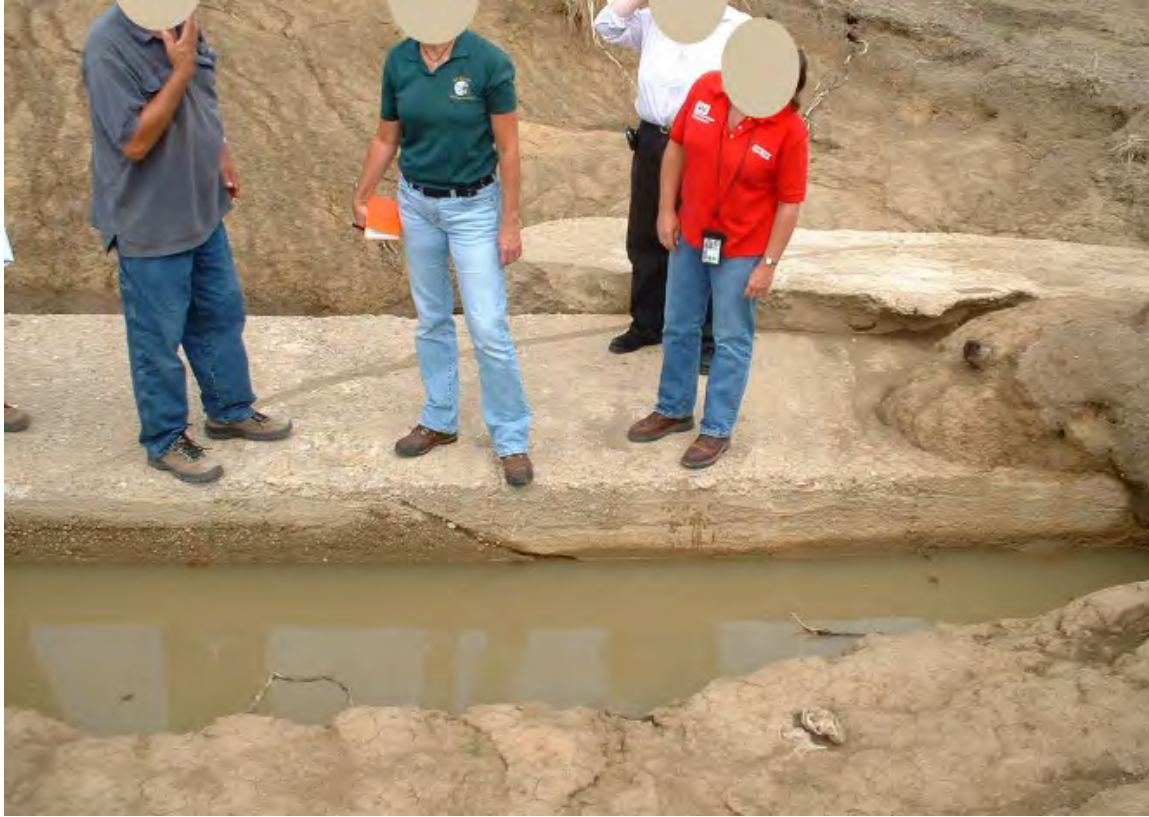
Figure 6. McGinnis Levee Failure with Crack in Concrete Culvert

Upon investigating the third breach, USACE representatives noted the levee to the left and right surrounding the breach did not appear to have been subjected to overtopping erosion or other distress. The culvert, exposed by the breach (see Figure 5), showed a large crack upstream of the levee centerline, visible just above the waterline. On the other side of the culvert, the team discovered a concrete placement adjacent the culvert as evidence of a prior repair.

It was theorized the cracked culvert may have led to the breach due to the internal erosion mechanism of internal migration (stopping). This potential failure mode (PFM) is a result of a flaw or open defect in the culvert, the existence of a downward gradient into the void, and loss of material into the void until a collapse of the levee crest occurs manifested as a sinkhole. Depending on the sinkhole location, overtopping can occur or lead to sloughing, erosion, and other instability. A schematic representation of the hypothesized slope development above the known crack is presented in Figure 7.

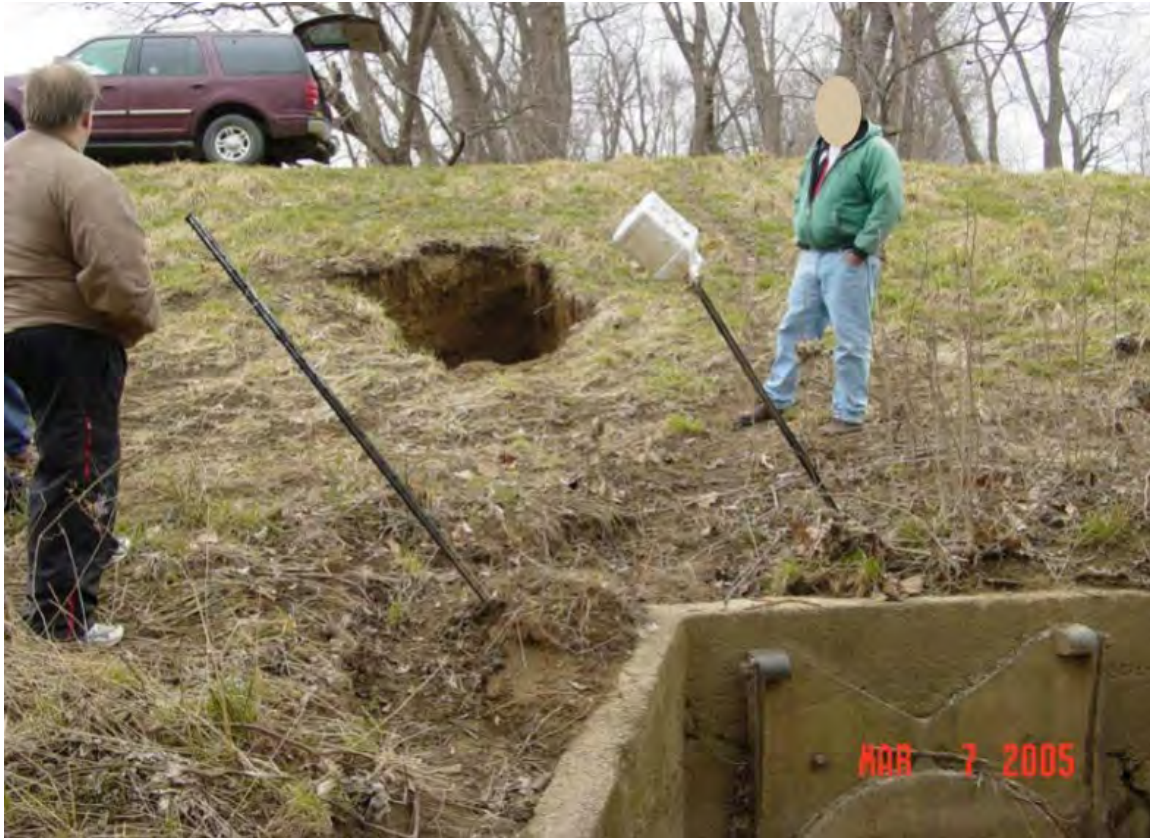
Figure 8. McGinnis 2005 Levee Collapse at Different Culvert Location

Further evidence of an internal migration PFM is the documented performance of a similar culvert upstream of the breach location during the 2005 flood event, as illustrated in Figure 8. While not the same structure, this culvert exhibits a similar rectangular conduit design, potentially indicating systemic vulnerabilities to cracking within this type of structure or its placement and backfilling. The construction dates of these concrete culverts are unknown.

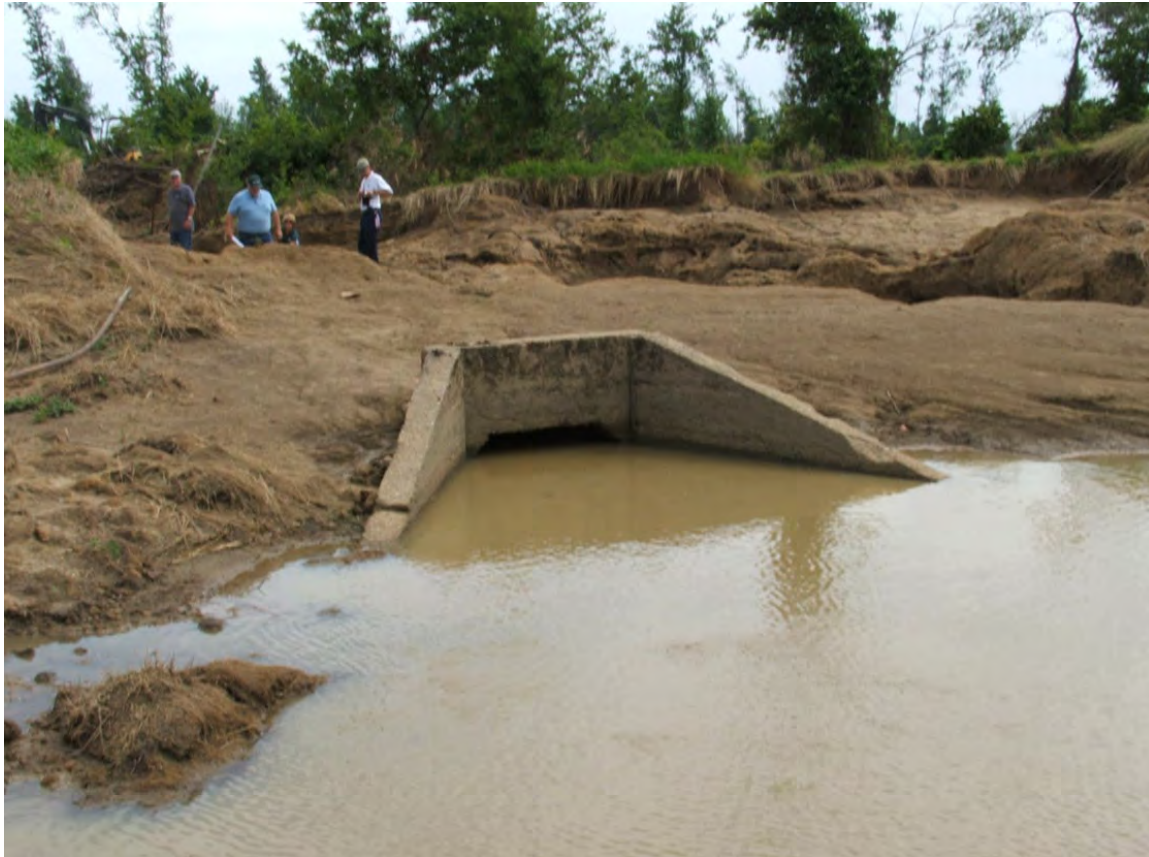
Figure 11. McGinnis Levee Failure Landside Headwall

Based on the known crack location upstream of the levee centerline, the levee crest was unlikely to have been completely compromised by a developing slope; however, internal migration may have contributed to crest settlement in the area, potentially creating a localized low point in the embankment leading to subsequent overtopping. The crack in the conduit was not further investigated by USACE as, the local sponsor elected to have repairs performed independently.

While overtopping cannot be excluded as the primary breach mechanism at this location, its probability is considered comparable to that of internal migration. Prior internal migration may have contributed to crest settlement in the area, potentially creating a localized low point in the embankment for overtopping. Concentrated leak erosion along the culvert is considered less probable based on the observed integrity of the embankment surrounding the downstream headwall, as depicted in Figure 11. For concentrated leak erosion to occur, a continuous flaw or preferential path must extend from the riverside to the landside. The intact material observed on the landside adjacent to the conduit is evidence against a continuous flaw.

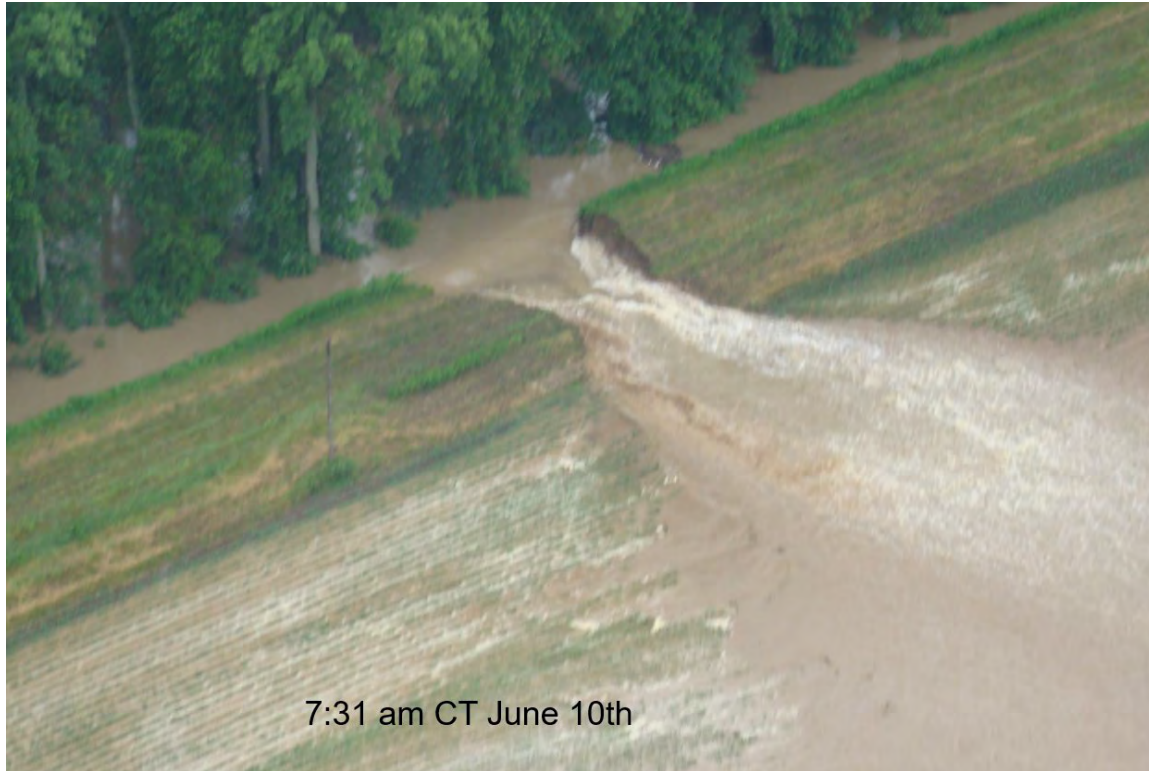
Figure 12. Russell Allison Levee Breach

The Russell Allison Levee, located downstream from Vincennes, IN, experienced a breach on the morning of June 10th. The local sponsor reportedly conducted a levee inspection approximately 2 to 3 hours prior to the breach being detected. While overtopping was occurring at locations downstream of this site, the levee at the breach location did not overtop. Following initial detection of the breach from a distance, aerial photography captured by a local pilot (Figure 12) revealed a relatively narrow breach width, estimated to be between 20 and 30 feet. The breach subsequently expanded to an approximate width of 300 feet. Post-breach inspection revealed that the upper clay blanket foundation remained largely intact, with no significant scour hole formation (Figure 13).

While the precise cause of this breach carries uncertainty, available evidence suggests that the most plausible PFM was the internal erosion mechanism of concentrated leak erosion (CLE). A notable observation supporting this hypothesis was the documented presence of animal burrows in this area during past inspections. Further evidence of animal burrowing was observed upstream of the breach location during the subsequent repair efforts. Although the sponsor levee inspection conducted earlier that morning did not reveal any indications of distress, given the time of day, there was likely low daylight during this inspection.

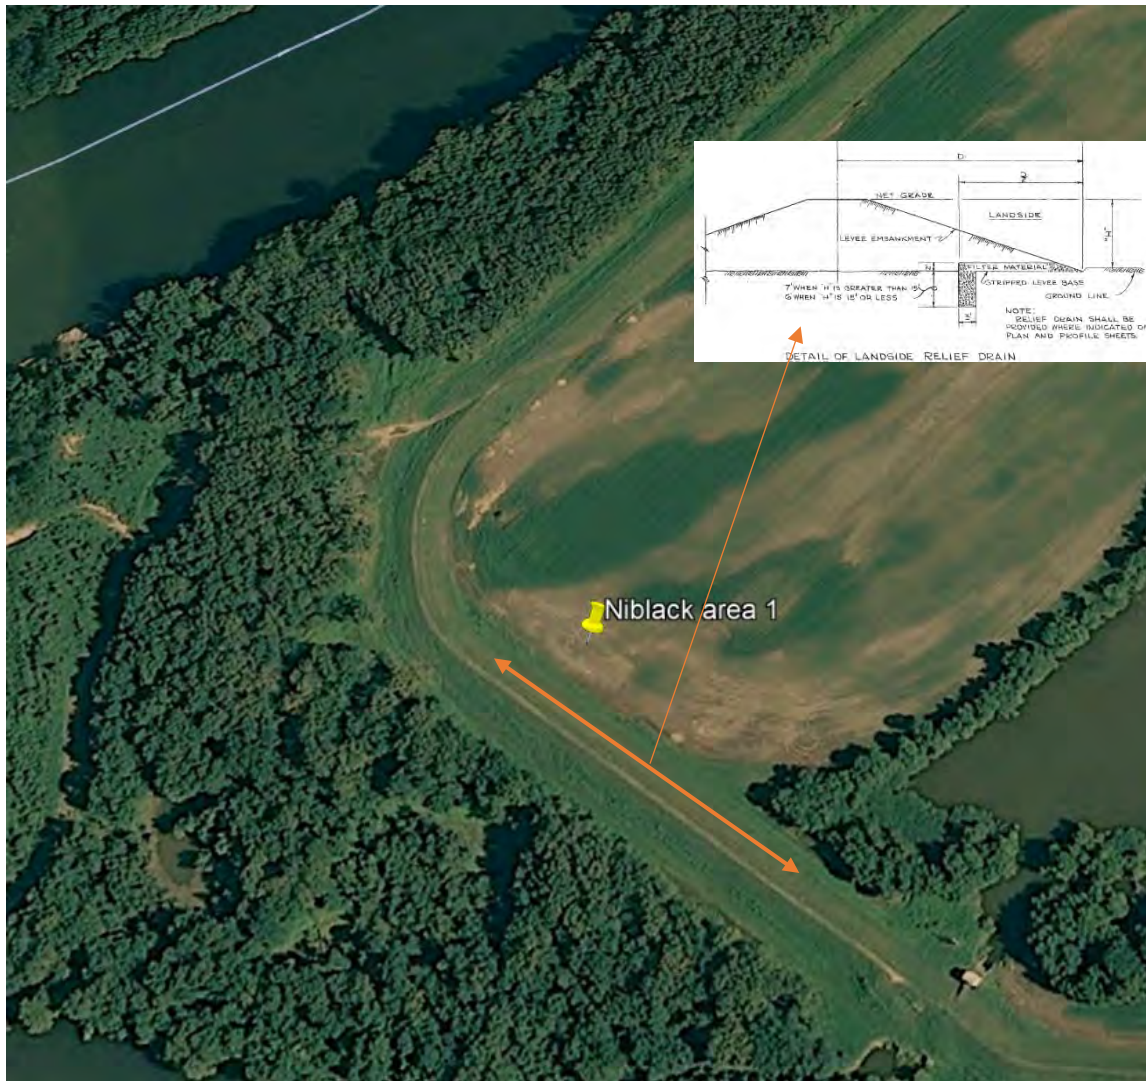
Figure 18. Niblack Aerial Image 2008 and Area with Relief Drain

Figure 18 aerial imagery shows several sand boils of notable size and discharge volume that were observed during the post-flood site visit. Contrary to initial expectations, the area incorporating the relief drain did not exhibit a demonstrably lower level of distress compared to the area on the opposite side of the bend. Representative photographs of the observed sand boils are presented in Figure 19 and Figure 20.

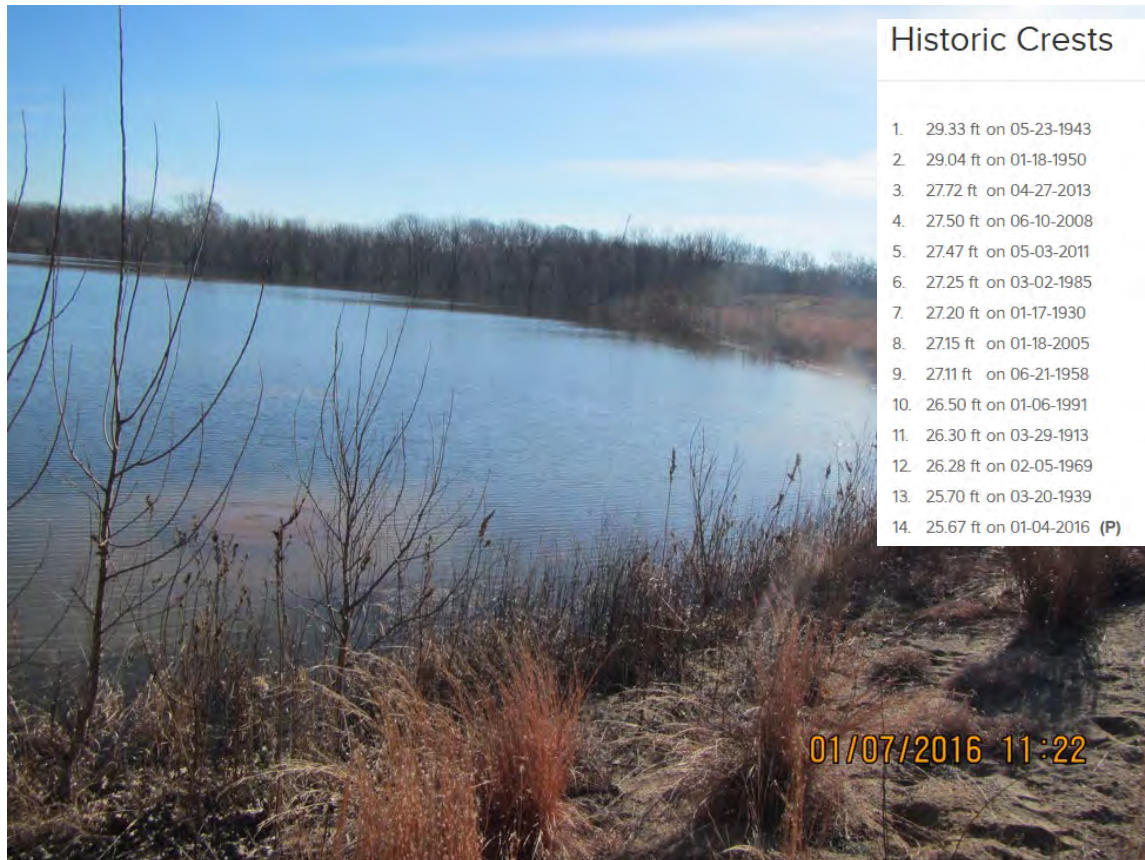
Figure 24. Photo of Toe of Niblack Sand Berm and Large Boil from 2016 Flood

The question of whether sand boils located beyond the landside berm pose a significant risk has been frequently raised. Measurements indicate that the closest boils are situated approximately 300 feet from the riverside levee toe. Given a maximum levee height estimated at 14 feet, the estimated horizontal hydraulic gradient for a top-of-levee loading condition is approximately 14 feet / 300 feet, or just under 0.05. Documented case histories of BEP progressing at such a low hydraulic gradient are considered rare. Forthcoming revisions to USACE Engineer Manual (EM) 1110-2-1913 *Design and Construction of Levees* will include berm length design criteria based on a target horizontal hydraulic gradient of 0.05. Therefore, backward erosion piping progressing to levee failure is not expected absent substantial lateral erosion of the riverside levee toe.

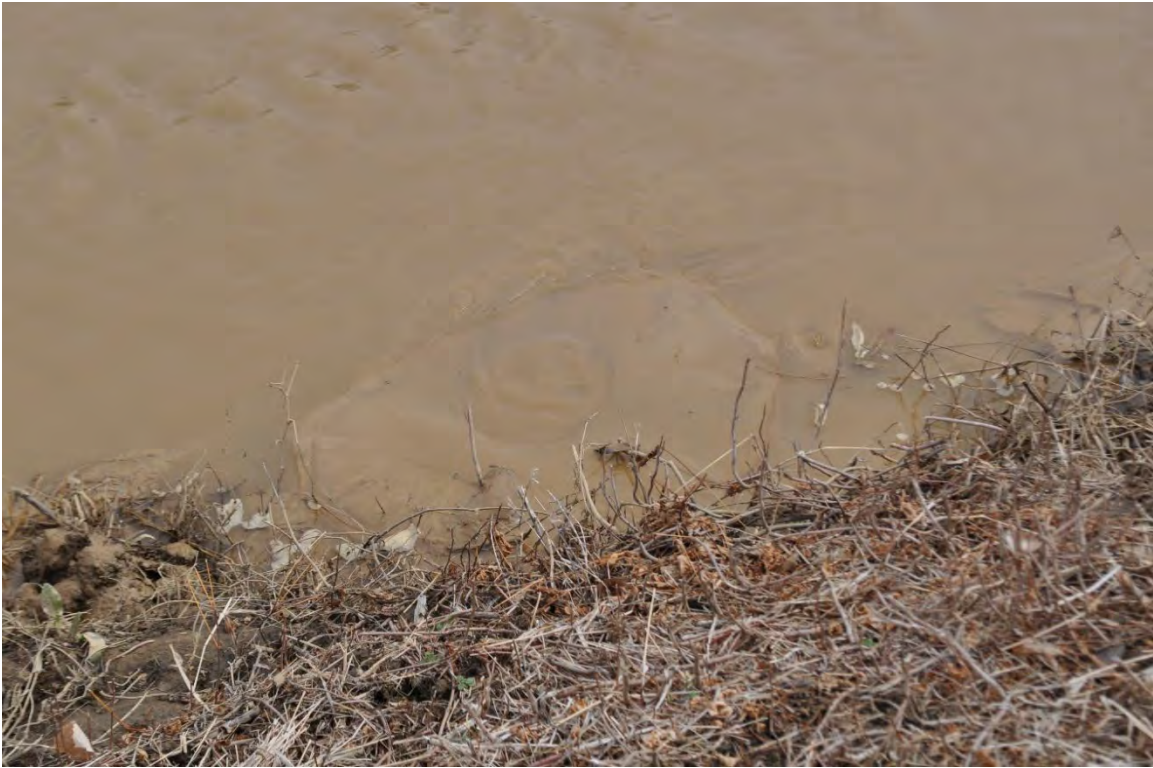
Figure 28. Boiling and Material Discharge within Landside Ditch

A drainage ditch situated landside of the levee embankment, likely just outside the levee easement, was exhibiting sloughing along its edges as shown in Figure 27. Seepage was observed within the sidewalls of the ditch, primarily manifesting as horizontal flow along both sides of the ditch and active boiling with cloudy discharge was noted (Figure 28) within the ditch in several locations. While these observations were concerning, they were not dissimilar to conditions observed by USACE personnel during prior flood events and did not, at the time, indicate an imminent failure. Given projections of a limited further rise in river stage, a recommendation was conveyed to the sponsoring agency to attempt to increase water levels within the ditch by ceasing pump operations at the downstream discharge point of the ditch and constructing a temporary dam to impound water within the ditch. The sponsoring agency subsequently installed a berm across the ditch near the pump station, but this may not have increased the water depth upstream where the breach occurred. During the March 3rd site visit, the river stage was at the riverside levee toe, resulting in an estimated hydraulic head differential of only a few feet in relation to the ditch bottom. The river stage continued to rise and crested with approximately 5 feet of freeboard remaining. Figure 29 presents a photograph taken from the levee crest, likely in close proximity to the eventual 2011 breach location. A previous breach repair from the 2008 flood event is shown just upstream.

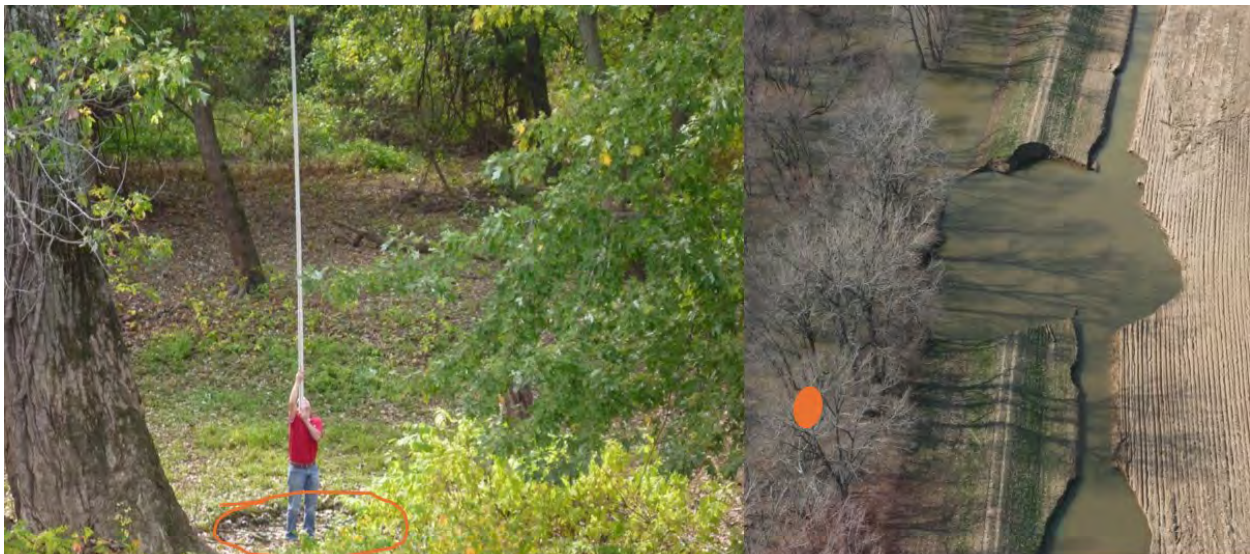
Figure 33. Location of Riverside Holes in Borrow Pit

During the inspection, the presence of two significant depressions were documented in the riverside borrow area. Regrettably, no high-quality photographs of these features were acquired during the field visit. However, Figure 33 shows one such depression in the background, along with its approximate location in the adjacent aerial imagery. These depressions were subsequently hypothesized to represent potential seepage entry points resulting from the progression and subsequent collapse of a backward erosion pipe.

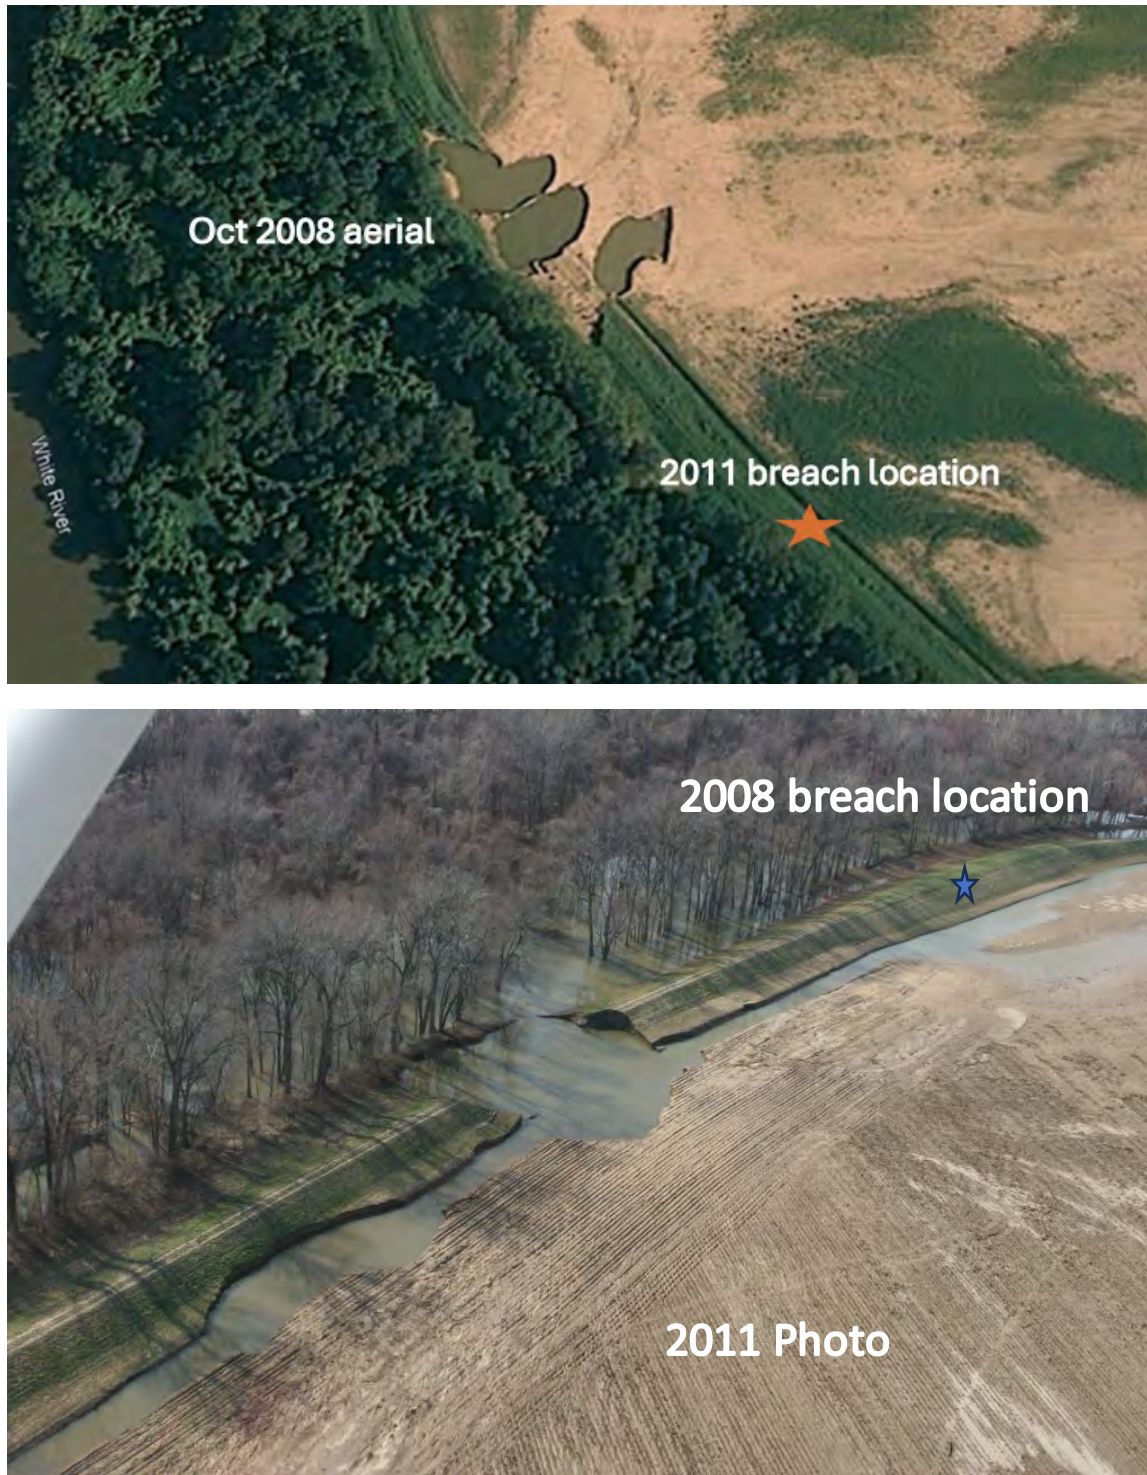
Figure 35. Levee Unit 8 2008 and 2011 Breaches

After the 2011 breach, the cause of the adjacent 2008 breach was reexamined. While the 2008 flood event was the flood of record for this levee system and photographic documentation confirms overtopping failure at two locations downstream of this location, this particular site may not have breached from overtopping. Aerial imagery from 2008 (Figure 35) reveals the presence of the ditch at this location, with subsequent reconnaissance of earlier aerial imagery suggesting the ditch was excavated in 2007. Notably, the 2005 flood event, the second highest on record after 2008, did not result in levee failure.

Given the possibility that the 2008 breach may also have been initiated by BEP, it is plausible that pre-existing vulnerabilities were present at the 2011 breach location. The 2008 event subjected the levee to a hydraulic loading approximately 5 feet higher than that experienced during the 2011 event. A remnant piping pathway may have existed beneath the embankment and reactivated erosion in 2011.

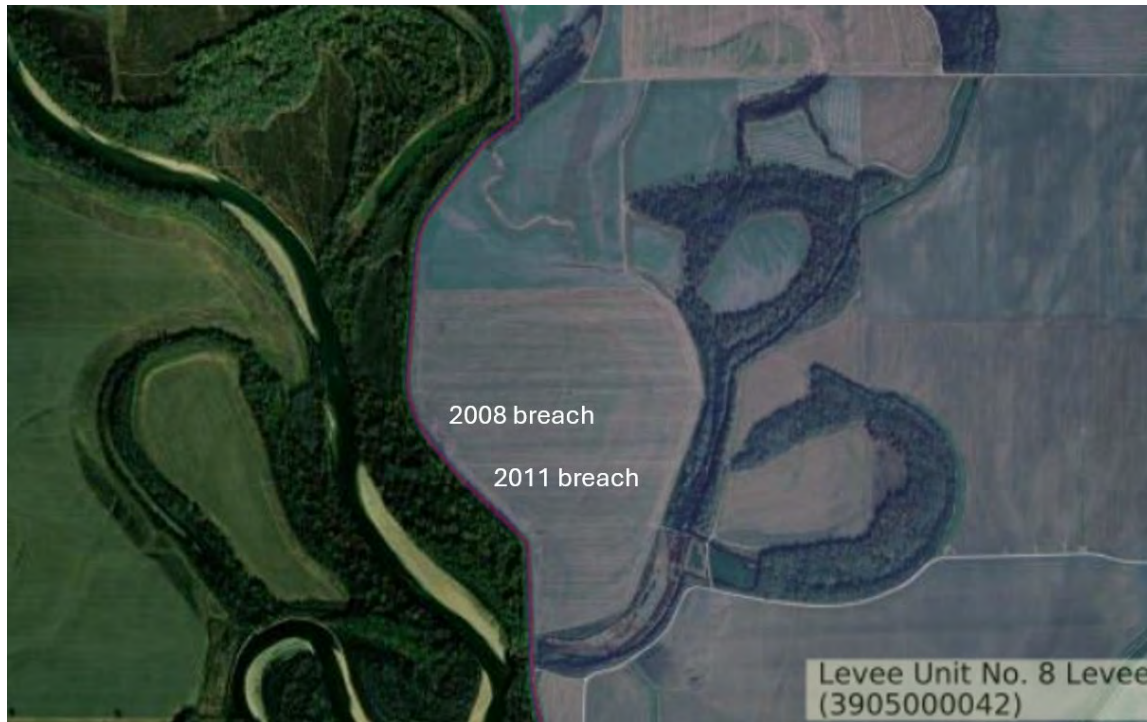
Figure 36. Levee Alignment at Breach Locations

Analogous to the Niblack Levee, potential three-dimensional hydraulic loading effects may have influenced conditions at this site. The failure location is within a levee segment characterized by two inside bends, as illustrated in Figure 36. Consequently, localized increases in uplift pressures and flow may have contributed to the observed distress at these breach locations.

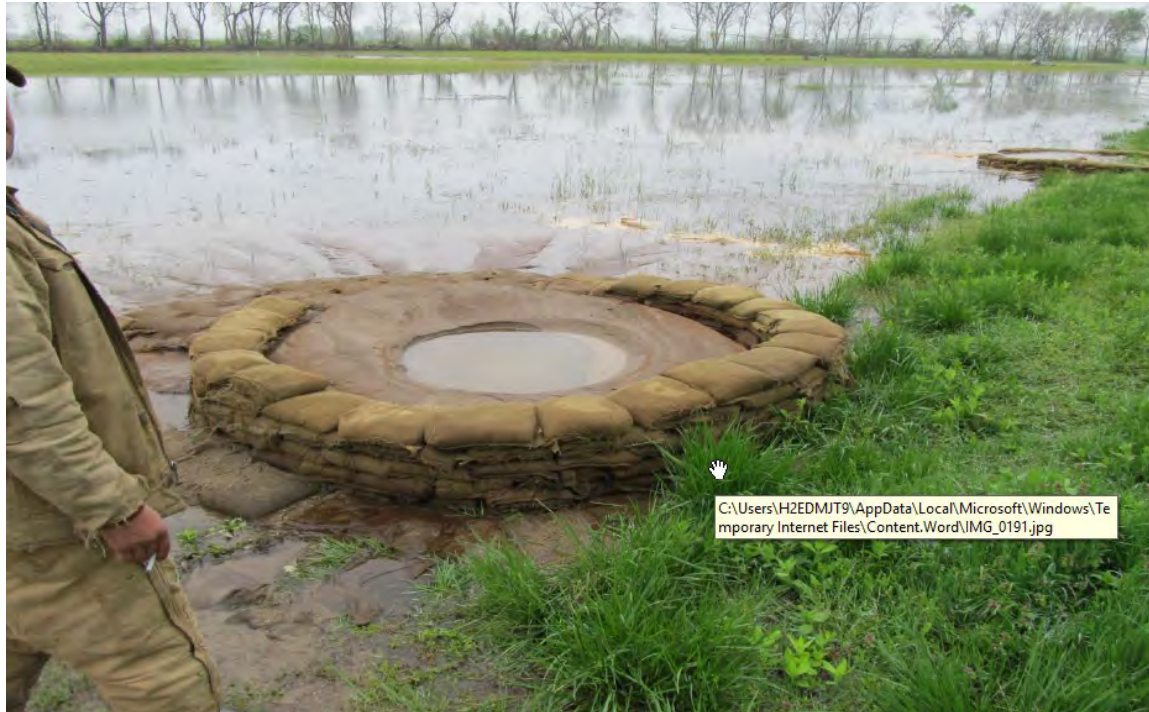
Figure 38. First and Second Boil During Flood

In 2013, the local sponsor discovered a large sand boil had developed and was discharging a high volume of sand. Immediate flood-fighting measures were initiated, involving the construction of a sandbag ring around the boil to increase the landside hydraulic head and thereby reduce the overall hydraulic gradient. This intervention resulted in a reduction in the boil's discharge rate, with the sandbag ring accumulating transported sediment. Shortly thereafter, a second sand boil exhibiting similar characteristics emerged. The local sponsor implemented the same sandbag ring construction technique, again achieving a reduction in the discharge rate. Subsequently, a third sand boil, located further from the levee, began discharging sediment at a high rate, transporting a considerable volume of material. The first and second boils, located near the landside levee toe, are shown in Figure 38.

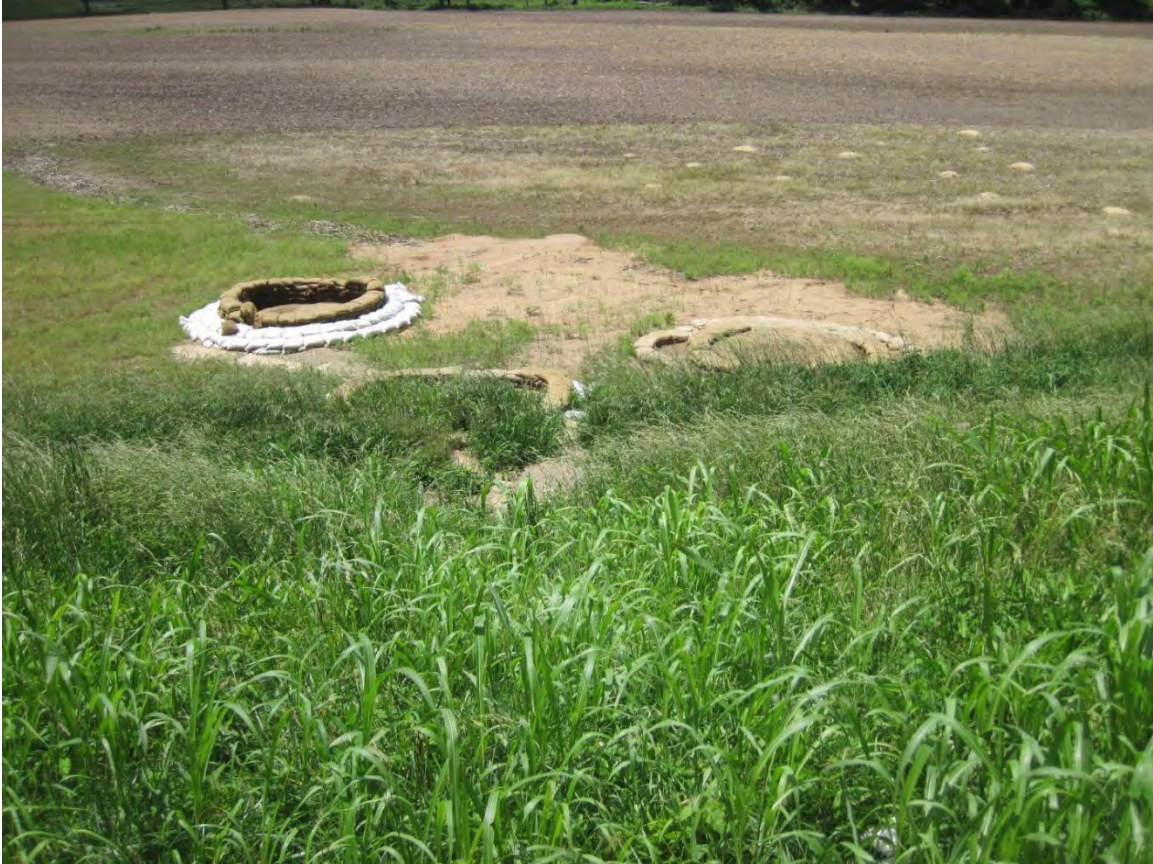
Figure 39. Three Large Sand Boils at Russell Allison 2013

The third sand boil was also encircled with sandbags, and it also continued to discharge sediment. Rather abruptly, the discharge from the third boil stopped. The local sponsor characterized this cessation to the author as an abrupt and unexpected loss of flow. The local sponsor anticipated the formation of additional boils, but no further activity was observed. A post-flood photograph illustrating the three boils is shown in Figure 39. As can be seen in the background, several smaller sand boils were also present in the area.

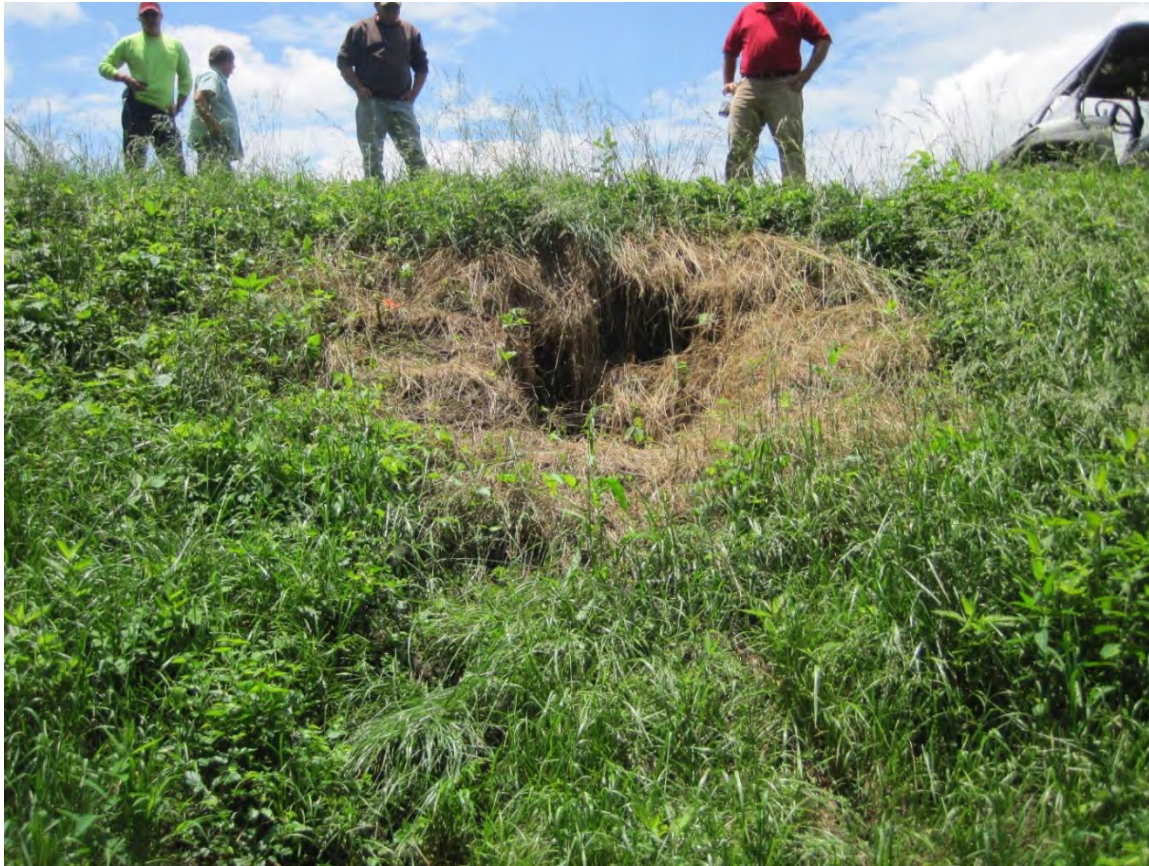
Figure 40. Riverside Slope Subsidence

Following the flood event, a collapse was identified in the riverside levee embankment slope, aligning directly with the location of the large boils observed during the flood. A photograph of the collapse, taken from the riverside levee toe, is shown in Figure 40.

The observed subsidence in the riverside slope and the abrupt cessation of flow from the third sand boil during the peak of the flood event presented unexpected phenomena. The characteristics of the boils, including their size and discharge rates, were consistent with those observed in other case histories where BEP was confirmed and, in some instances, led to levee breaches. In this particular scenario, the sudden stoppage or reduction in flow may be attributable to a roof collapse over the developing pipe beneath the levee embankment. A schematic representation of this potential mechanism is shown in Figure 41.

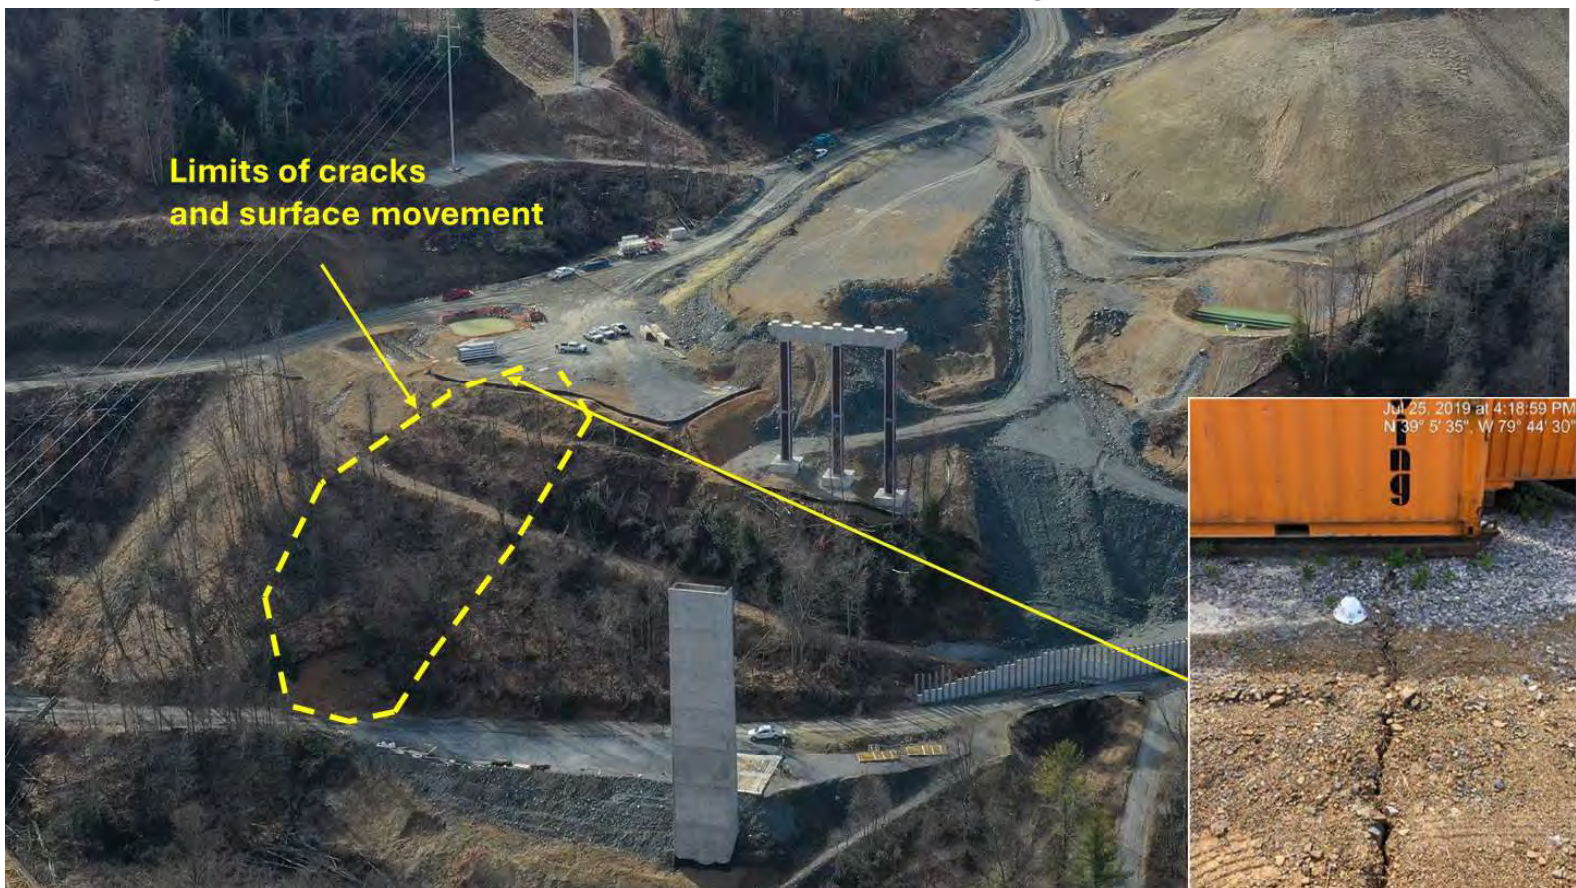
July 22, 2019 KCC found inconsistencies in position of Pier #1 of 12 inches
~2 ½ inches displacement to NE between Aug 16, 2019 and Jan 15, 2020

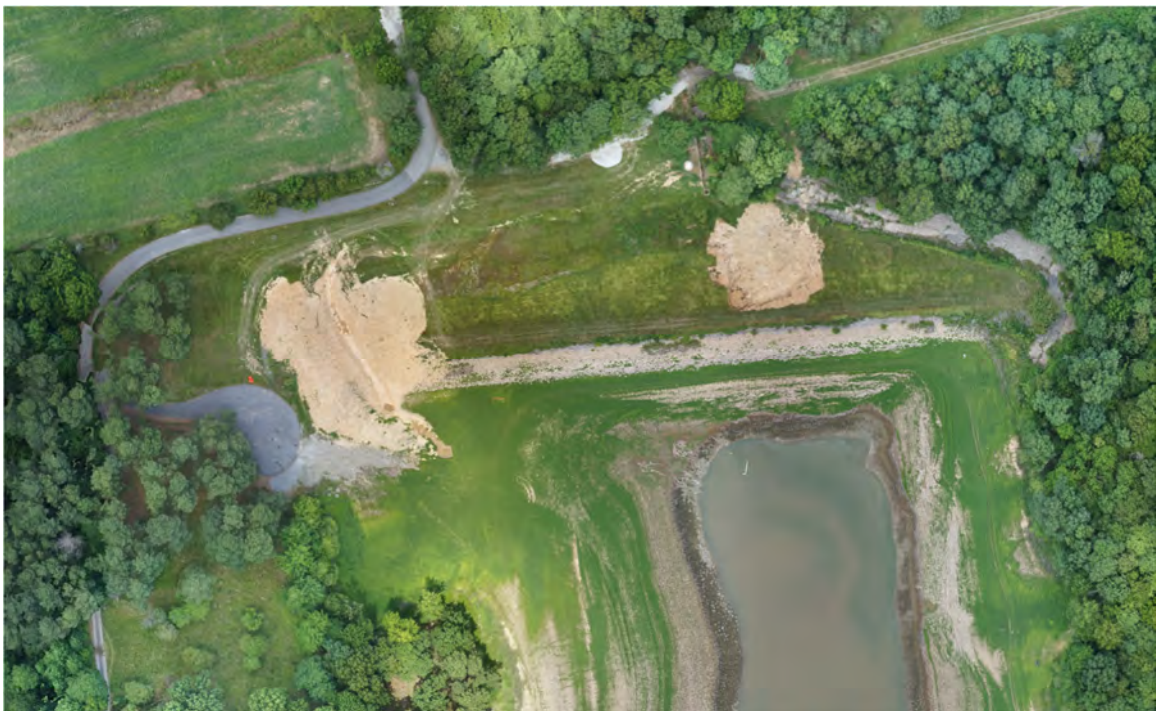
Figure 7. Post Failure Aerial from June 2022

Figure 7 is an aerial image from June 2022 showing the breach at the left abutment and the excavation of the downstream slope near the location of the sinkhole. Note that the reservoir level at the time was well below the breach invert elevation, presumably due to continued draining of water through the 12-inch CIP and evaporation due to dry hydrologic conditions following the initial Dam Safety incident.
