OHIO RIVER VALLEY
SOILS SEMINAR XLII
October 21, 2011 | Cincinnati, OH

LESSONS LEARNED: FAILURES AND FORENSICS

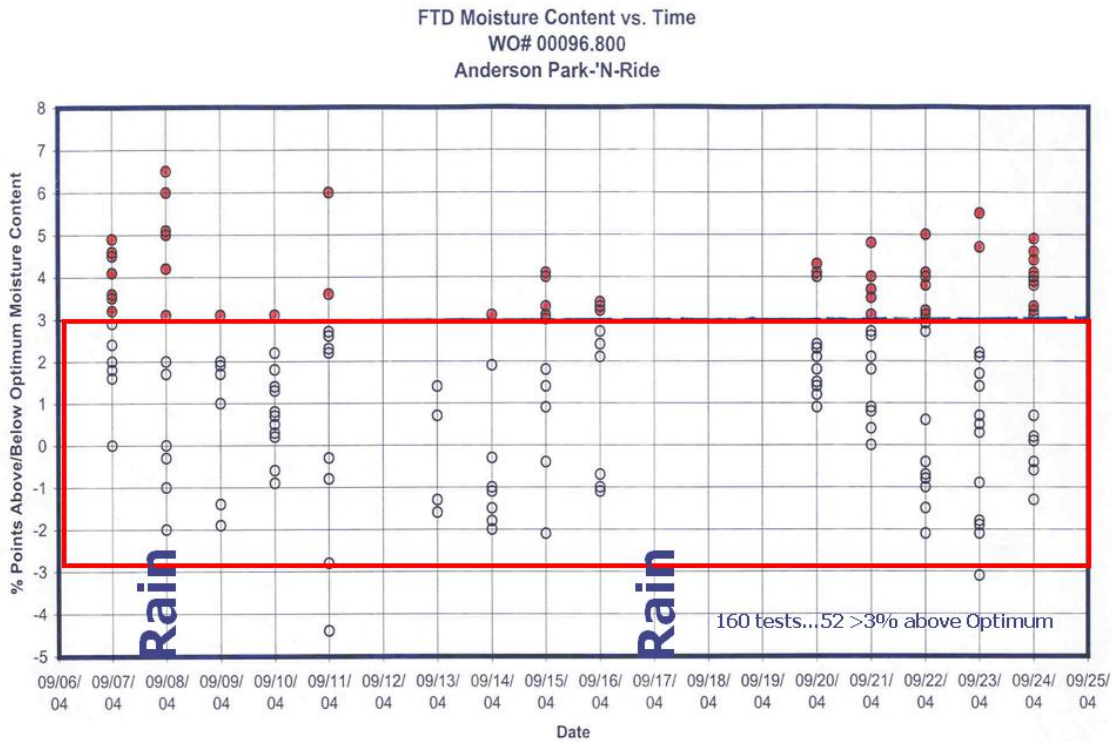
Fig. 1. Field Density Test Moisture Content vs. Time

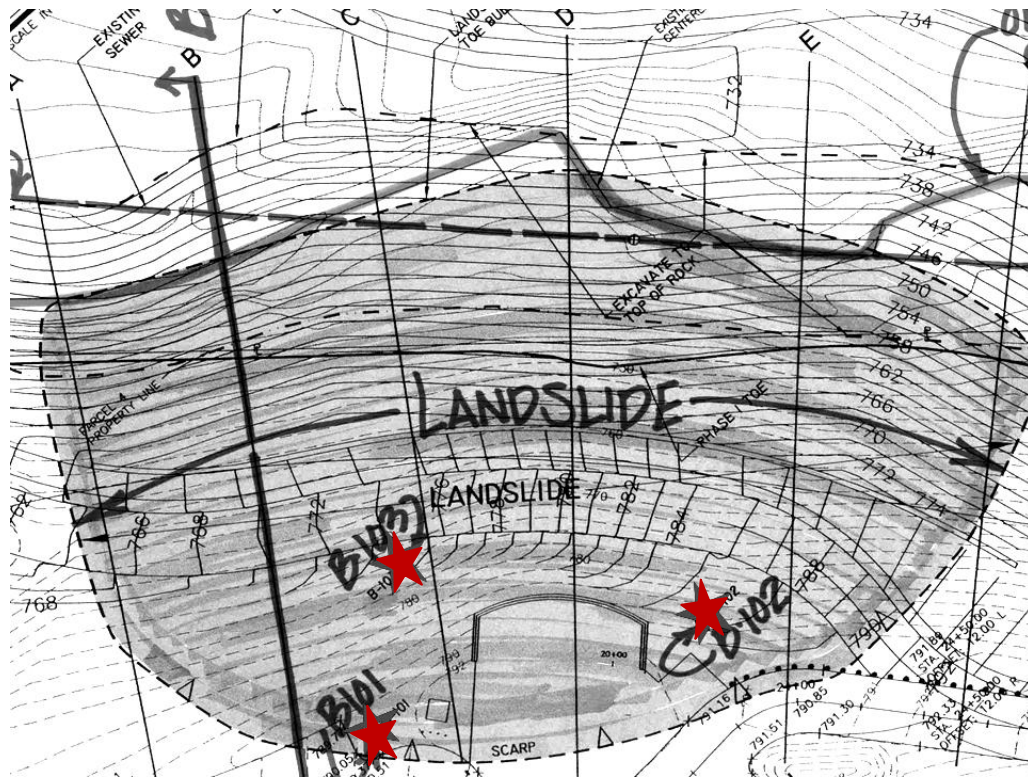
Fig. 2. Test Boring Location Plan

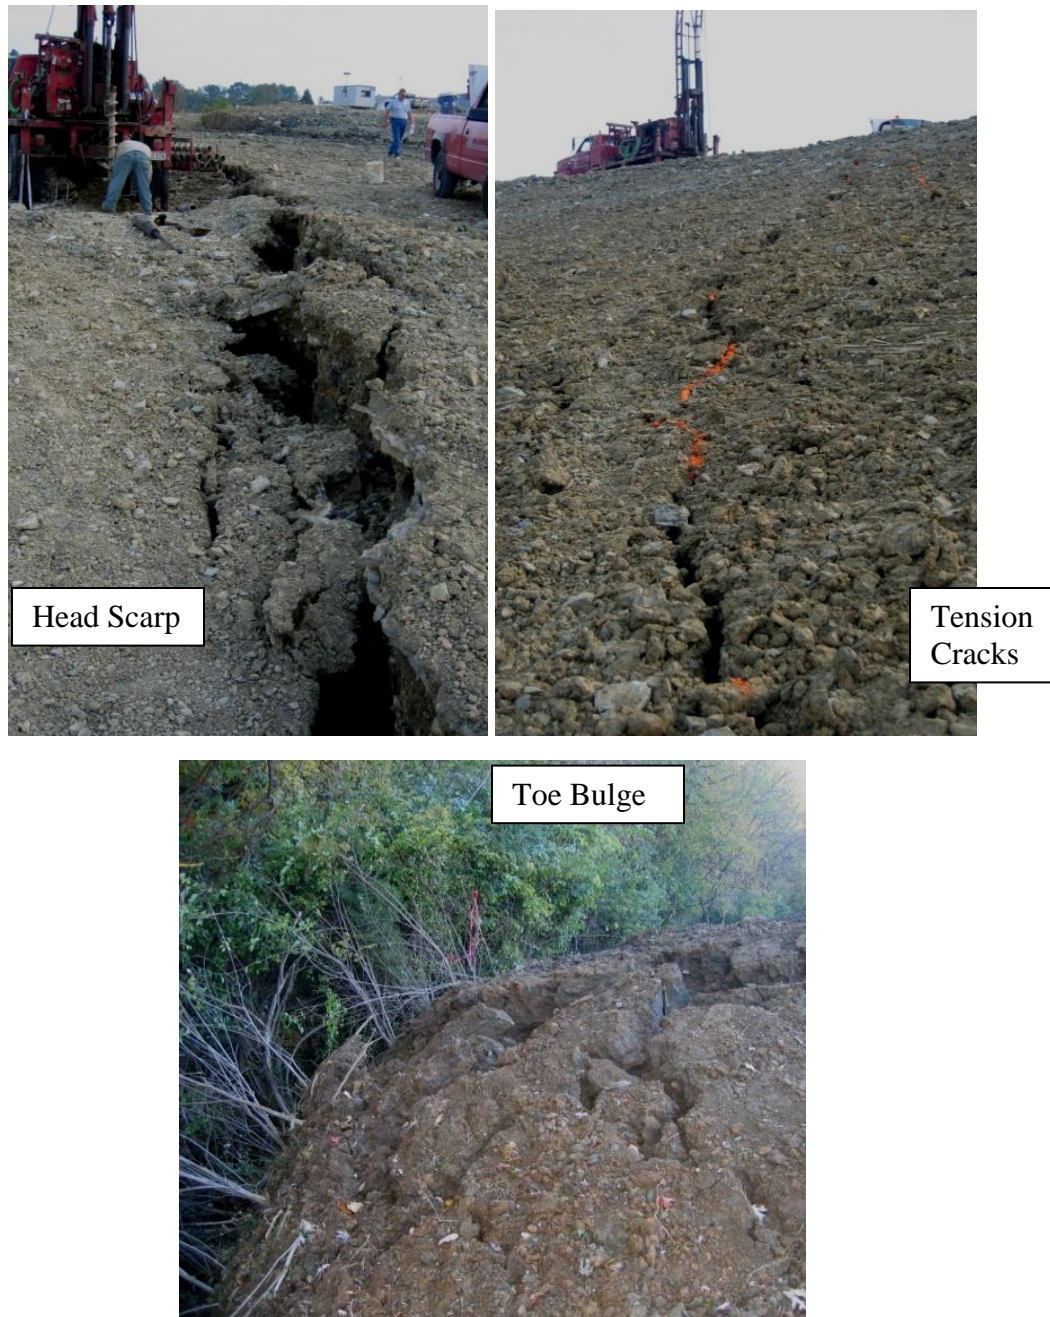
Fig. 3. Landslide Photos from October 2, 2004

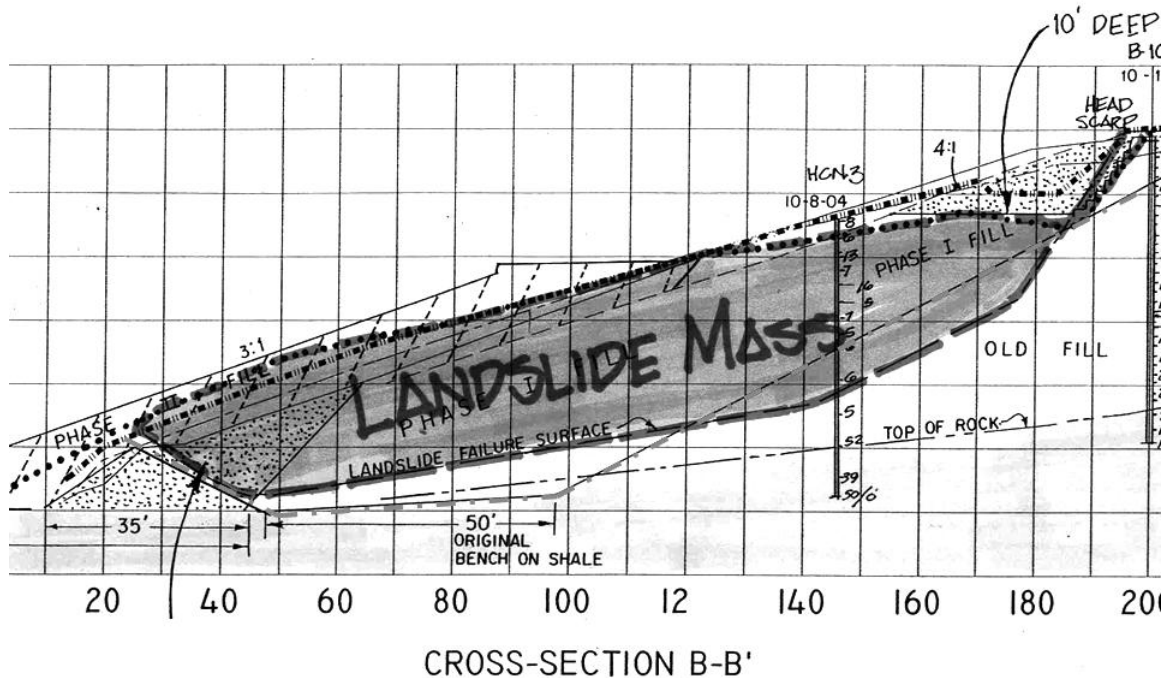
Fig. 4. Cross section showing the embankment failure mass

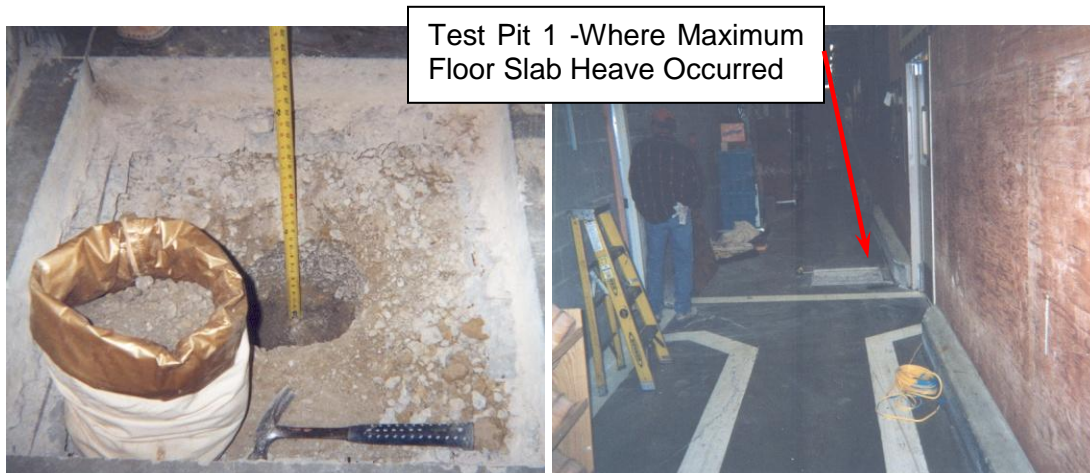
Fig. 5. Photos of Test Pit 1 in “Back-Room”

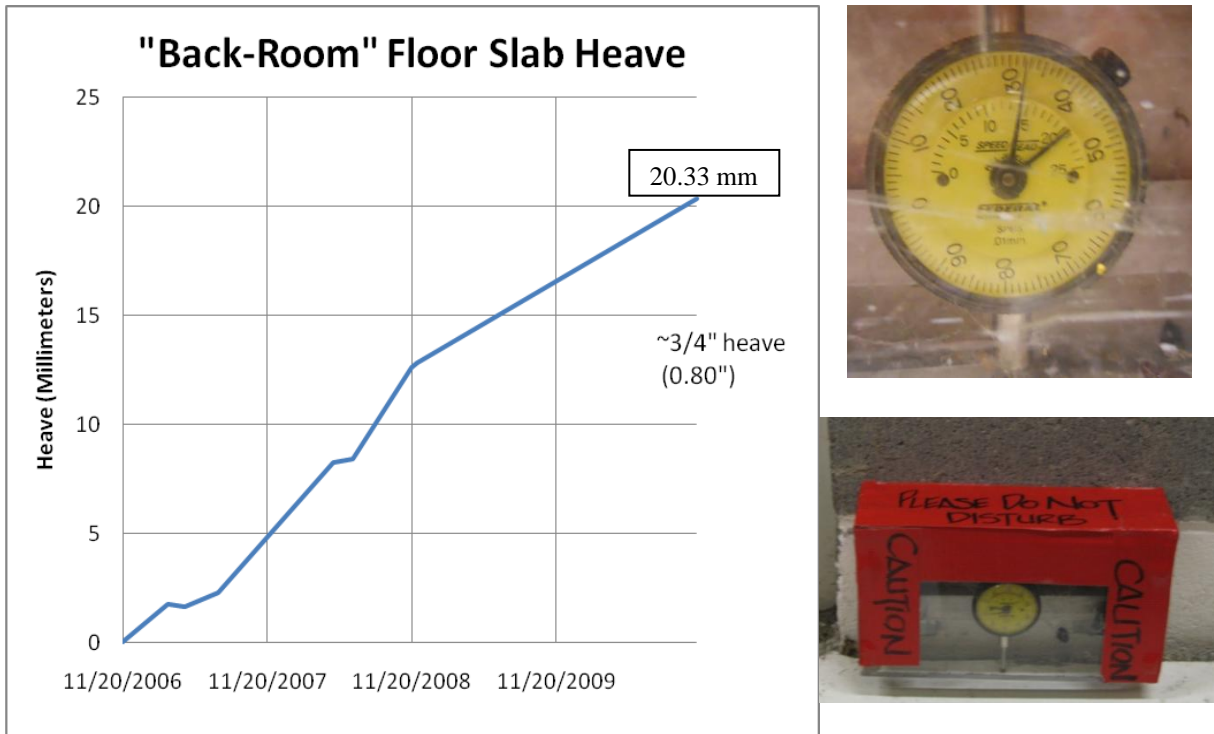
Fig. 6. Floor slab heave versus time

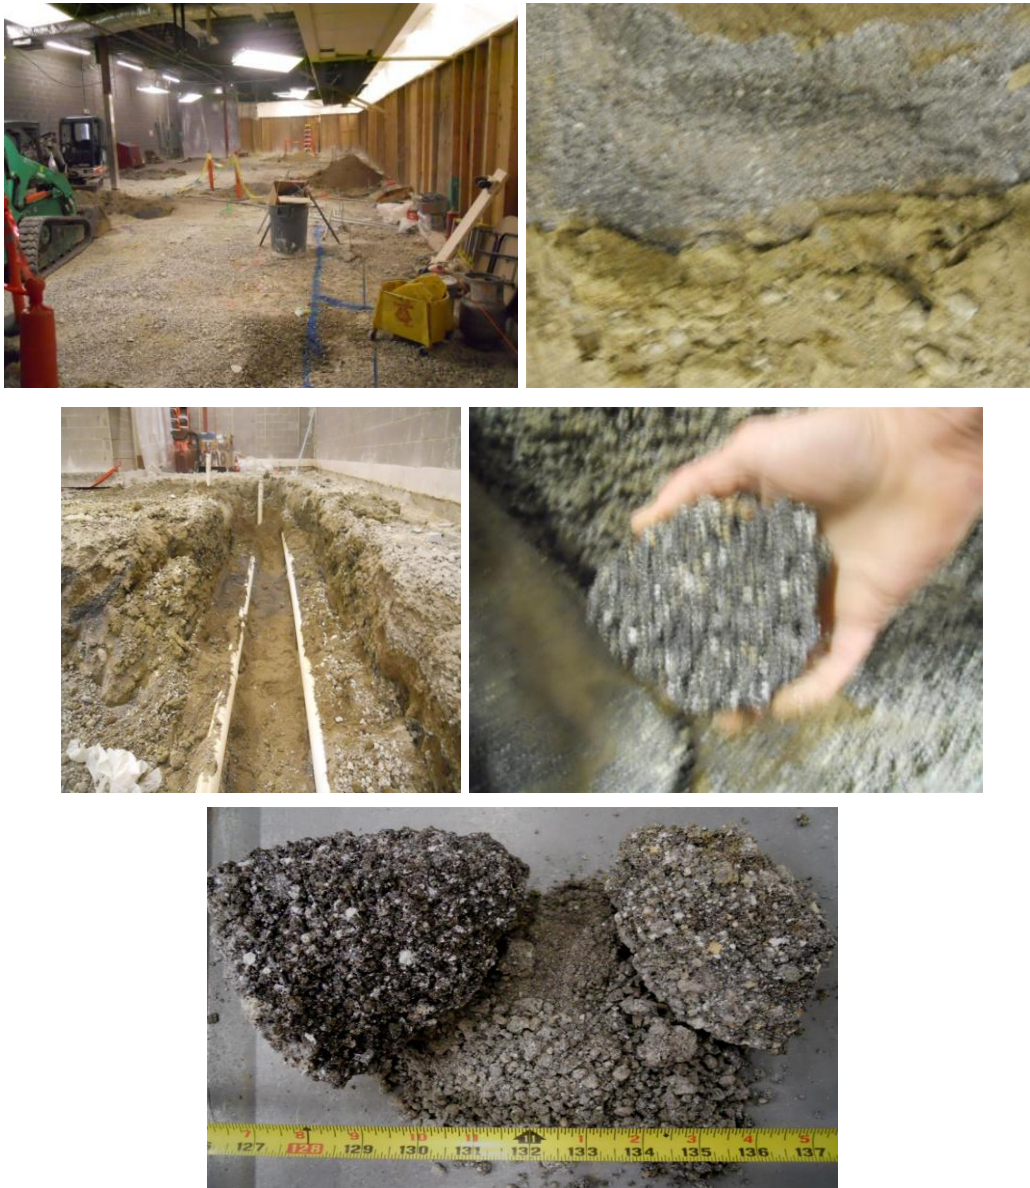
Fig. 7. Photos showing bands of cinder and slag backfill within the utility trenches and gypsum inclusions within the cinder and slag backfill.

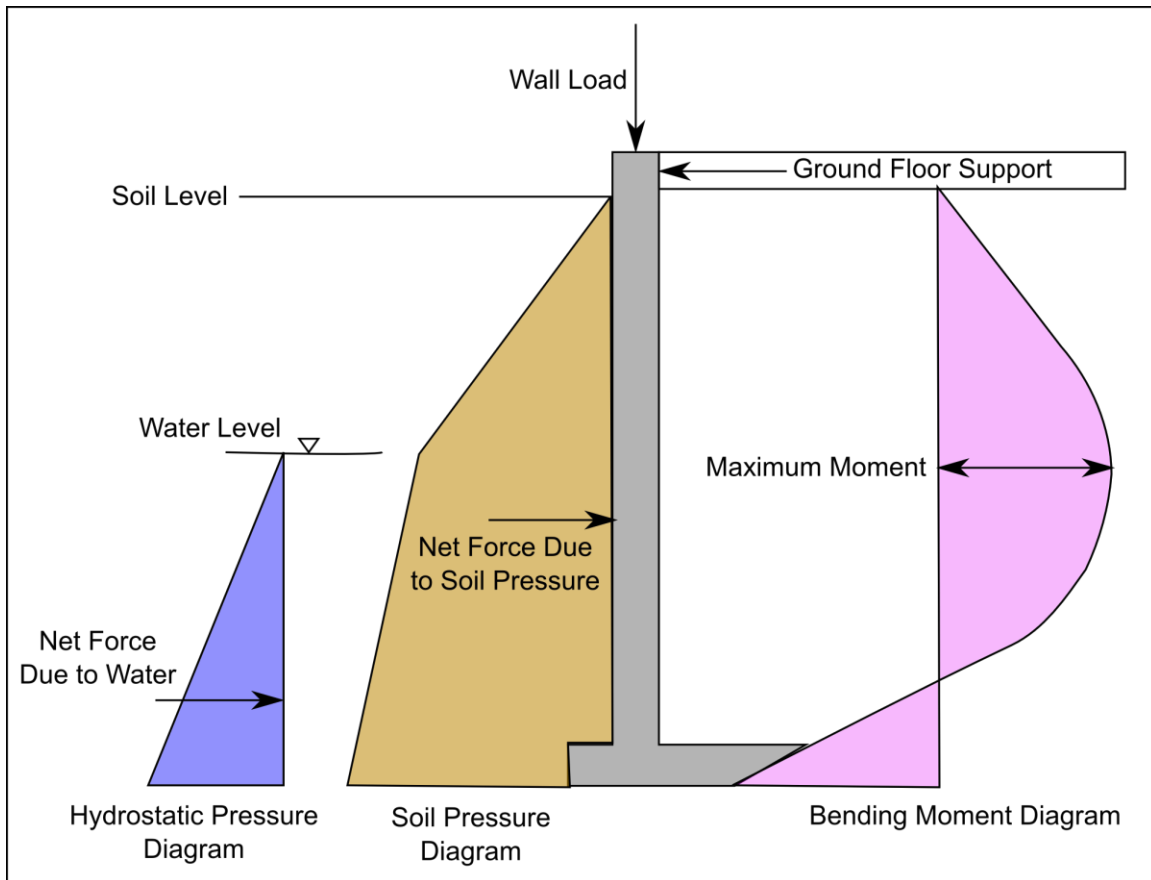
Fig. 1. Basement Wall Loading Conditions - schematic, not to scale

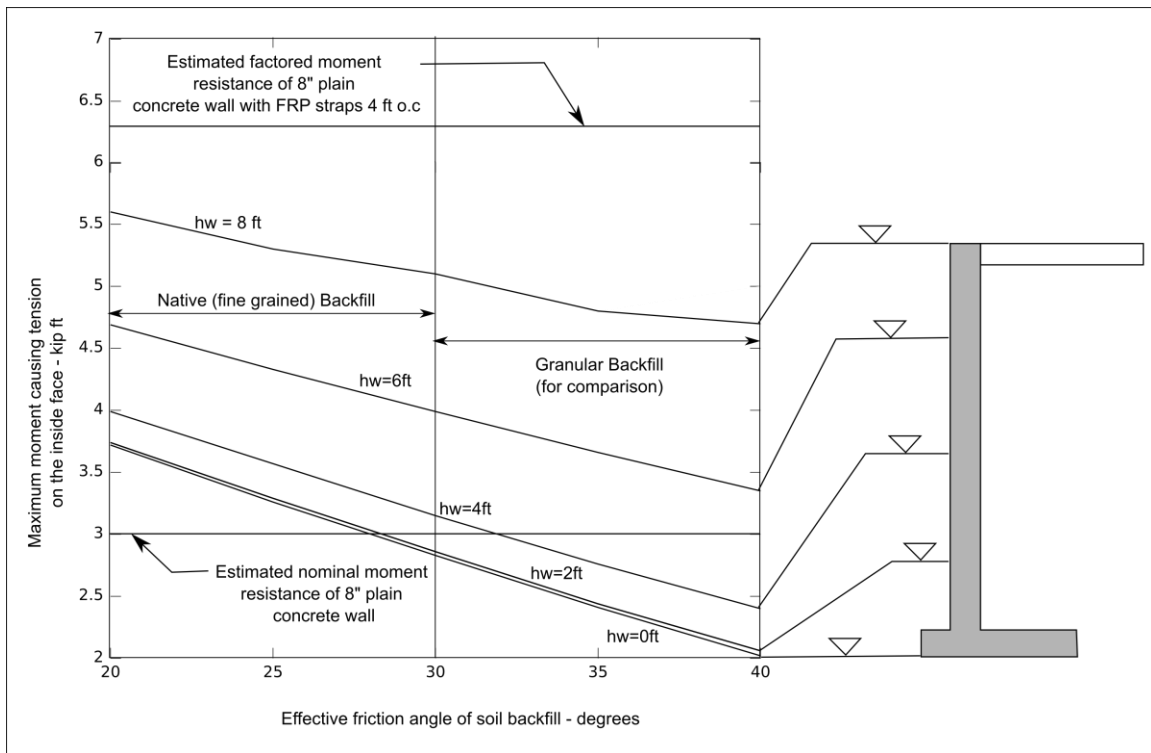
Fig. 2. Bending Moments and Structure Resistance

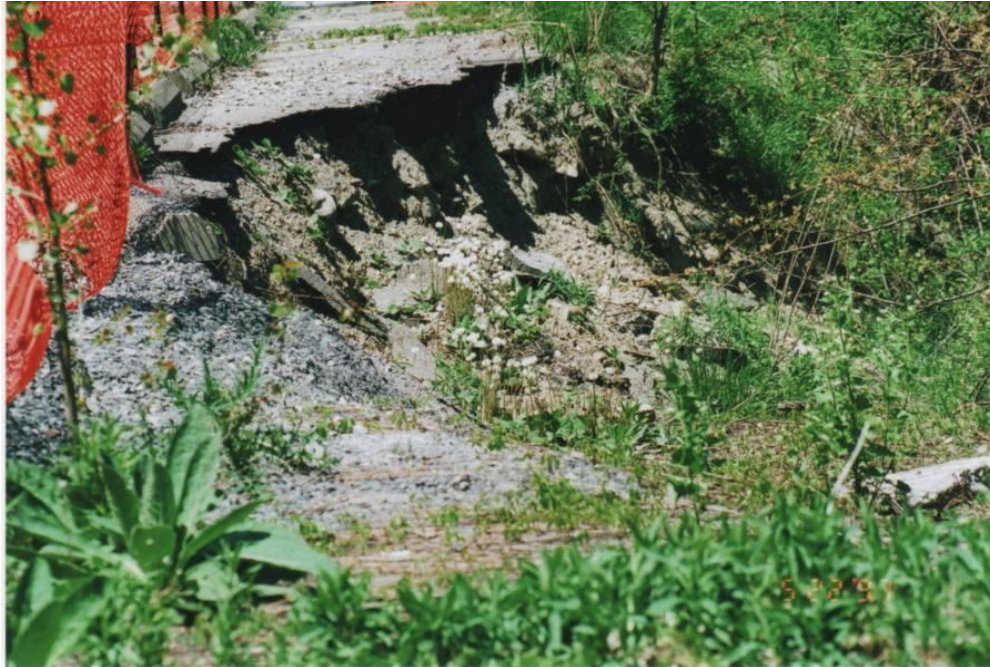
Fig. 1. North end of the ground movement on May 22, 1997

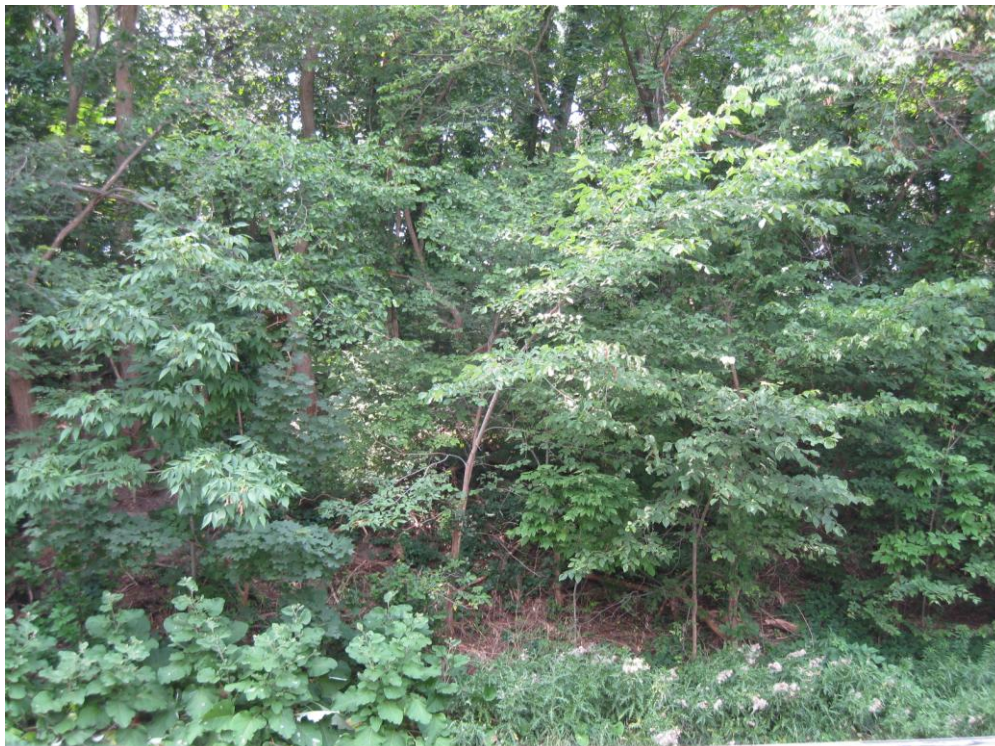
Fig. 2. Ground conditions on the west side of the Parkway in the slide area

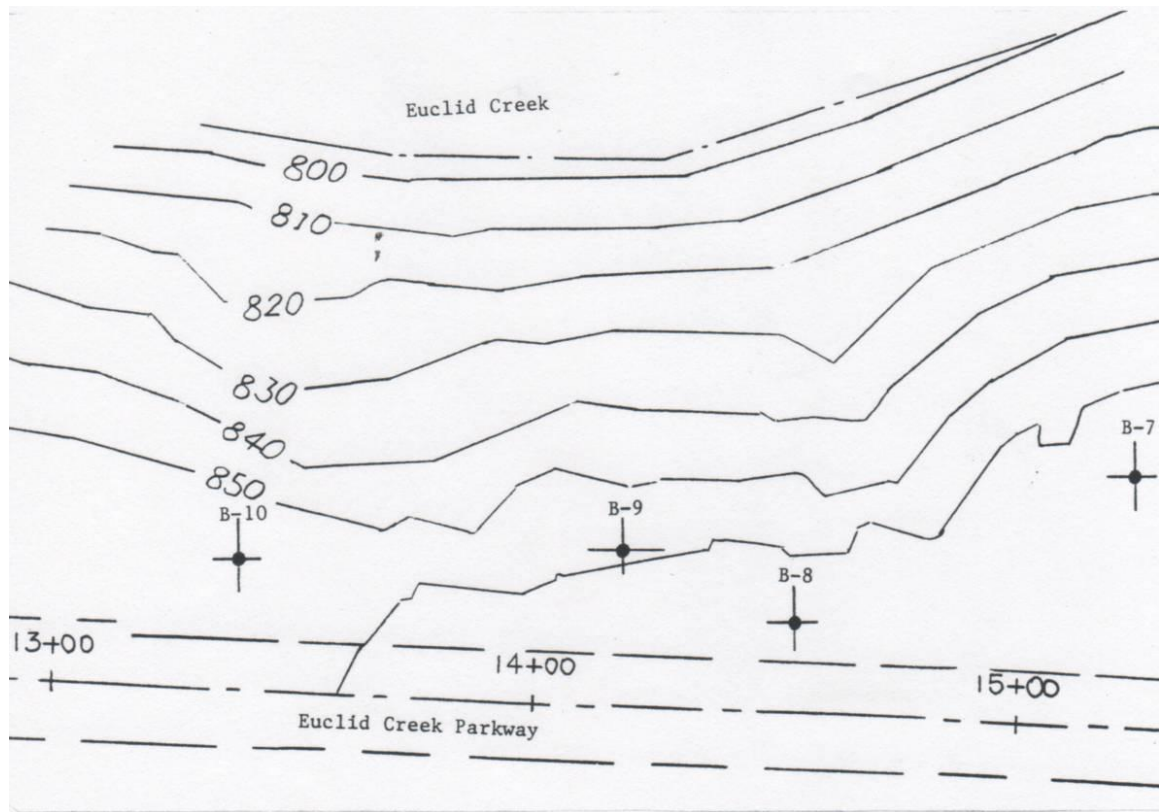
Fig. 3. Locations of borings

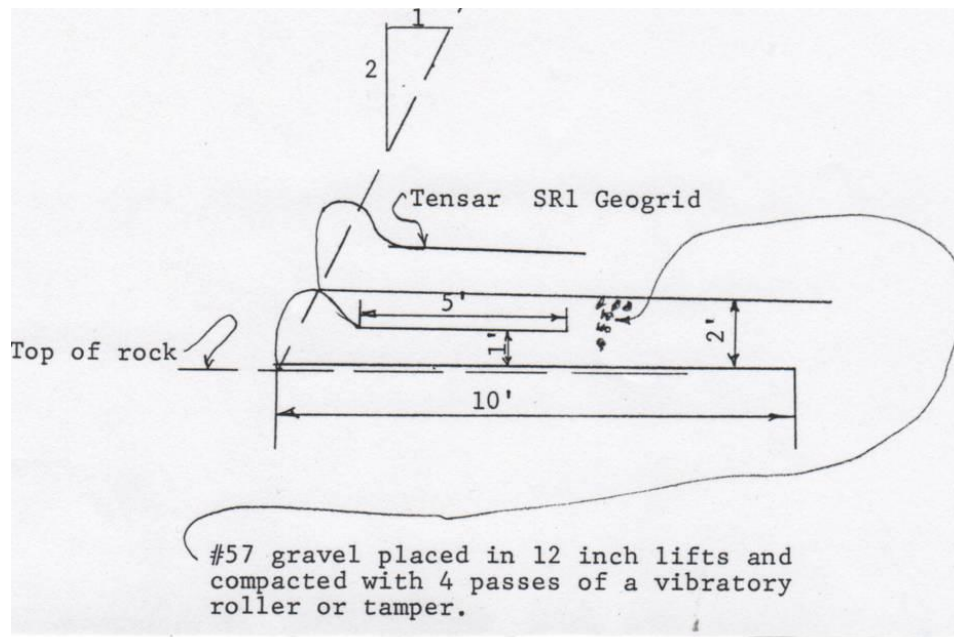
Fig. 8. Schematic construction procedure for the geogrid reinforced slope

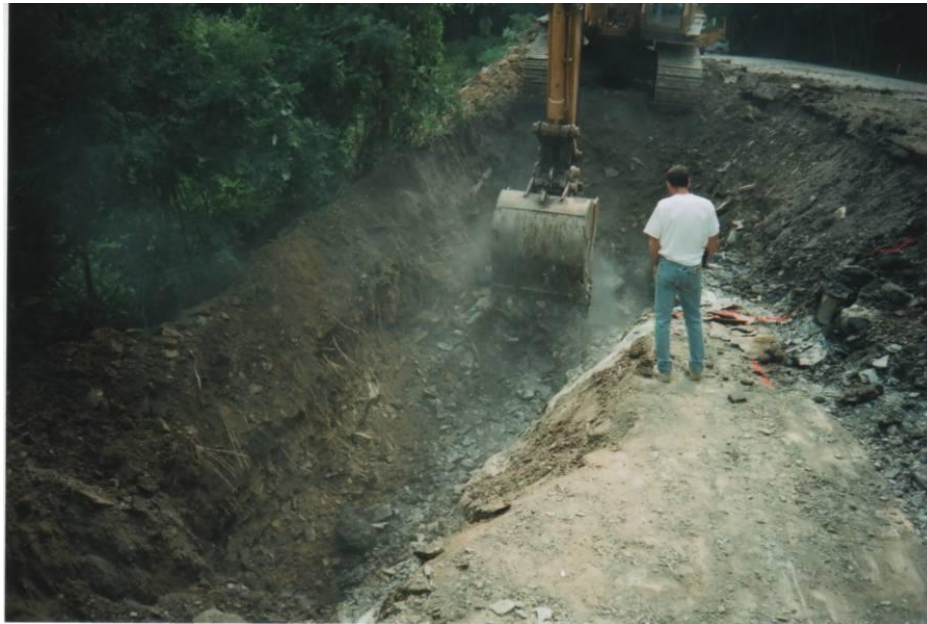
Fig. 10. Excavation at the north end of the slope repair

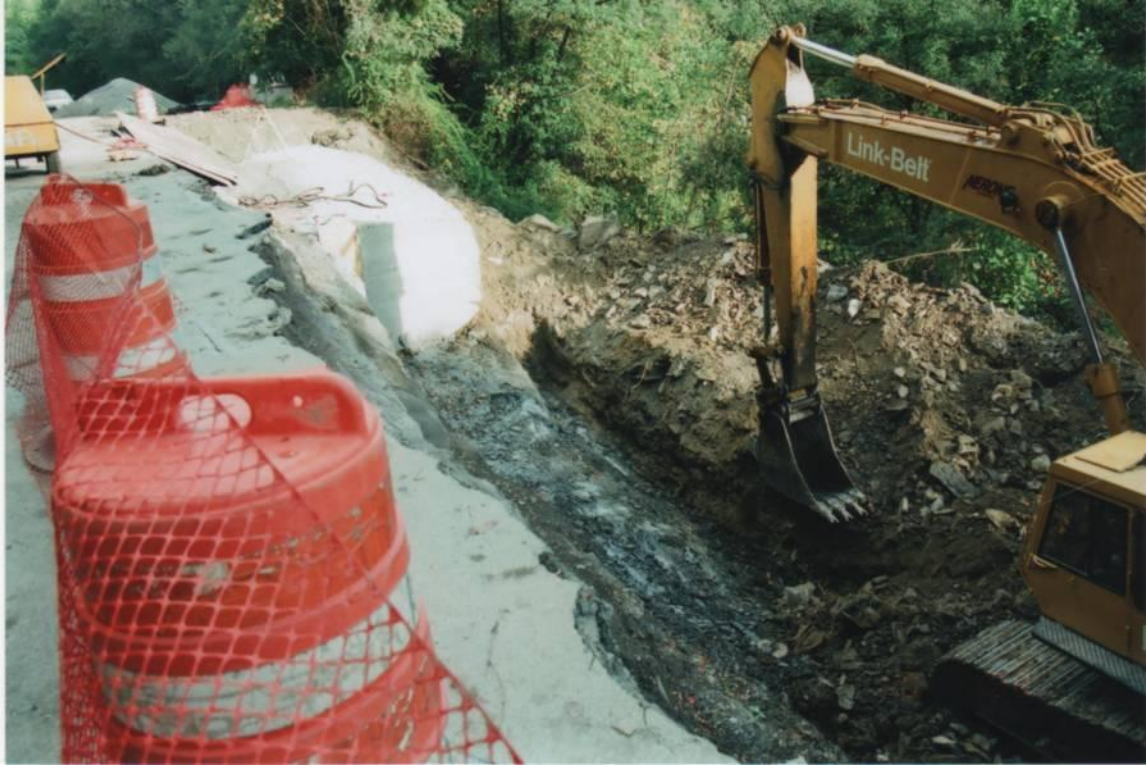
Fig. 11. Block of concrete placed at the north end to avoid rock excavation

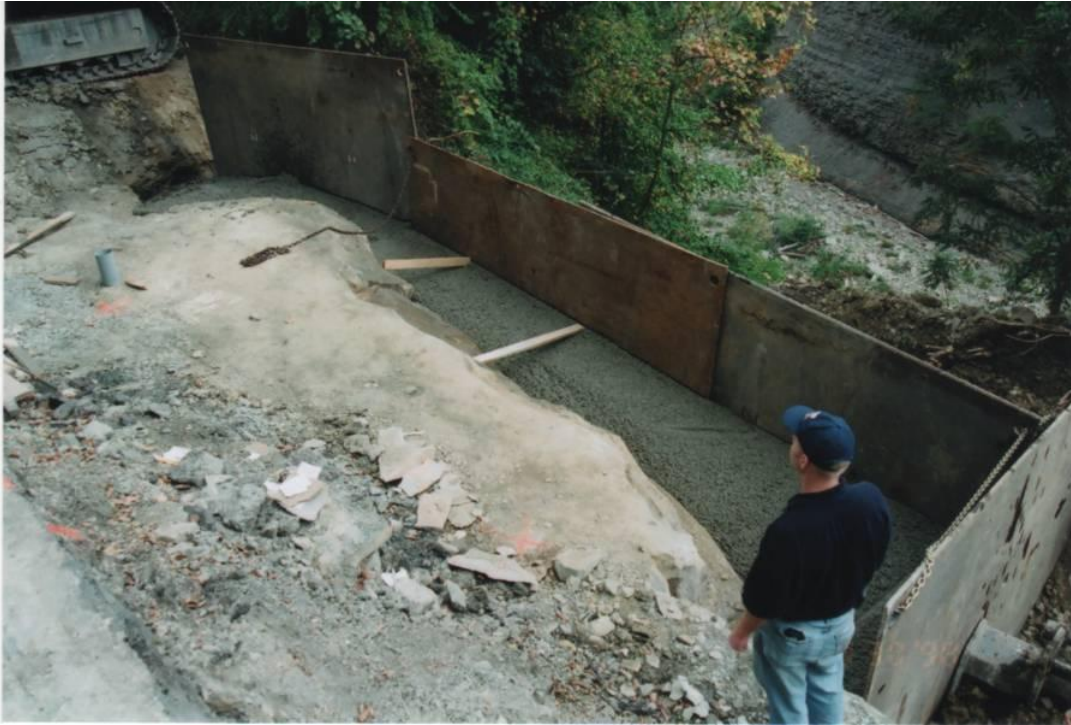
Fig. 12. Southward extension of the concrete foundation for the geogrid wall

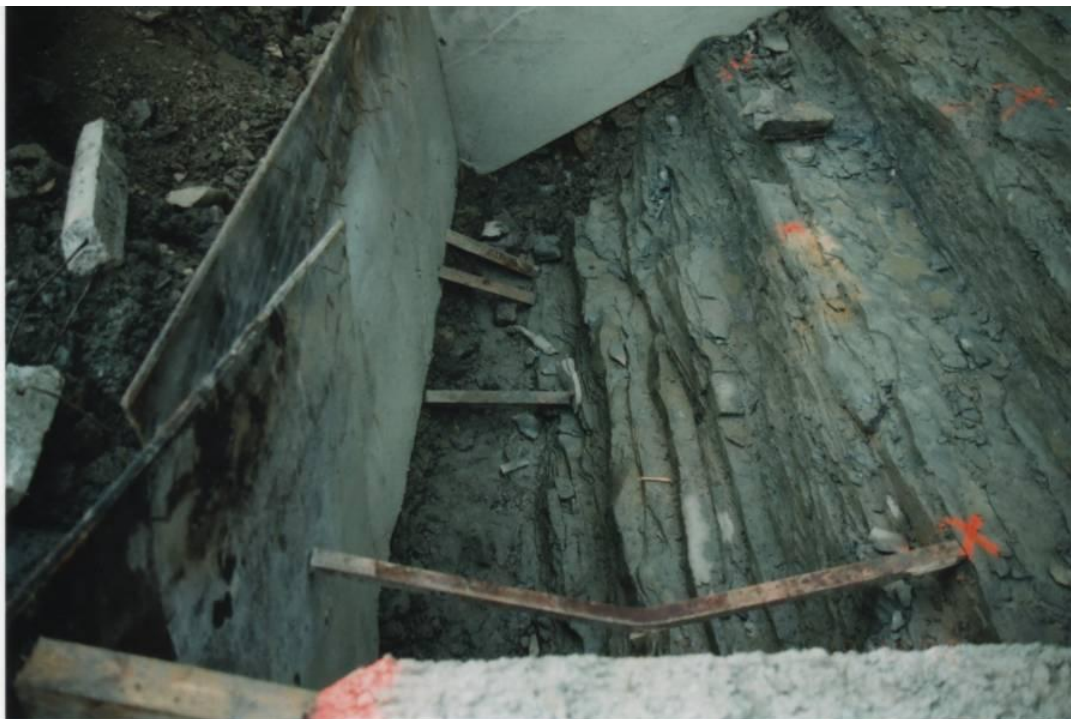
Fig. 13. Form work in area of sloping rock

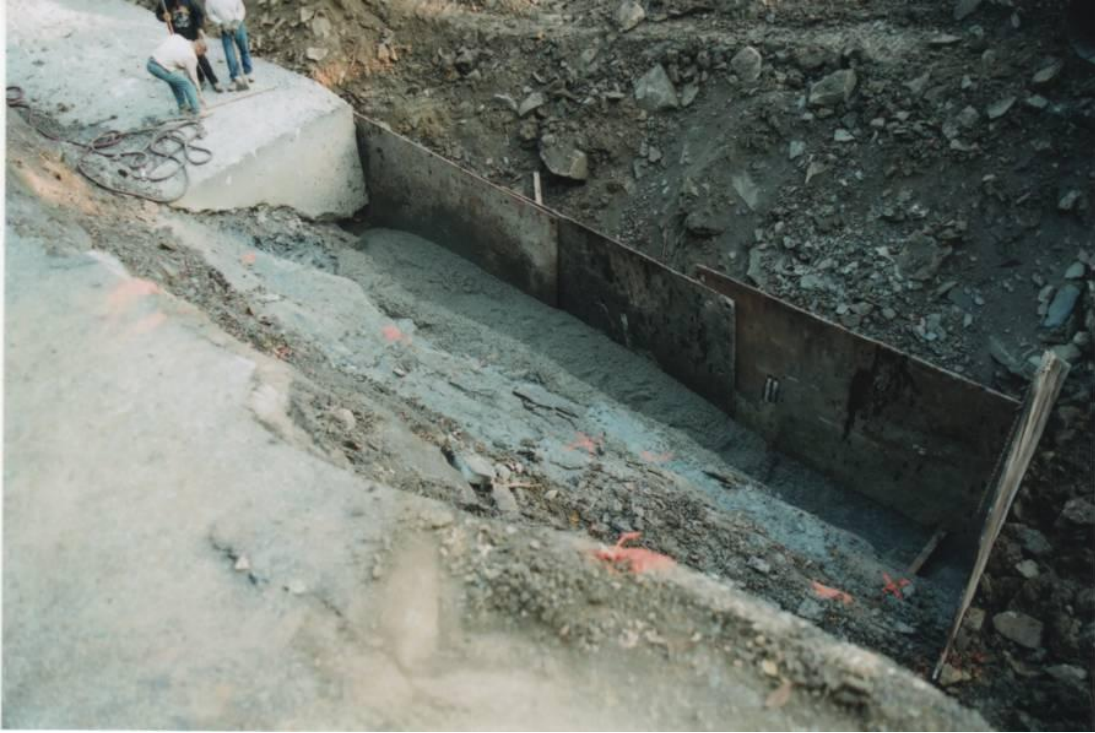
Fig. 14. Extension of concrete block foundation in area of sloping rock

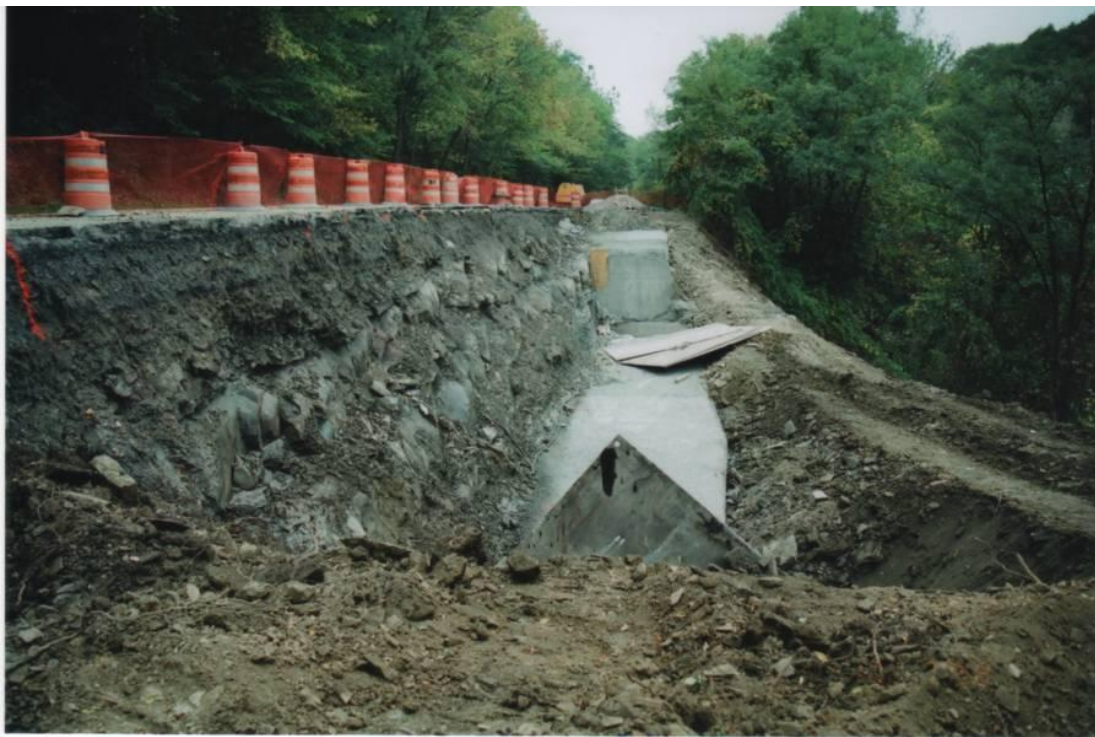
Fig. 15. Concrete block foundation looking south to north

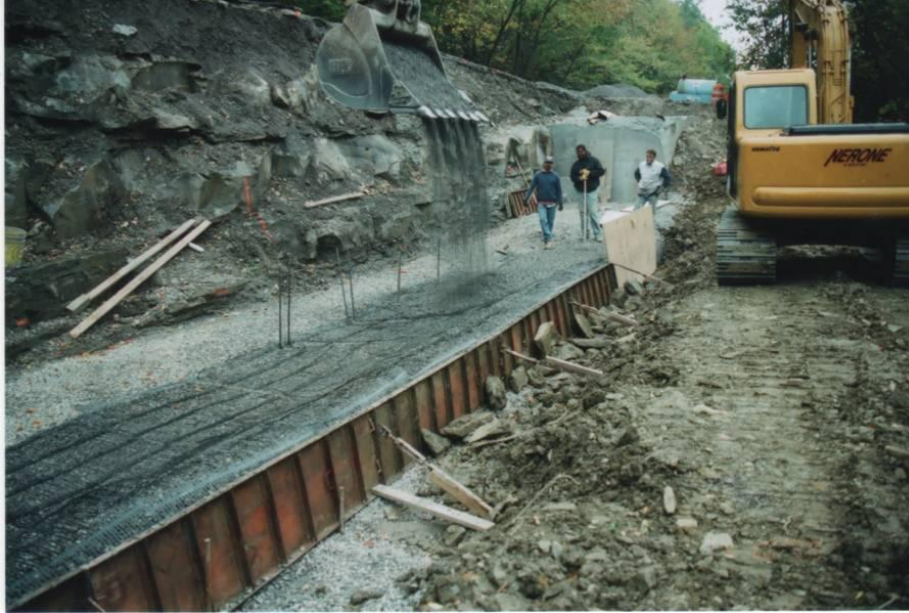
Fig. 16. The start of the geogrid reinforced wall

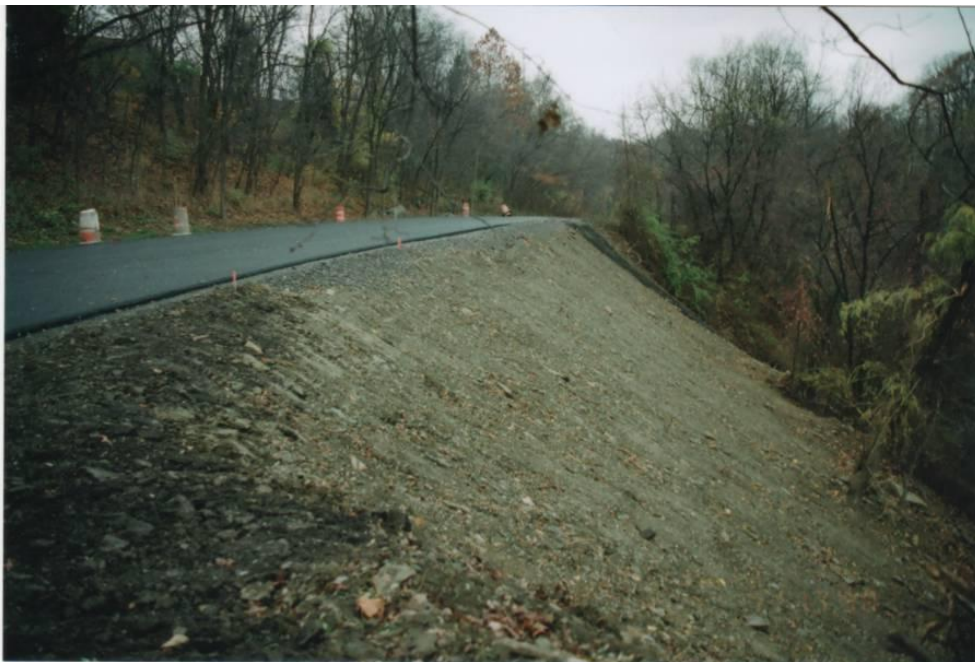
Fig. 19. The completed repair

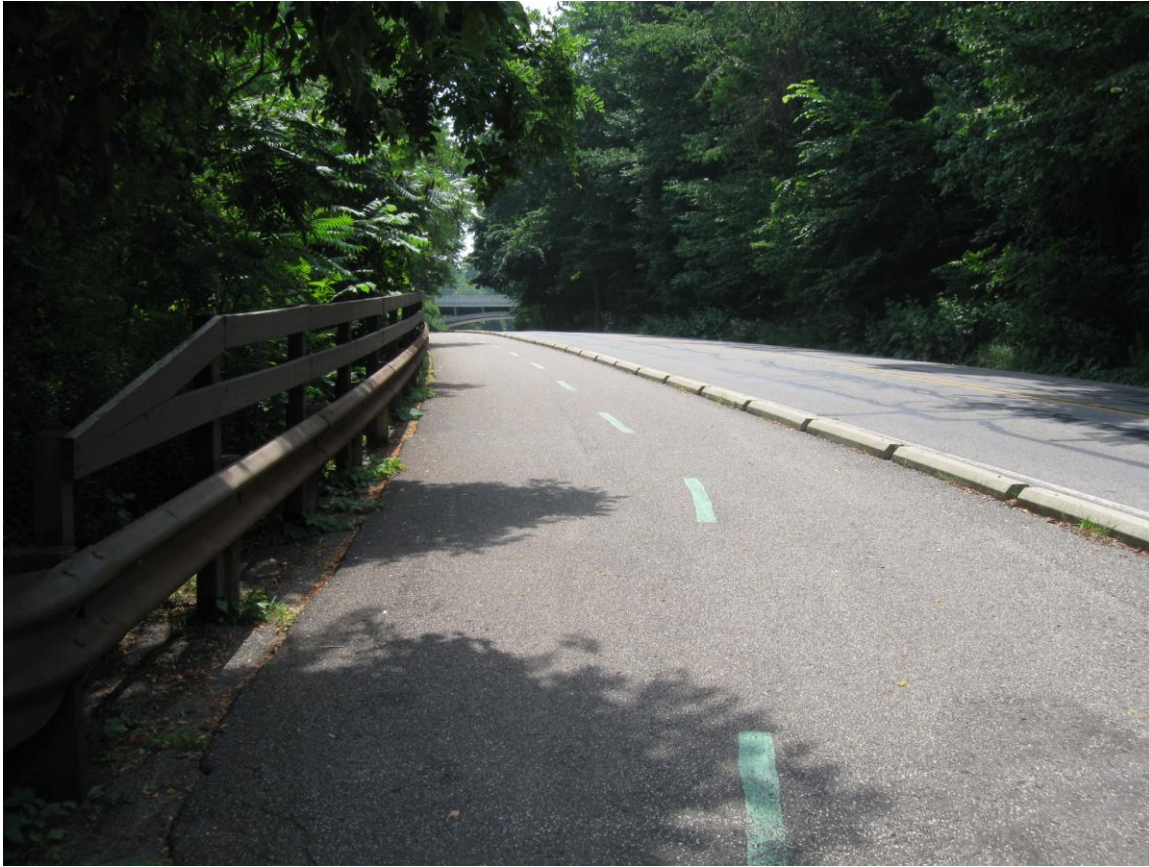
Fig. 20. The hiking trail on July 17, 2011

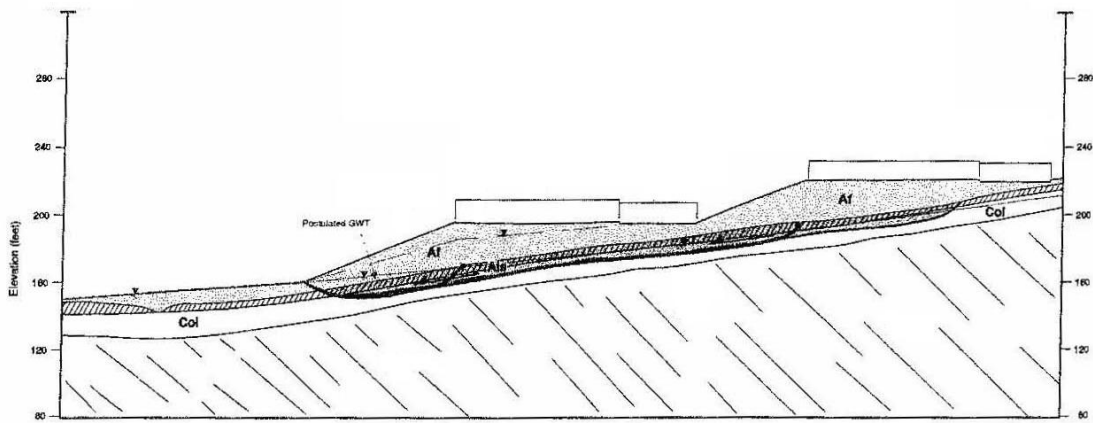
Fig. 1. Typical Cross Section

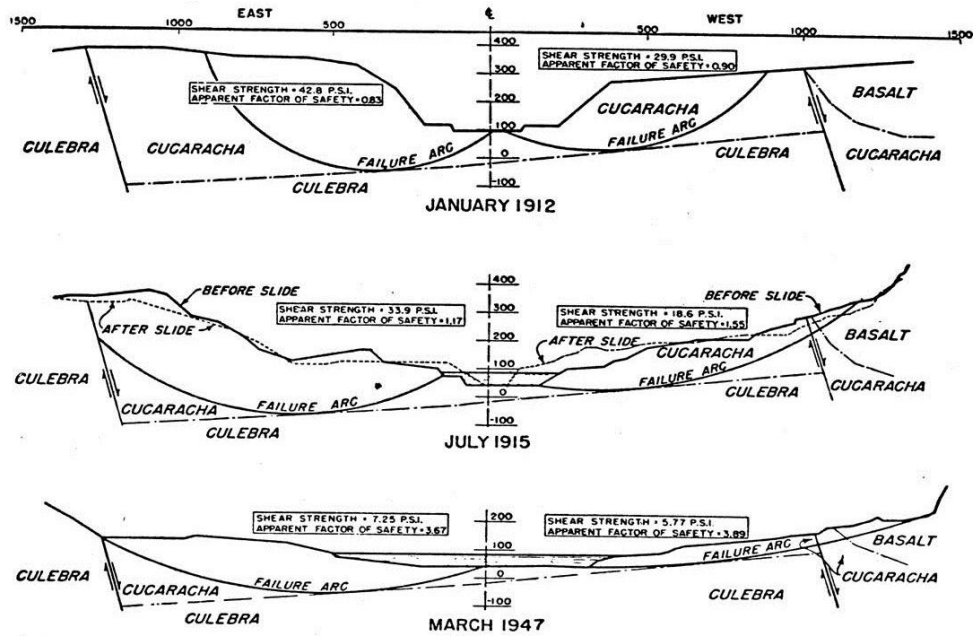
Fig. 2. Historical Landslide Stability

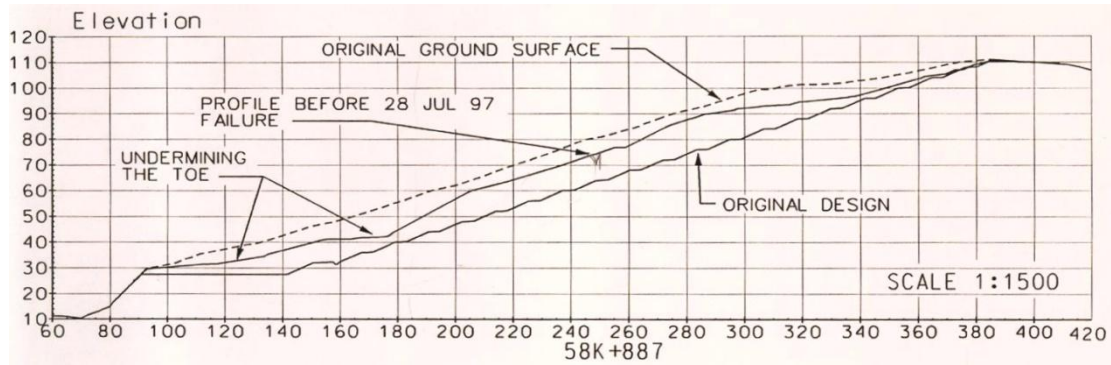
Fig. 4. Cross Section of Excavation Prior to Failure

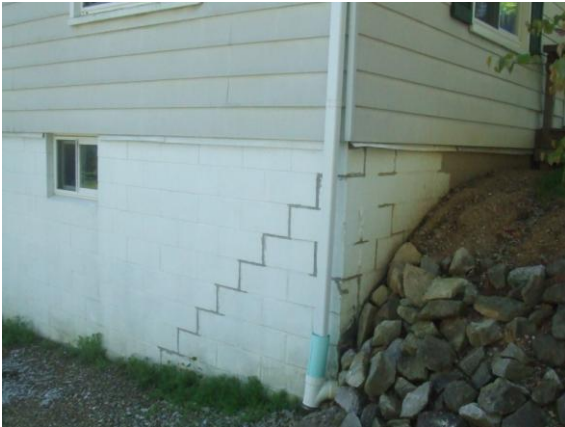
Fig. 1. Non-replaced corner of basement walls, showing previous tuckpointing.

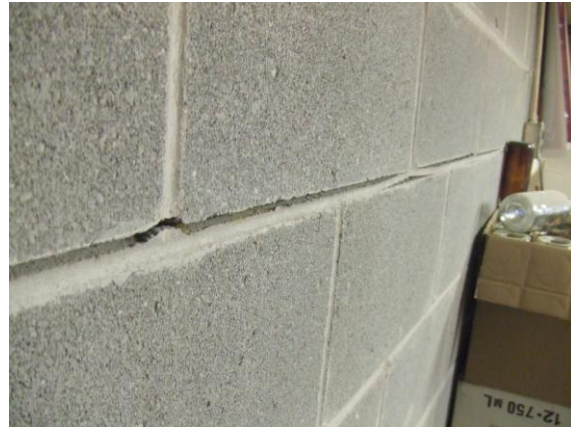
Fig. 2. View of inward bowing of replaced portion of basement wall.

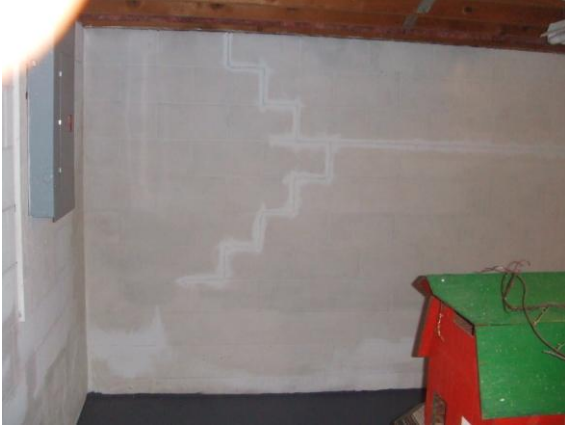
Fig. 3. Previous repairs visible on basement walls.

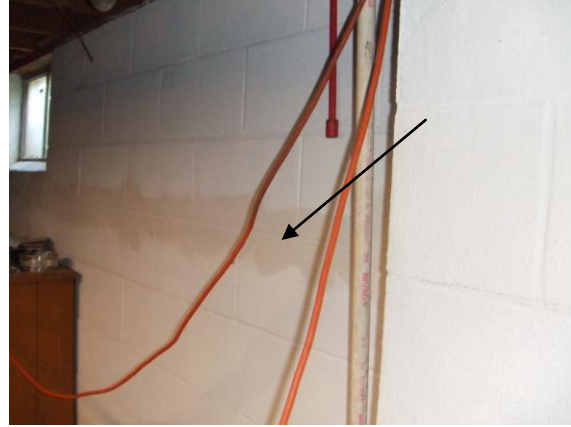
Fig. 4. Previous repairs visible (darker paint) on basement walls.

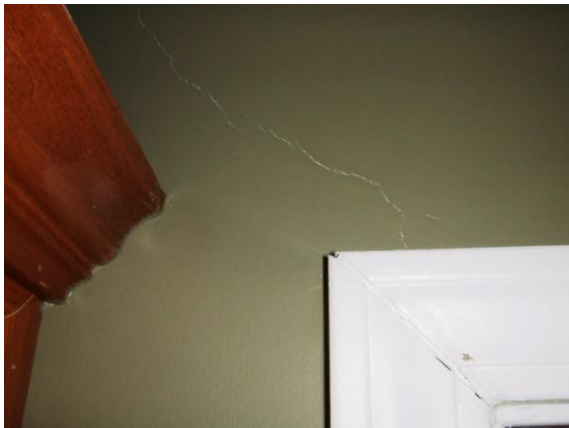
Fig. 5. View of jagged crack above doorway.

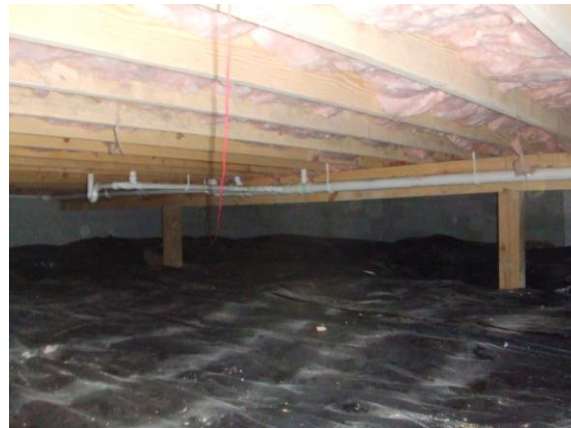
Fig. 6. View of wood beam in crawl space.

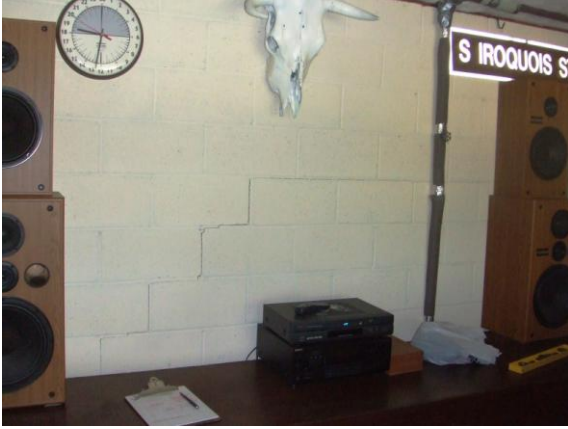
Fig. 9. Stair-stepped cracking in CMU wall of basement-level garage.

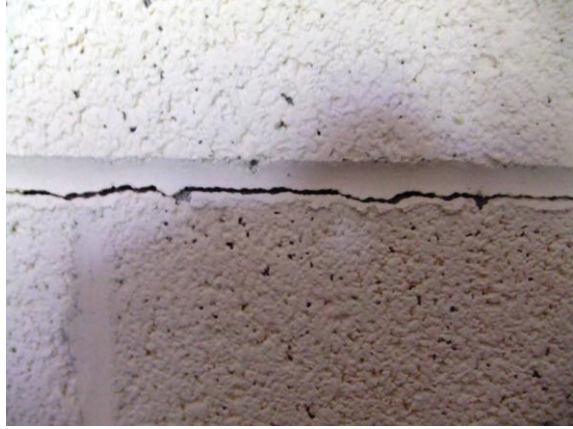
Fig. 10. View of 1.6-mm (1/16-inch) horizontal offset in crack.

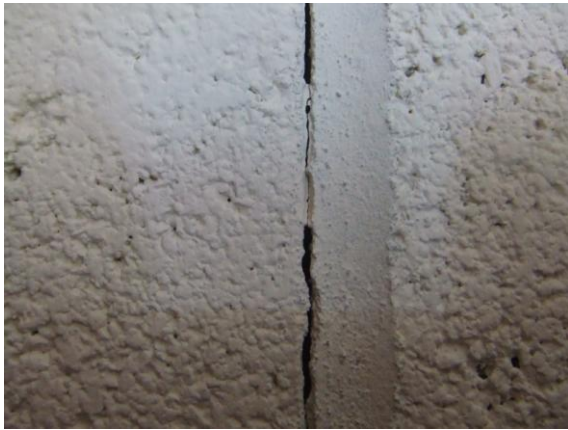
Fig. 11. View of year-old paint spanning sides of crack.

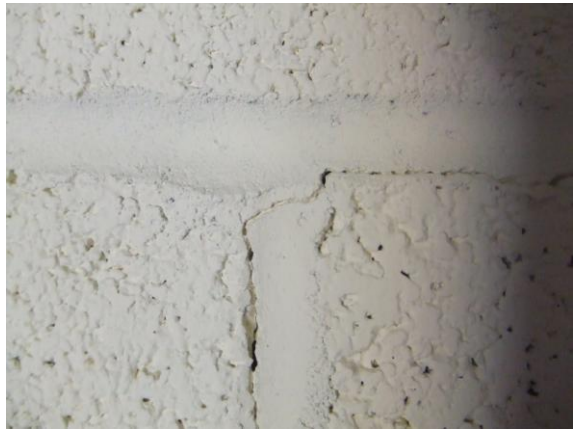
Fig. 12. View of year-old paint filling crack space.

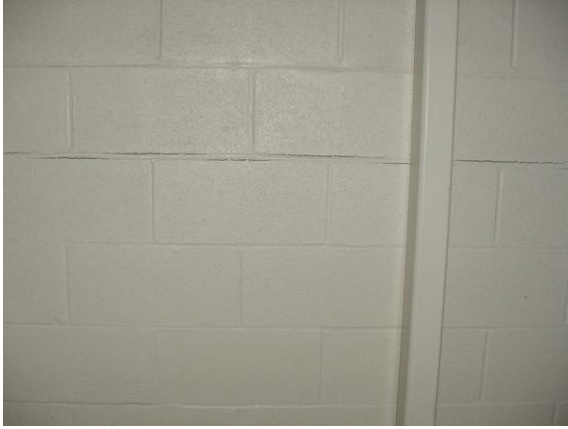
Fig. 13. Horizontal cracking behind steel tube column in garage.

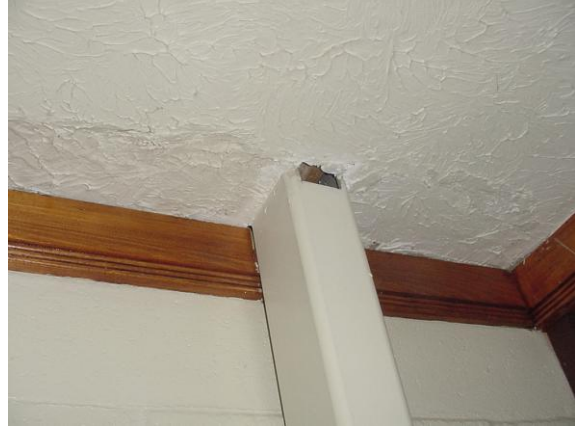
Fig. 14. Evidence that column was installed after basement was finished.
