OHIO RIVER VALLEY
SOILS SEMINAR XLII
October 21, 2011 | Cincinnati, OH

LESSONS LEARNED: FAILURES AND FORENSICS

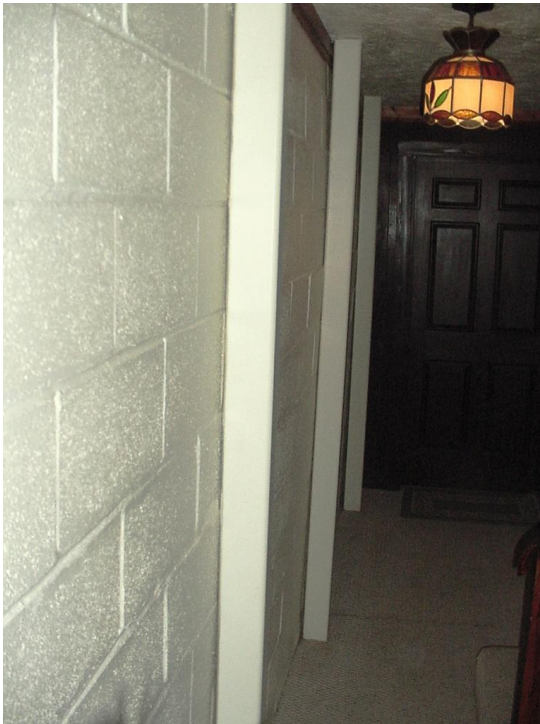
Fig. 15. View of inward buckling of wall restrained by steel columns.

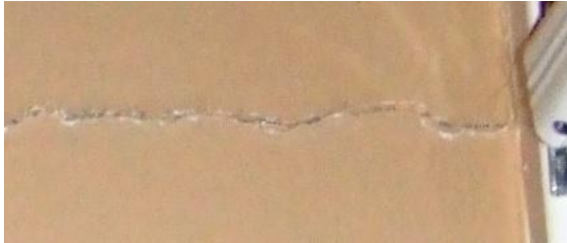
Fig. 17. View of jagged crack at upper left window corner.

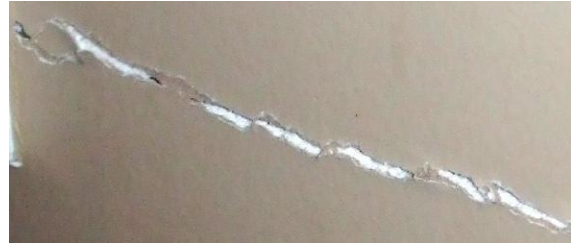
Fig. 18. Closeup of jagged crack shown in Fig. 19.

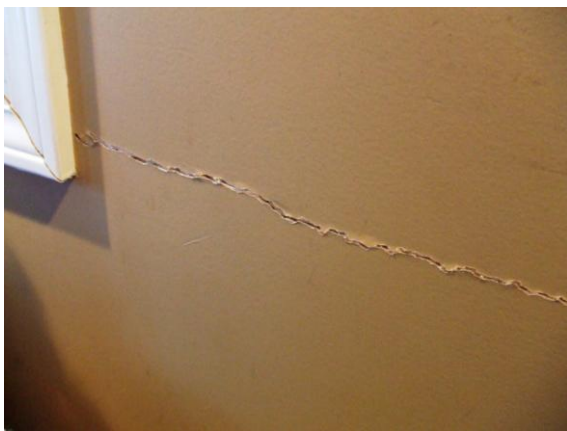
Fig. 19. View of jagged crack at lower right window corner.

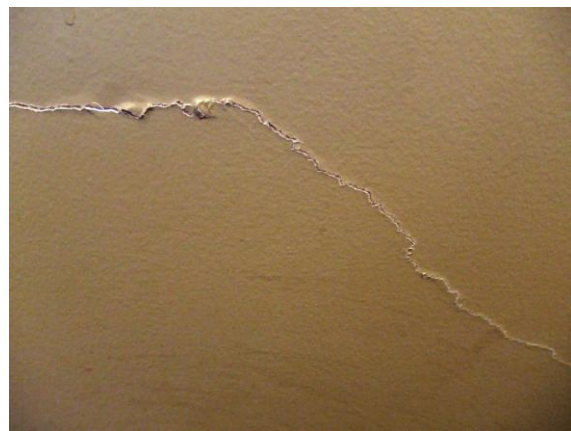
Fig. 20. Extension of crack shown in Fig. 19.

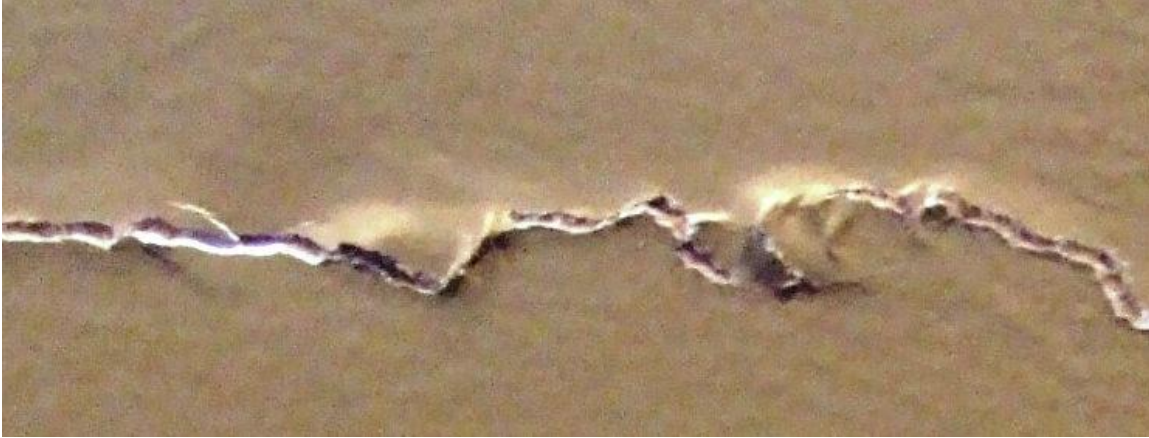
Fig. 21. Closeup of crack shown in Fig. 20, showing horizontal offset and crushing of drywall caused by shear.

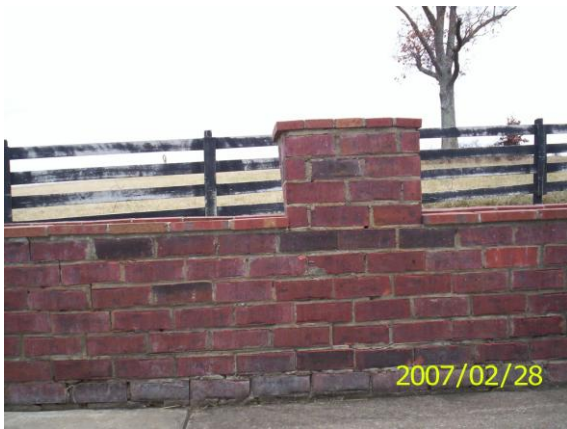
Fig. 22. Pre-blast photo of brick planter.

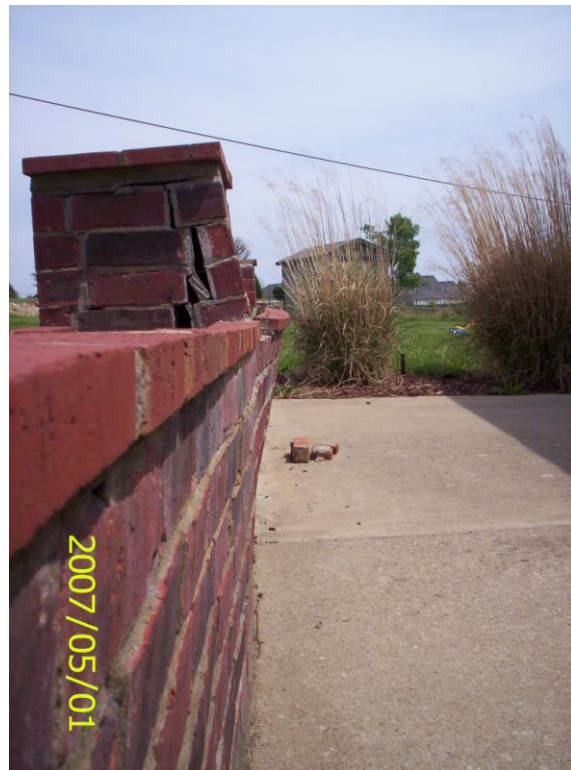
Fig. 24. Post-blast photo of brick planter. Roadcut being widened is between the wall and the house in the background.

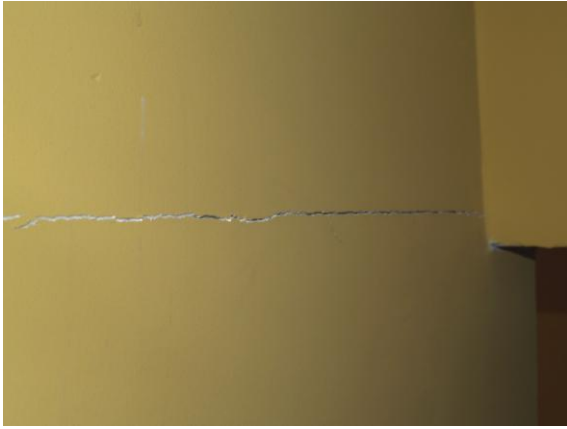
Fig. 25. Jagged horizontal crack in interior stairwell.

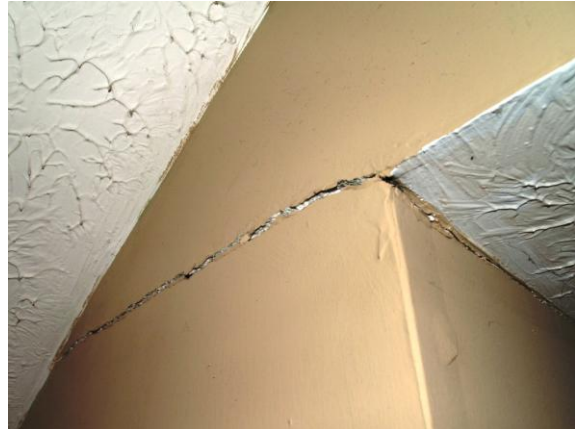
Fig. 26. Jagged crack near ceiling between stairwell and entry to second-floor bedroom.

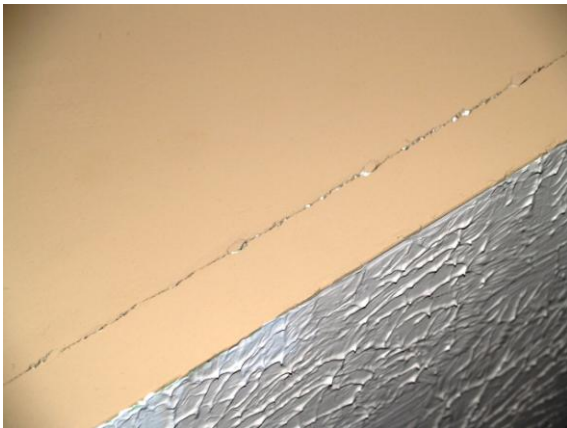
Fig. 27. Jagged crack at ceiling of second-floor dormer, showing lateral offsets.

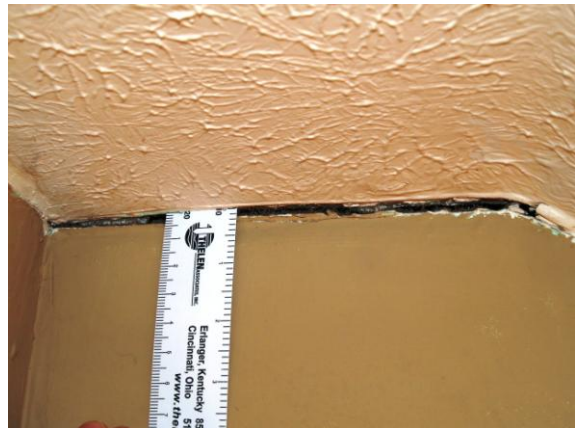
Fig. 28. Jagged crack at ceiling of second-floor dormer, showing lateral offsets.

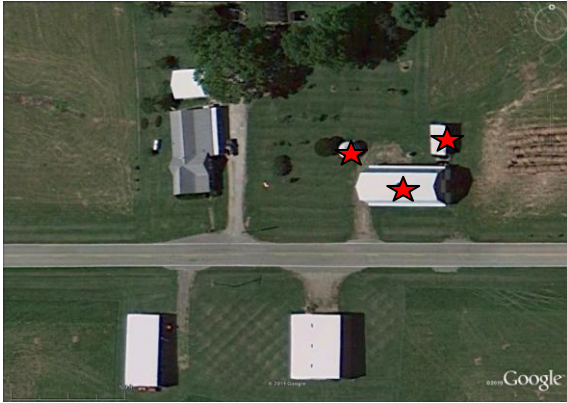
Fig. 29. Aerial view of farm. Buildings marked by stars destroyed by tornado. West (left) wall of large barn about 43 m (140 ft) from house.

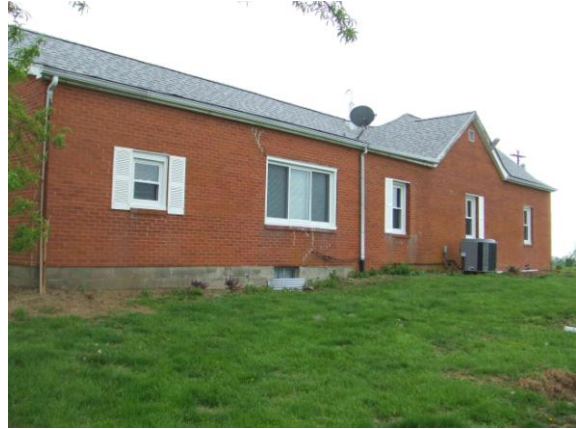
Fig. 30. West wall of house. Heaviest damage to brick façade occurs over partial basement (see window well).

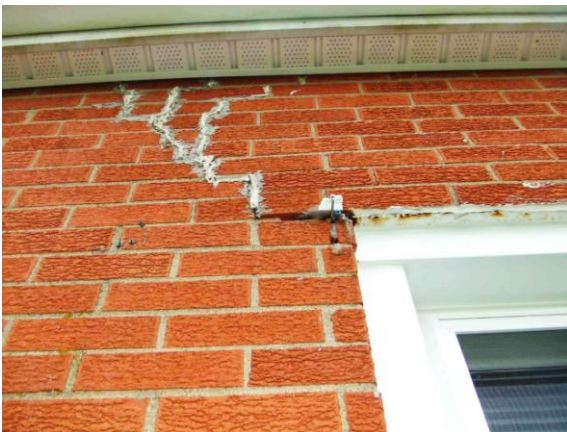
Fig. 31. Previously-caulked damage over upper left corner of picture window. Subsequent movement has squeezed caulk out of cracks.

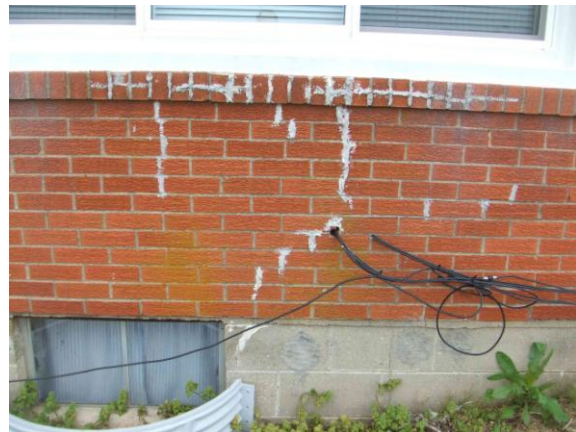
Fig. 32. Previously-caulked damage beneath picture window.

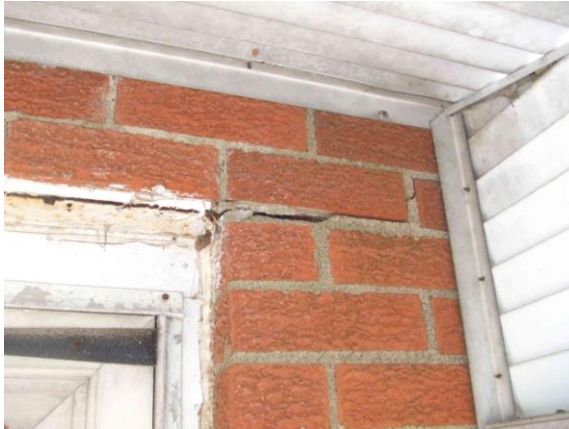
Fig. 33. Horizontal cracking caused by expansion of rusting steel lintel at top of door frame.

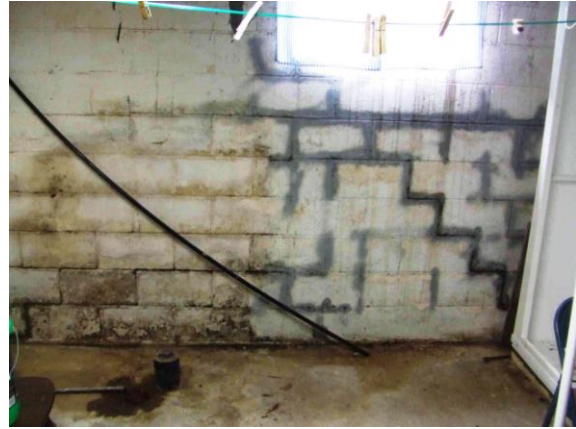
Fig. 34. Water damage visible to west basement CMU wall. This wall has bowed inwards under active earth and hydrostatic pressures.

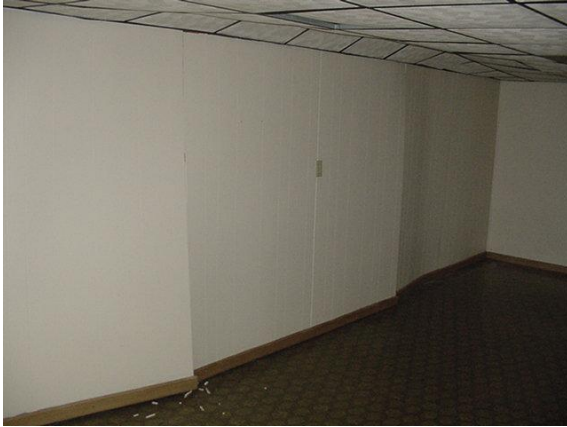
Fig. 35. View of buckled basement walls and drop ceiling.

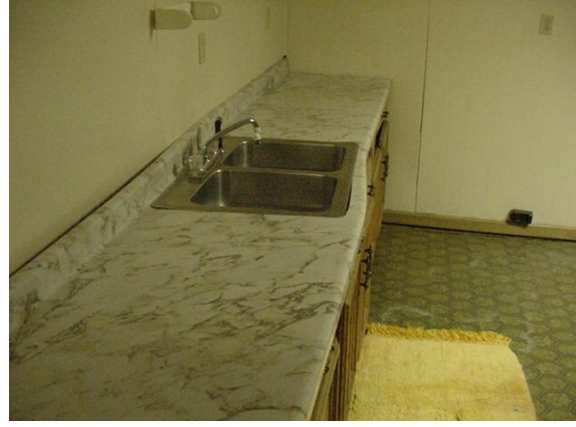
Fig. 36. Buckled basement wall caused buckling of kitchen countertop.

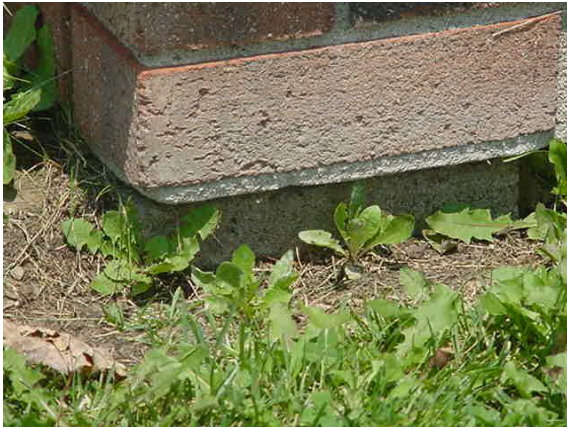
Fig. 37. Horizontal offset in brick on rear wall caused by thrusting of first floor to the rear.

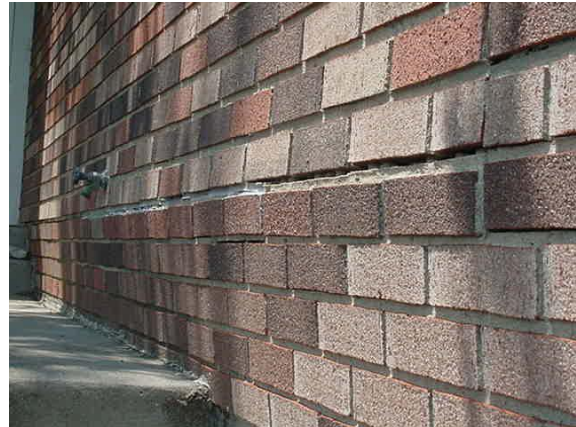
Fig. 38. Buckling of brick façade on rear wall caused by thrusting of first floor to the rear.

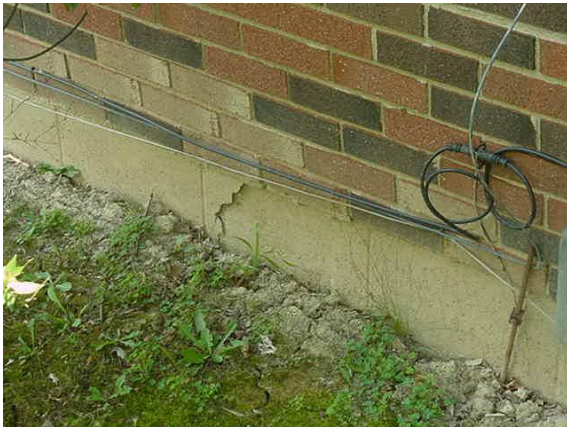
Fig. 39. Depression in ground surface resulting from inward buckling of front basement wall.

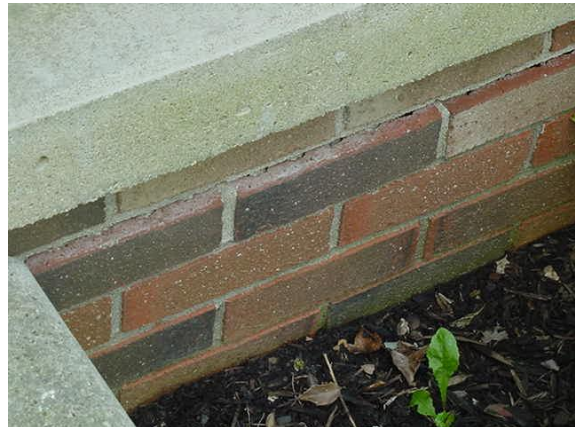
Fig. 40. Short front porch wall has stayed in place while front porch slab is dragged to the rear along with the first floor.

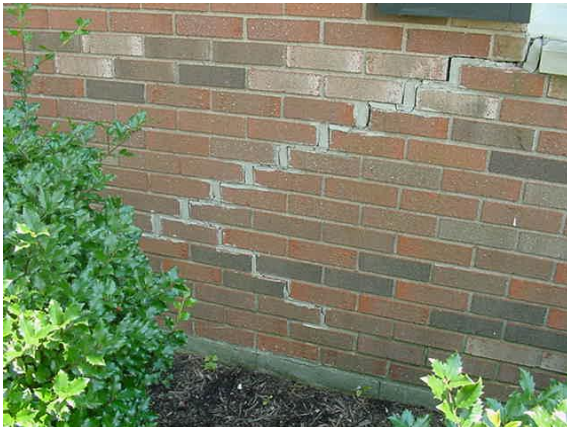
Fig. 41. View of front wall near junction of basemented (to left) and non-basemented (to right) portions of the house.

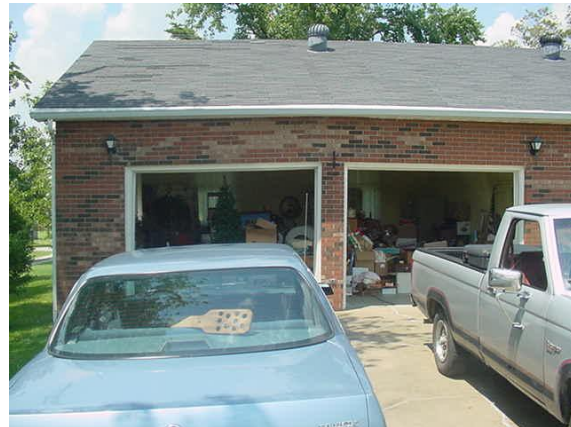
Fig. 42. Settlement of slab-on-grade garage corner caused by seasonal moisture extraction from mature tree off left side of photo.

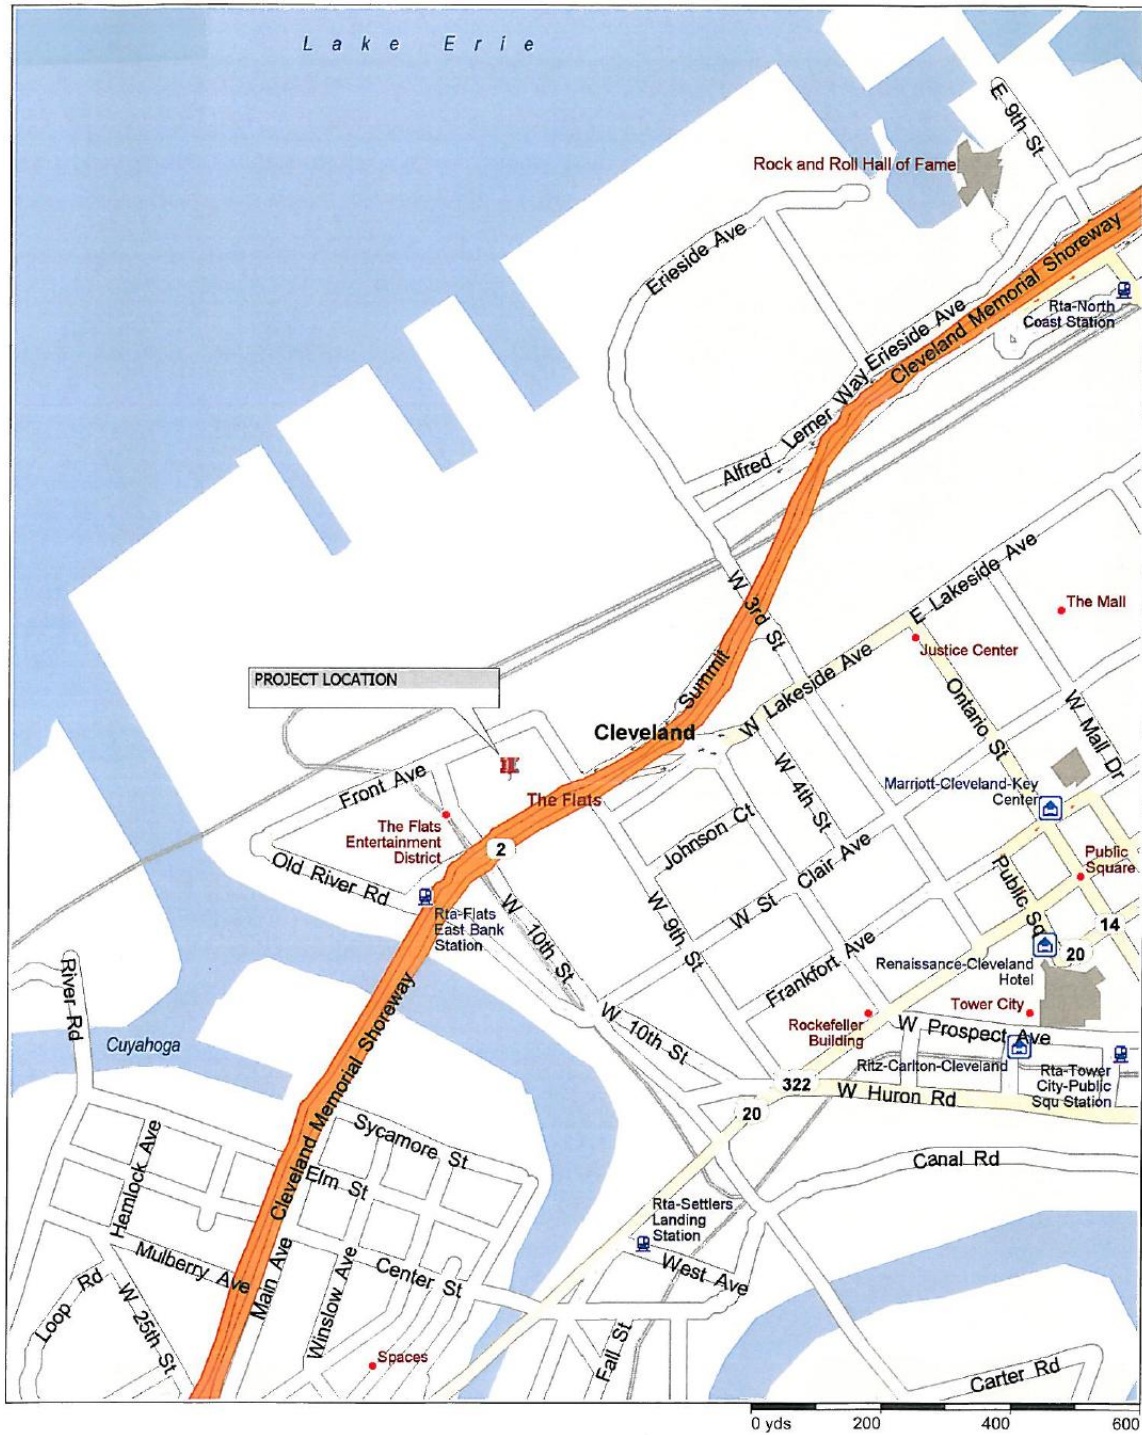
Fig. 1. Project site map

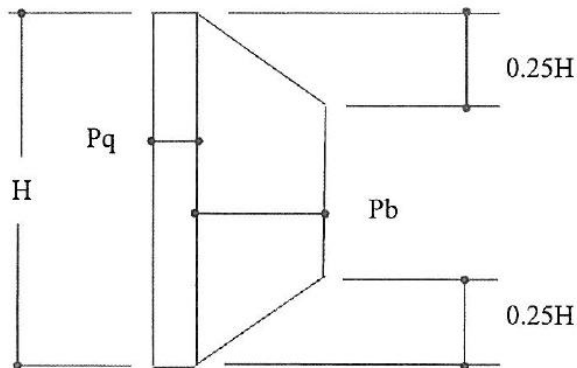
$P_q =$ Surcharge Pressure, as applicable

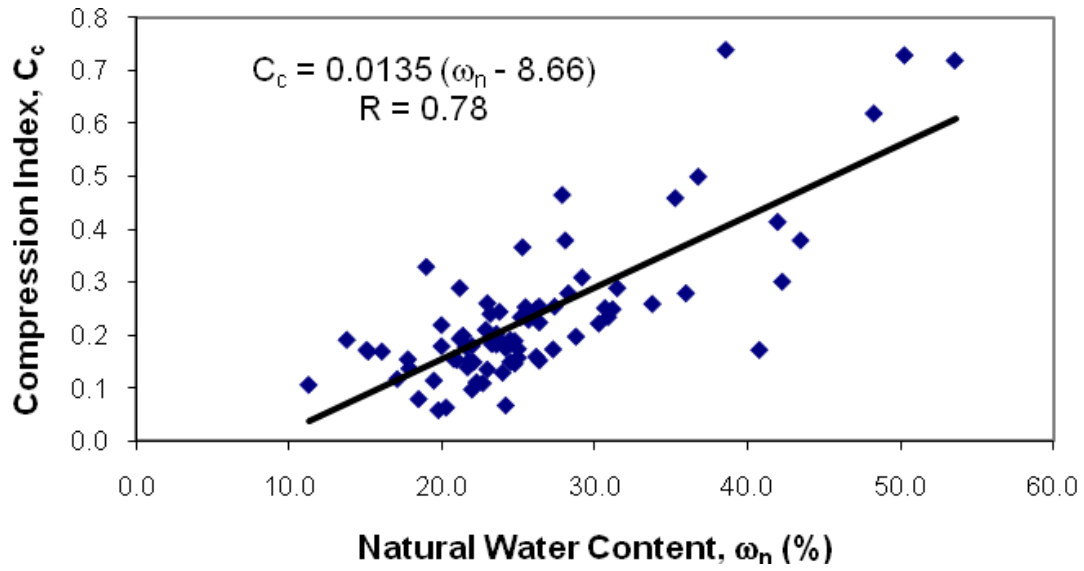
Fig. 5. Compression Index Vs Natural Moisture Content

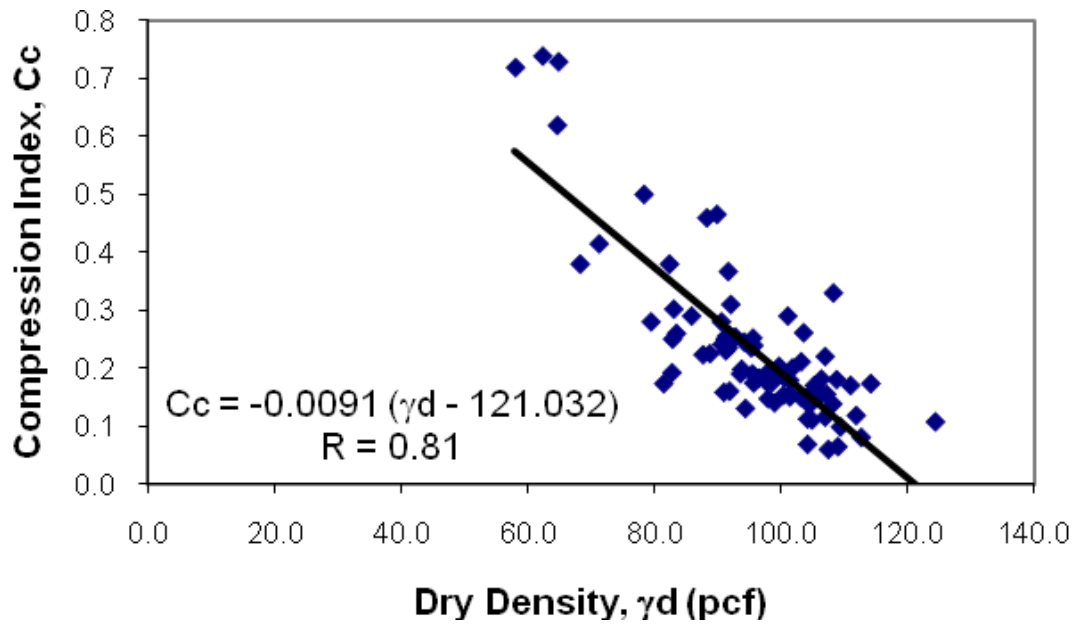
Fig. 6. Compression Index Vs Dry Density

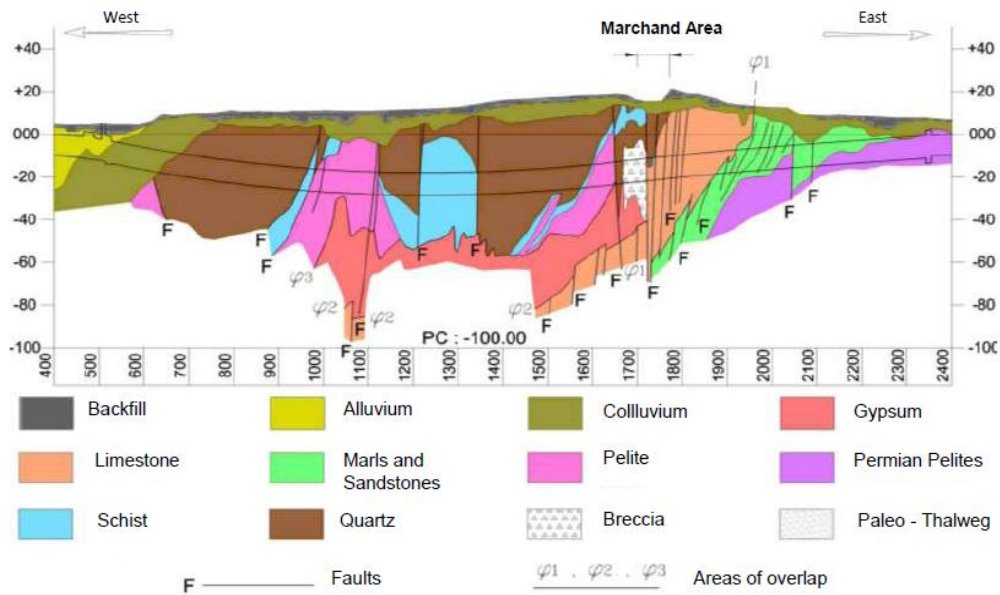
Fig. 1. Geological profile along the alignment

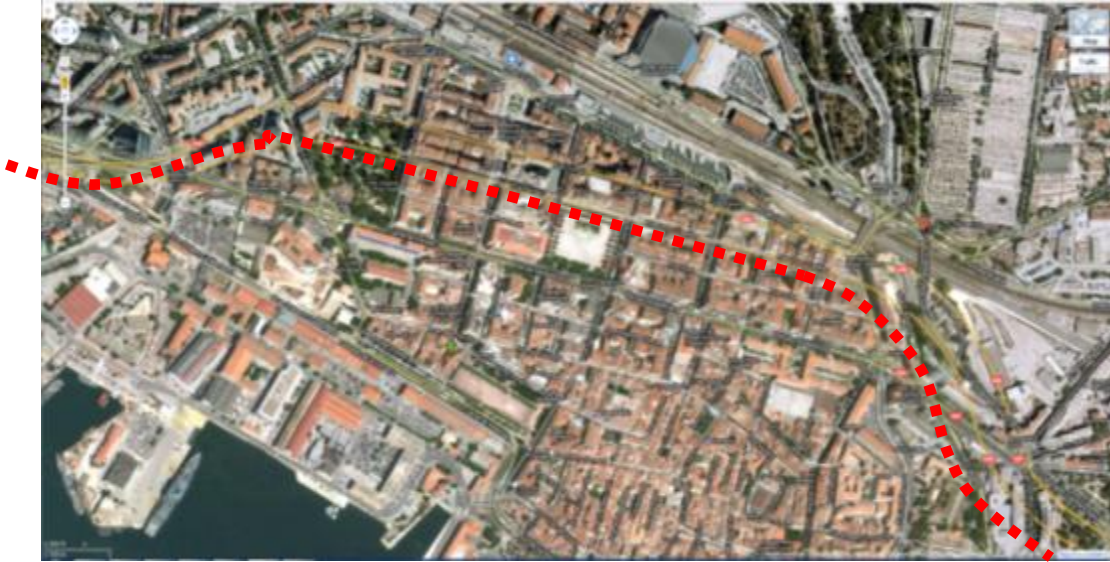
Fig. 2. Aerial view of the alignment

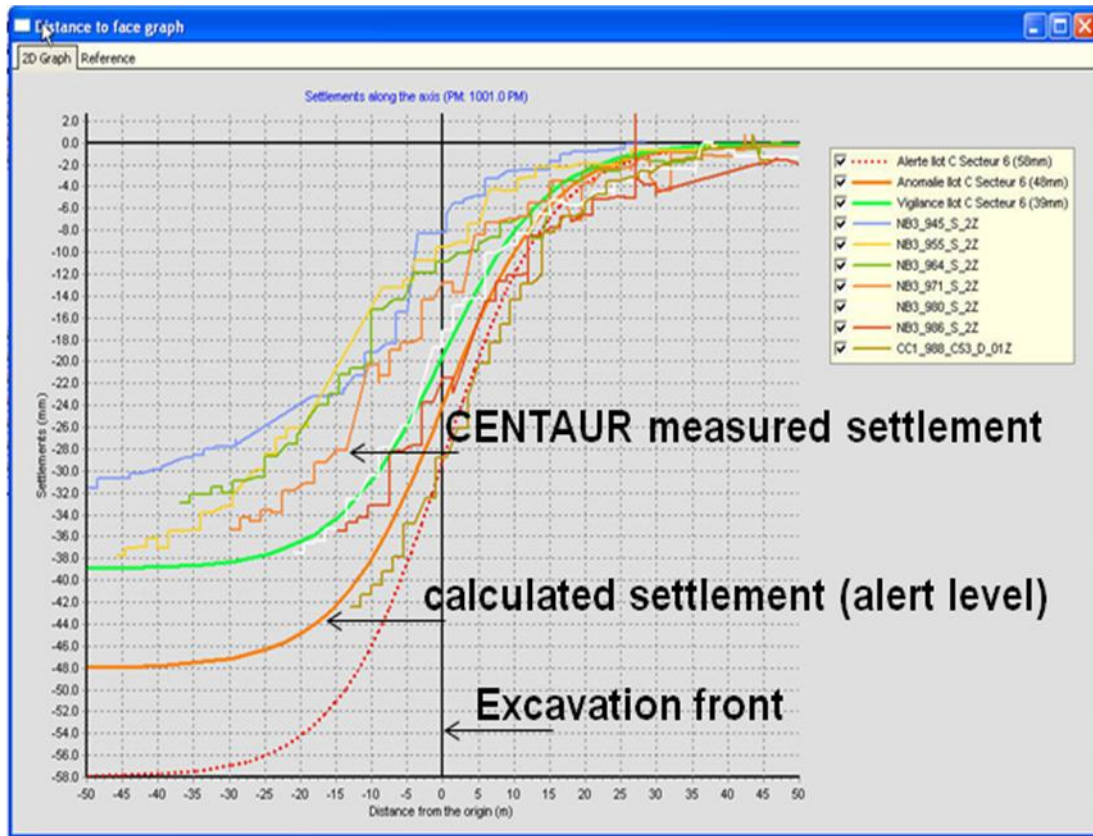
Fig. 10. Comparison between calculated settlement curves and actual measured data before (right) and after (left) the excavation front

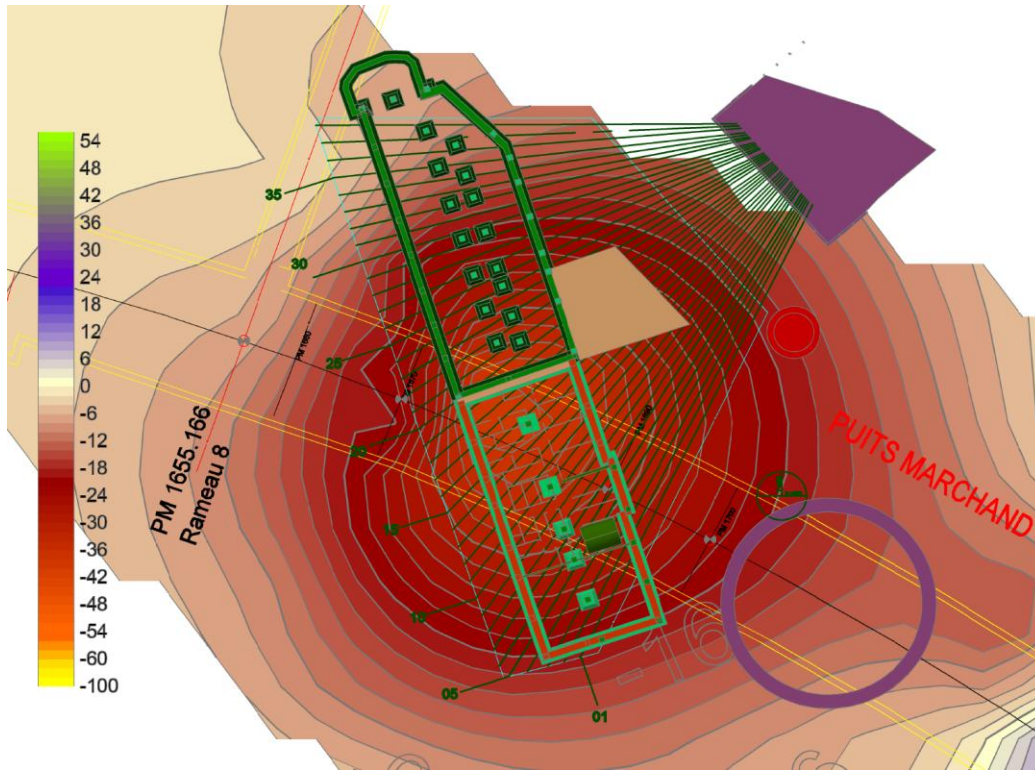
Fig. 11. Settlement Hollow in the Marchand area and compensation grouting program

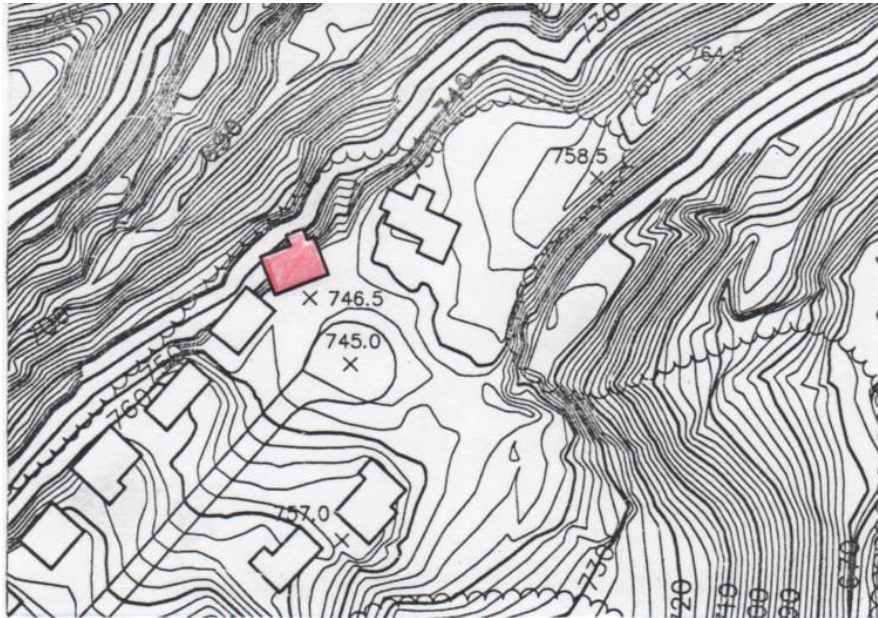
Fig. 1. Excerpt from the April 1993 County topographic map.

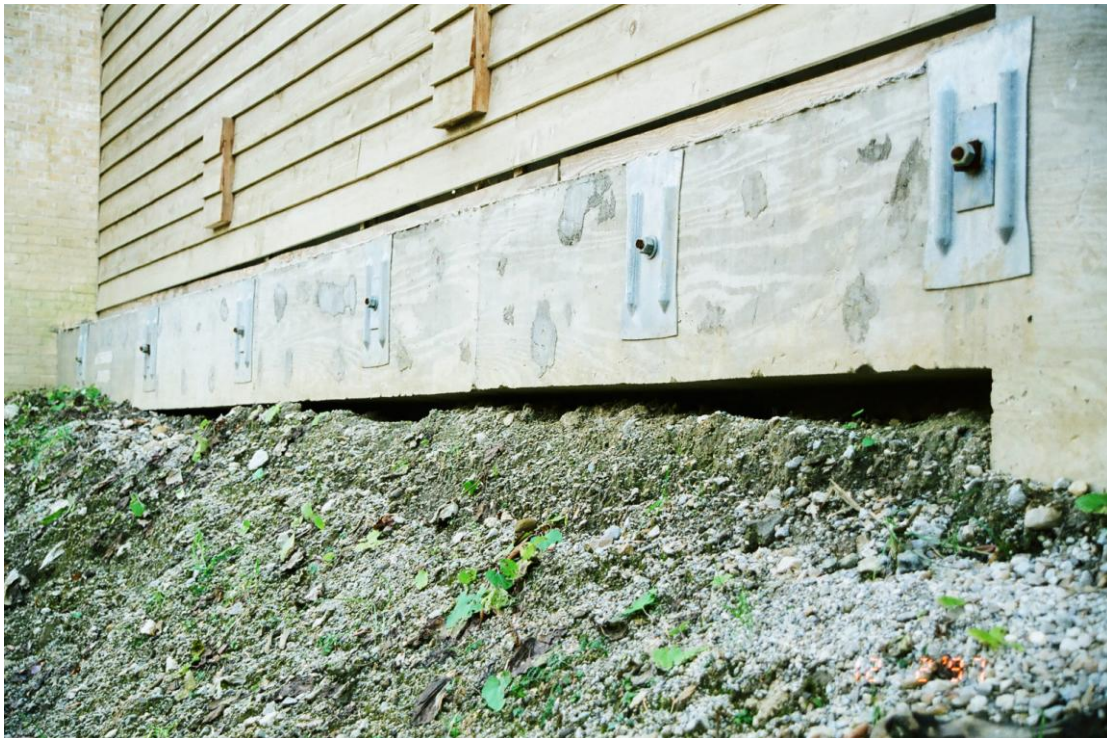
Fig. 5. Underpinned and tied back downhill foundation wall.

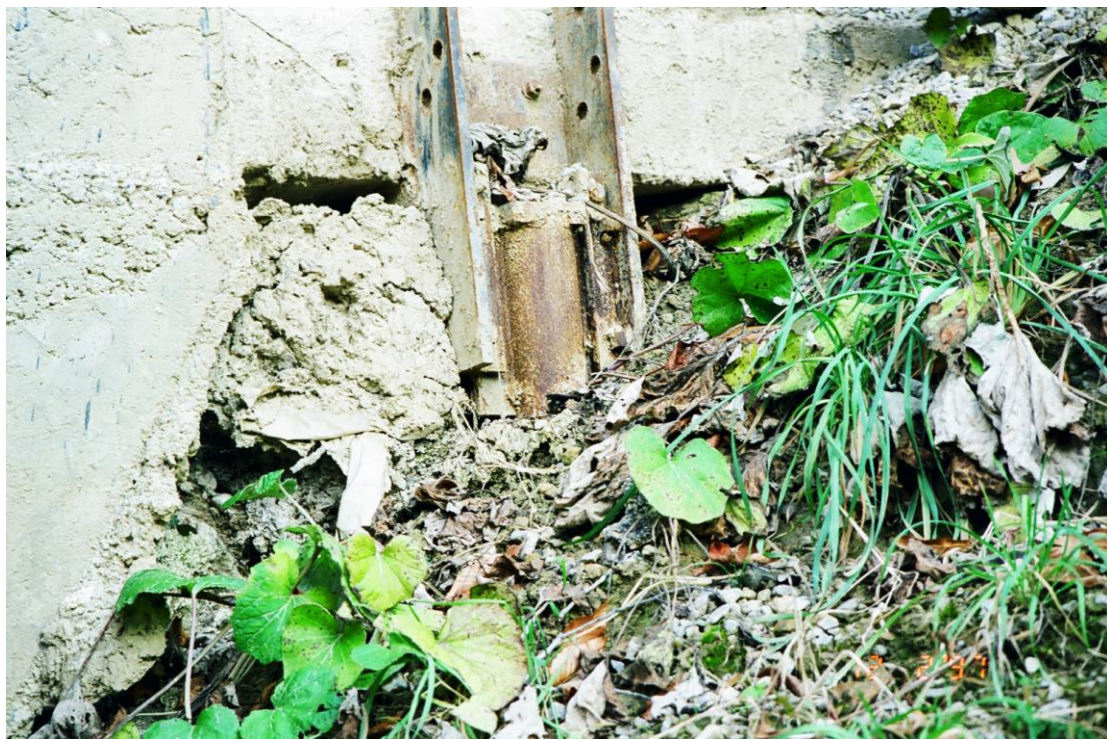
Fig. 6. West wall being underpinned with an Atlas pier.

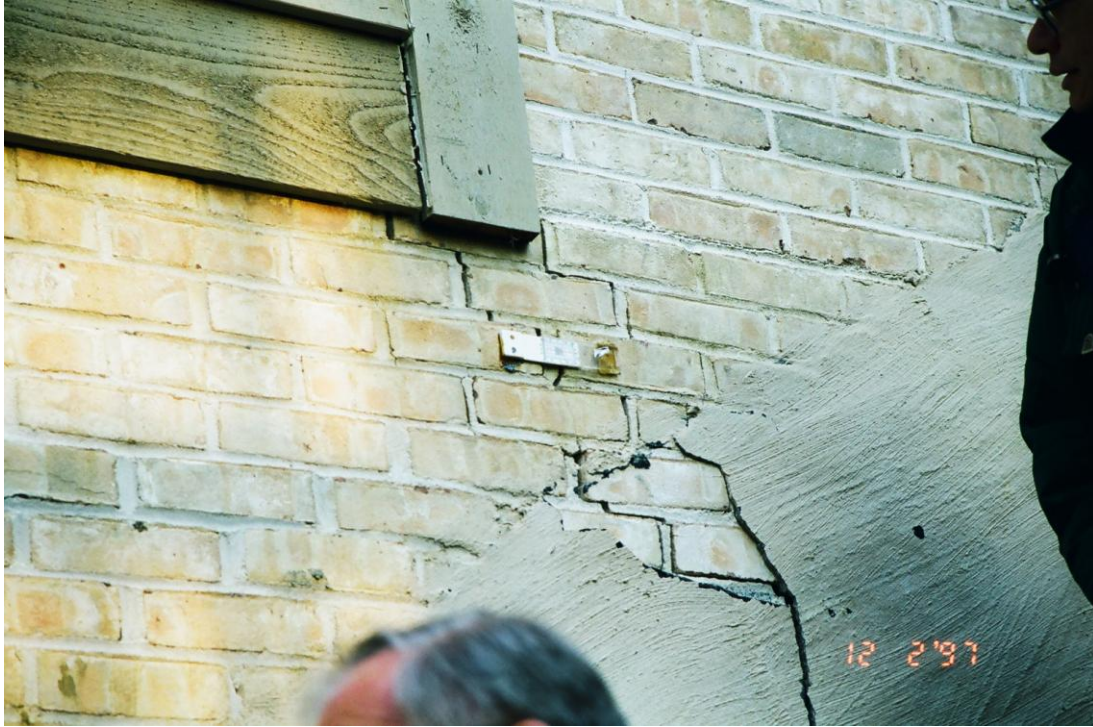
Fig. 7. Cracks in west wall.

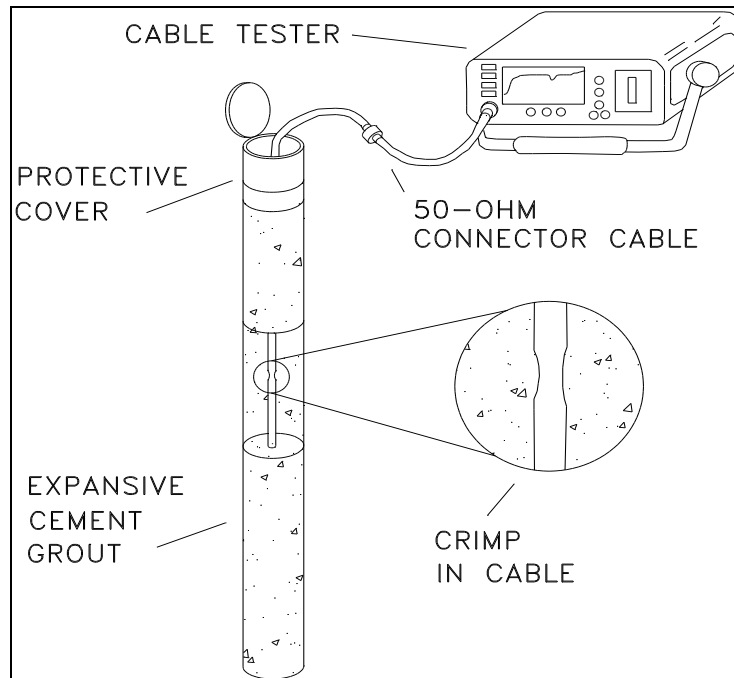
Fig. 1. Schematic of cable installation for deformation monitoring

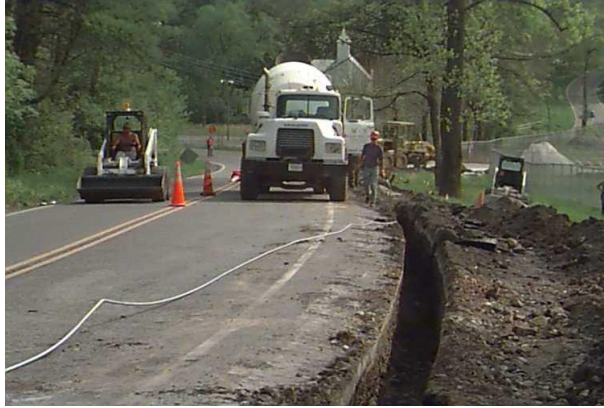
Fig. 2. Installing cable in a trench along SR 91; cables were also installed in angled holes drilled below the road from the berm (see Fig. 3)

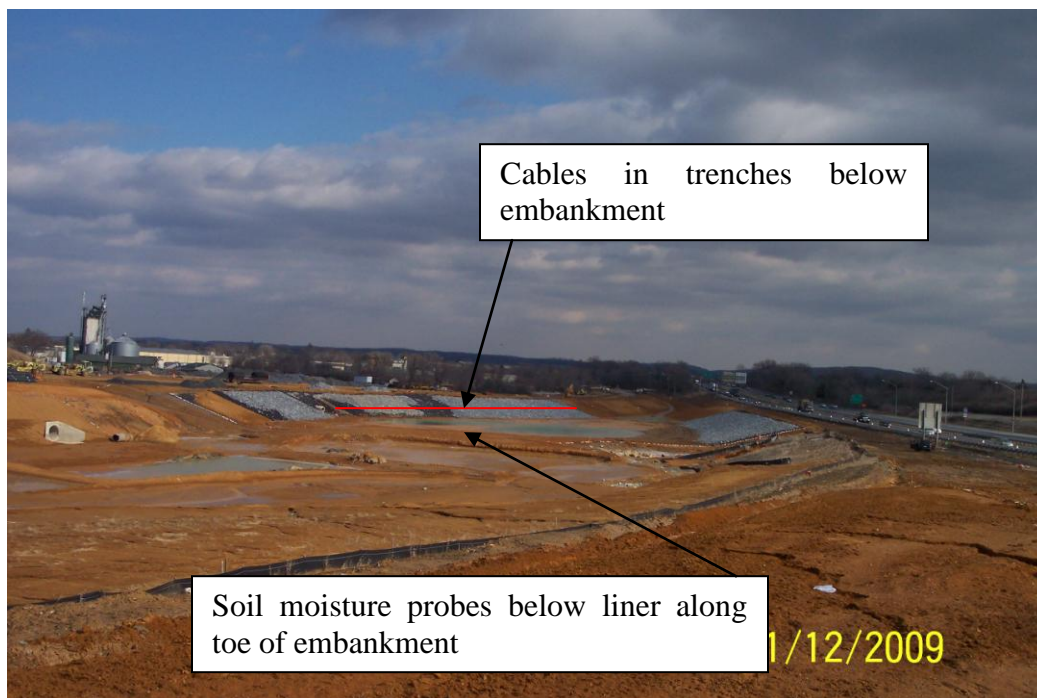
Fig. 5. Cables were installed in trench prior to construction of Monocacy Boulevard embankment; I-70 is on the right side of the photograph

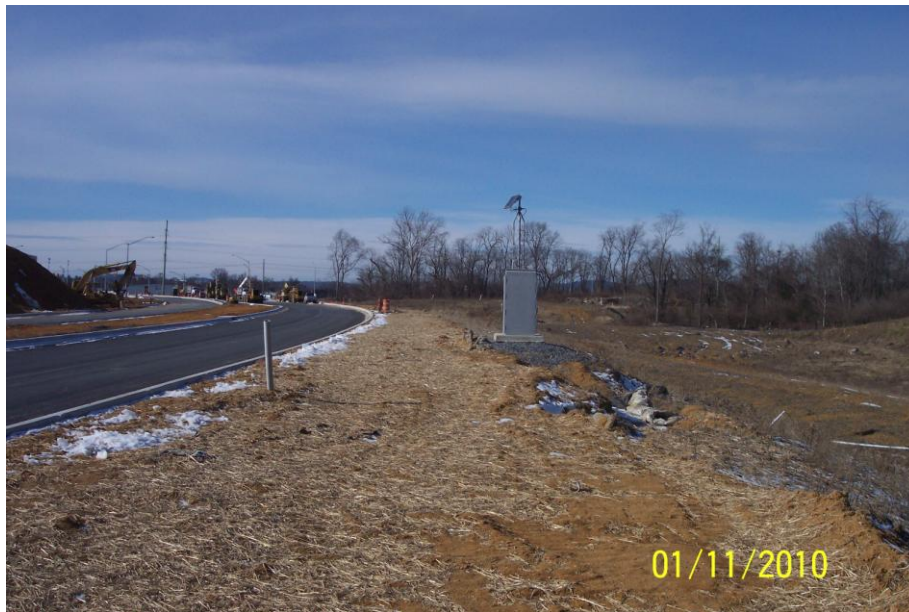
Fig. 6. Data acquisition system on north berm of Monocacy Boulevard embankment

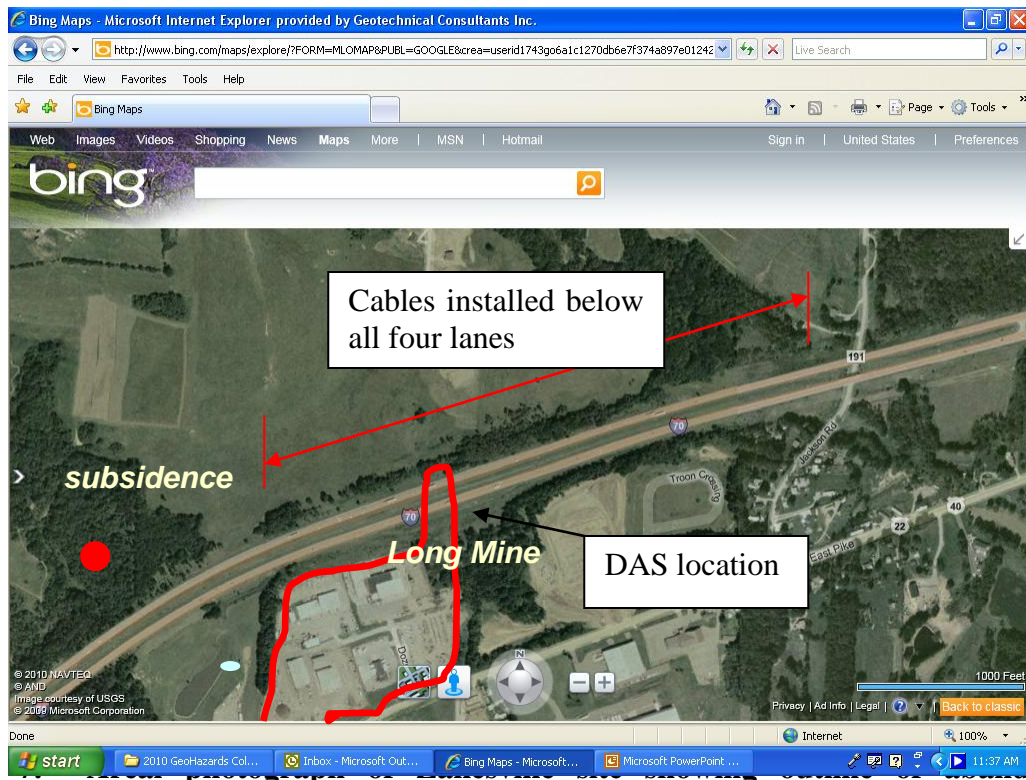
Fig. 7. Aerial photograph showing the location of the Long Mine and a subsidence sinkhole on the north side of I-70

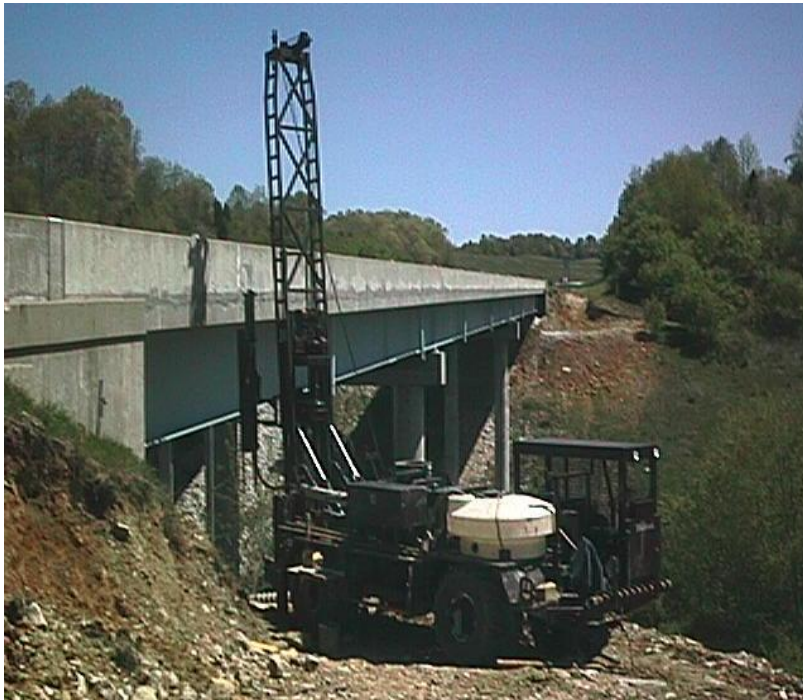
Fig. 12. Drilling vertical hole in west abutment slope to install coaxial cable.

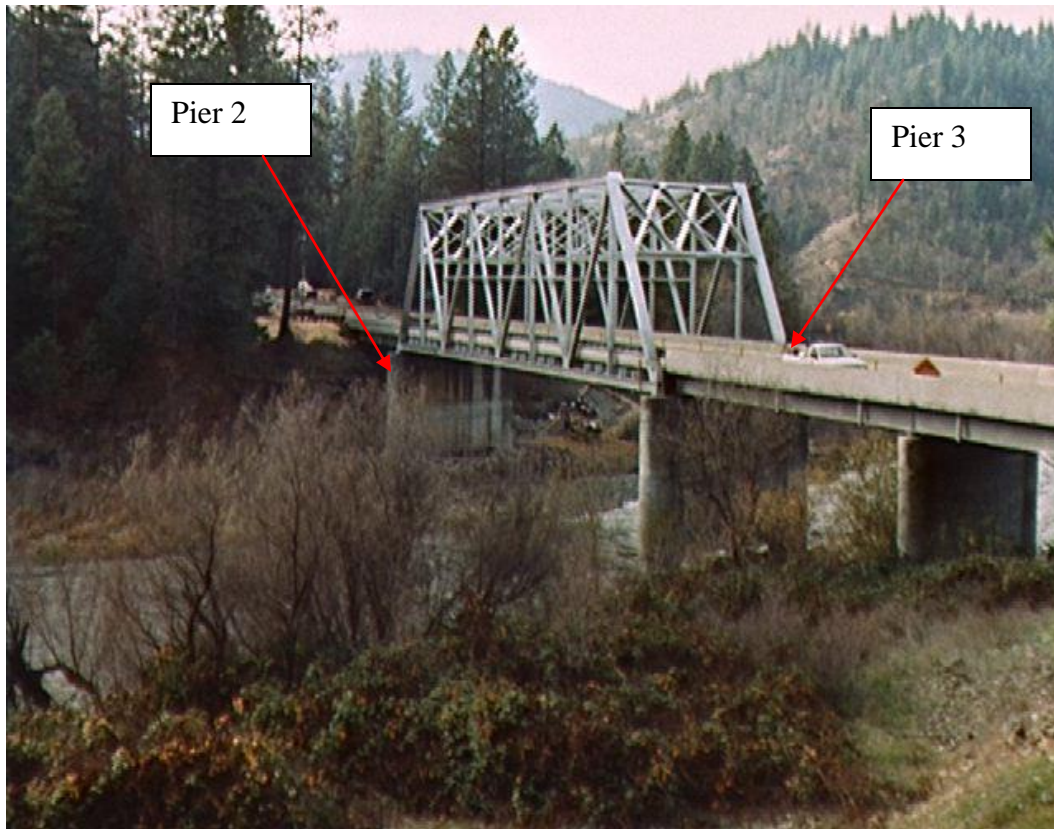
Fig. 14. Bridge over Klamath River; scour pocket developed under Pier 2 in the background; cables was installed through the foundation of Pier 3 in foreground.

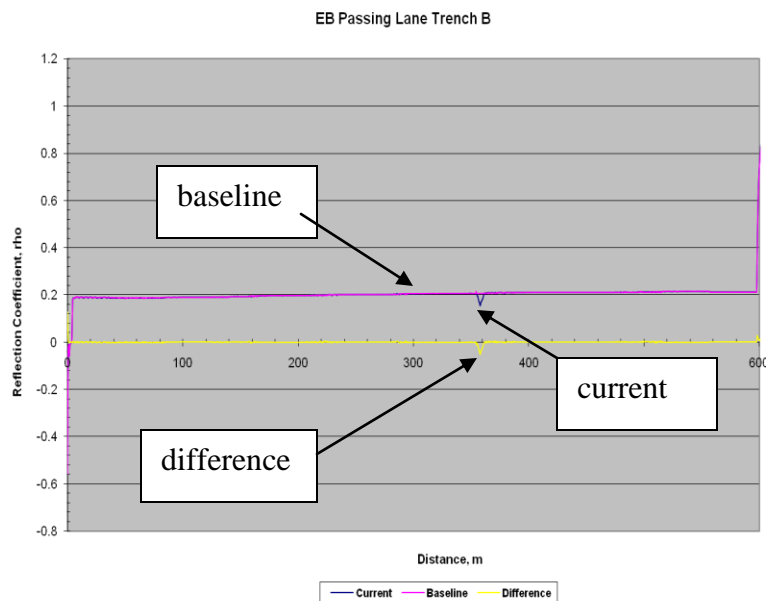
Fig. 17. Baseline waveform, current waveform with a reflection at 360 m, and the difference waveform
