IN-SITU SOIL MODIFICATION

PROCEEDINGS OF THE TWENTY-THIRD
OHIO RIVER VALLEY SOILS SEMINAR

October 16, 1992
Holiday Inn - Hurstbourne
Louisville, Kentucky

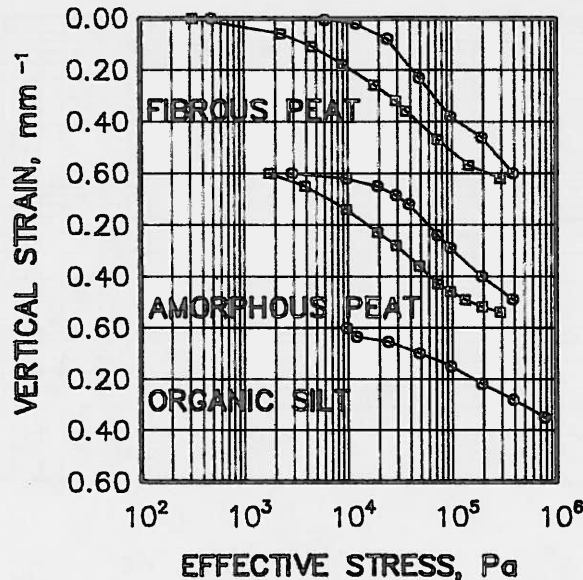
In a finite element analysis involving layered systems one must convert the consolidation coefficients to the fundamental parameters of hydraulic conductivity, k , and specific storage, S_s . The vertical coefficient of consolidation C_v equals $k/(\gamma_w m_v) = k/S_s$, where m_v equals the soil compressibility and γ_w equals the unit weight of water. The use of consolidation coefficients to satisfy continuity of flow between soils of different compressibilities results in an incorrect ratio in the hydraulic gradients at the layer interfaces (McNulty, 1982, Pg. 40). Instead, one can calculate the compressibility, m_v , from the stress-strain curves in Figure 3.

Figure 3. Ranges in stress-strain curves for laboratory tests where upper curves (open circles) represent undisturbed and lower curves (open squares) represent disturbed soils.

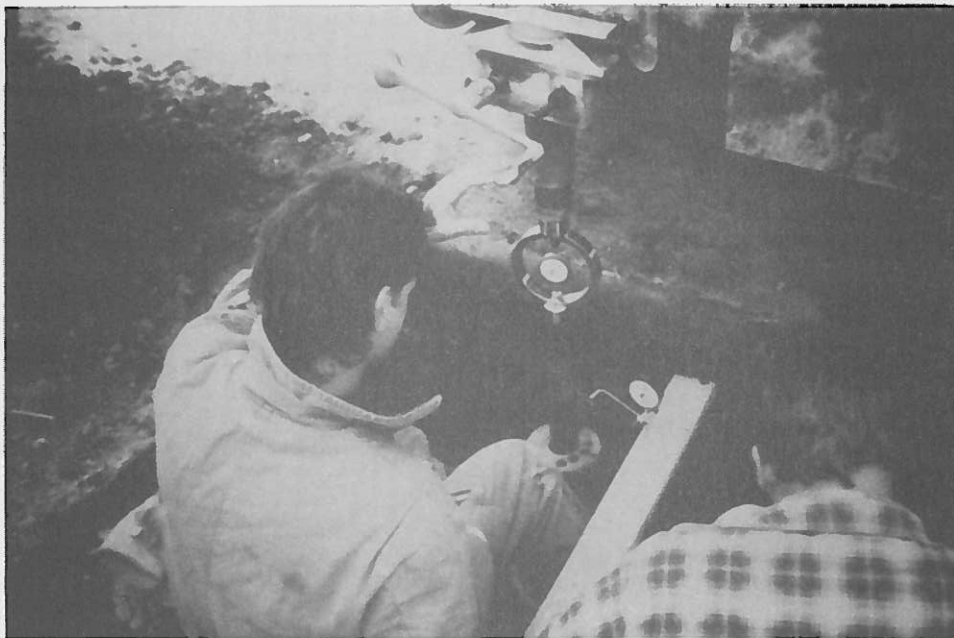
FIGURE 3 Conducting field CBSs on subgrade.

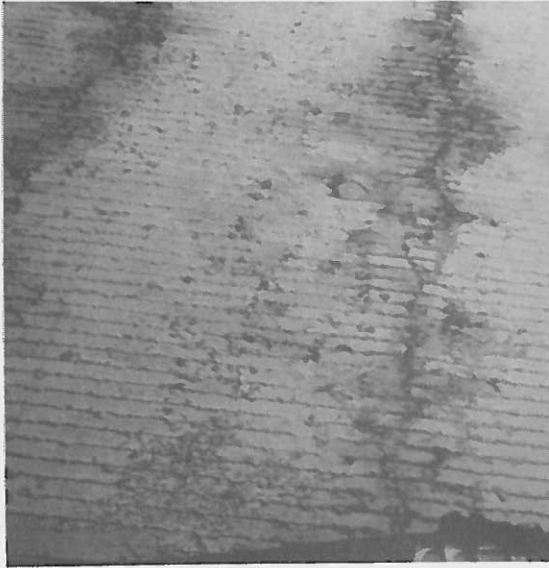
Longitudinal Cracks
(Medium to high severity)

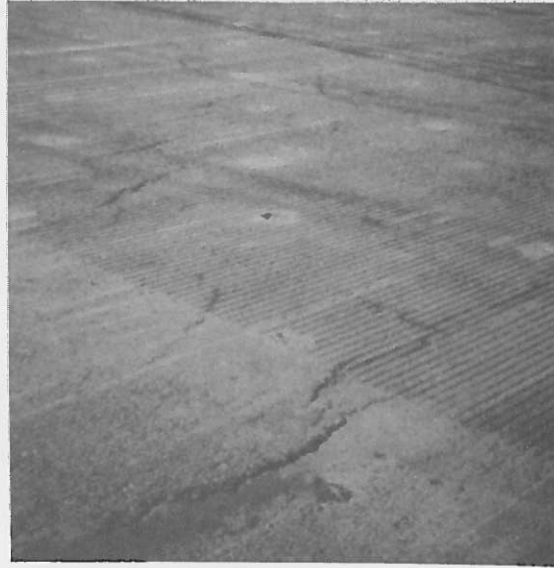
Block Cracks
(Low severity)

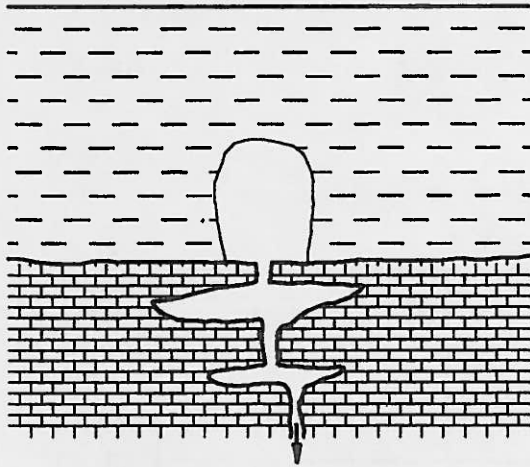
*INITIAL STAGE – Void
Formation Near Dominant
Fracture Inlet.*

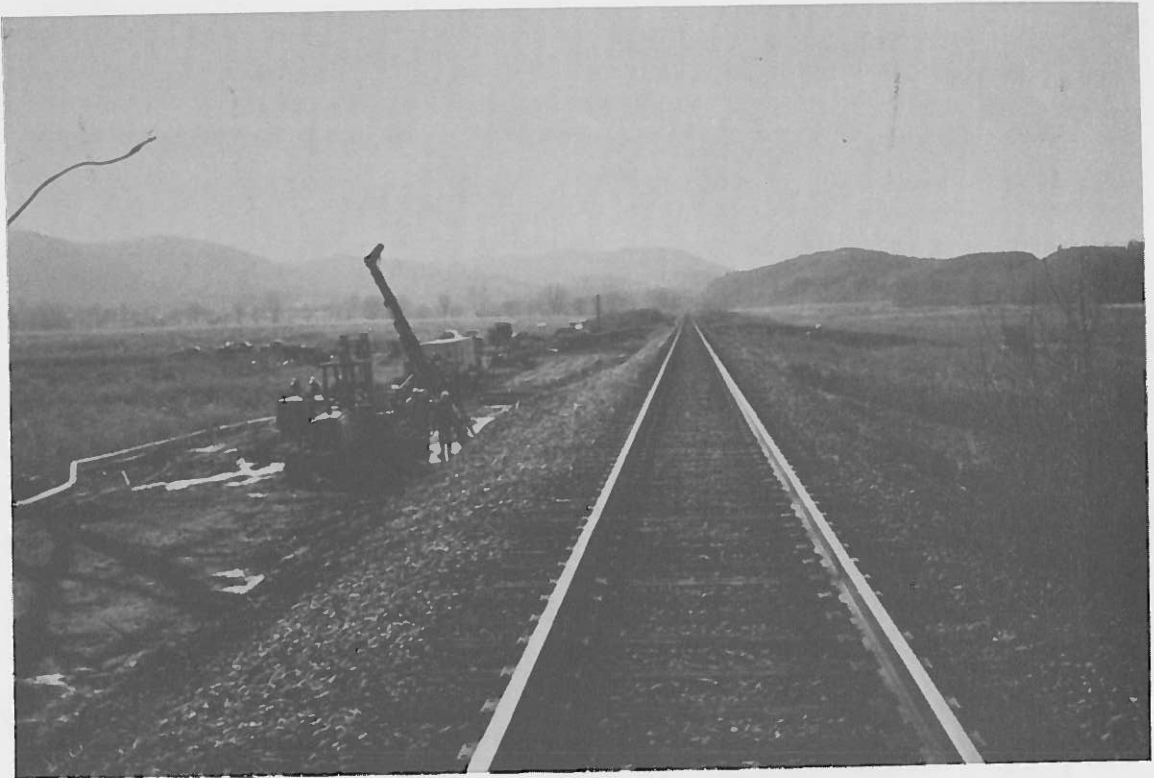
Figure 6. Photograph Facing Railroad South Showing Angle-Drilling Operations.
