# GEO TECHNICAL ASPECTS OF INFRASTRUCTURE RECONSTRUCTION

PROCEEDINGS OF THE TWENTY-FOURTH  
OHIO RIVER VALLEY SOILS SEMINAR

October 15, 1993  
Holiday Inn - Cincinnati Airport  
Erlanger, Kentucky

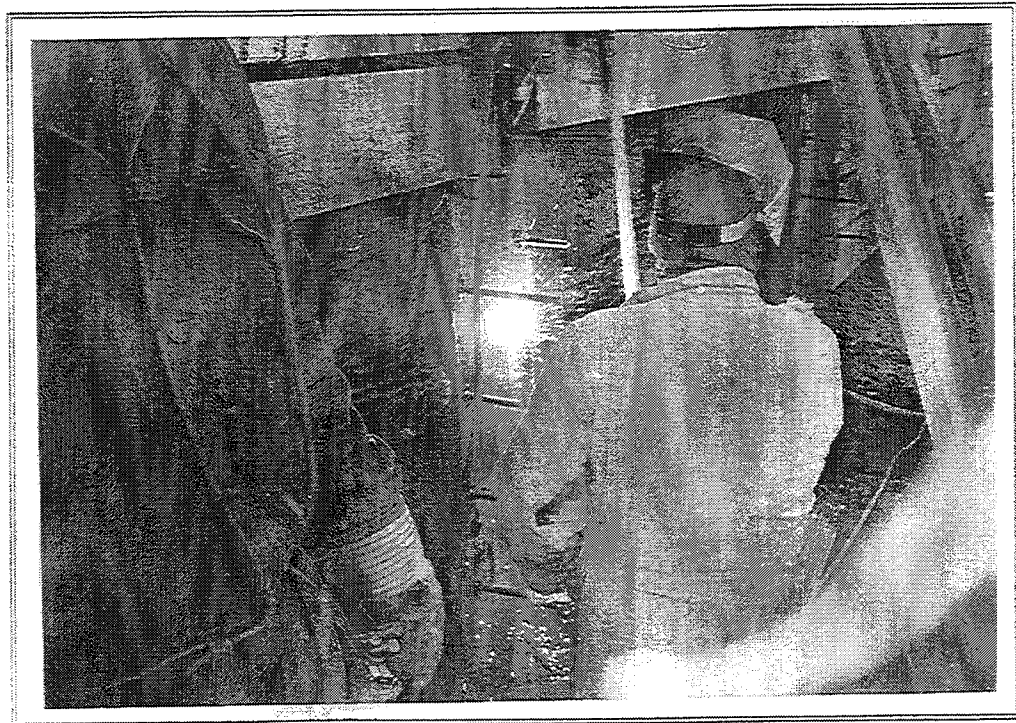
Figure 4. Installation of lagging studs

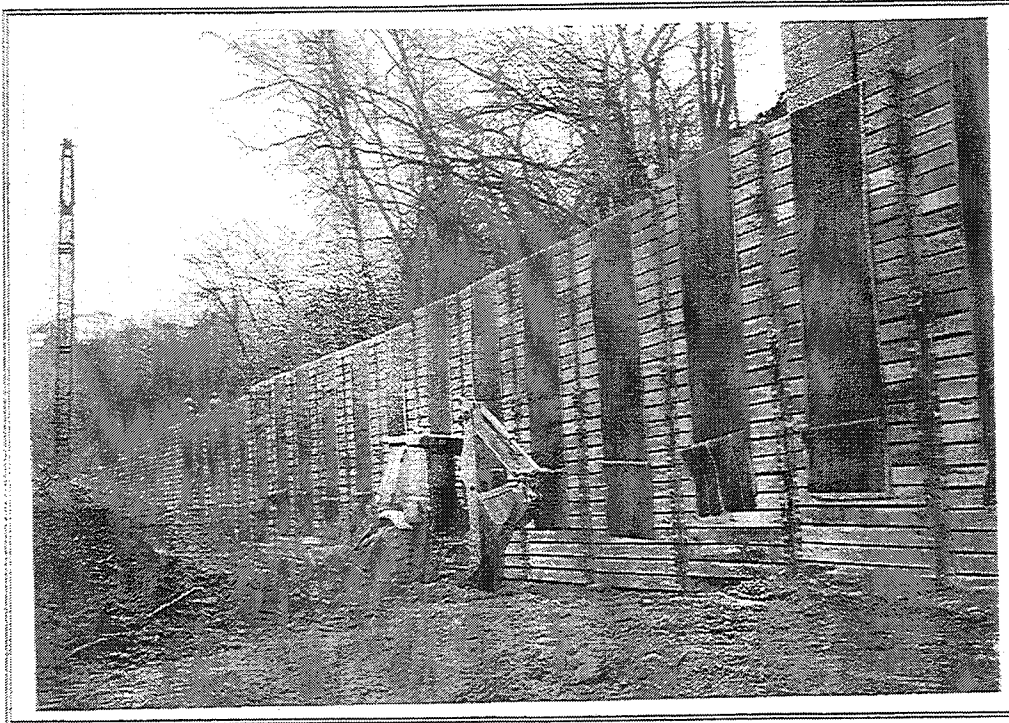
Figure 7. Placement of drainage material

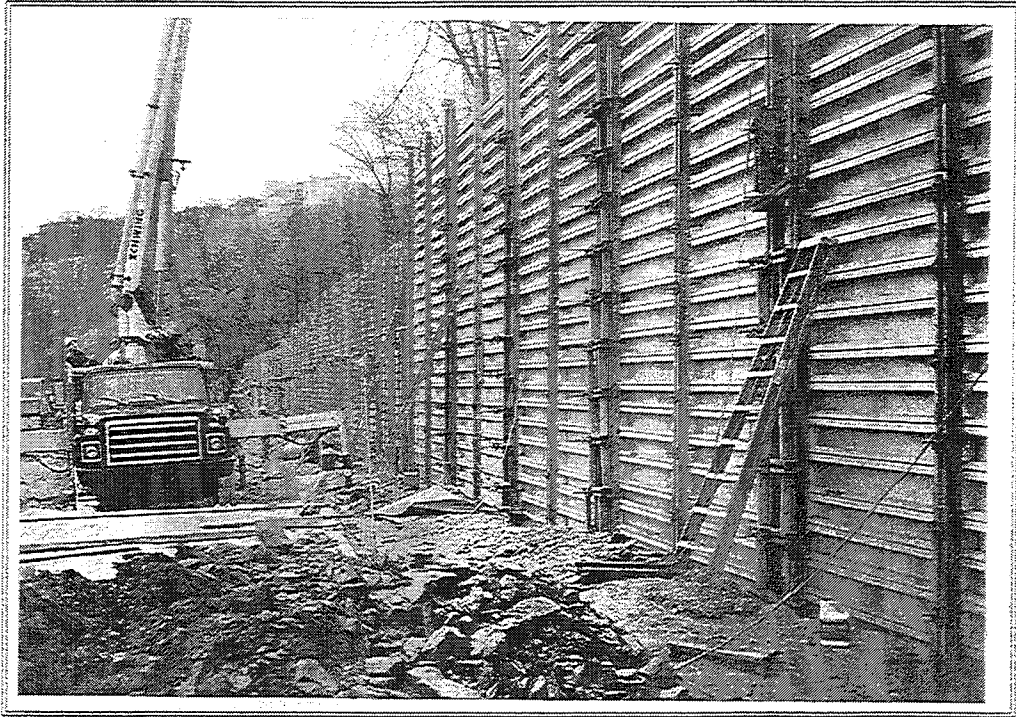
Figure 9. Facing wall gang forms

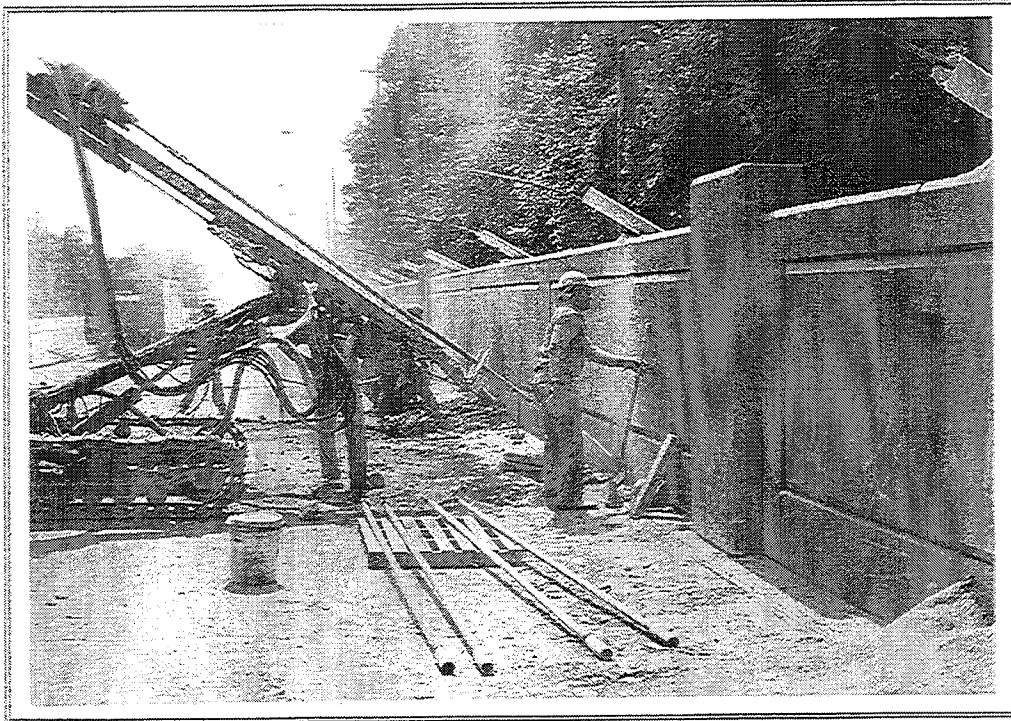
Figure 23. Installation of anchors in existing uphill wall

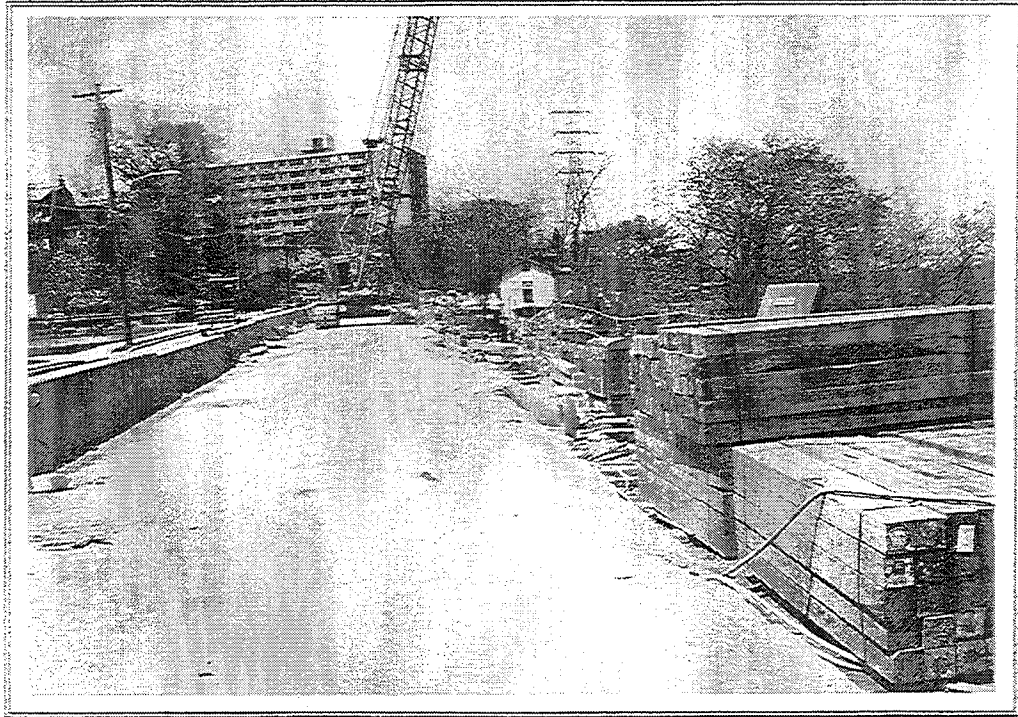
Figure 25. Traffic lane used as working bench

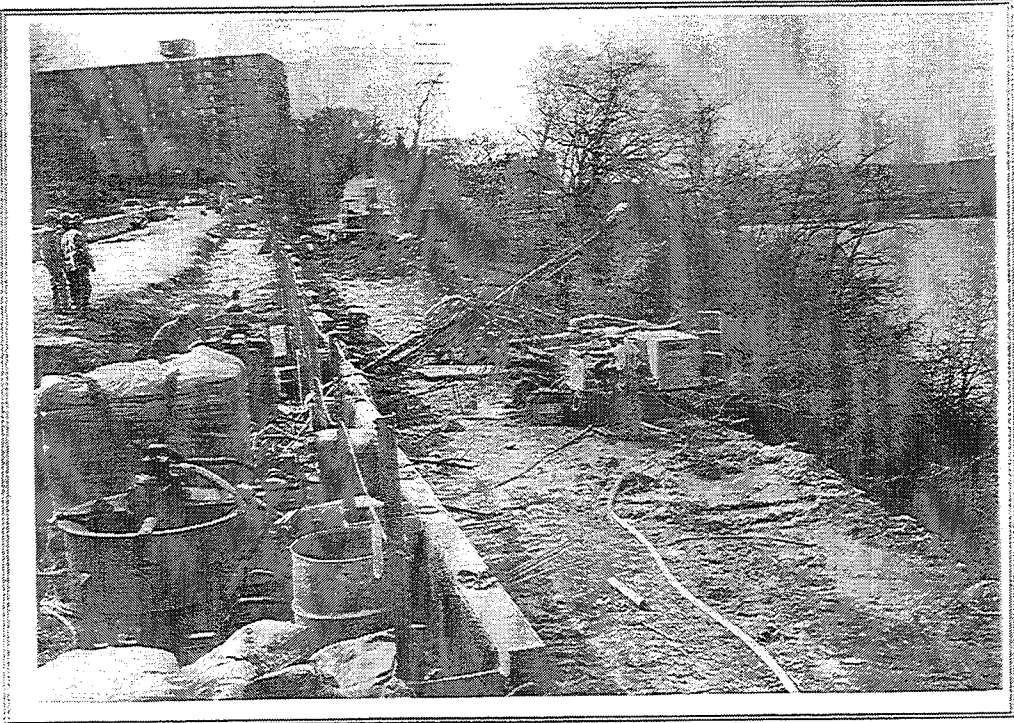
Figure 27. Installation of top row tieback anchors

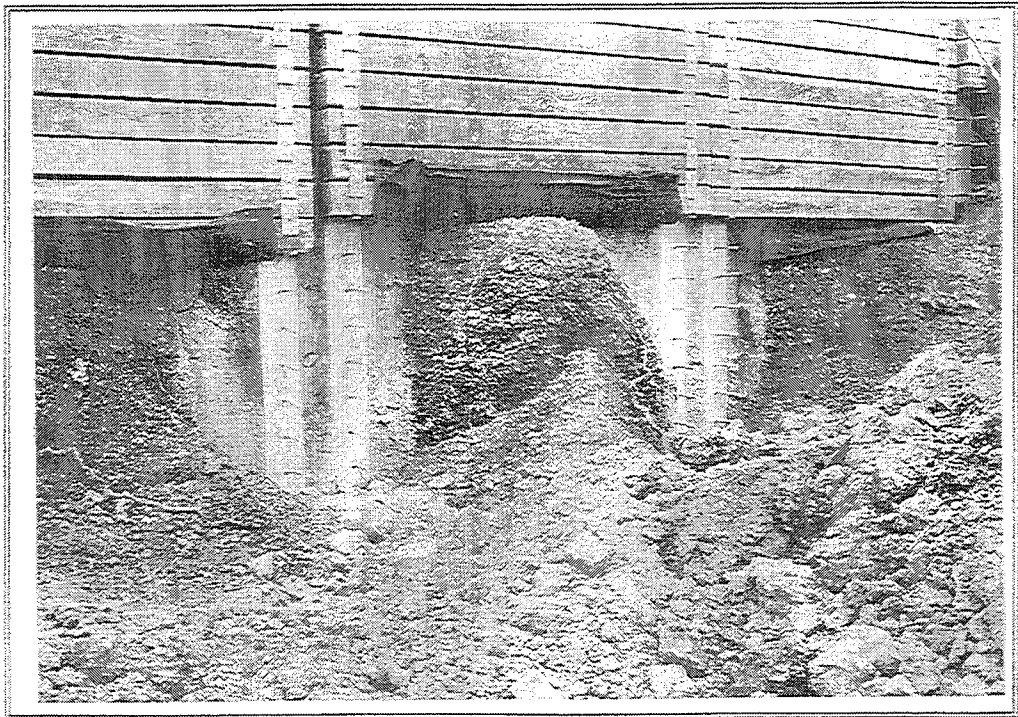
Figure 30. Soldier beams, lagging, studs, and drainage material

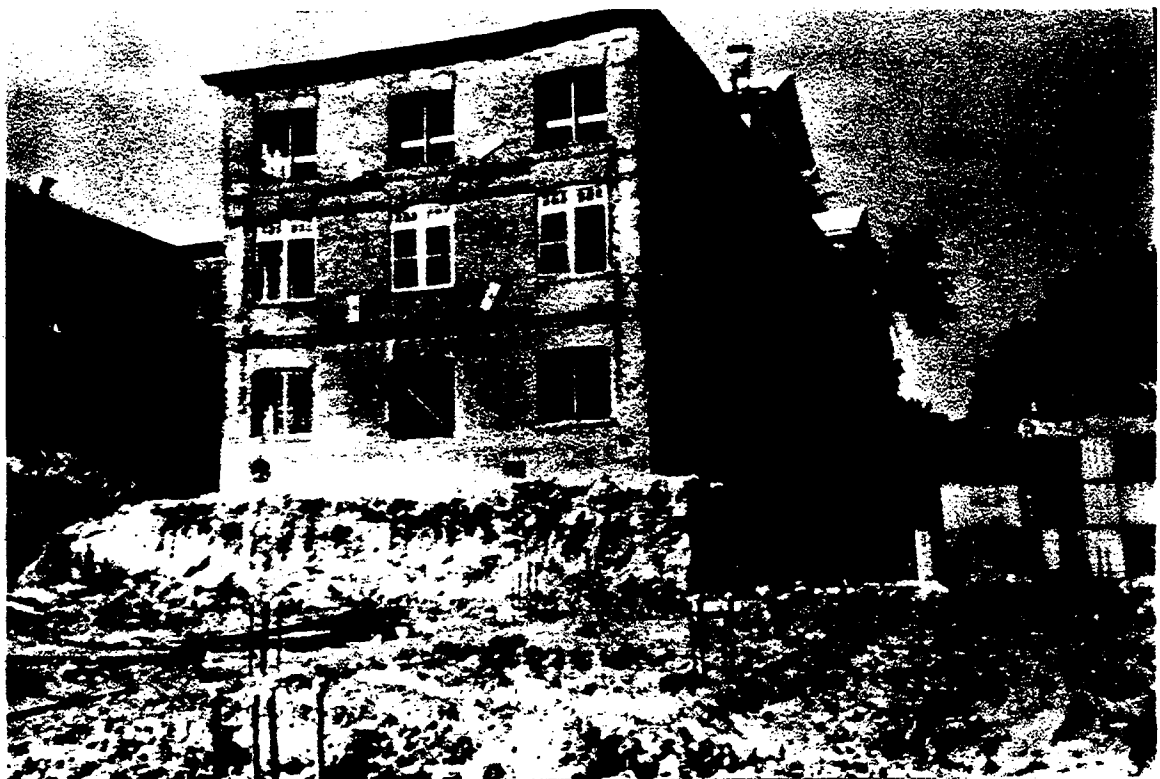
**Photograph 2 - Excavation completed, the soilcrete wall is exposed.**
