Proceedings of the 54<sup>th</sup> Annual Ohio River Valley Soils Seminar

# Water in Geotechnical Engineering

November 13, 2024  
Great American Ball Park  
100 Joe Nuxhall Way  
Cincinnati, Ohio

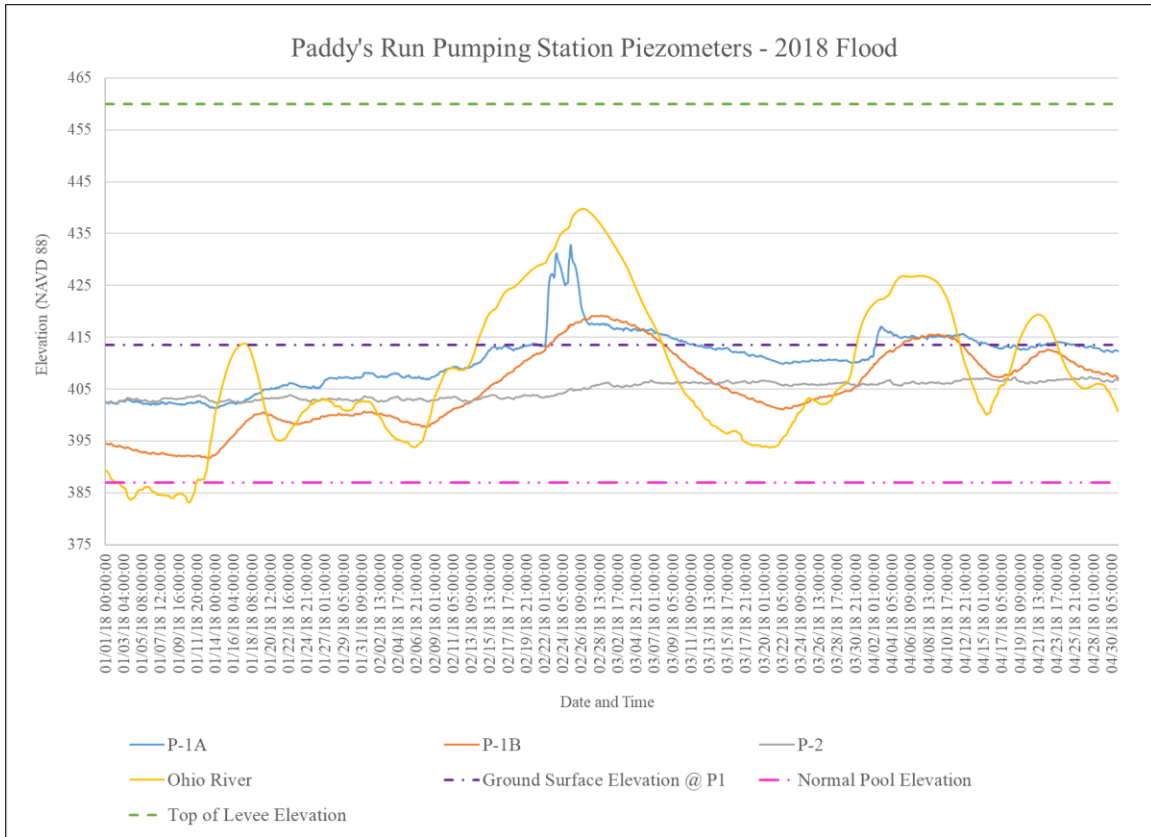
**Figure 4: Piezometer data recorded during the 2018 flood event.**

justified the concern that the relief wells are not functioning at the design capacity. The quick rise in piezometer P-1A shown in Figure 4 at this same time was assumed to be caused by the land side ponding area significantly flooding during this storm event. An aerial google image shown in Figure 9 shows the water elevation in the ponding area during this flood event.

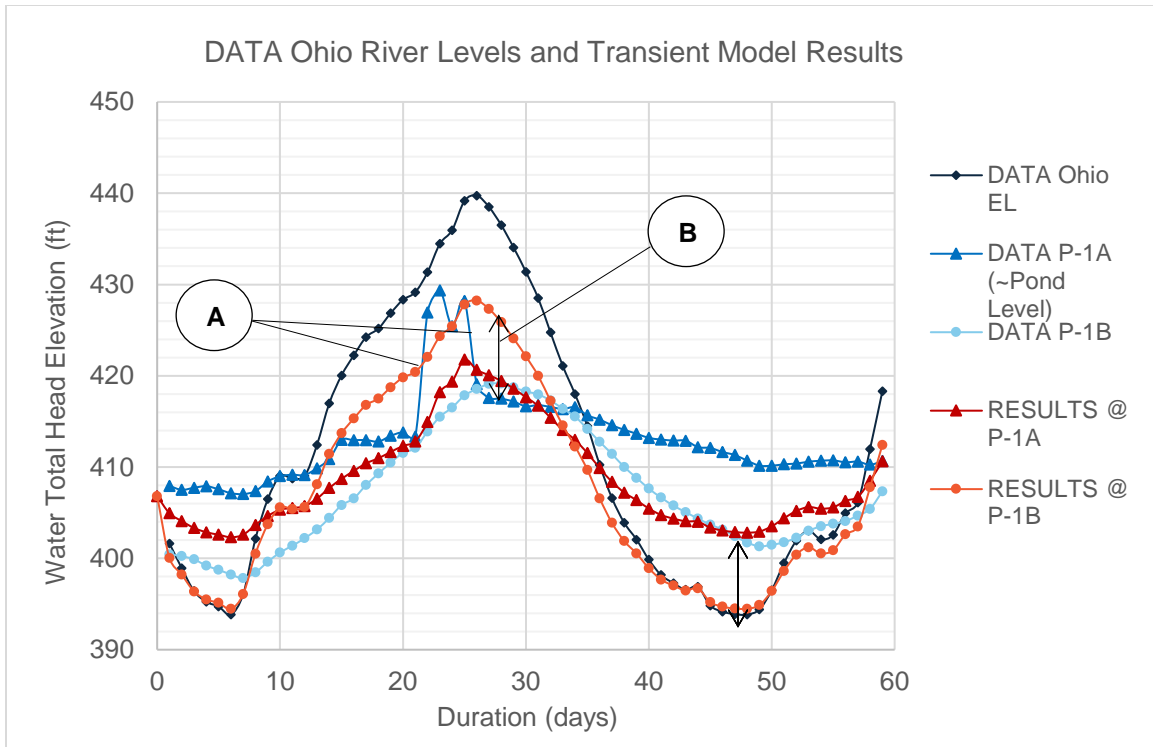
**Figure 8: The Ohio River Hydrograph (black), in-field piezometer readings (blueish) and transient results at piezometer locations for the 2018 flood (reddish).**

Figure 8 below summarizes the 2018 Ohio River flood event data with the measured pore water pressures in P-1A and P-1B along with the calculated pore water pressure results from the model.

As mentioned above, P-1A records pore water pressures within the clay blanket. The model estimates the pore water pressures within the clay blanket during the time of elevated water levels in the ponding area. This data is coherent with Google Earth images at the time of elevated water levels in the ponding area during the 2018 flood event (Google, 2018). Figure 9 below shows the outline of sediment remains after the ponding area filled to approximately 430.0 feet on February 23, 2018. The estimated pore water pressure from the model for location PZ-1A estimated a difference of approximately 7.0 feet compared to the measured pore water pressure in the field. Additionally, the model does not show the spike and drop in pore water pressure measured by P-1A, as shown in Figure 8, Point A. This situation is due to the model not accounting for the ponding area quickly filling from the storm event and subsequently being drained by the existing flood pump station. The transient seepage model only recognizes changes in water pore pressures, not additional effective stress applied by the weight of the water in the ponding area.

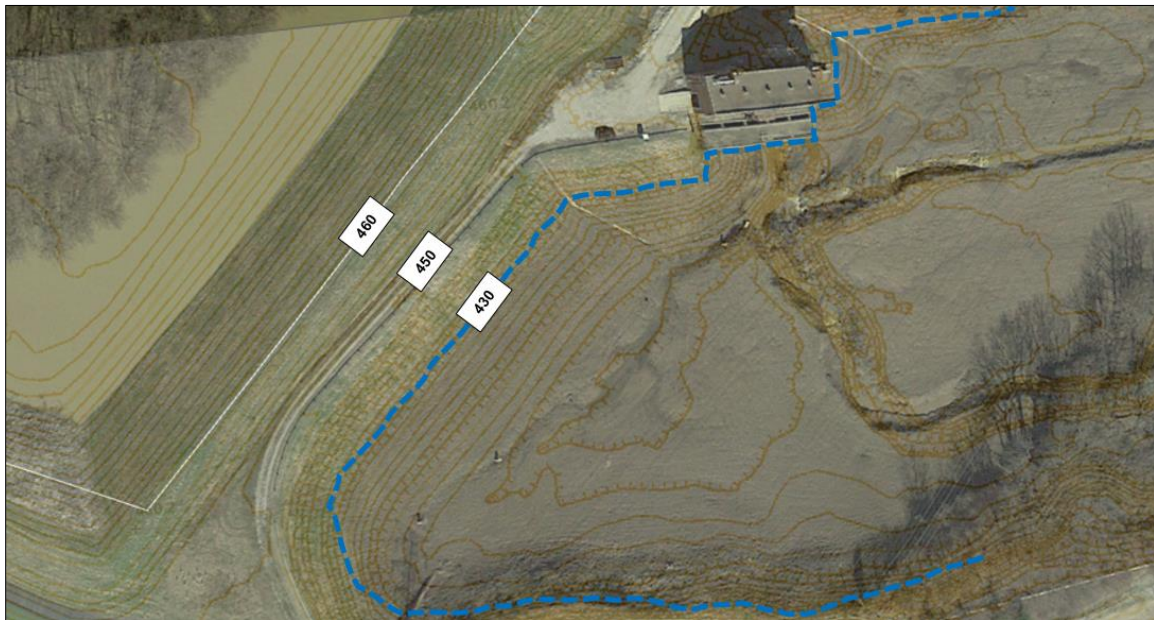
**Figure 9: Aerial view of the ponding area on February 28, 2018, five days after the maximum P-1A reading of 429.36 feet (Google, 2018).**

Piezometer P-1A data shows more consistent water pore pressures before and after the flood, excluding the 27 days when the Ohio River peaked during the 2018 flood event. P-1A measured less impact by the Ohio River fluctuations but recognized water pore pressures caused by a saturated or filled ponding area. This condition could be the result of unknown degrees of saturation in the clay blanket that cannot be implemented into the model, or localized permeability material characteristics of the soil that develop a better connectivity to the ground surface than to the alluvial sands; therefore, subjecting P-1A primarily to loads caused by ponding area levels.

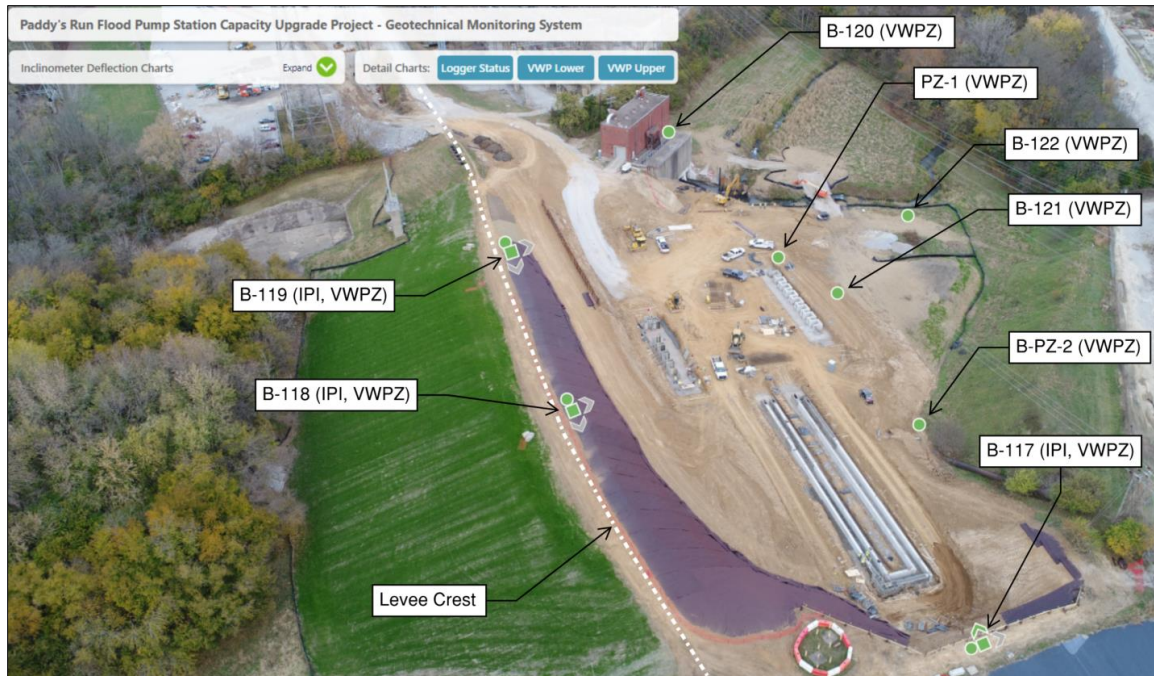
**Figure 16: In-place slope inclinometer (IPI) and vibrating wire piezometer (VWPZ) locations.**

In addition, vibrating wire piezometers were set and grouted in-place at two open well locations (PZ-1 and PZ-2). The well locations were installed during the project's initial geotechnical subsurface exploration phase.

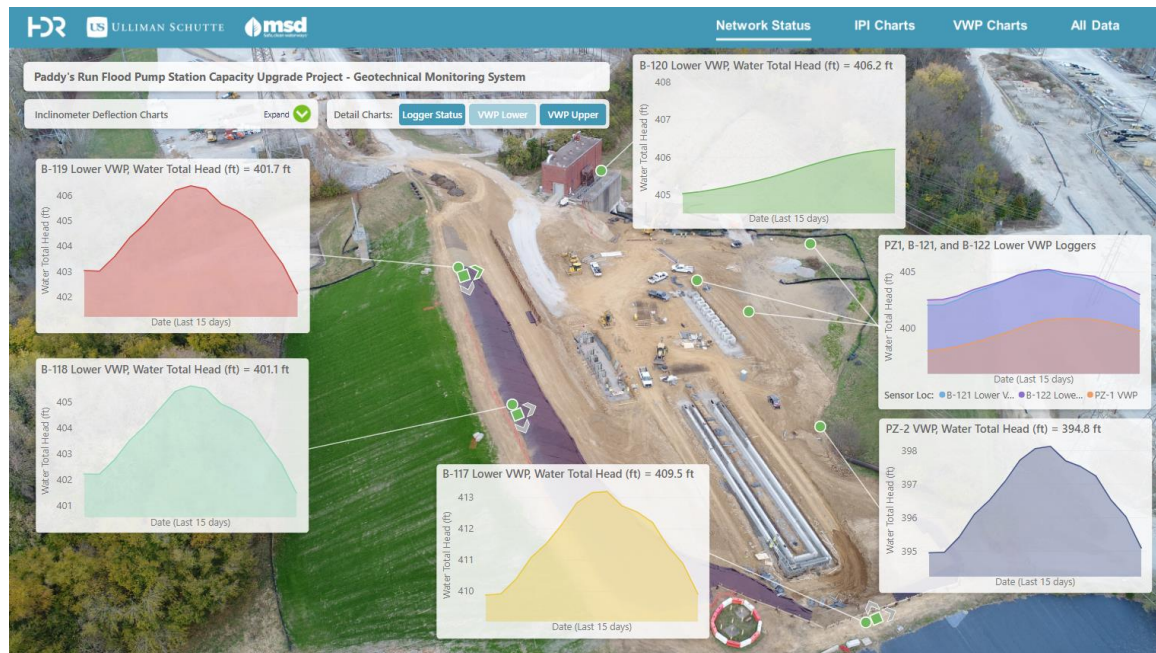
**Figure 18: Typical BI Dashboard View of the Monitoring Data Collection**

GEOKON equipment was selected for the monitoring instruments described above. GEOKON’s 4500S-350KPA model was used as the vibrating wire piezometer and the GEOKON 6180 instruments were utilized for the in-place slope inclinometers. The VWPZ and IPI data collection is automated through an on-site mesh connection between five battery powered data loggers that are continuously collecting data from the instruments. The data is uploaded into GEOKON’s network through a solar powered cellular gateway and can be accessed as soon as data is uploaded. HDR furnished an automated online dashboard that is updated every four hours with data from the GEOKON network through an API connection. The dashboard allows a user-friendly and quick overview of the collected data. Figure 18 below shows a typical dashboard view.

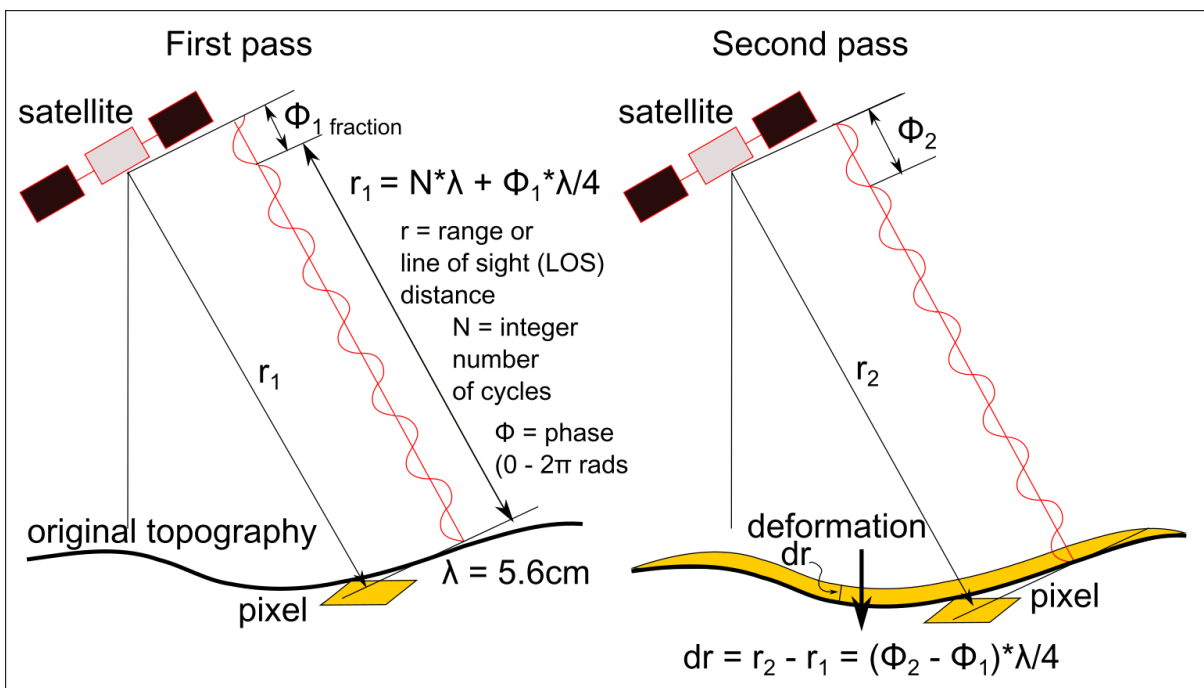
Figure 1 - Illustration of Radar Phase Change and Deformation

To perform interferometric analysis requires multiple (at least two) SAR acquisitions. As successive reflected signals are received from a given point on the ground their phases can be compared, the difference quantified and used to determine a key property known as the 'phase velocity' i.e. how fast is the phase change occurring? The general concept is depicted in Figure 1. With appropriate corrections for topography and climatic conditions the phase velocity can be plotted to form interferograms at which point the process has transitioned from SAR to InSAR.

If deformation is rapid, the resulting phase difference from one orbit to the next may exceed  $\pi$  radians, in which case the data become ambiguous - is the deformation one wavelength or two, or even more? This problem is solved using some mathematical sophistication known as 'phase unwrapping' that attempts to assign correct values to the deformation represented by each phase velocity. The final result is a data set that includes line of sight (los) velocity and displacement values for each pixel at a typical resolution of 40 m (~130 ft) this is ready for the analysis planned by the user.

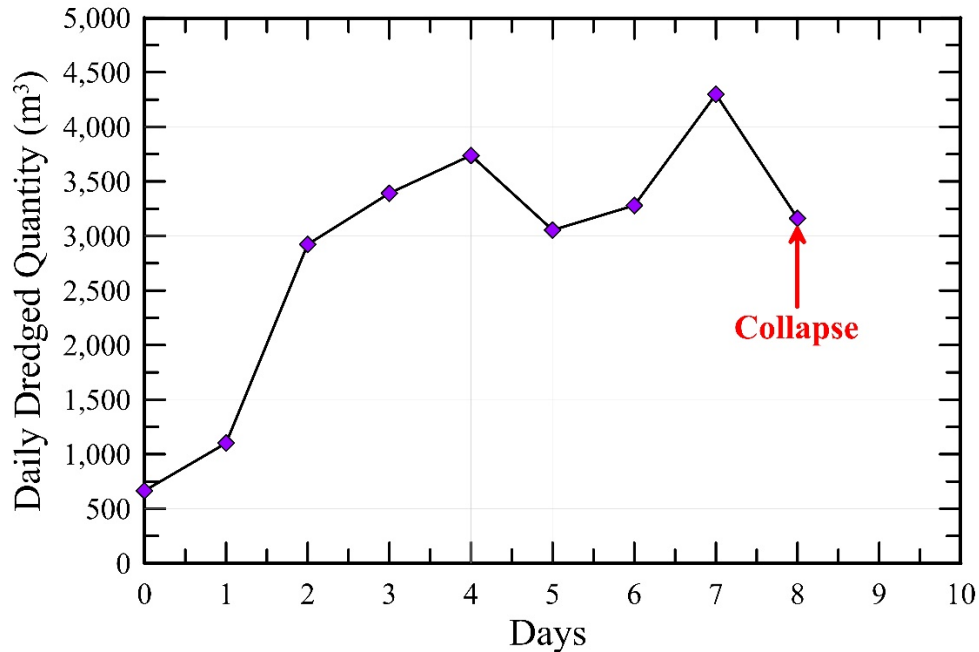
**Figure 3. Daily dredging quantities between July 21 and July 29, 2011.**

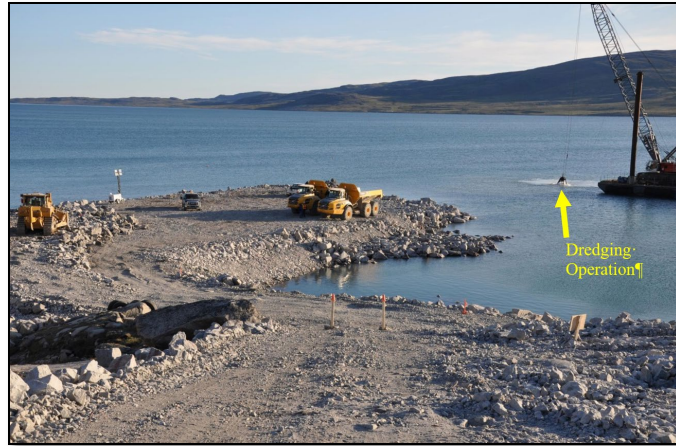
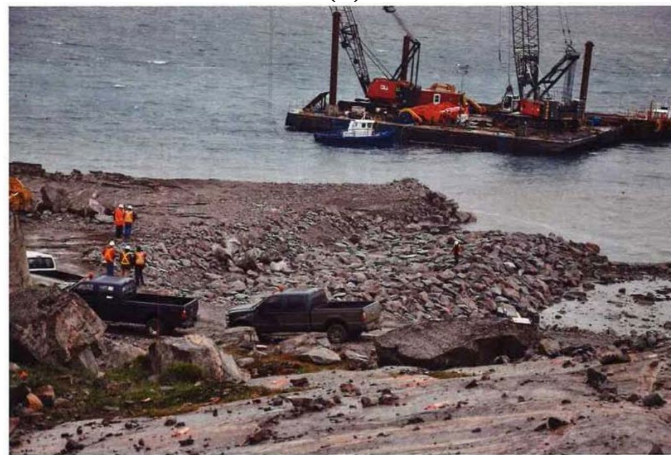
**Figure 6. Photographs showing: (a) overview of rockfill causeway and dredging operation and (b) formation of tension cracks near end of causeway and distance to distance to dredging just prior to collapse and stabilizing rockfill on east side (right) of causeway.**

The causal link between the dredging and causeway filling is also corroborated by the mobilized slide mass damaging two of the vertical pylons or spuds that were stabilizing the dredge barge at the time of collapse (see **Figure 6(a) and (b)**). In other words, the material from the rockfill causeway moved until it was under the dredging equipment during the causeway collapse. This also means the slope toe was near the dredged excavation because the rockfill could move or flow below the dredging equipment (see **Figure 6(b)**).

For the failure surface of the first slide mass, it is known that the length of the top of the block was about 8 m (see **Figure 9**). Furthermore, the failure was known to be translational as observed in the field and evident from the photographs shown in **Figure 6(b)**, **Figure 8**, and **Figure 9**. Therefore, the critical translational failure surface was searched manually in SLIDE2 until a failure surface with the lowest FoS was located. This critical translational failure surface was considered in the inverse analysis for calculating the mobilized undrained strength of the clay.

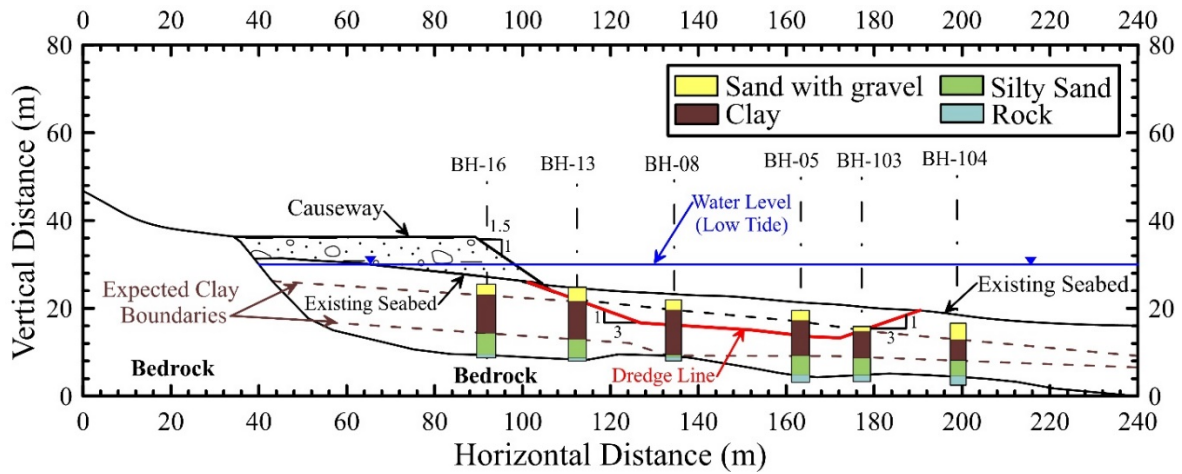
Figure 7. Cross Section at location shown in Figure 1 with soil borings superimposed.

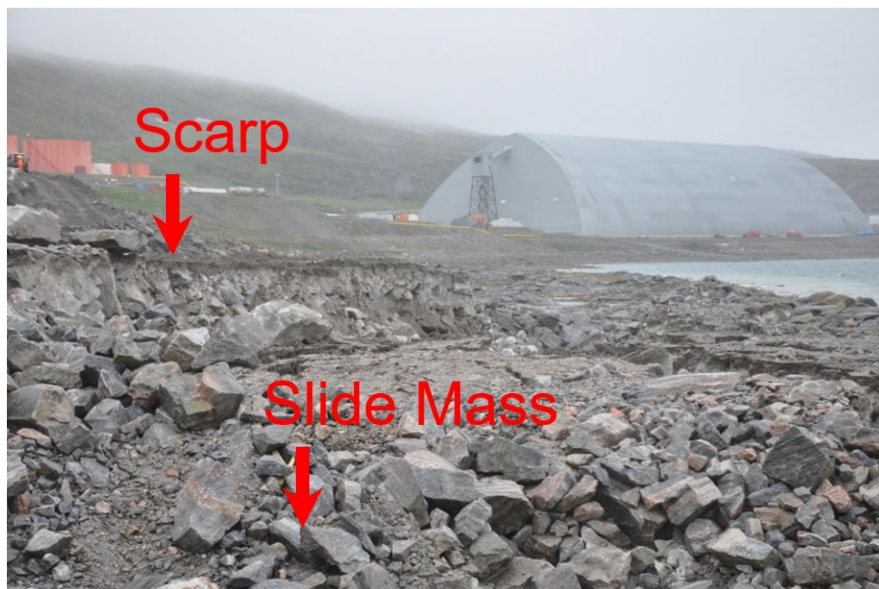
Figure 8. Almost vertical scarp through causeway of the last slide mass near the shore.

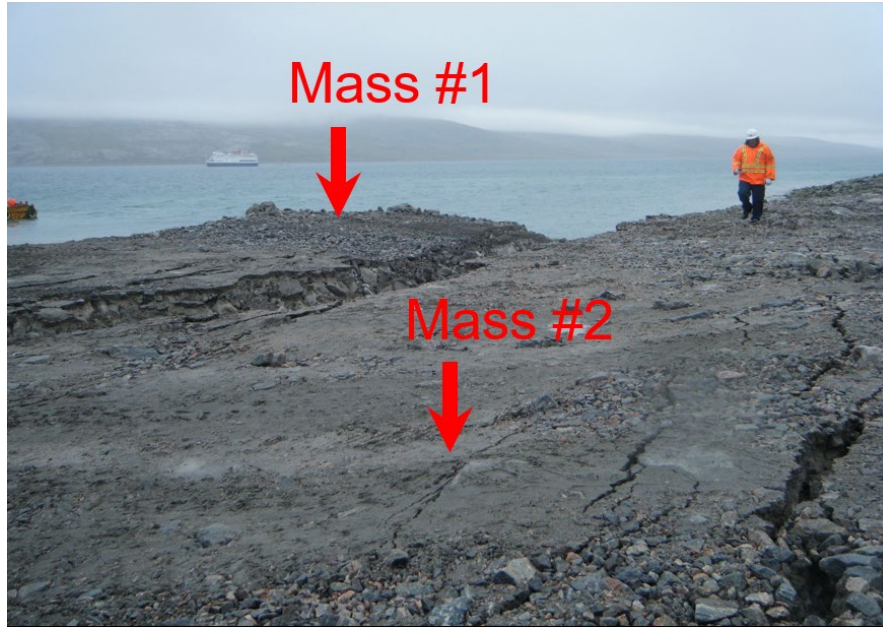
**Figure 9.** Photograph of slide masses #1 and #2 with the second slide mass developing without large displacement of the first slide mass (Note rockfall off the back of the first slide block into the gap between the two masses).

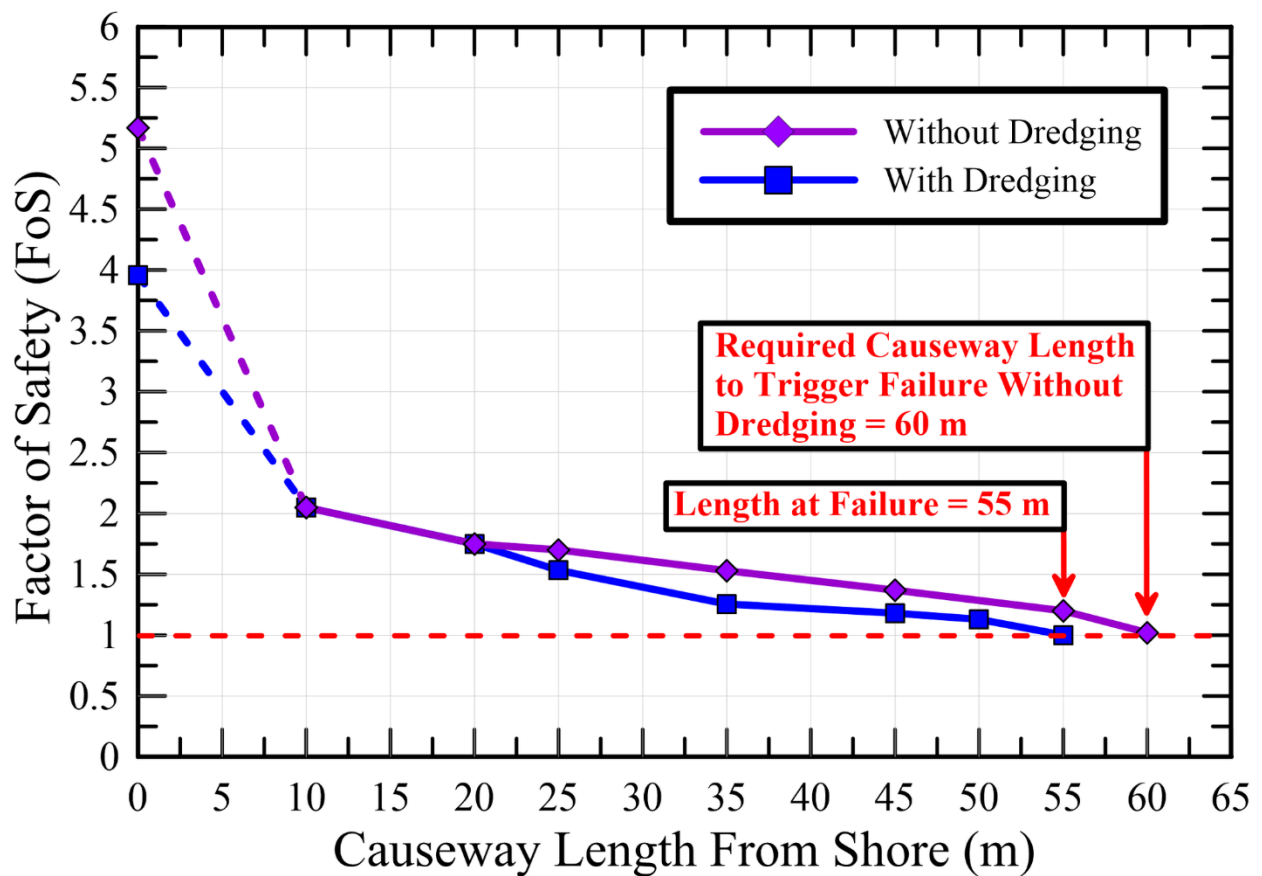
Figure 12. Impact of dredging and causeway rockfilling on FoS as a function of causeway distance from shoreline.

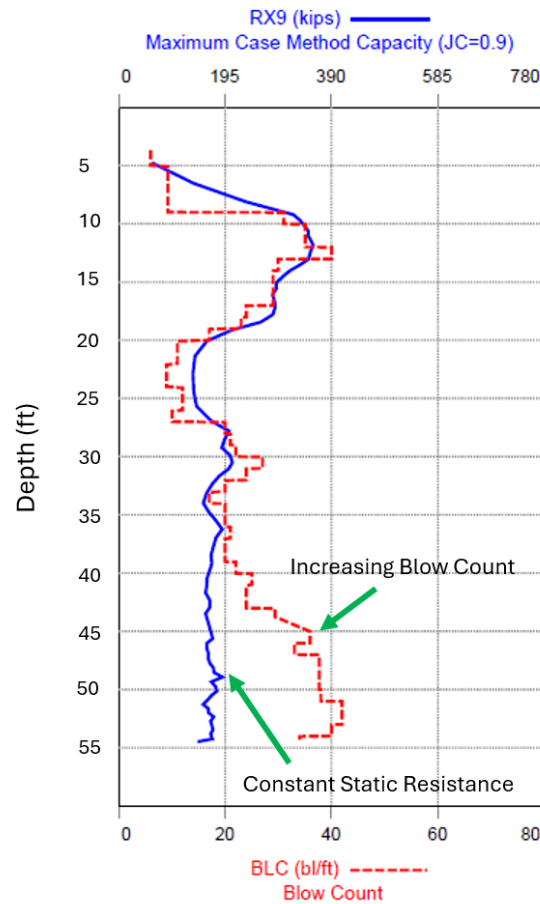
**Figure 1: Blow Count and Capacity vs. Depth – A Demonstration of Pore-Water Pressure Effects on soil resistance during driving**

After pile installation, the excess porewater pressure dissipates and static soil resistance (in relation to the soil resistance at the end of installation) increases. This phenomenon is often referred to as soil set-up. In addition to the increased resistance due to excess porewater pressure, Hannigan (2012) discusses how set-up can also be attributed to the closing of an annulus around the pile caused by an oversized boot plate or pile tip reinforcement, the remolding of disturbed soil against the pile, long term soil strength gains (aging effects), or a combination of these effects.

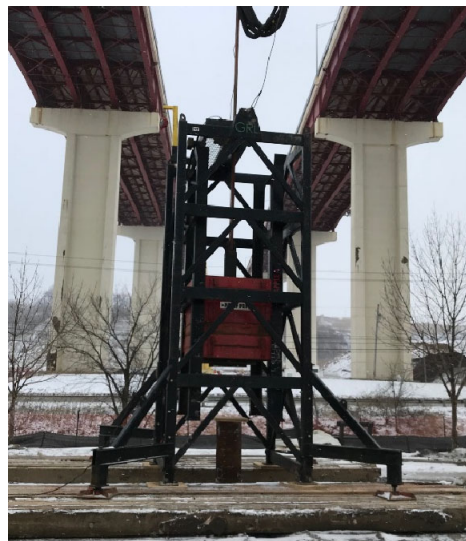
**Figure 2: 28-Ton Drop Weight Hammer**

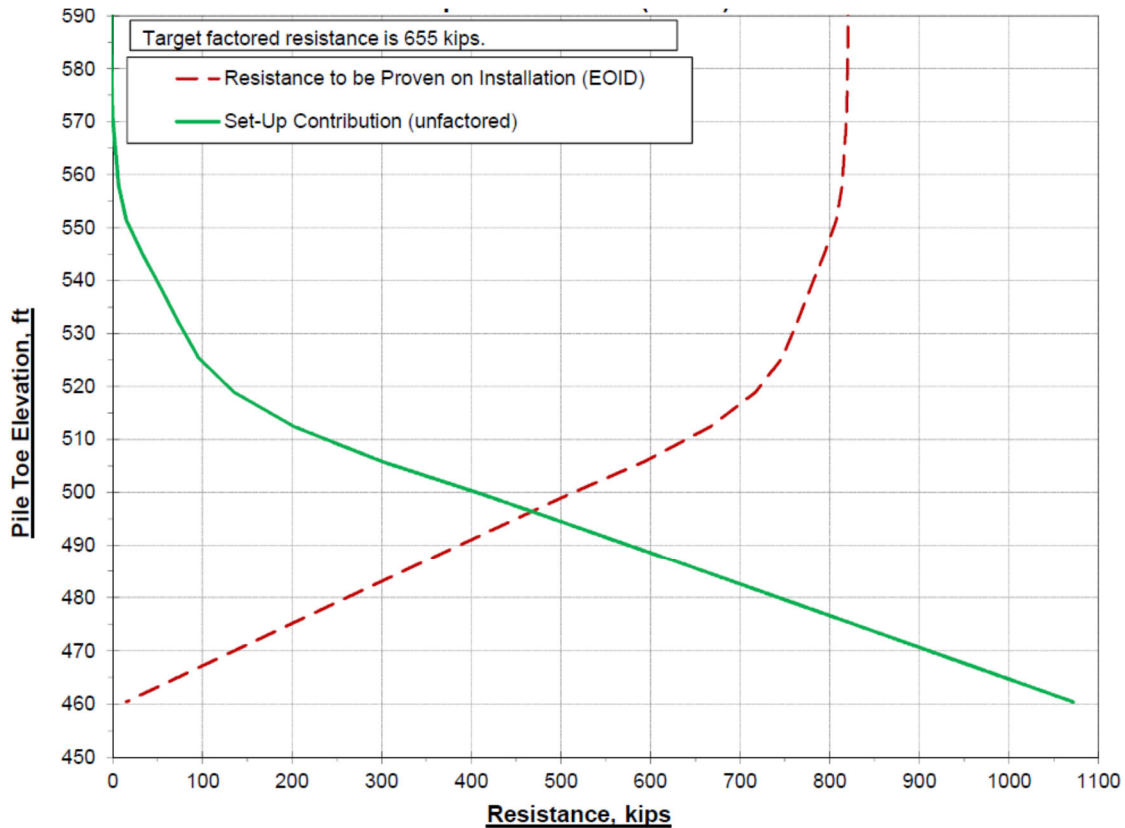
**Figure 4: Example of Soil Set-up Profile and Required Soil Resistance vs. Elevation**

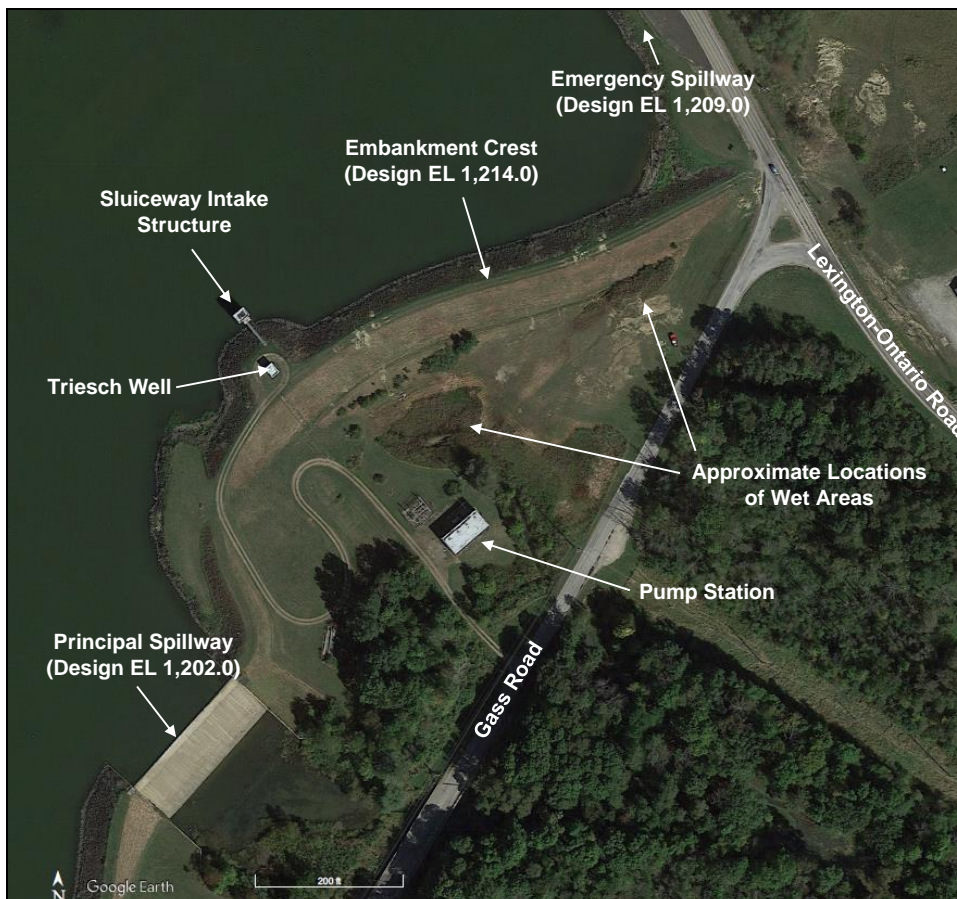
**Fig. 1. Overview of Study Area (from GoogleEarth, August 2018)**

Clear Fork Reservoir is located in Richland and Morrow counties in Ohio, approximately 7 miles southwest of Mansfield, Ohio. The reservoir was designed to be the primary source of water for the City of Mansfield. The reservoir is retained by an earthfill embankment dam located at the southeast end of the reservoir. The construction of the dam and appurtenant structures was completed in 1949. Clear Fork Reservoir Dam is a Class I High Hazard dam due to the storage capacity and potential loss of life and/or property in the event of dam failure. Fig. 1 shows an overview of the study area with pertinent dam features labeled.

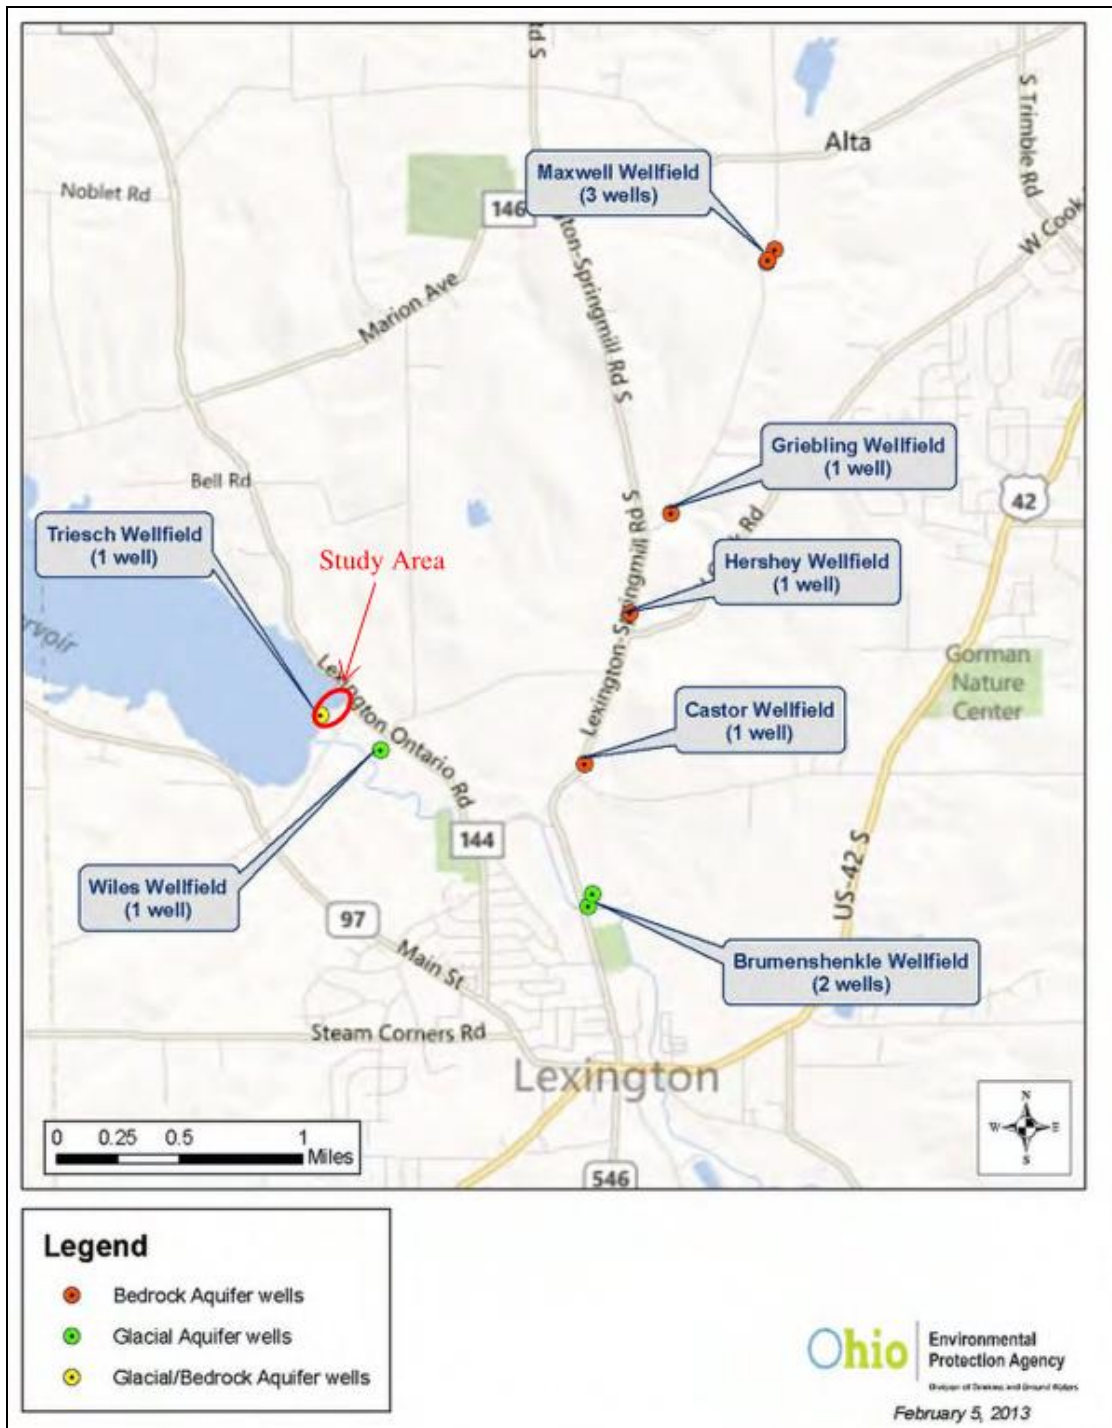
**Fig. 6. Groundwater Wells in Vicinity of Study Area (from OEPA 2013)**

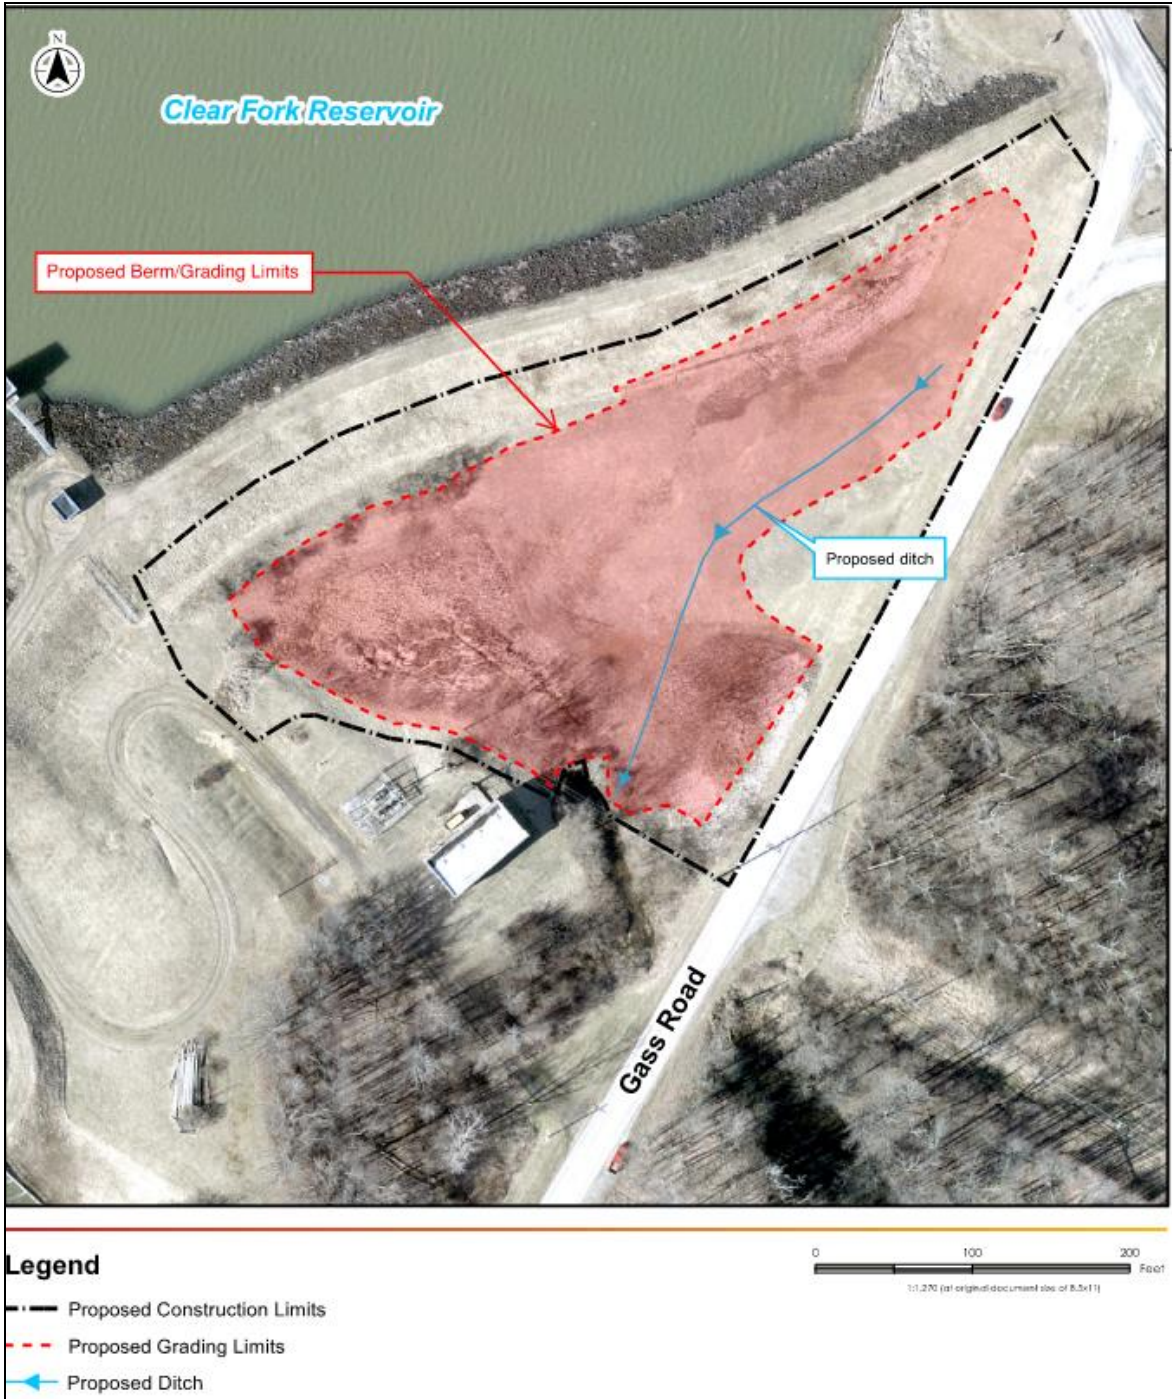
**Fig. 11. Graded Filter Toe Berm – Plan View Extents**

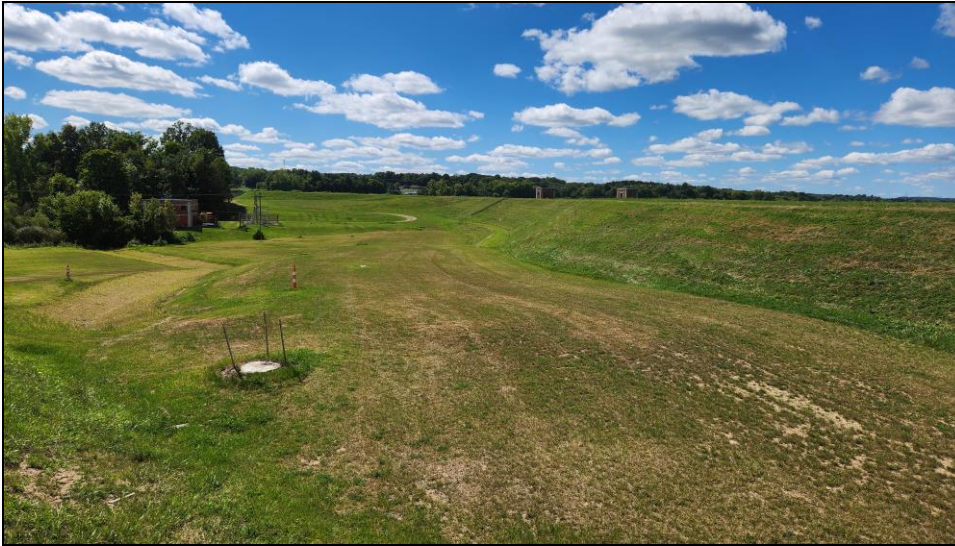
**Fig. 12. Completed Construction of the Graded Filter Toe Berm**

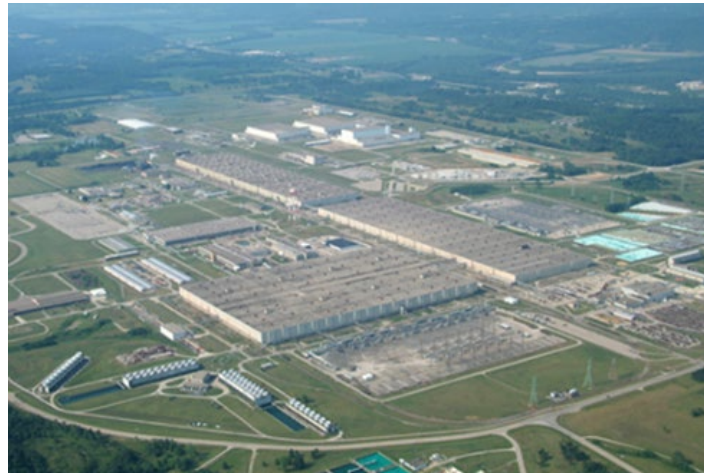
**Fig. 1. Aerial View of the Portsmouth Gaseous Diffusion Plant Site.**

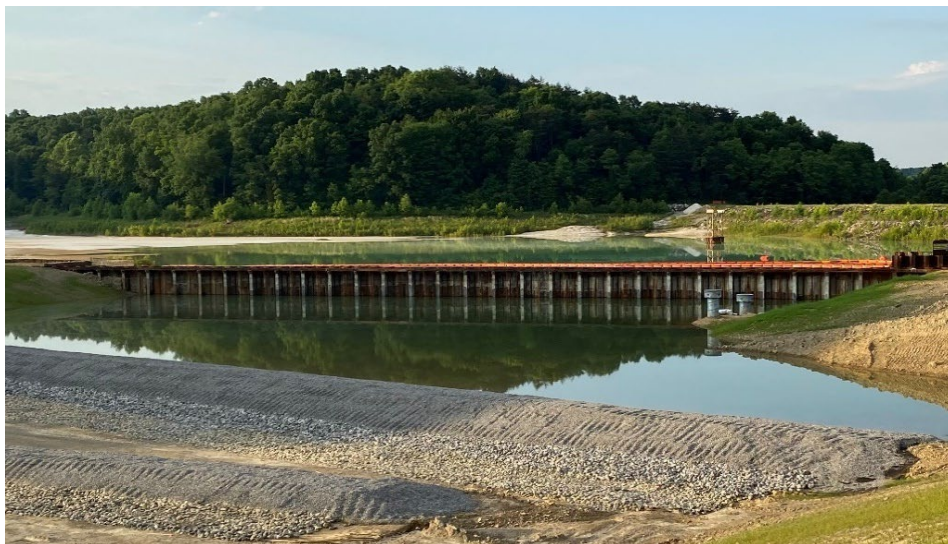
**Fig. 7. Completed Sedimentation and Detention Pond 1B.**

The completed wall and sedimentation and detention Pond 1B (**Figure 7**) was put into operation in June 2022. The following are some of the lessons learned and takeaways from this project:

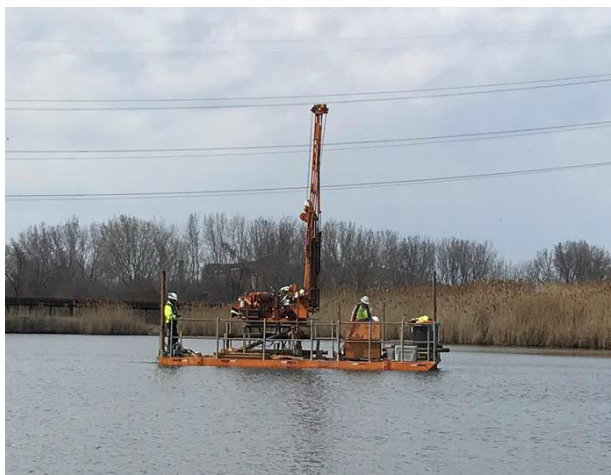
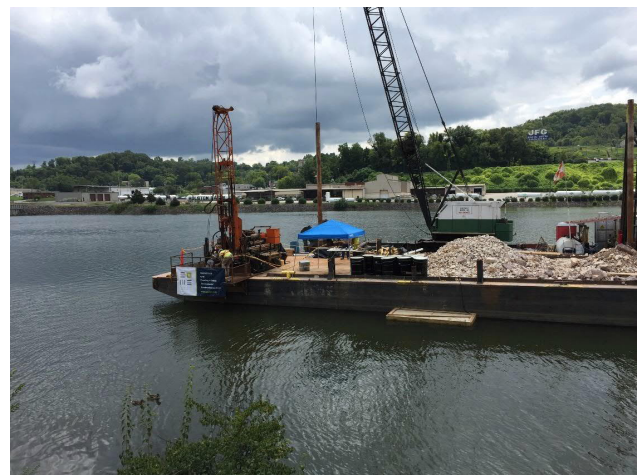
S&ME employees are conducting amphibious drilling operations on two different scales: a smaller barge platform on the left and, to the right, a river barge setup.

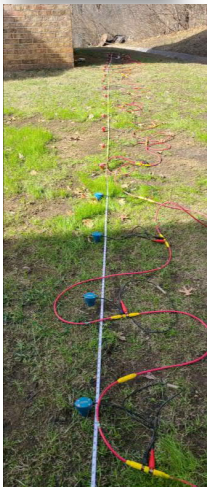
Multi-Channel Analysis of Surface Waves (MASW) consists of recording different frequency surface waves generated from an active energy source traveling across a linear array.

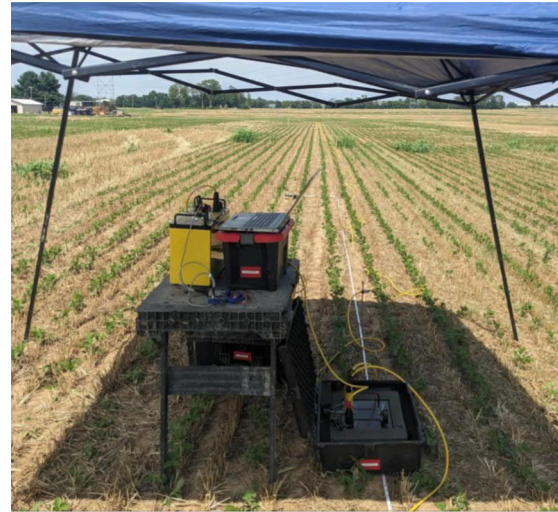
Electrical Resistivity Tomography is a measure of how strongly a material opposes the flow of an electrical current (DC).

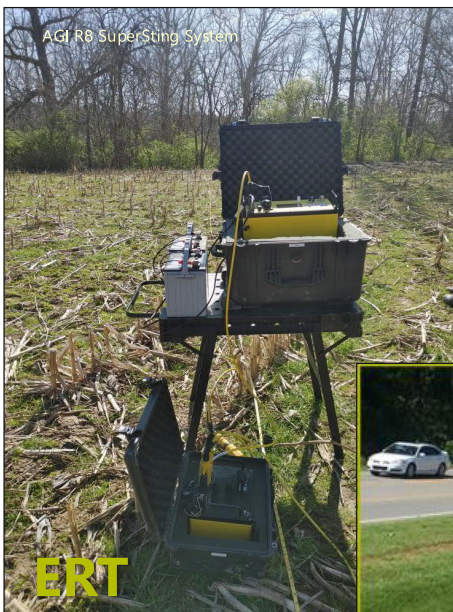
- ERT – Identify possible karst features, depth to rock, and general subsurface information.
- 1D MASW/MAM – Site classifications/shear wave velocity estimation
- FDEM – Measure the electrical conductivity of subsurface soil, rock, and groundwater.
