Ohio River Valley Soils Seminar XX

Construction in and on Rock

October 27, 1989
Louisville, Kentucky

PROCEEDINGS OF THE TWENTIETH
OHIO RIVER VALLEY SOILS SEMINAR

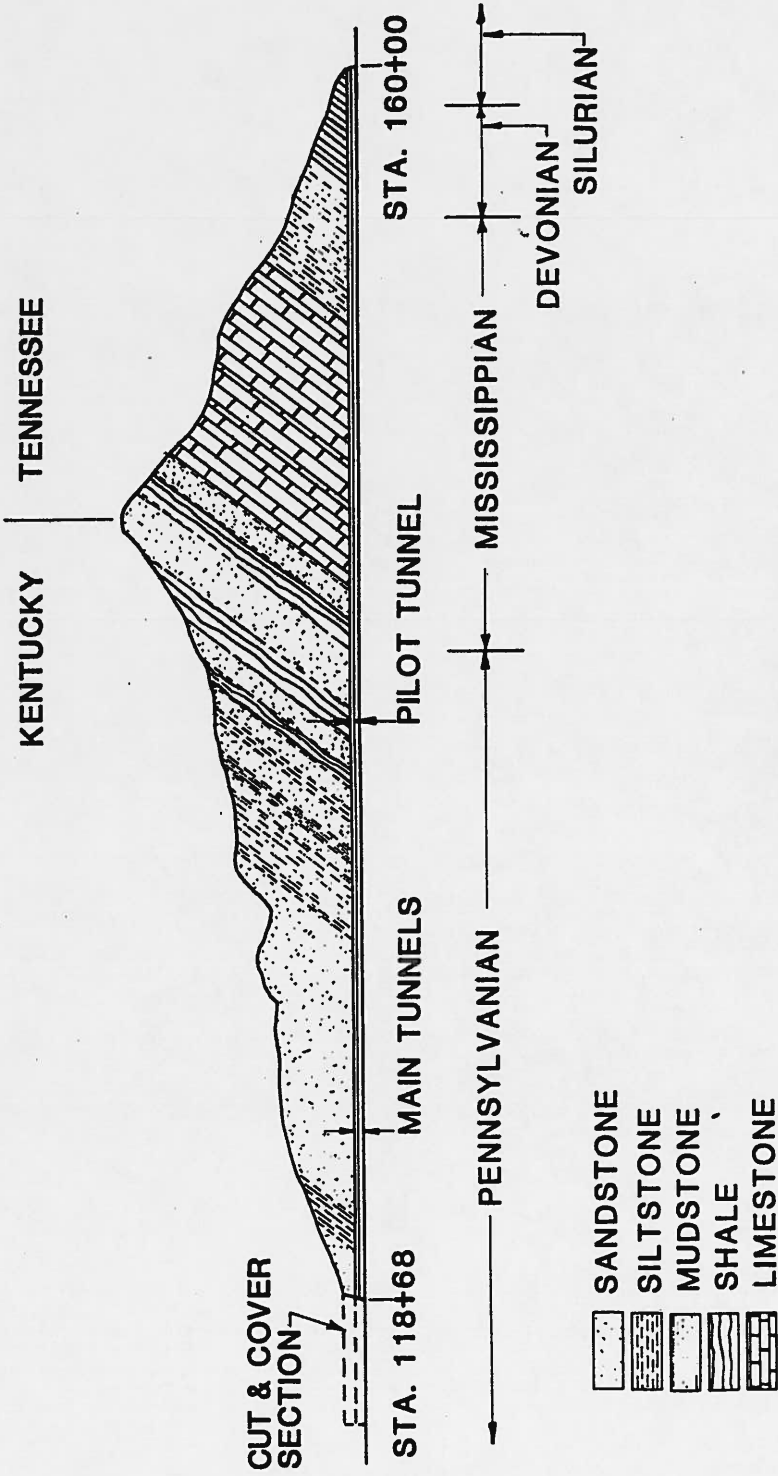
GEOLOGIC PROFILE
FIGURE 1

These investigations provided much additional information about the geology of the area and served as the basis for the design of the pilot tunnel. Cumberland Mountain is an overthrust block near the junction of the Valley and Ridge and Appalachian Plateau provinces. The rocks within the mountain range from Silurian to Pennsylvanian age formations. Rock conditions are extremely variable and range from uniform shales and limestones to interbedded sandstones, shales, and coals. Bedding dips at 35 to 50 degrees toward Kentucky and strikes nearly perpendicular to the tunnel alignment. Figure 1 shows a generalized geologic profile along the tunnel alignment.

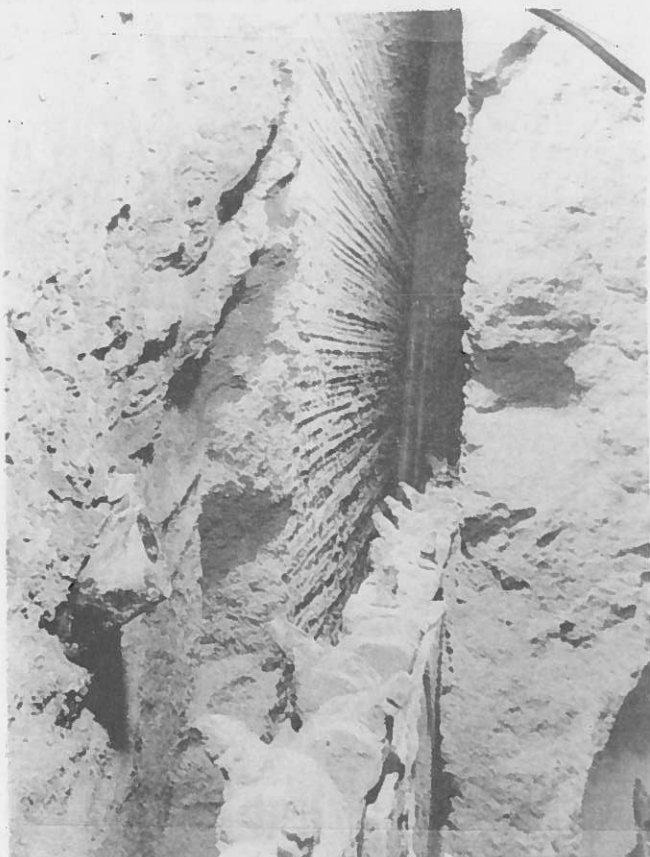
Figure 2. Pre-cutting of a slot along the tunnel periphery in progress.

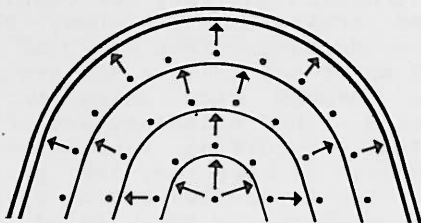
Figure 8. Conventional drilling and blasting pattern for a full face advance.

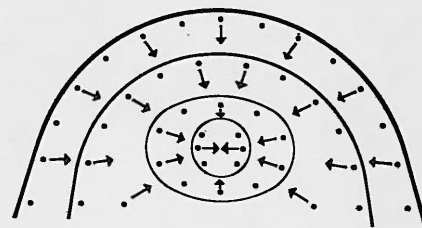
Figure 9. Drilling and blasting pattern for a full face advance with pre-cutting. Advantage is taken of the free surface provided by the pre-cut slot along the tunnel periphery.

slot along the tunnel periphery now serves as a substantial free surface towards which the rock can be broken. The first blasting delay therefore is situated on the outside and successive delays are placed more and more towards the centre. In this way, the amount of drilling is greatly reduced, by as much as 80 %, and the amount of explosives by as much as 50 %. And with it all, we deal with a much safer blasting operation, giving a smooth tunnel surface without overbreak. The greatly reduced intensity of explosions per round and the shielding of these explosions from the surrounding rock mass by the pre-cut slot has resulted in the elimination of all objectionable vibrations. It is not surprising that the first applications of mechanical pre-cutting in rock were prompted by environmental requirements, imposed by an urban environment. It was to serve Paris, France, that the first double-track tunnels, which had to pass under old existing buildings, were excavated using mechanical pre-cutting as a tunneling technique.

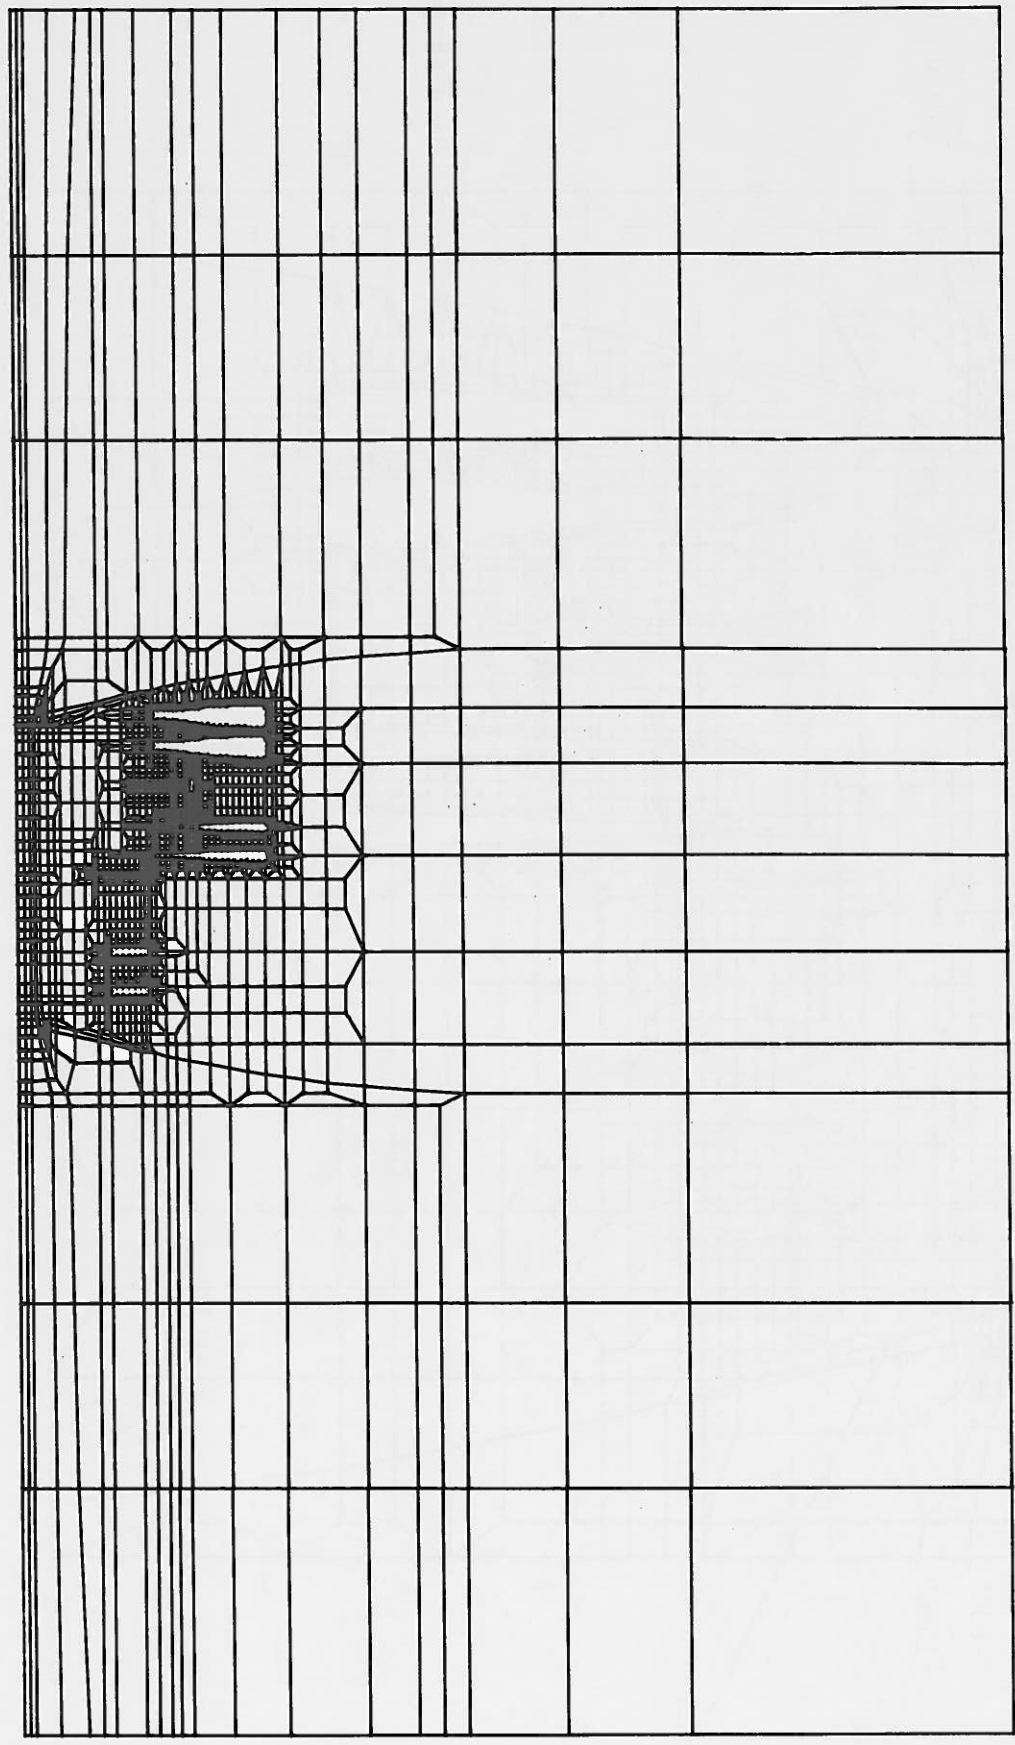
Figure 3. The complete finite element network of 8 - cavern system for the vertical section.

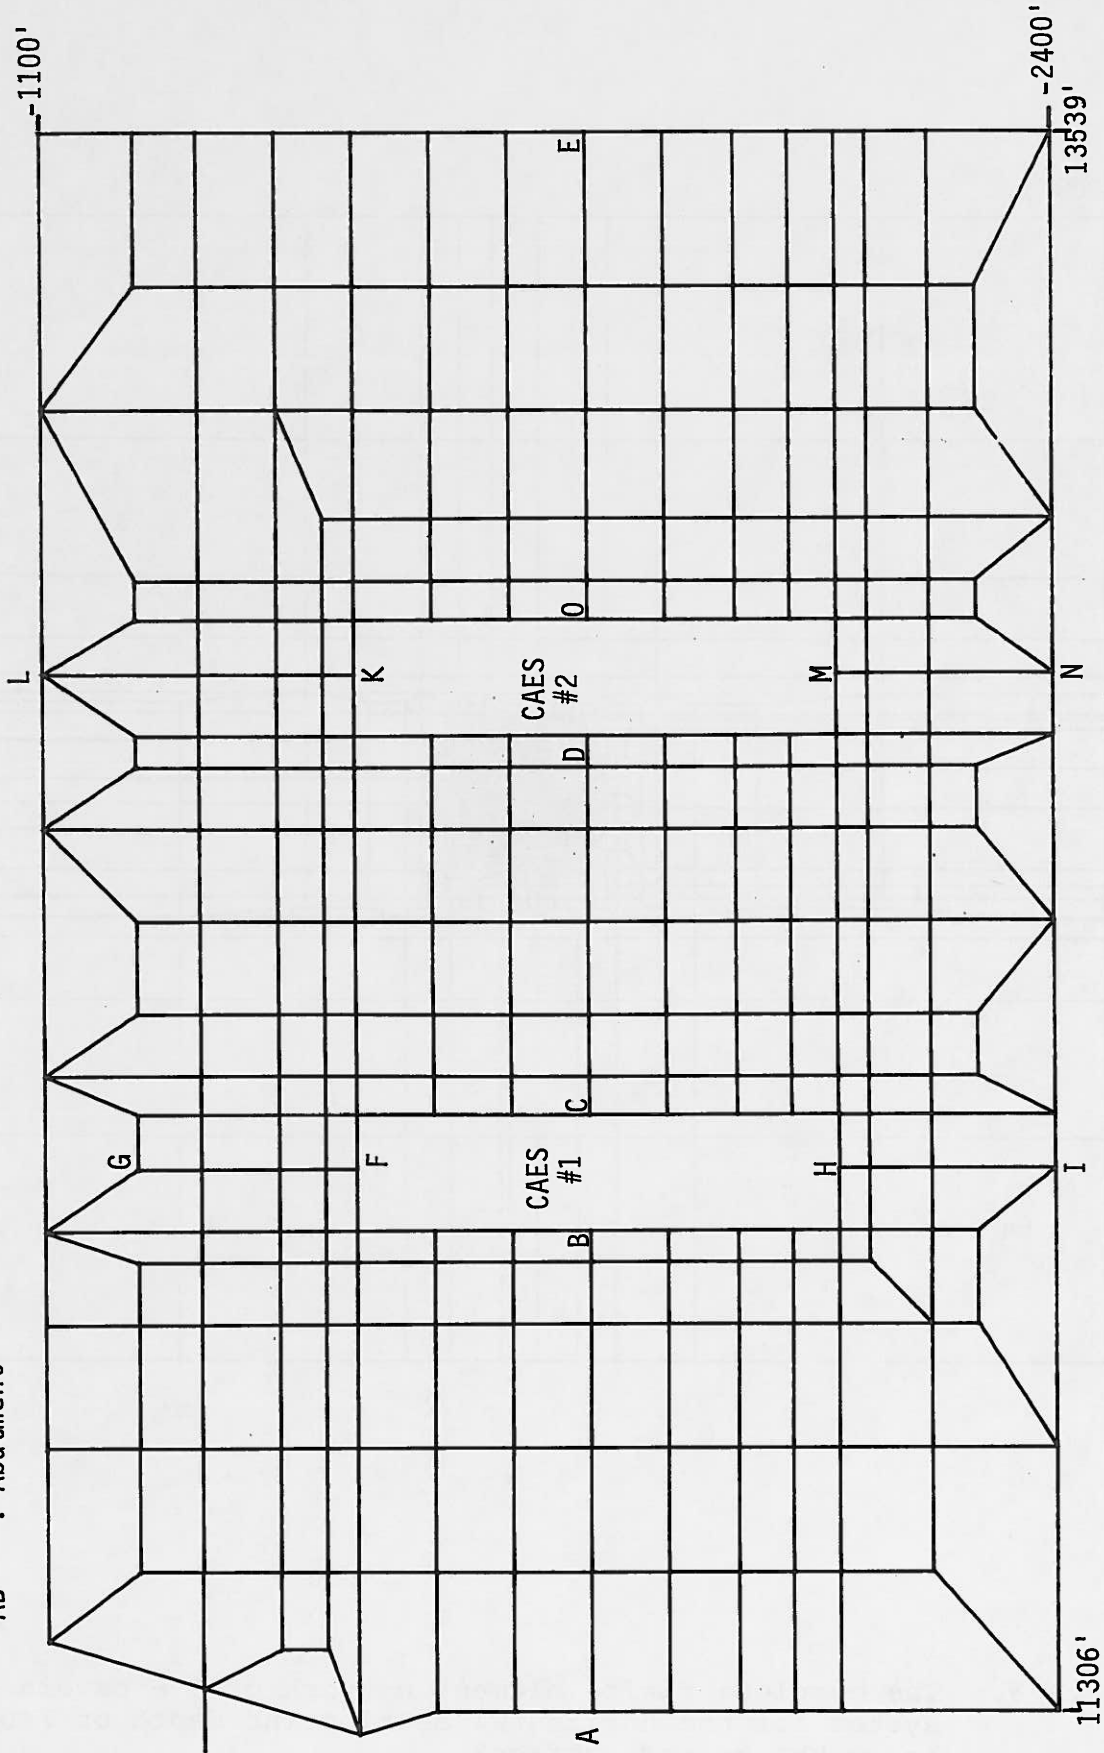
Figure 5. Close-up of the finite element mesh of CAES 2-cavern system for the vertical section.

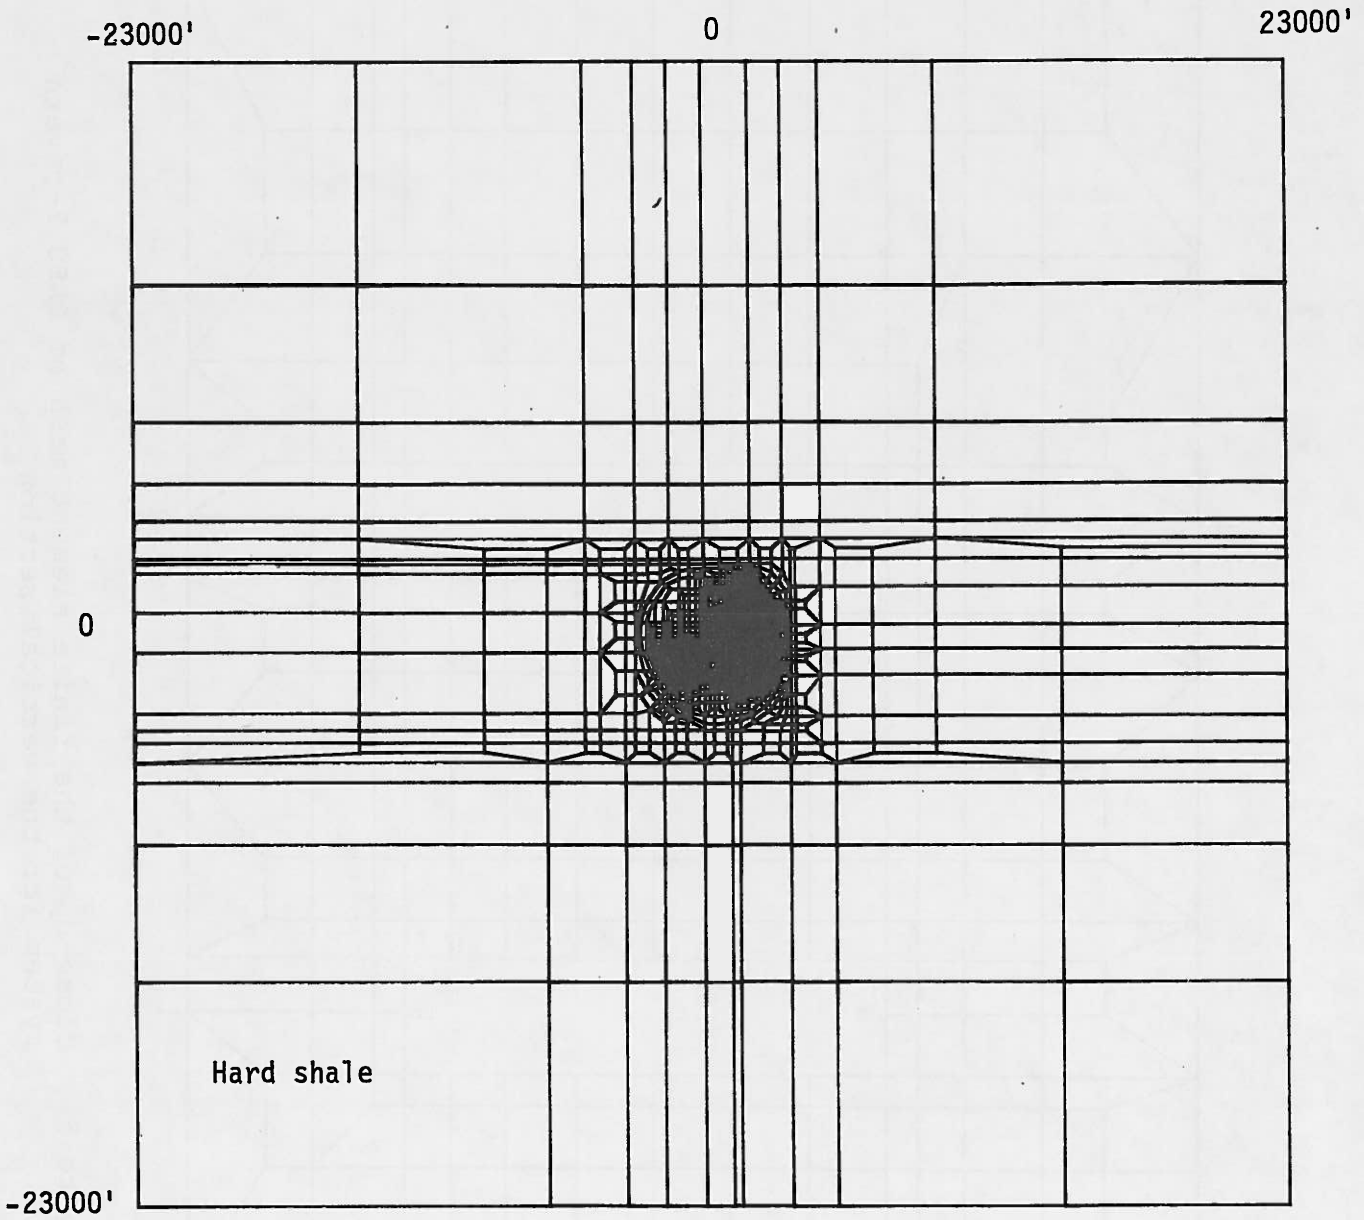
Figure 6. The complete finite element network of 8 - cavern system for the horizontal section (at depth of 2400 ft below the ground surface).

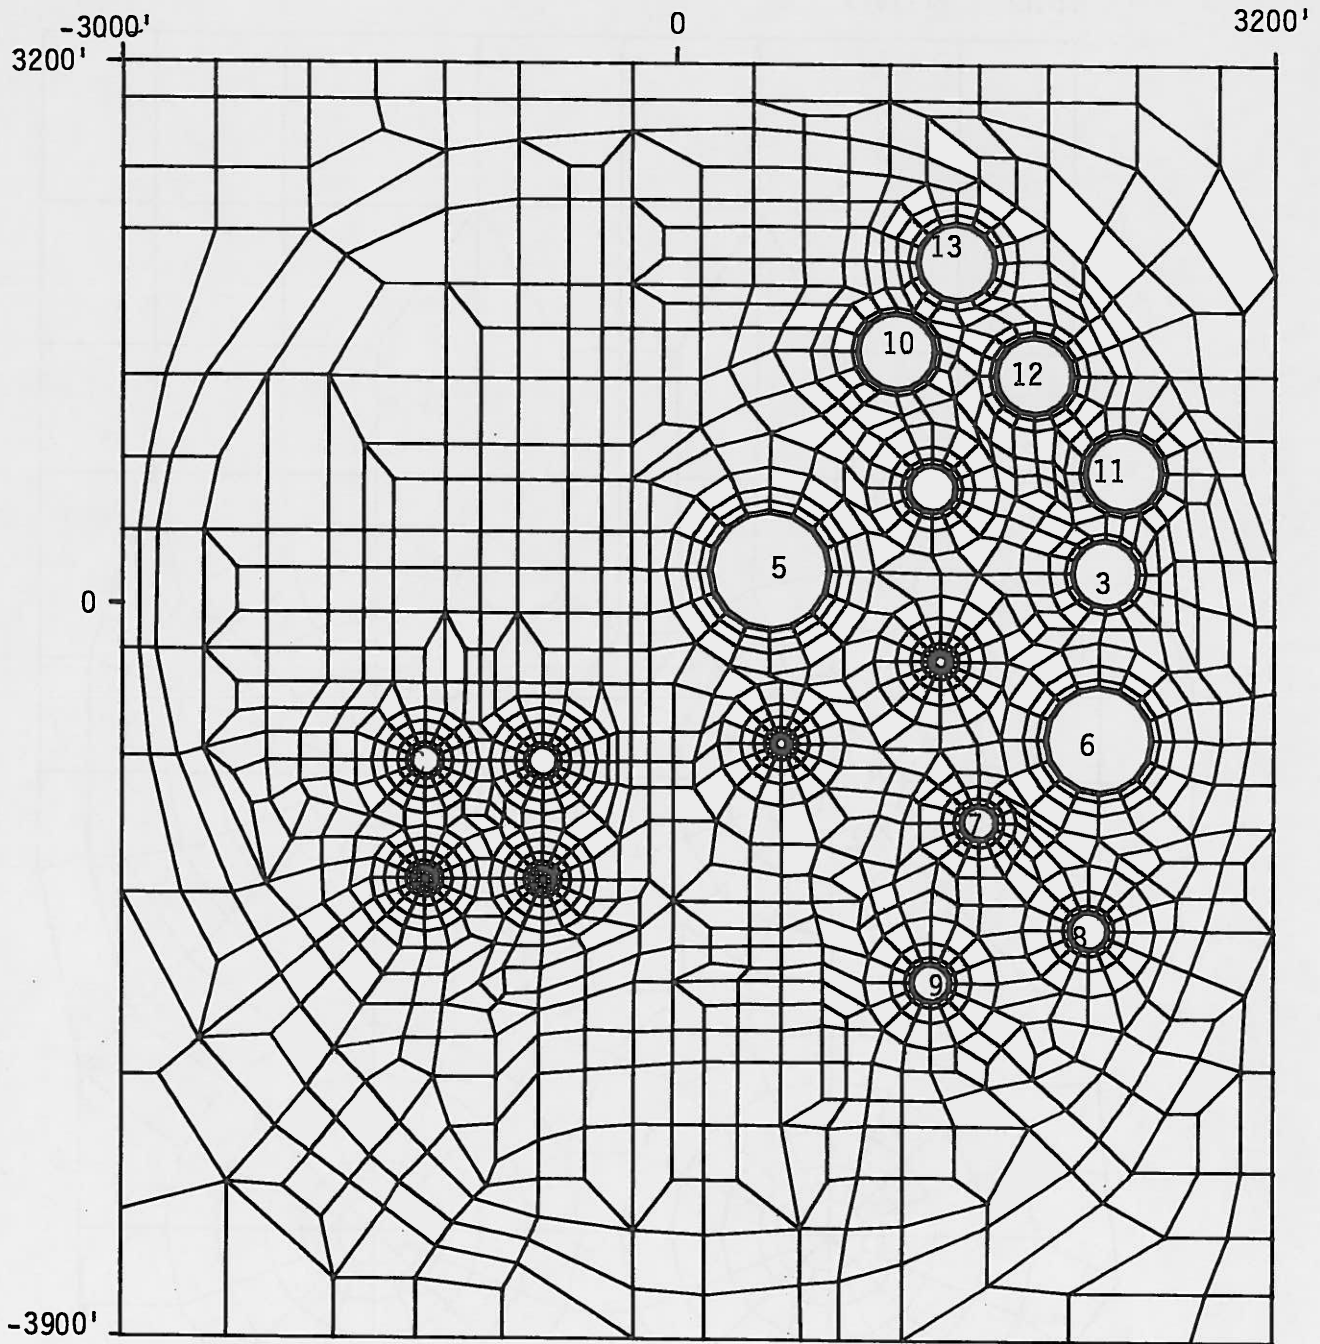
Figure 7. Close-up of the finite element network of 15 - cavern system illustrating the cavern geometry and the geological formation for the horizontal section.

AB : Abutment
CD,EF : Pillars

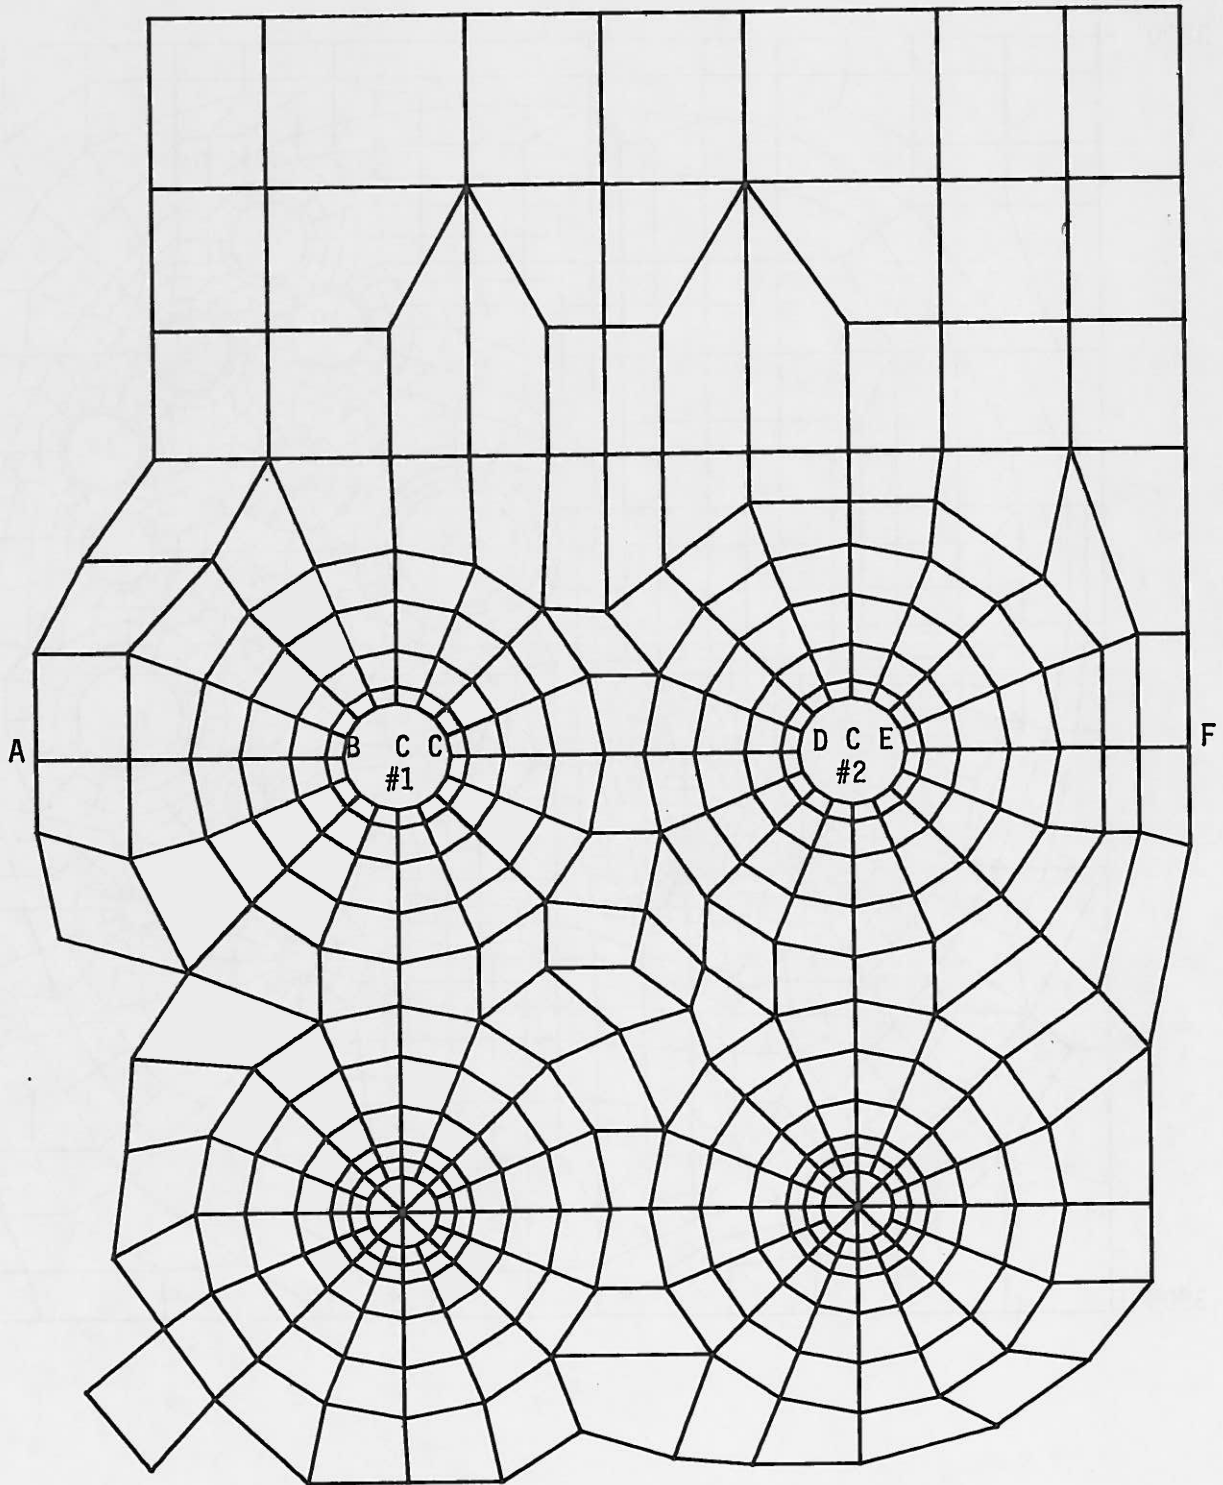
Figure 8. Close-up of the finite element mesh of CAES 2 - cavern system for the horizontal section.

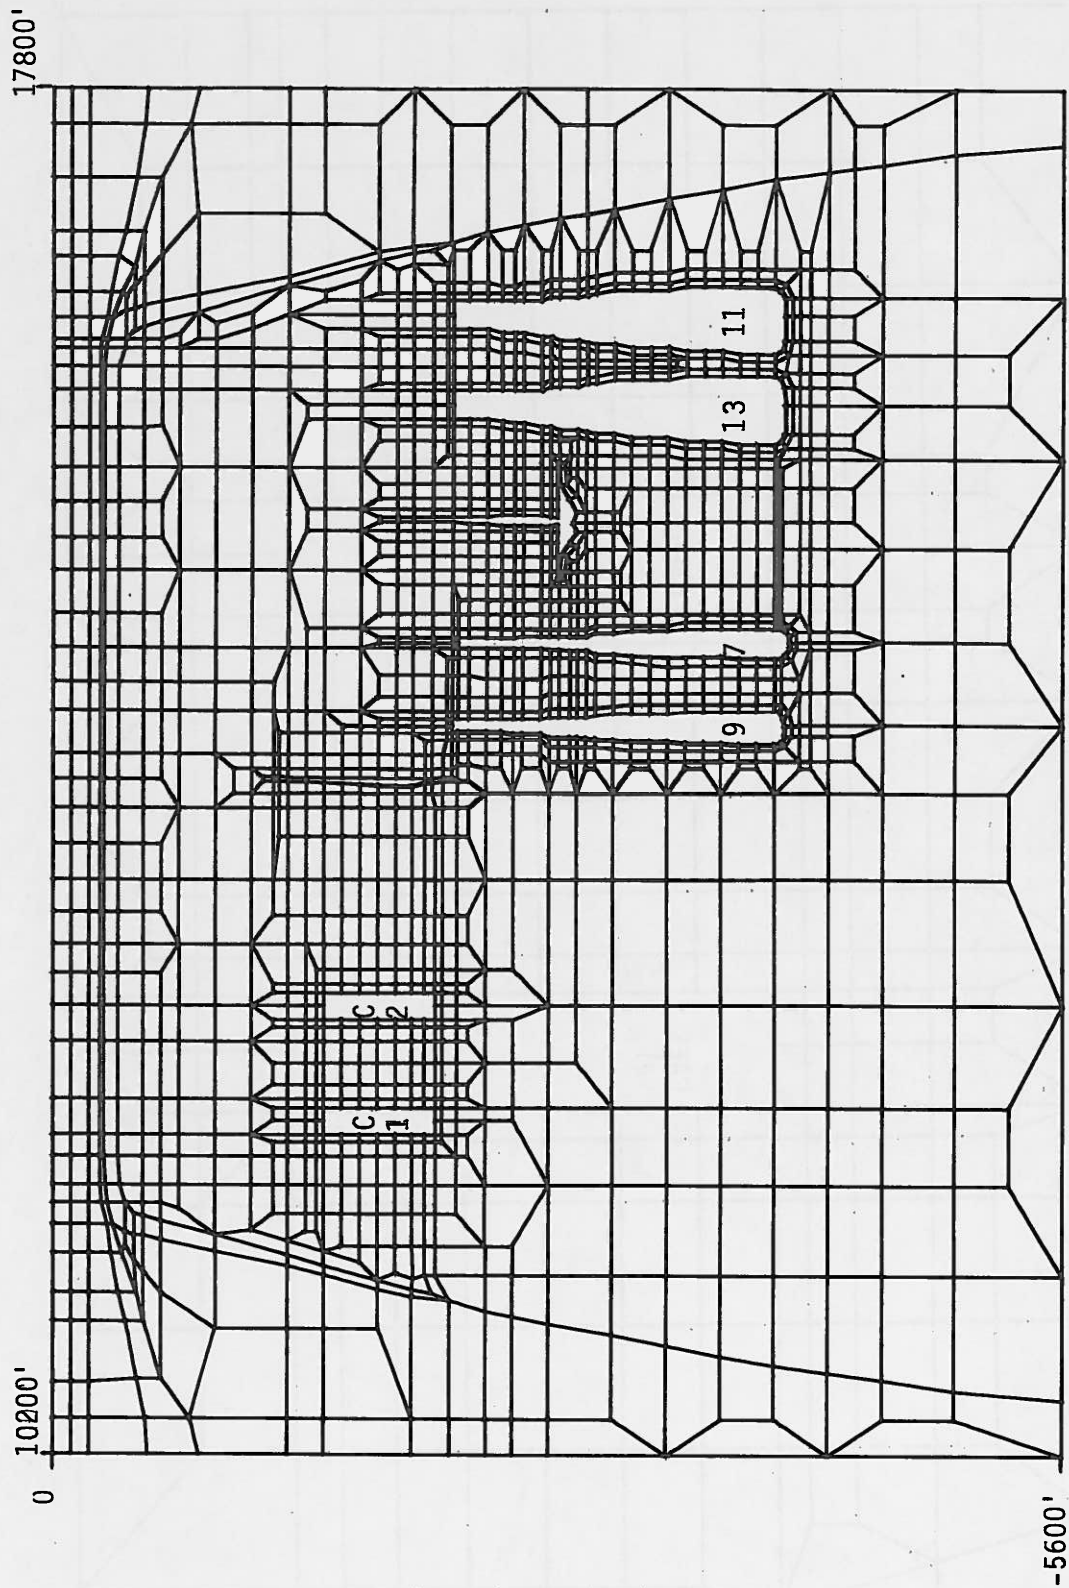
Figure 9. Displacement pattern around caverns C1, C2, 2, 6, 7, 9, 11 and 13 after 60 years of excavation -- the vertical norm run (magnification x 2).

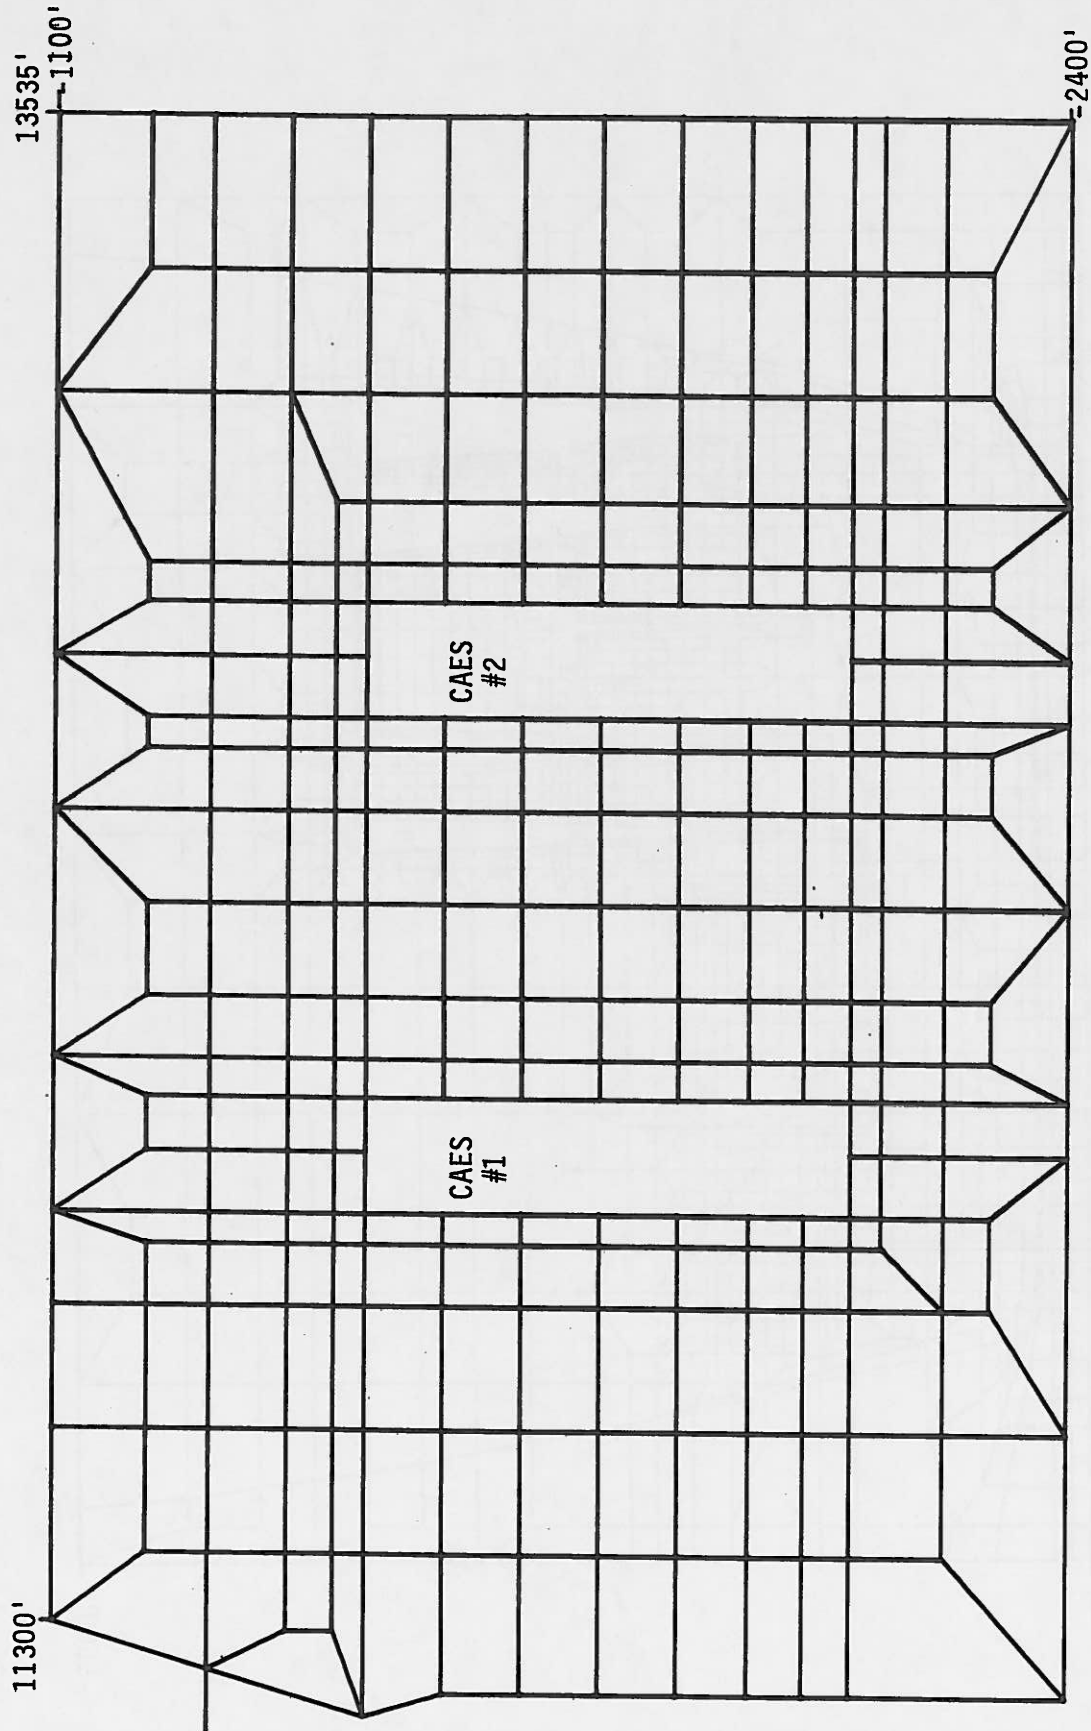
Figure 10. Close-up of the displacement pattern around CAES caverns 1 and 2 after 30 years of excavation -- the vertical norm run (magnification x 2).

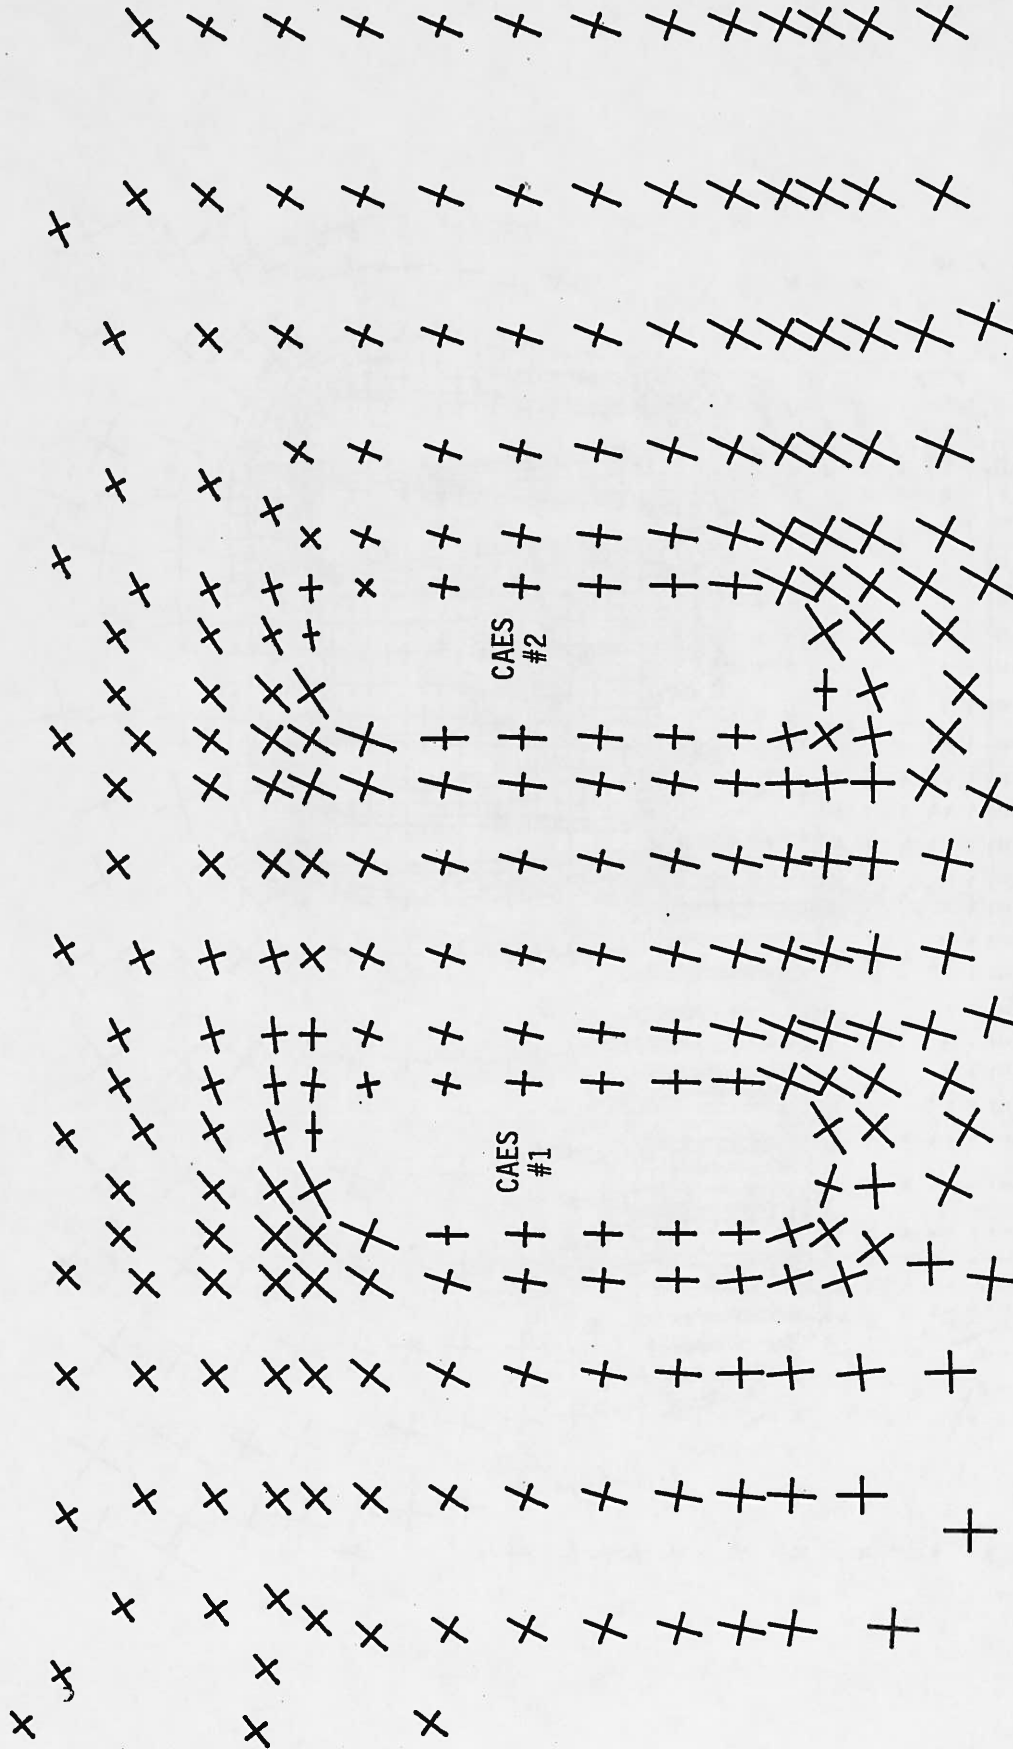
Figure 12. Close-up of the principal stress distribution pattern around CAES caverns 1 and 2 after 30 years of excavation -- the vertical norm run (scale: 1"=8000 psi).

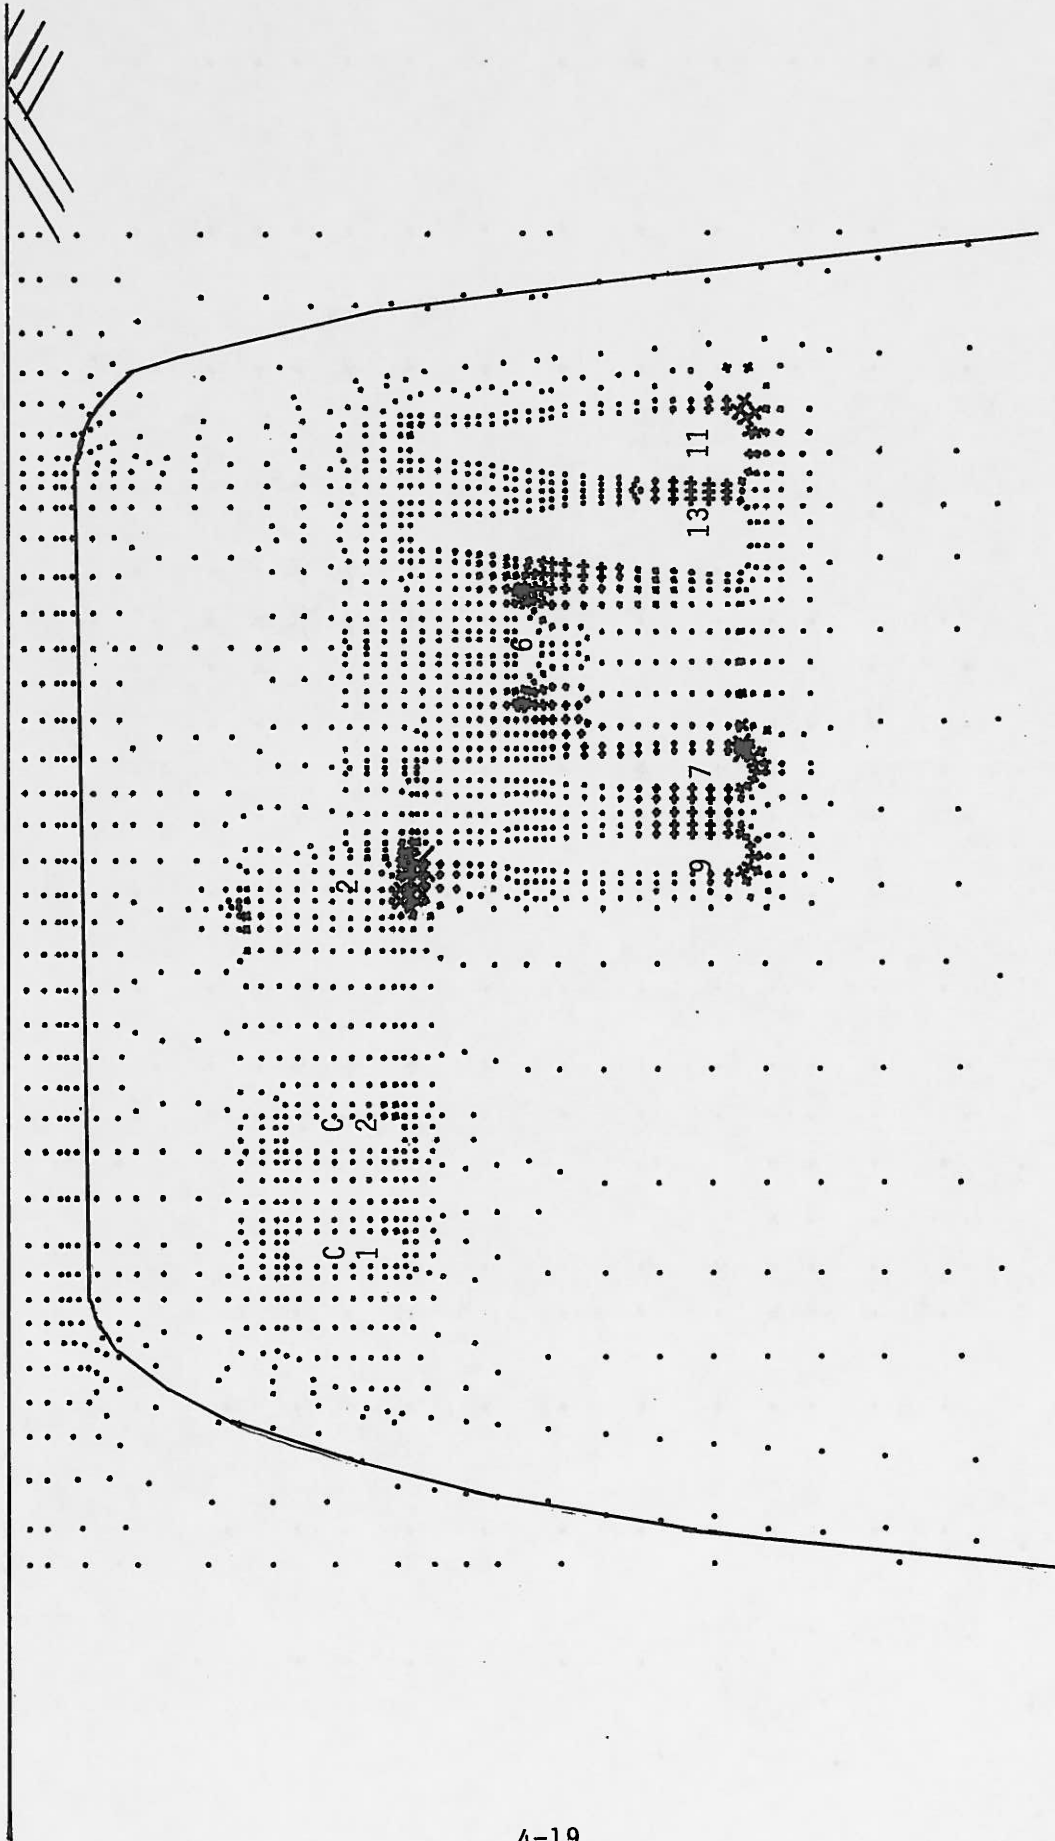
Figure 13. The principal strain distribution pattern around caverns C1, C2, 2, 6, 7, 9, 11 and 13 after 60 years of excavation -- the vertical norm run (scale: 1"==25%).

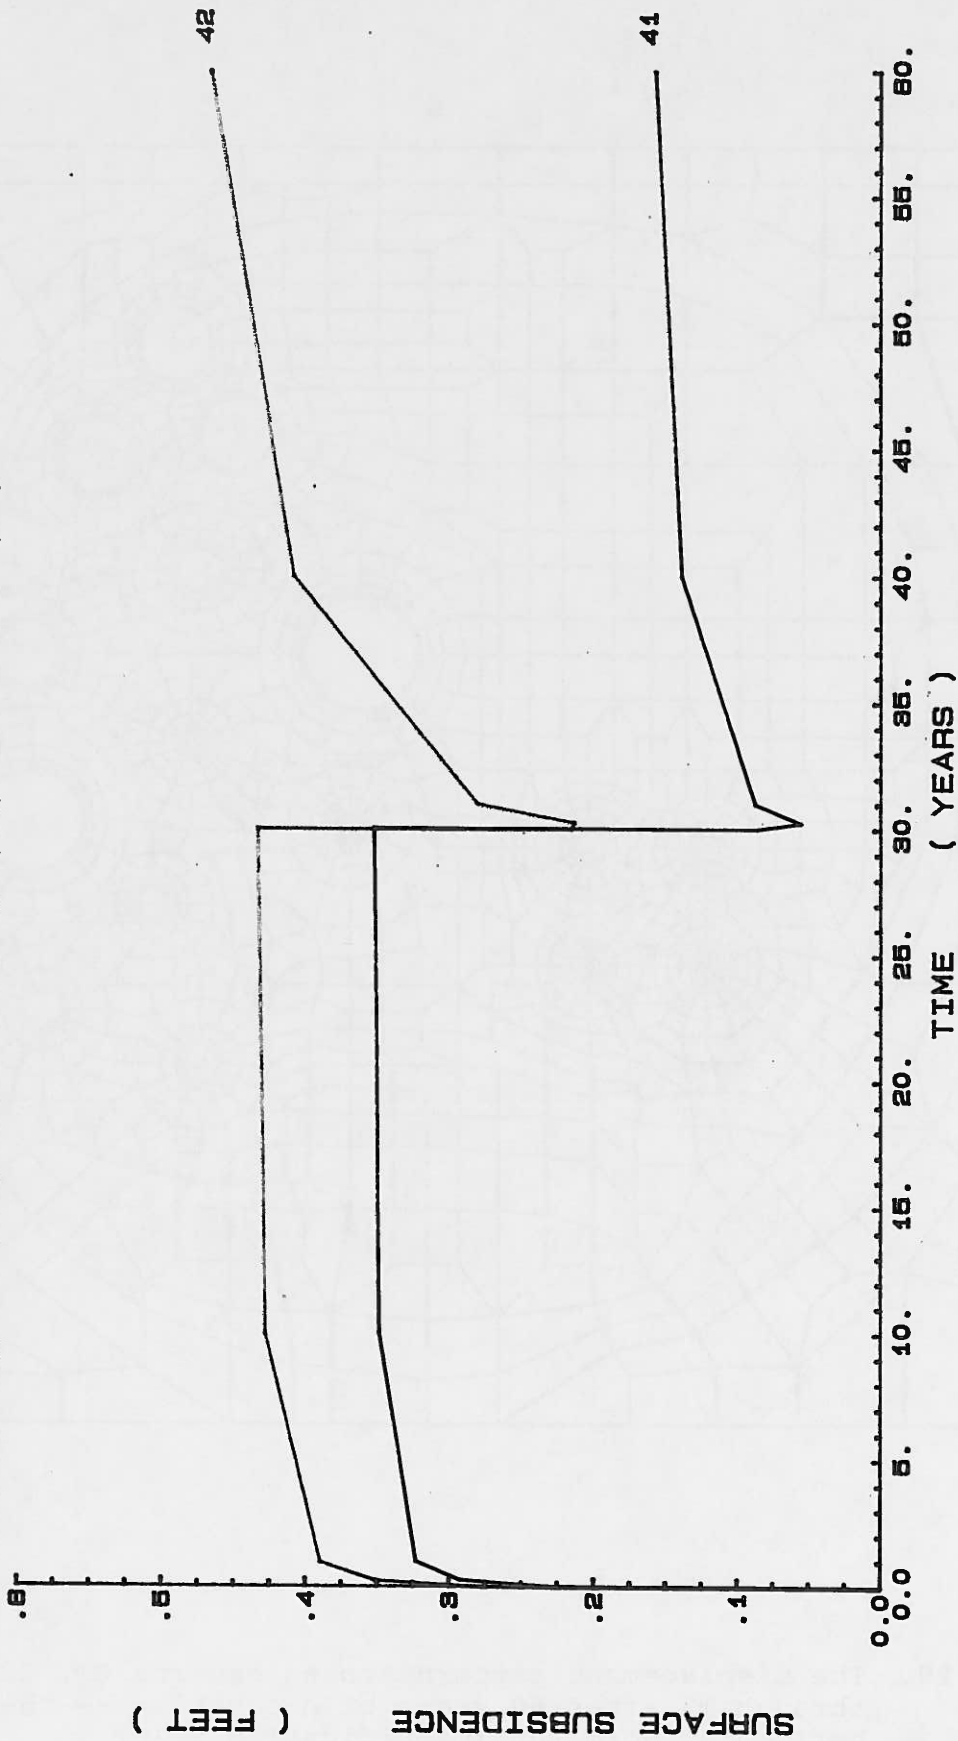
Figure 19. The surface subsidence over CAES caverns 1 and 2 --- the vertical norm run

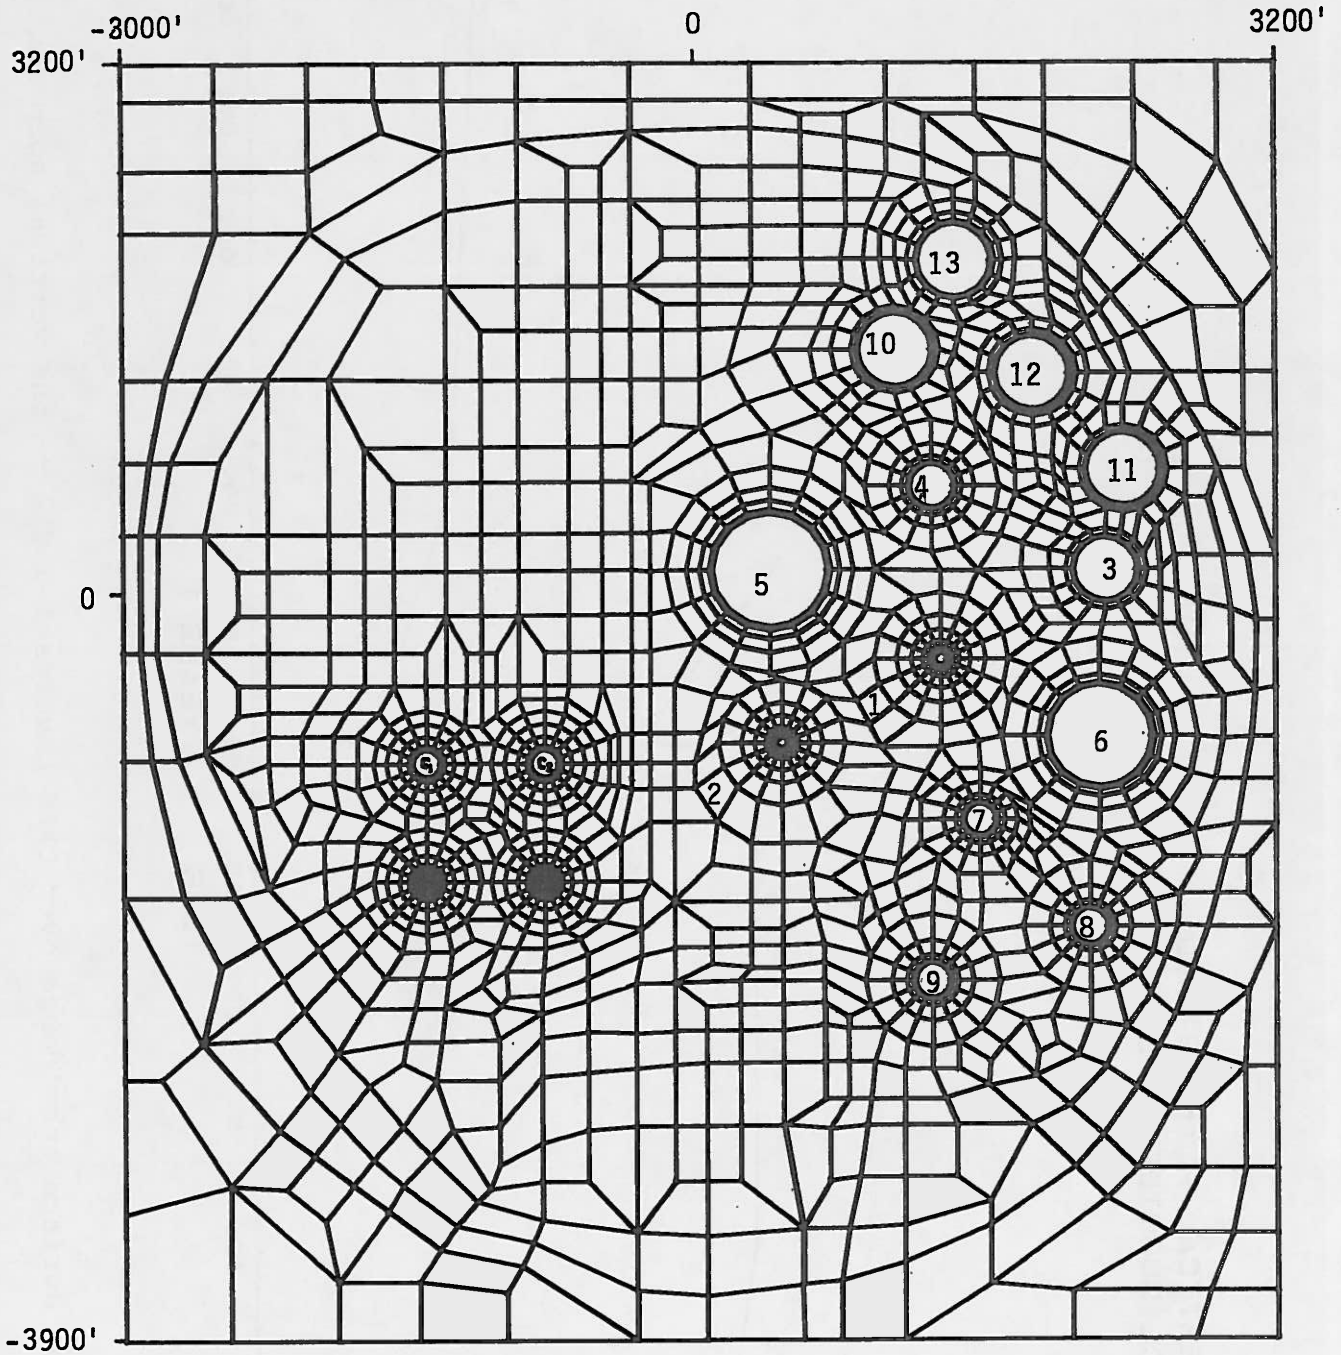
Figure 20. The displacement pattern around caverns C1, C2, and 1 through 13 after 60 years of excavation -- the horizontal norm run (magnification x 10).
