Ohio River Valley Soils Seminar XX

Construction in and on Rock

October 27, 1989
Louisville, Kentucky

PROCEEDINGS OF THE TWENTIETH
OHIO RIVER VALLEY SOILS SEMINAR

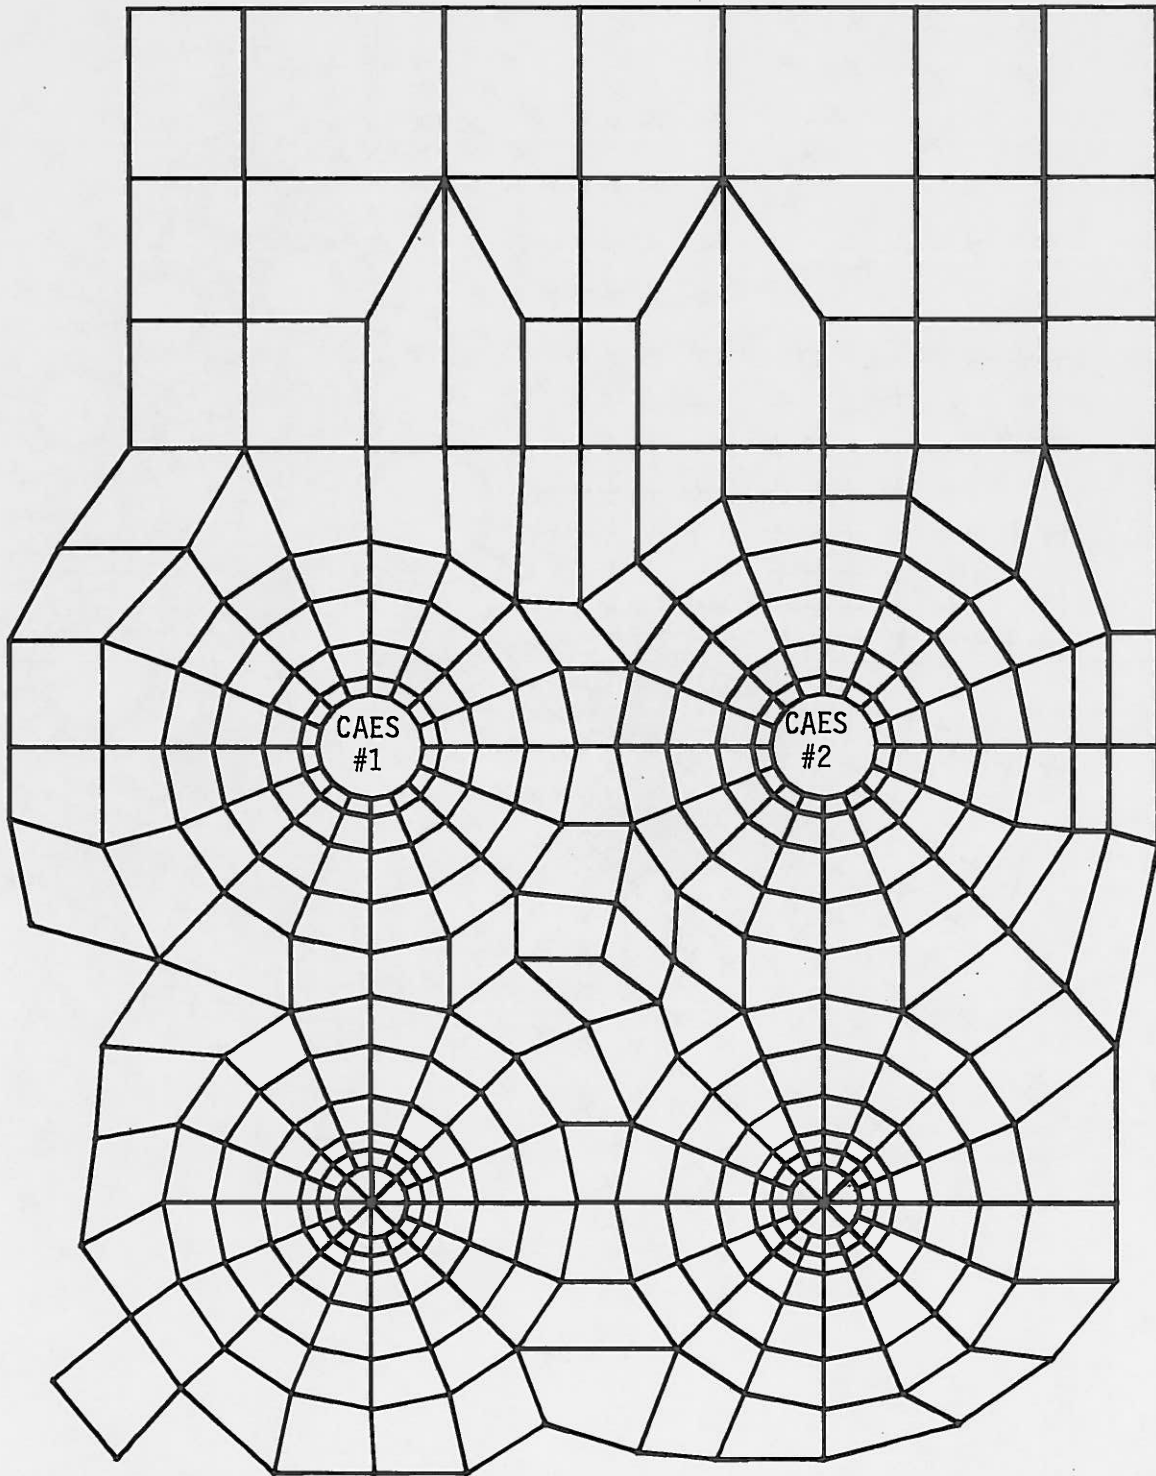
Figure 21. Close-up of the displacement pattern around CAES caverns 1 and 2 after 30 years of excavation -- the horizontal norm run (magnification x 10).

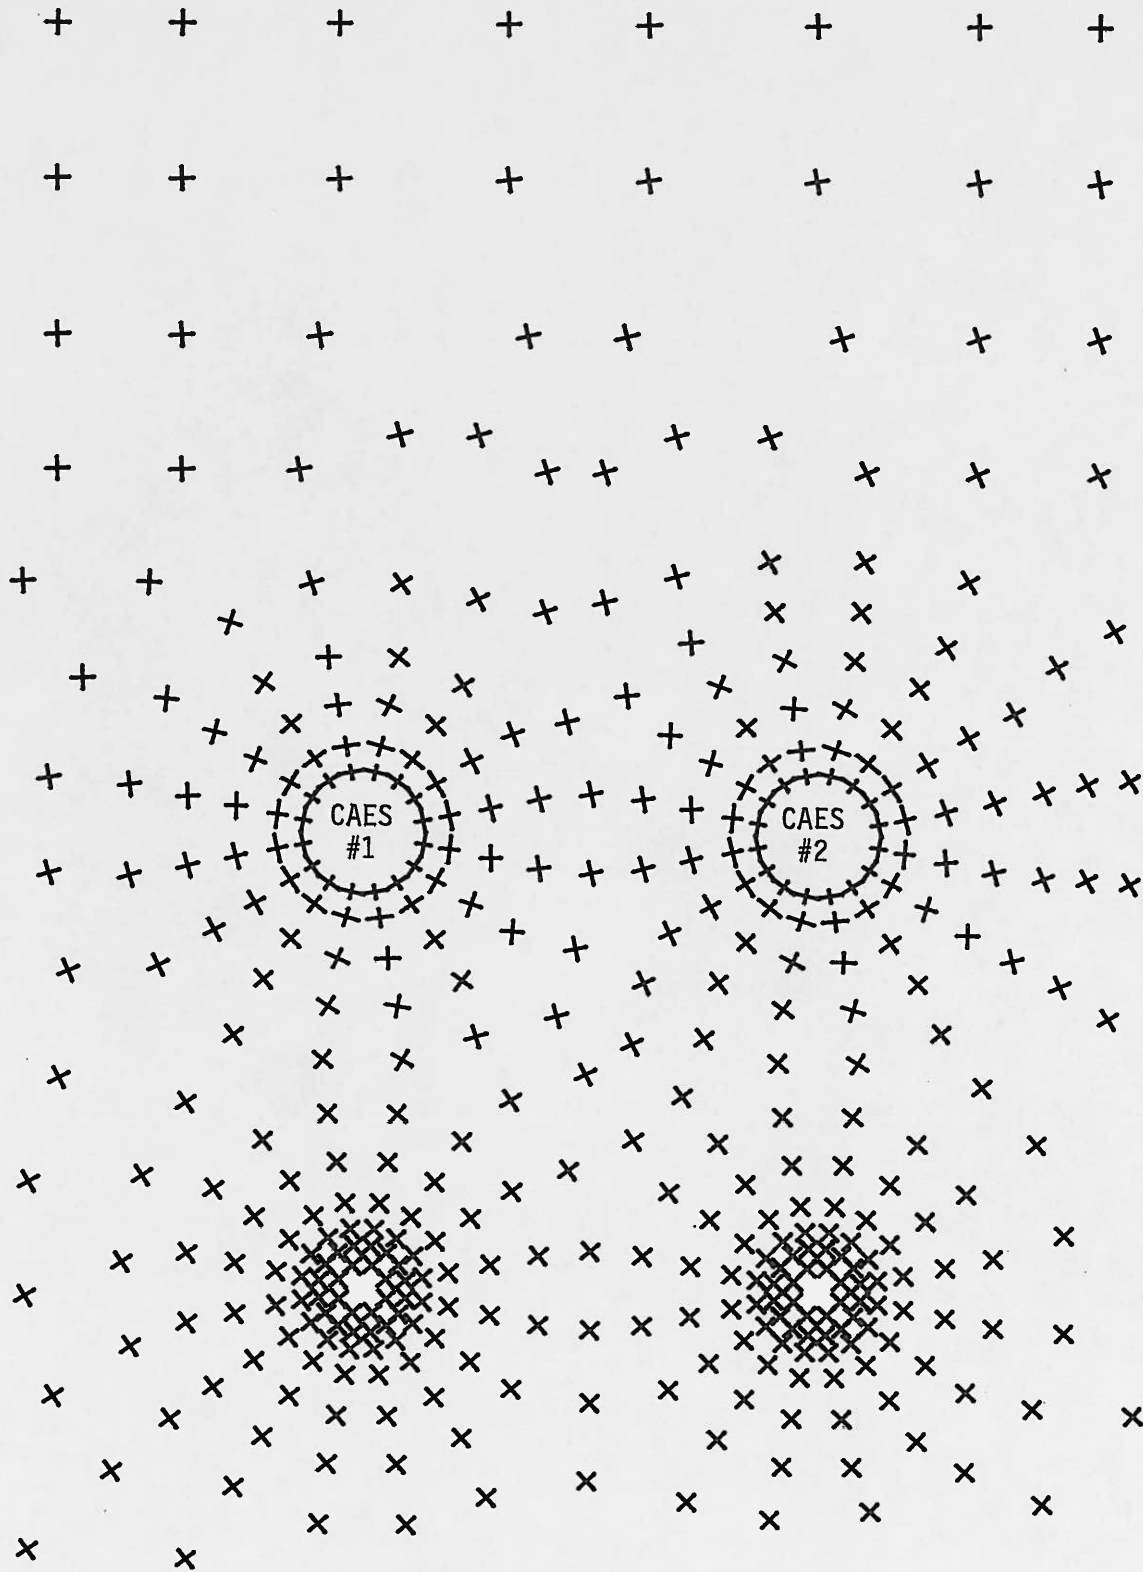
Figure 23. Close-up of the principal stress distribution pattern around CAES caverns 1 and 2 after 30 years of excavation -- the horizontal norm run (scale: 1"=20,000 psi).

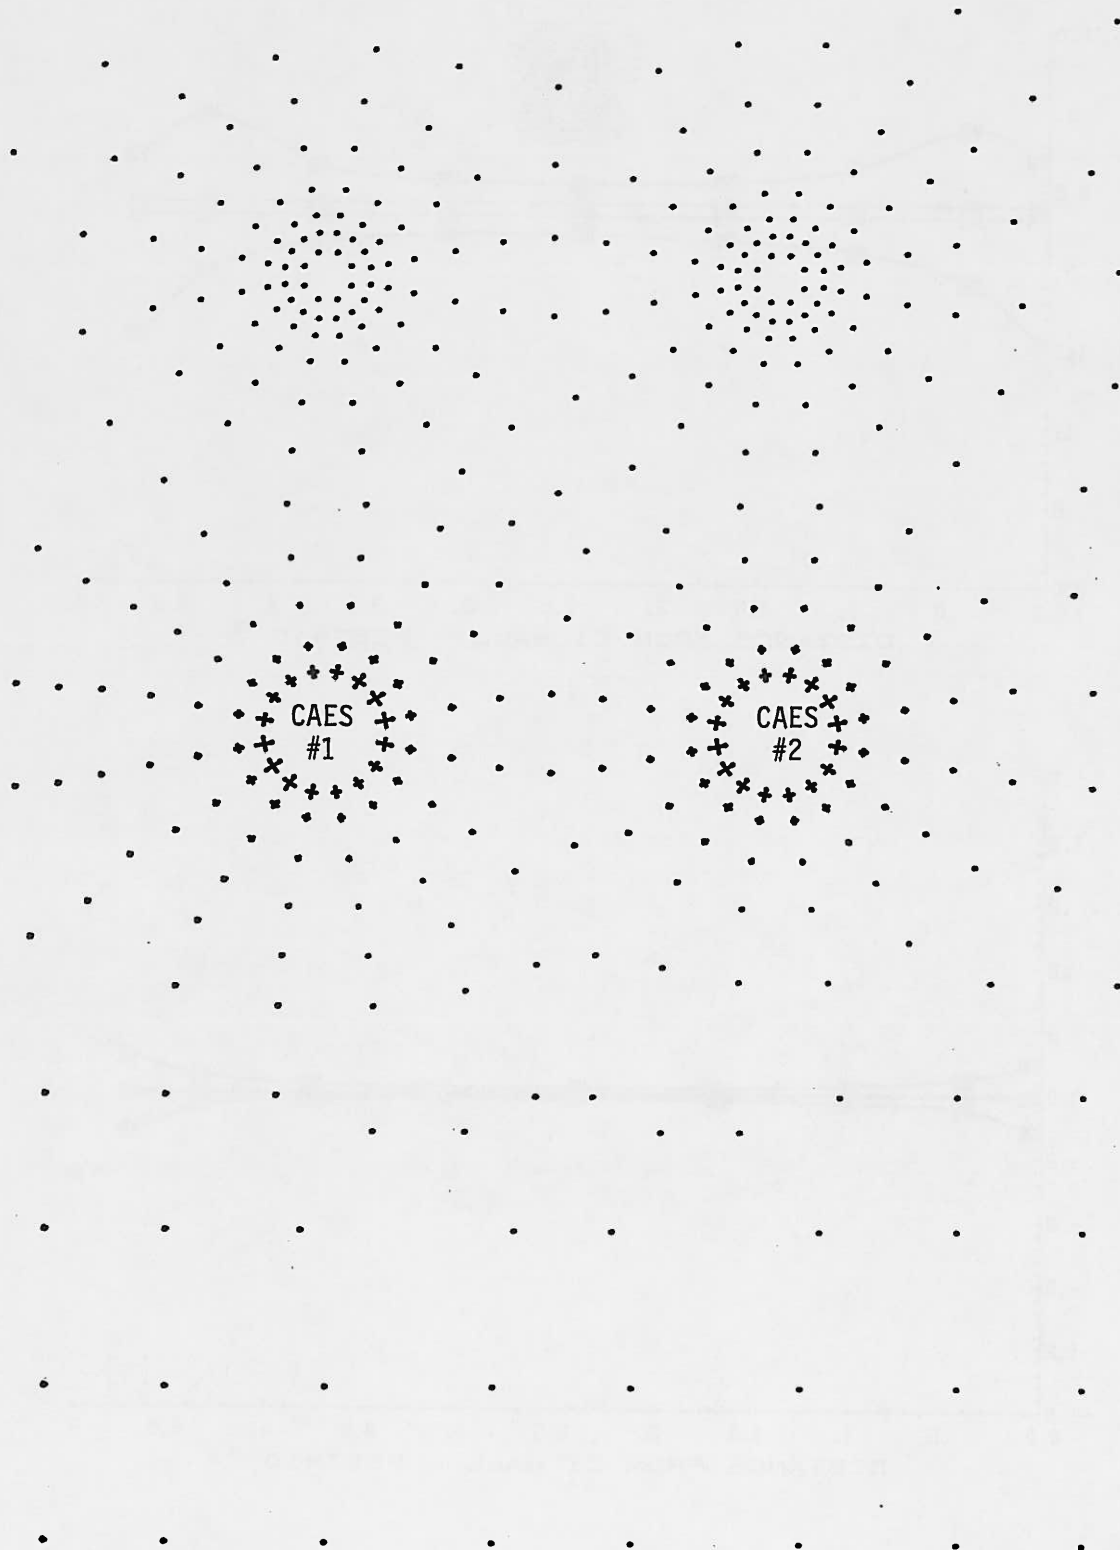
Figure 25. Close-up of the principal strain distribution pattern around CAES caverns 1 and 2 after 30 years of excavation -- the horizontal norm run (scale: 1"=2.5%).

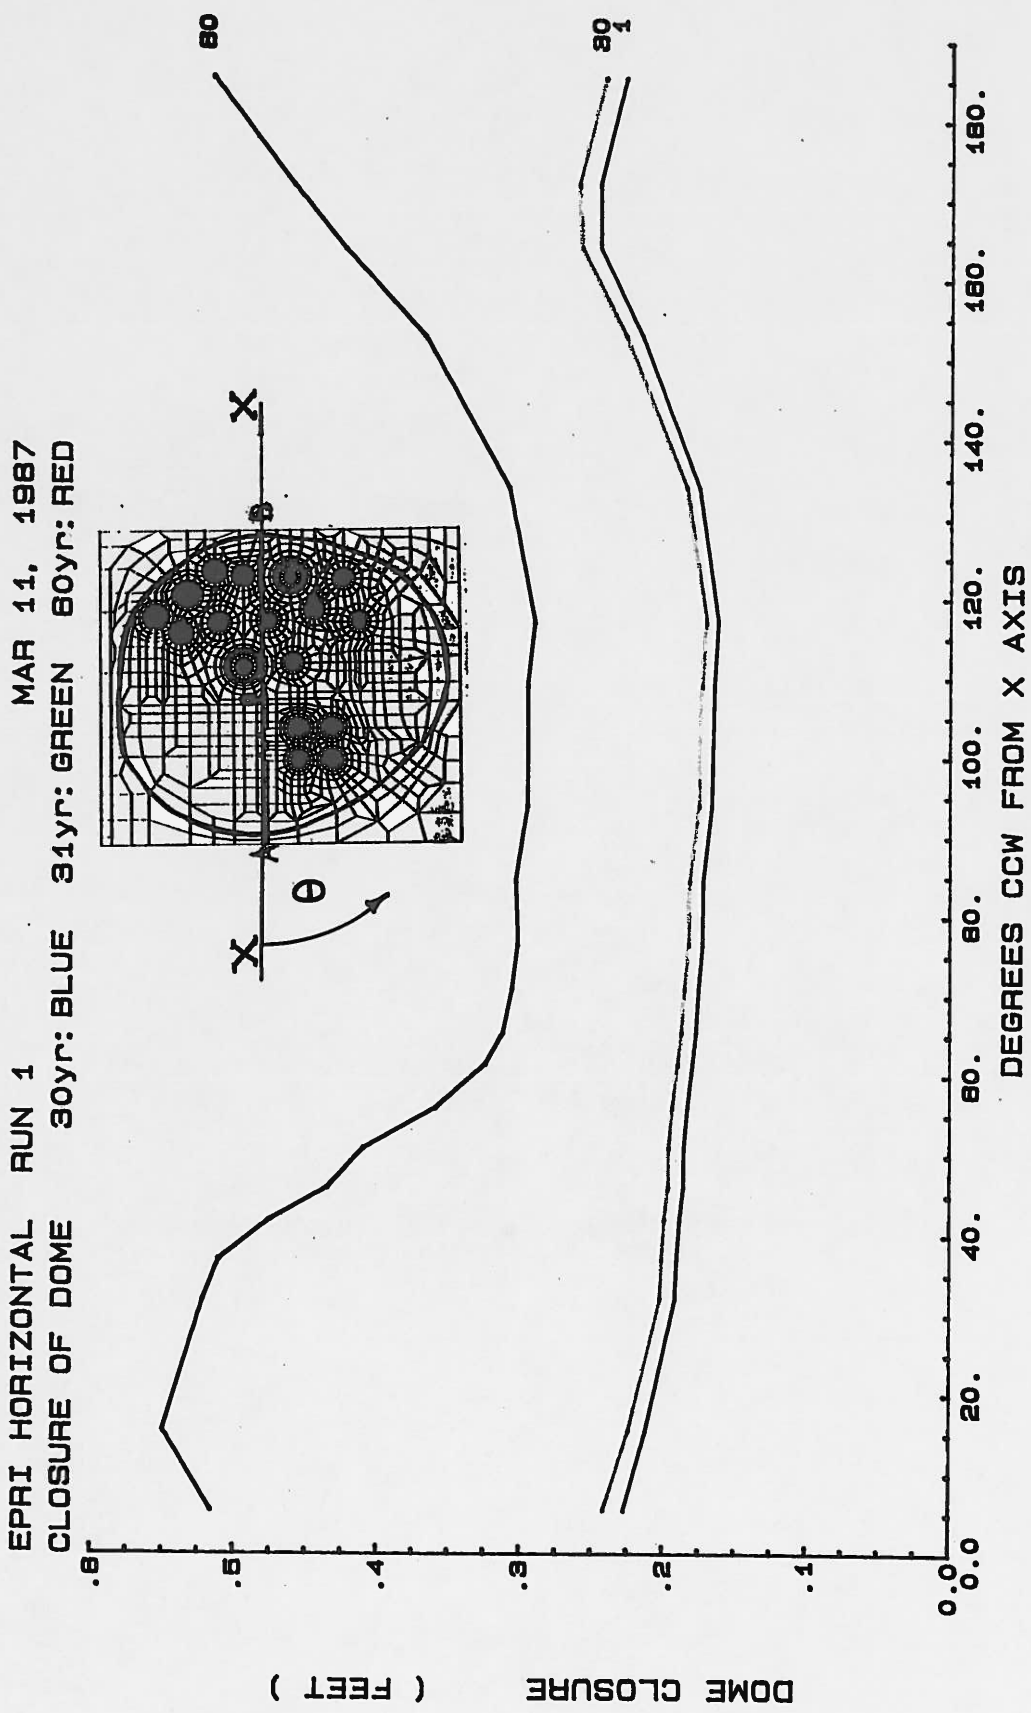
Figure 29. Time variation of the deformation of the salt dome boundary at the depth of 2400 ft below the ground surface -- the horizontal norm run.

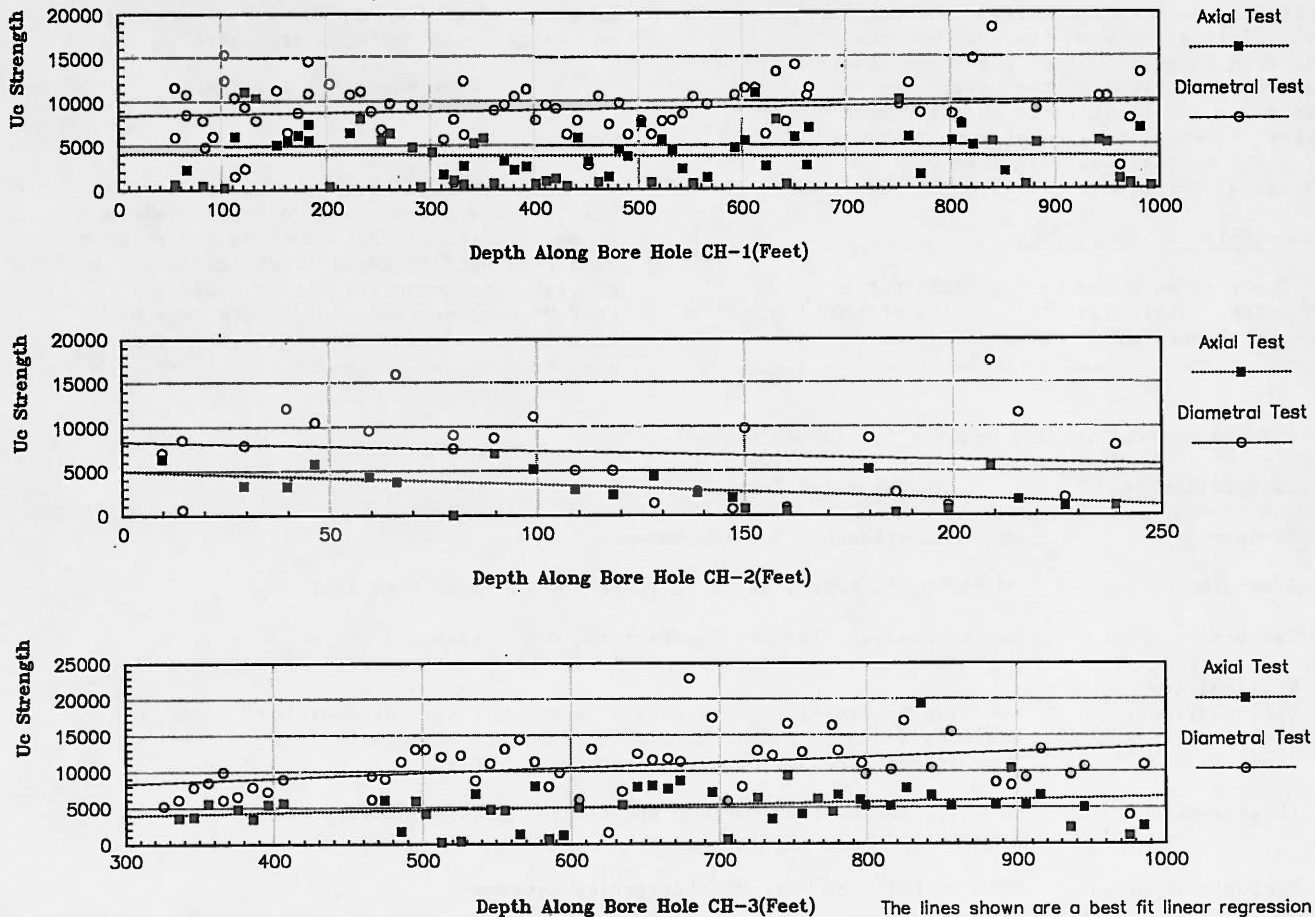
Test Results. A planar failure surface is often not possible with this test which results in a lot of scatter in the data. Scatter also resulted from lateral changes in the strength, especially for the axial tests. This variation in bedding plane strengths is typical, resulting from differences in cementation, planarity, cohesion, texture, etc. On the whole the tests indicate that the rock at the tunnel level is quite homogeneous for a bedded material with the average strength across the beds being 170 to 250% higher than the tests with the beds. Plots of the Uc strength, computed from the point load index, Is, versus depth for the horizontal holes is shown on Figure 9.

Figure 9. Point Load Test Data.

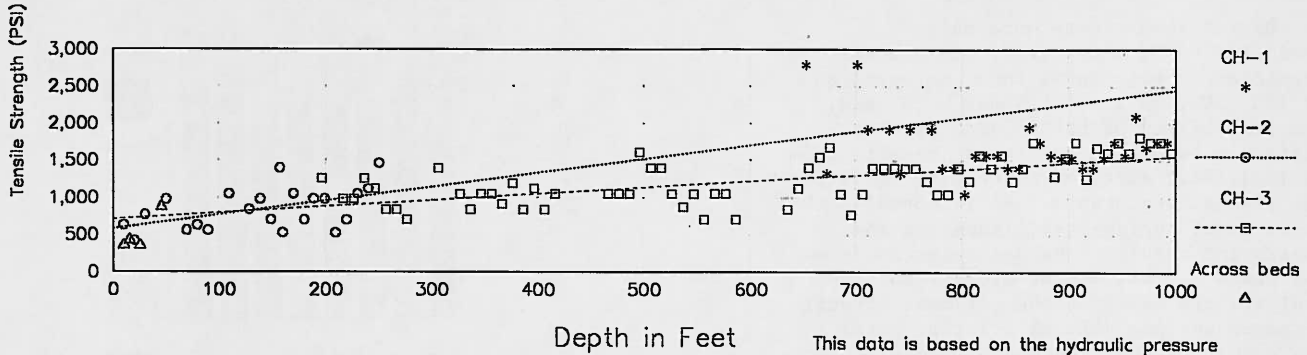
might result from worn equipment. Figure 10 shows the results of this study. There is good correlation between the tensile strengths derived by this method and the laboratory test results and a rough correlation with fluctuations in the point load strength data versus depth.

Figure 10. Pull Break Tensile Strength Test

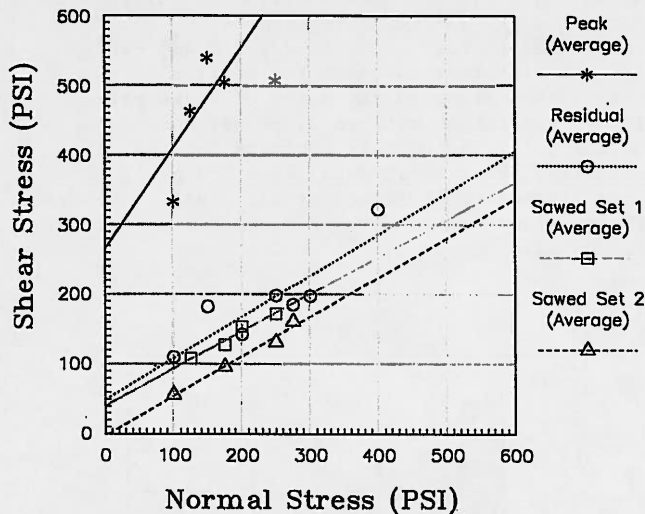
Direct shear tests were only conducted on PQ size cores. To bracket the predicted in-situ conditions, normal loads of 100, 200, 300, and 400 psi were used. The variability of the bedding made it very difficult to obtain consistent results from an individual suite of tests especially in the peak strength data. As is normally the case, sawed surface tests gave the most consistent results. Values selected from the tests for use in the slope stability analysis are based on the ultimate strength or sawed surface sliding friction data. The resulting shear strength parameters are $\phi = 31^\circ$ and cohesion = 46 psi for the ultimate strength and $\phi = 21.5^\circ$ and cohesion = 30 psi for the sawed surface tests. A plot of the average data and the failure envelopes is shown on Figure 12.

Figure 12. Direct Shear Data, Averages
Light lines are based on linear regression analysis of the data.

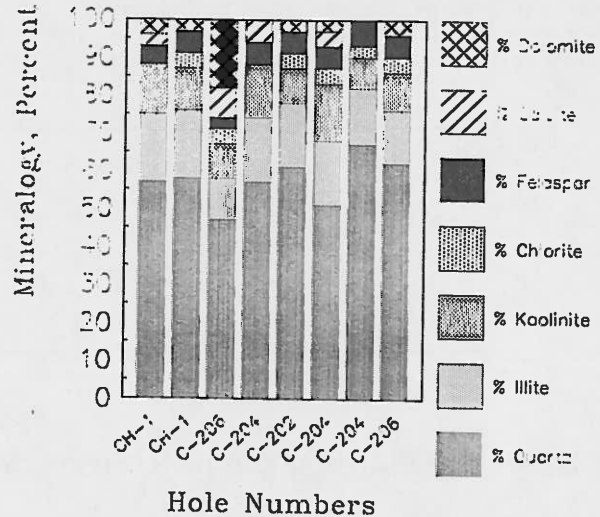
machine performance and pick wear.⁵ Figure 13 graphically represents the x-ray diffraction data.

Figure 13. X-Ray Diffraction Data

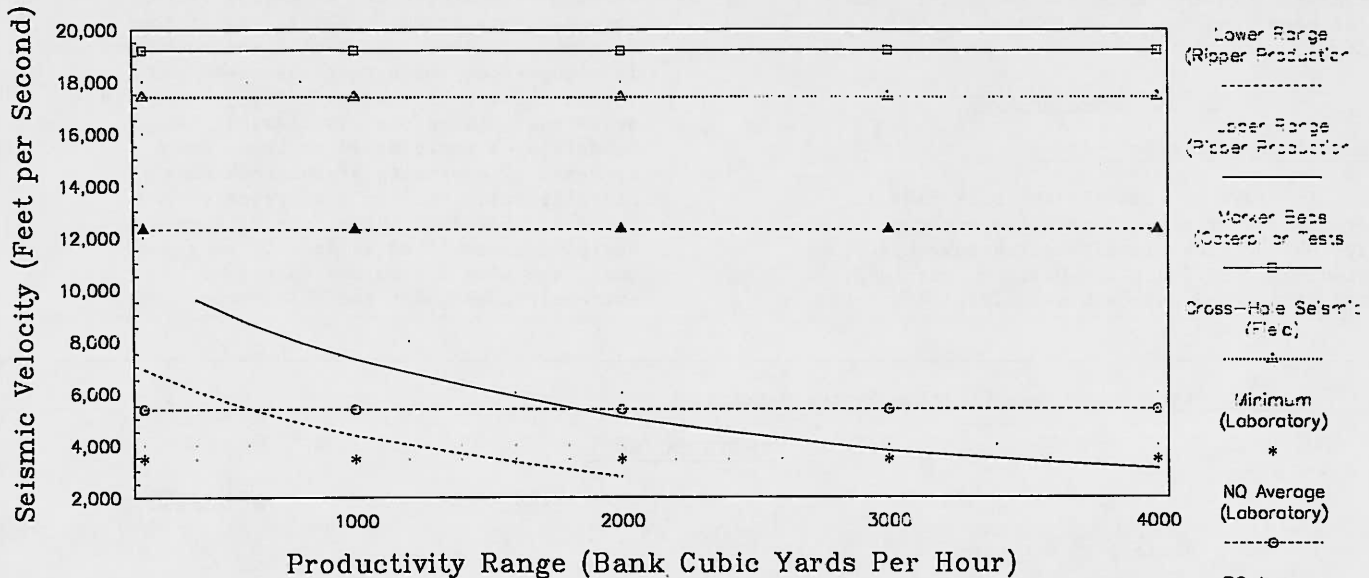
Independent seismic velocity measurements on the sandy "marker" beds in the tunnel profile were performed by Caterpillar Inc.'s rock mechanics testing facility. These tests indicated an average seismic velocity of 19,293 feet per second. This material is not considered rippable without pre-blasting. Based on visual examination by Caterpillar, the siltstone is considered rippable, however this is not confirmed by testing and absence of natural breaks in the rock mass suggests otherwise. Figure 14. shows the results of the seismic

Figure 14. Rippability Estimate

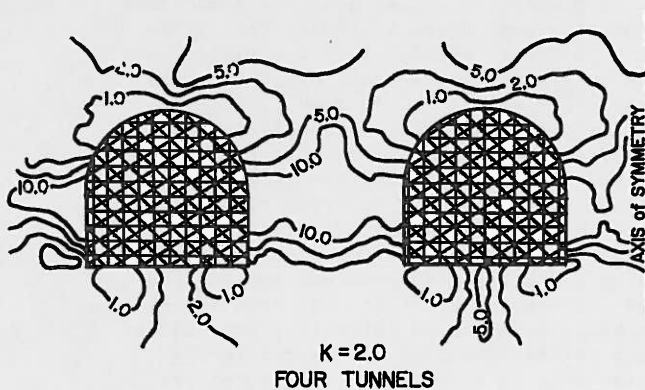
Figure 15. Boundary Element Analysis

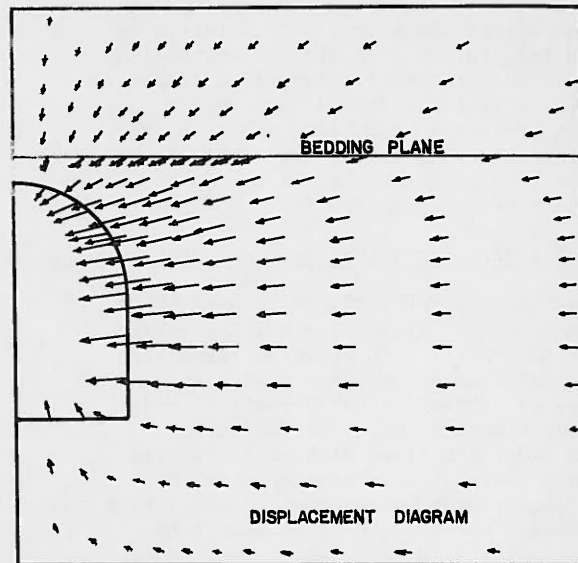
a FLAC run which included the 12-foot bolts, shotcrete and a bedding plane.

Figure 16. FLAC Analysis

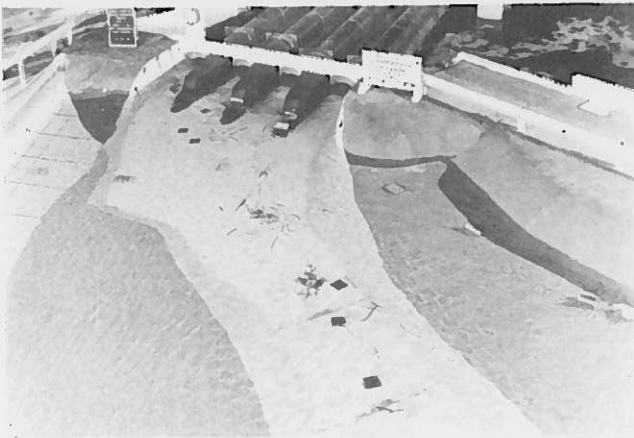
The tunnels are required to pass the standard project flood plus a 30% blockage factor for debris. To optimize the design of the upstream portal with regard to passage of debris a 1 to 30 physical model was constructed at WES. The model was tested under SPF flows with scaled debris loading. Several runs were made on the model with various geometries on the intake and debris "noses". It was found that incorporating a 10-foot radius "bell mouth" at the intake eliminated vortices and greatly improved the hydraulic efficiency. The "noses" were modified several times to improve their ability to shed debris. It was found that any sharp corners below the water surface tended to capture material so the outline of the "noses" was smoothed out. The final design is shown on Figure 15.

Figure 17. Hydraulic Model of the Upstream Portal

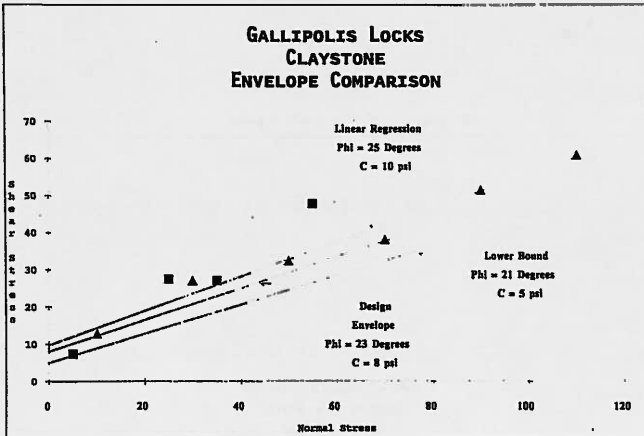
Figure 1

for the appearance of this lower bound. The indurated clays are essentially over-consolidated claystones with fractures and planes of previous failures present throughout the material. Naturally the strength of a small sample is influenced considerably by the orientation of the loading with respect to these planes of weakness. Since the plane which will control the strength cannot be identified prior to testing, the loading is applied at random with respect to the planes. The resulting scatter in the data is obvious.

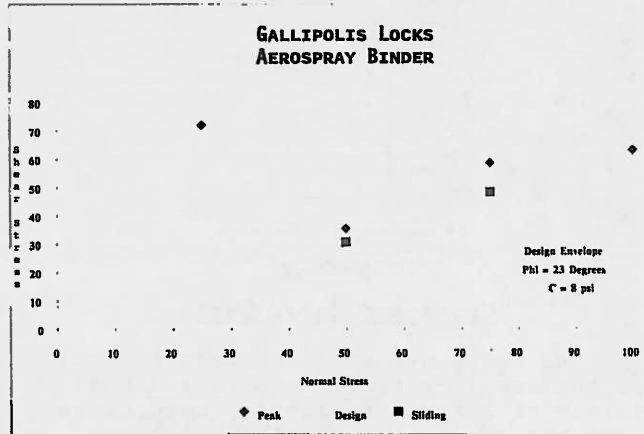
performed only on the claystones since no structures were founded in the indurated clays. Figure 14 shows that the influence of the aerospray binder is negligible. In fact the tests were probably more indicative of the rock strength since failure often occurred in the rock rather than at the interface.

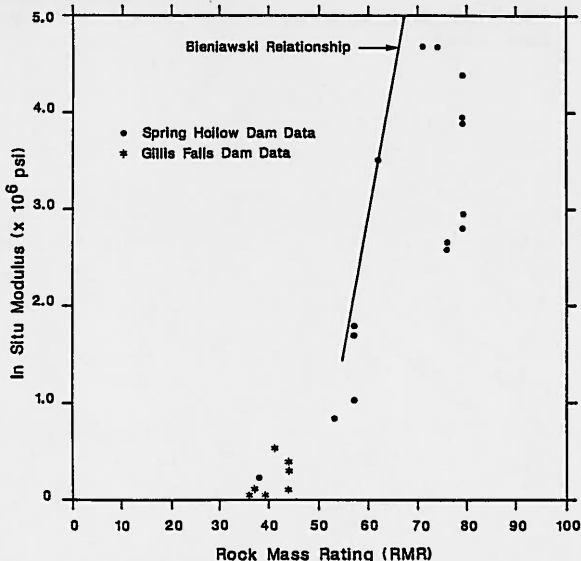
Figure 2 presents a plot of the data available from the dam sites. In addition, the line that represents Bieniawski's relation is shown on the plot. It should be noted that according to Bieniawski, the lower limit of applicability of his relation is a RMR of 55.

Figure 2: Plot of RMR versus In Situ Moduli Data

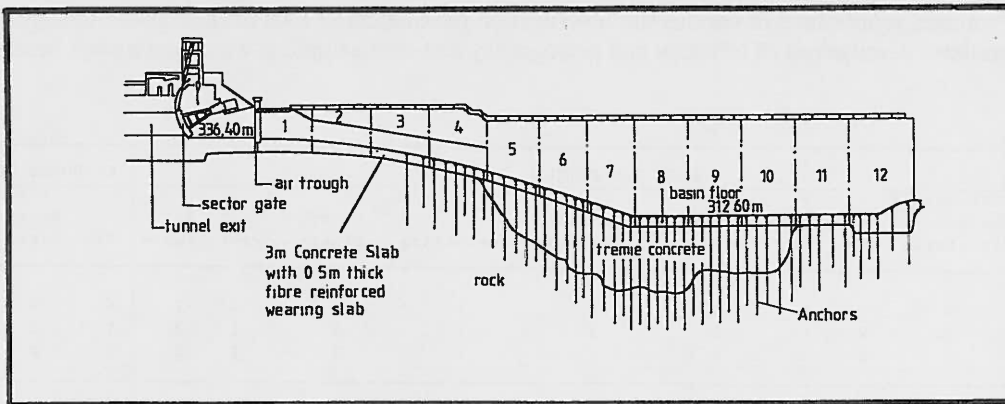
Figure 3. Anchors to repair stilling basin, Tarbela Dam, Pakistan¹¹.

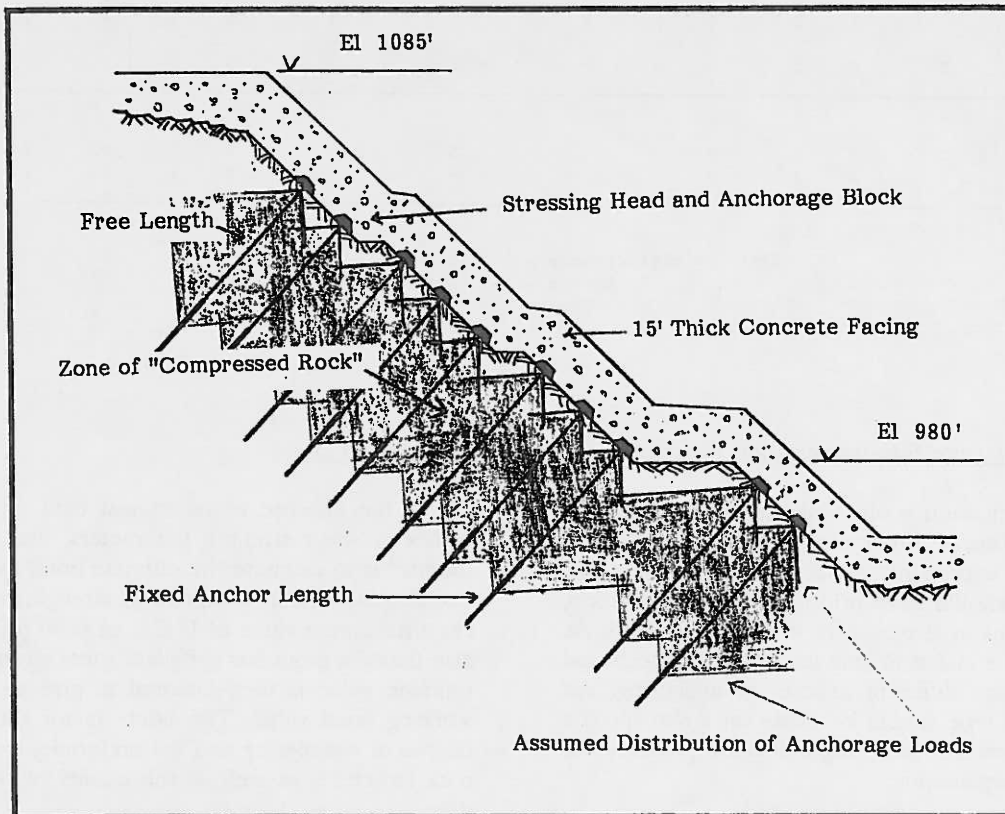
Figure 4. Anchors for slope stability and rock reinforcement, Service Spillway Plunge Pool, Tarbela Dam, Pakistan (idealized section).

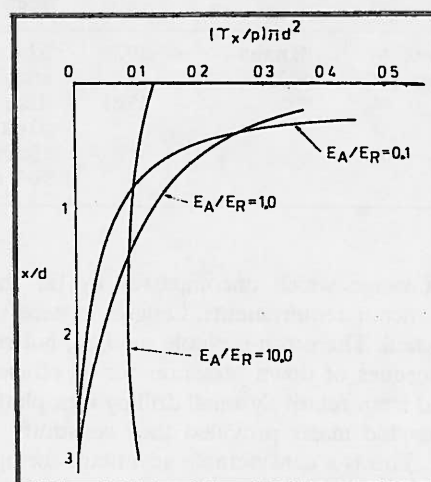
Figure 6. Variation of shear stress with depth along the rock/grout interface of the bond length. E_R and E_A are the moduli of elasticity of the rock and anchor grout respectively²⁶.

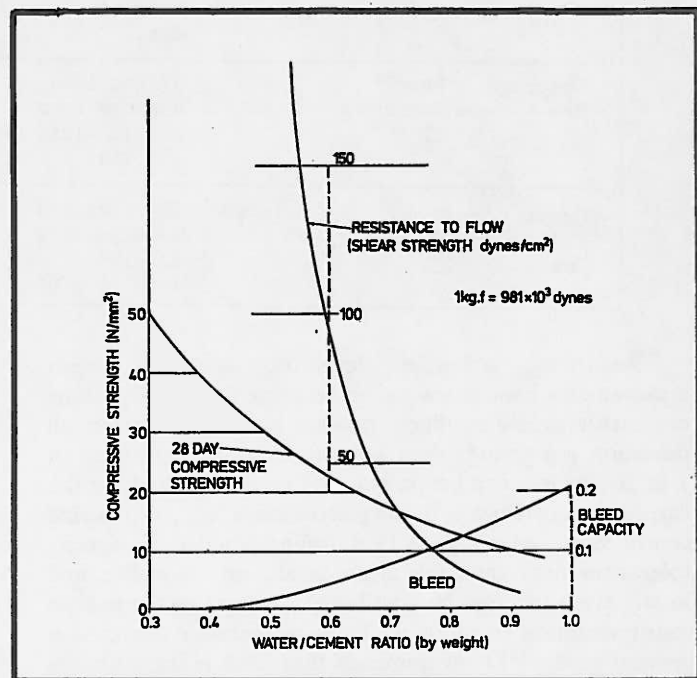
Figure 7. Influence of water cement ratio on grout strength, bleed and fluidity¹⁶.

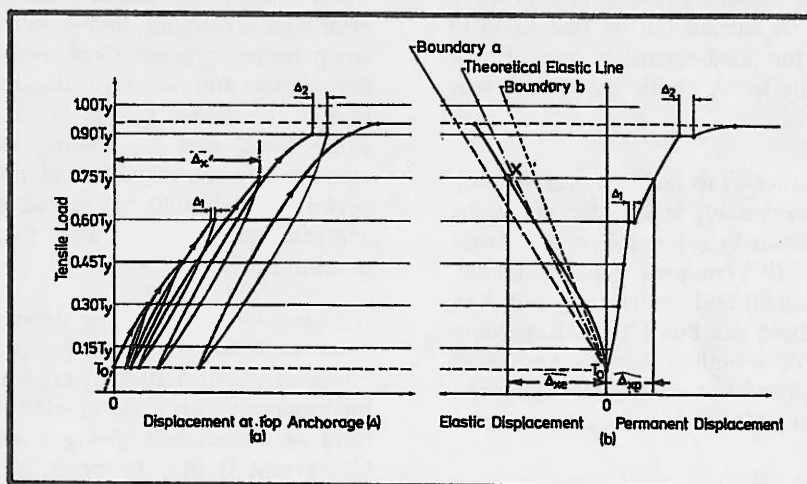
Figure 9. Resolution of total tendon extension (a) into Elastic and Permanent (Residual) Components, (b) for analysis of Performance Tests³³.

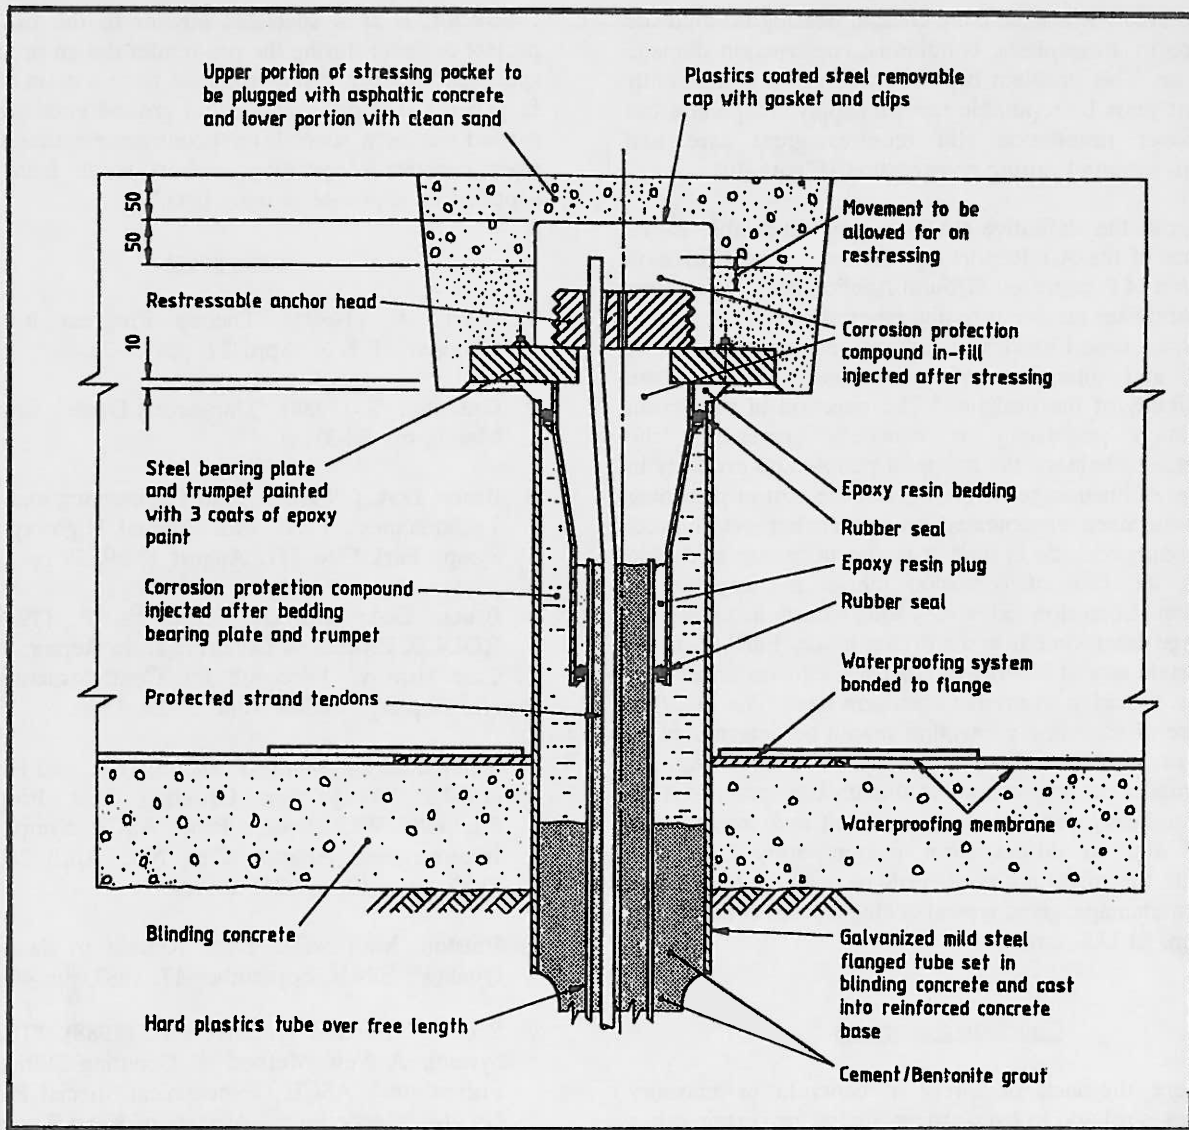
Figure 10. Typical anchor head detail for double corrosion protection of a restressable strand tendon in a water retaining structure²⁰.

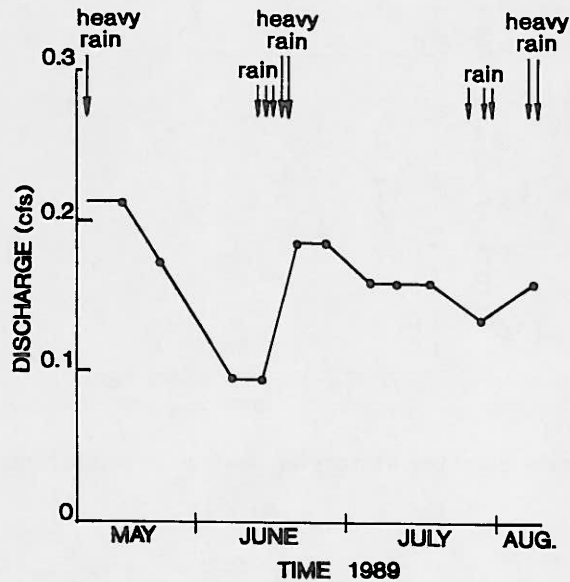
Figure 11. Seepage and rainfall versus time.

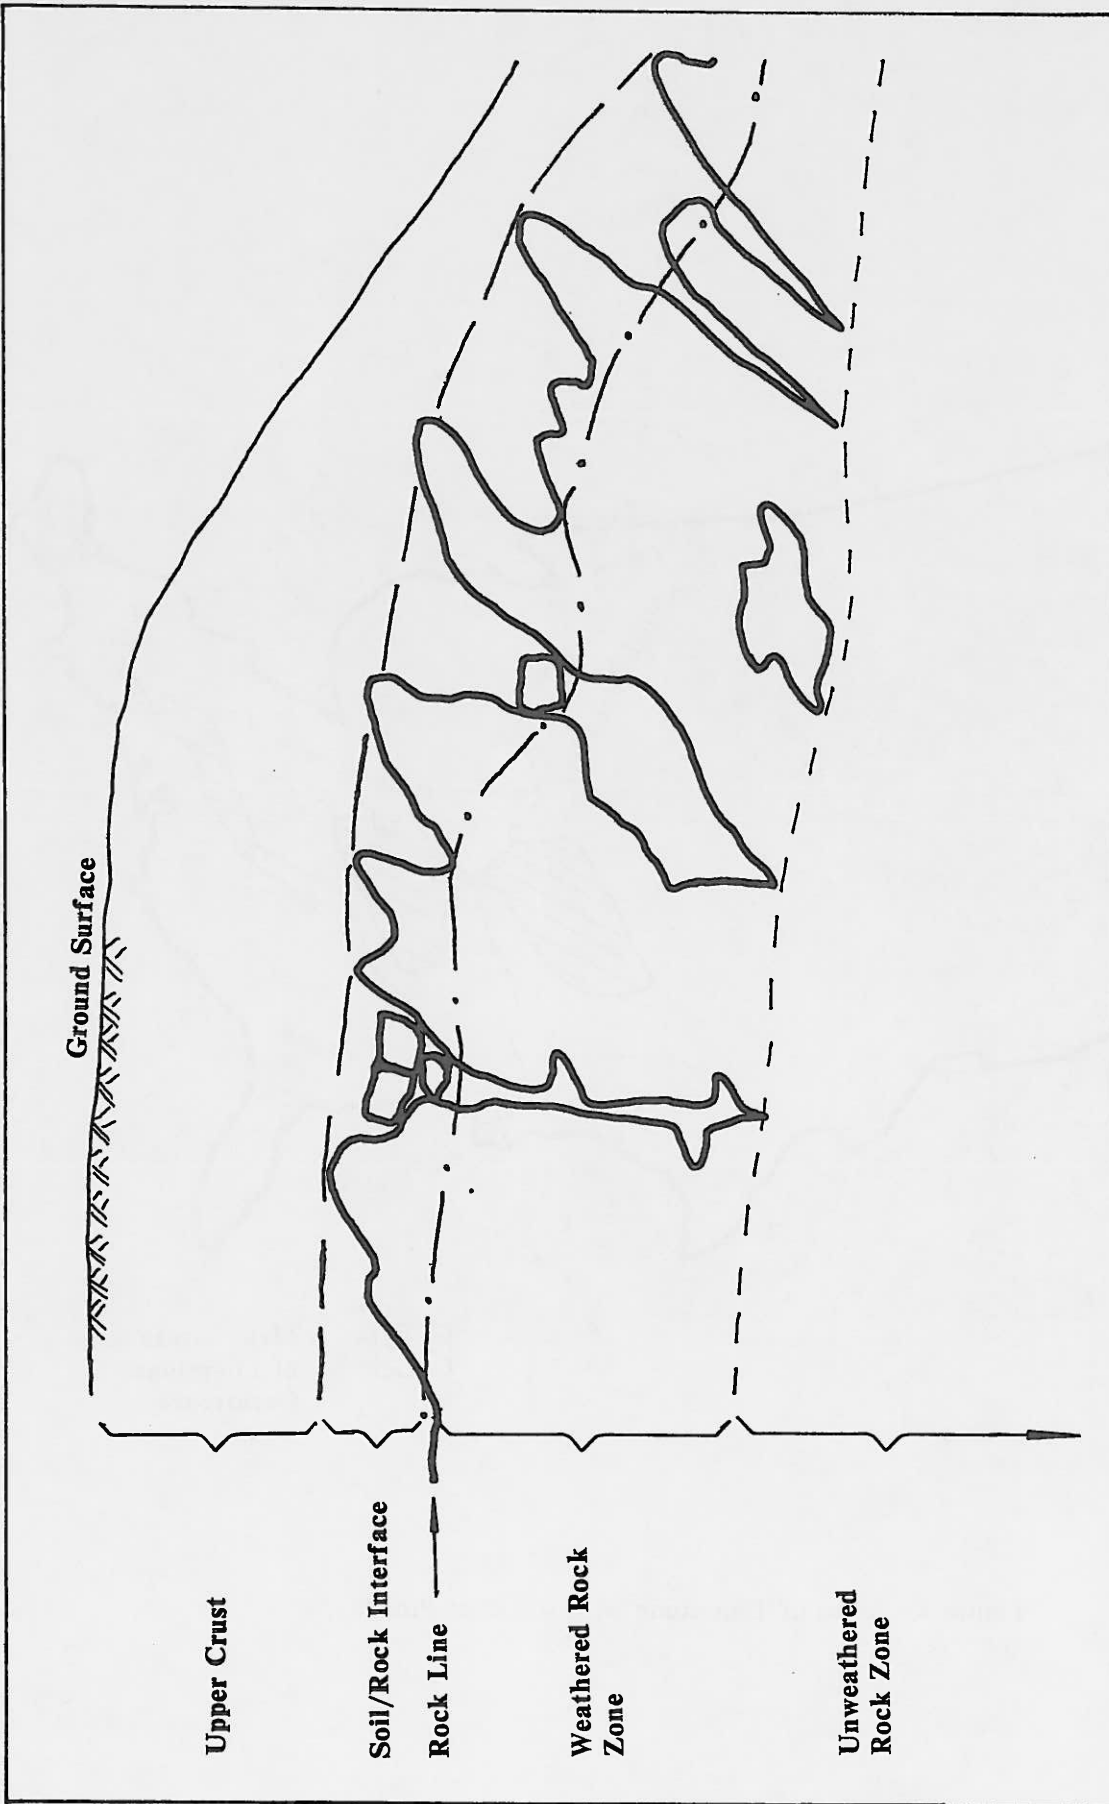
Figure 2. Typical Residual Soil Profile and Divisions.

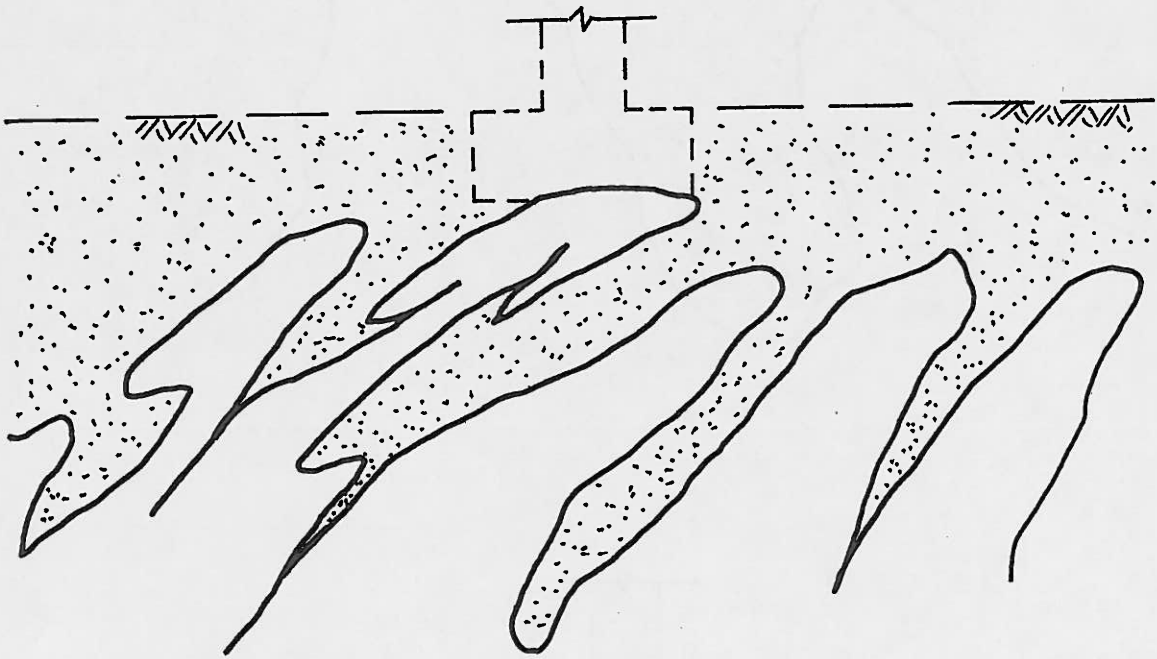
Figure 6. Sketch Shows Instability of Pinnacled Rocks.

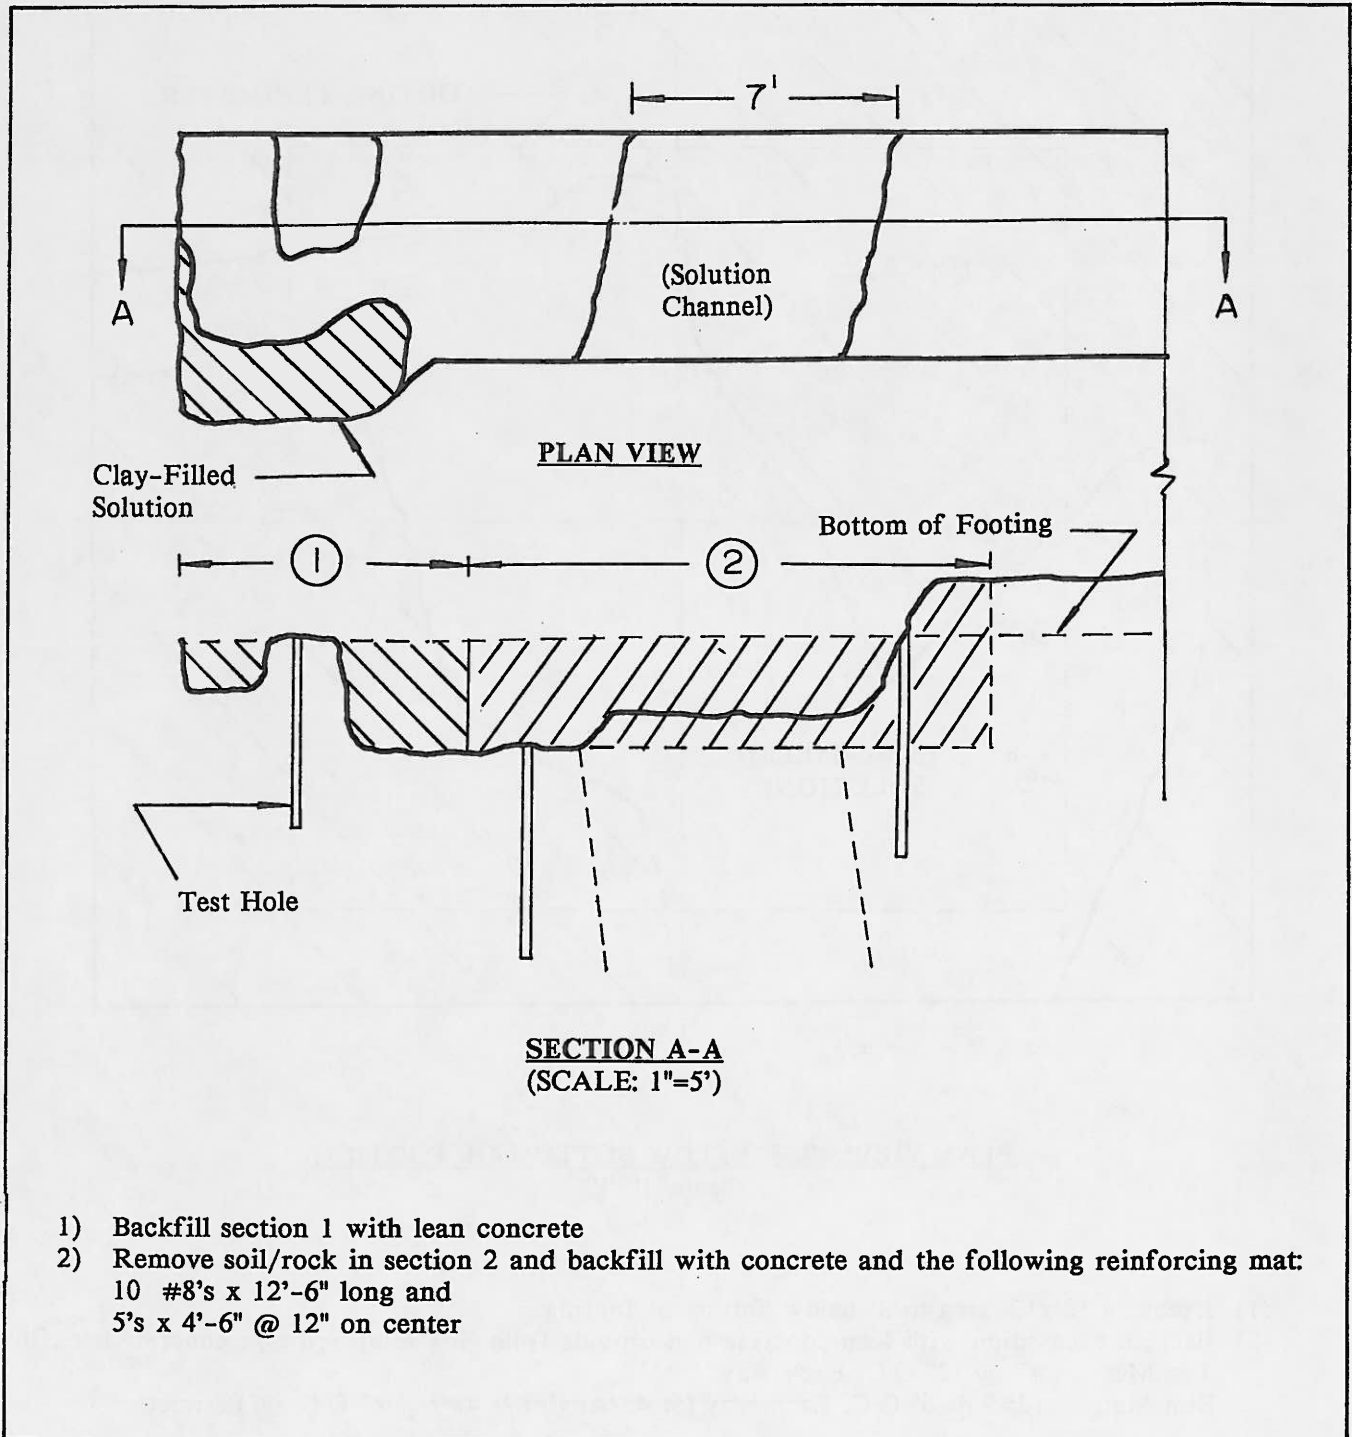
Figure 9. Sketch Shows A Continuous Footing with Solution Pocket and Channel.

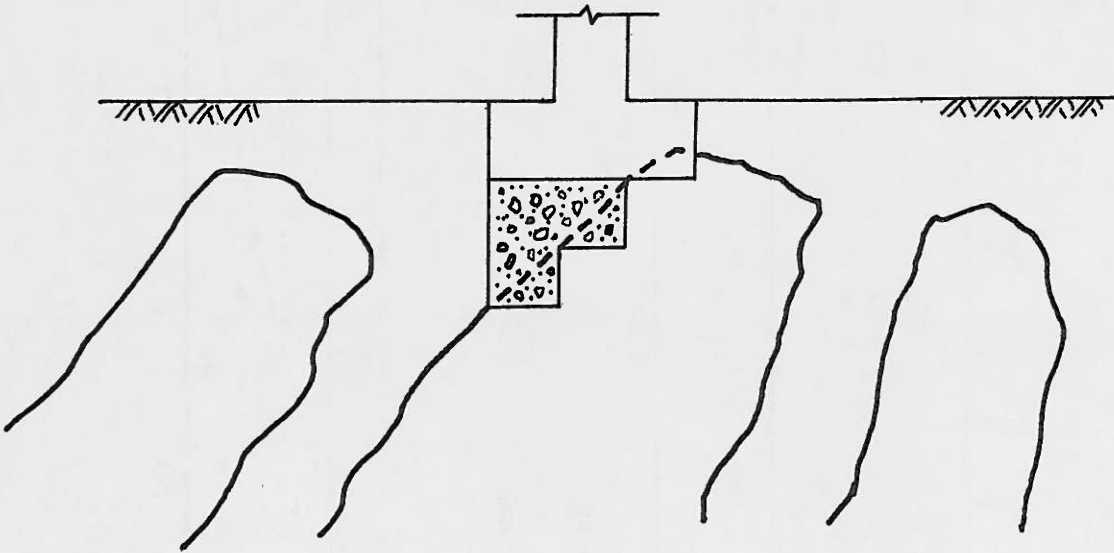
Figure 11. Foundation with Stepped Rock.
