Ohio River Valley Soils Seminar XX

Construction in and on Rock

October 27, 1989
Louisville, Kentucky

PROCEEDINGS OF THE TWENTIETH
OHIO RIVER VALLEY SOILS SEMINAR

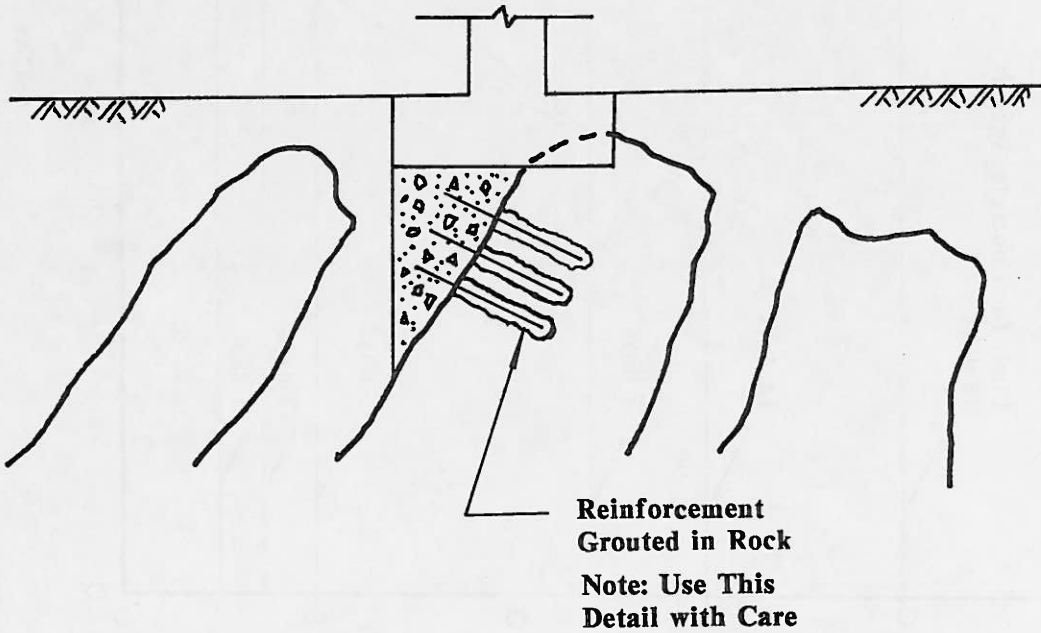
Figure 12. Foundation with Dowels.

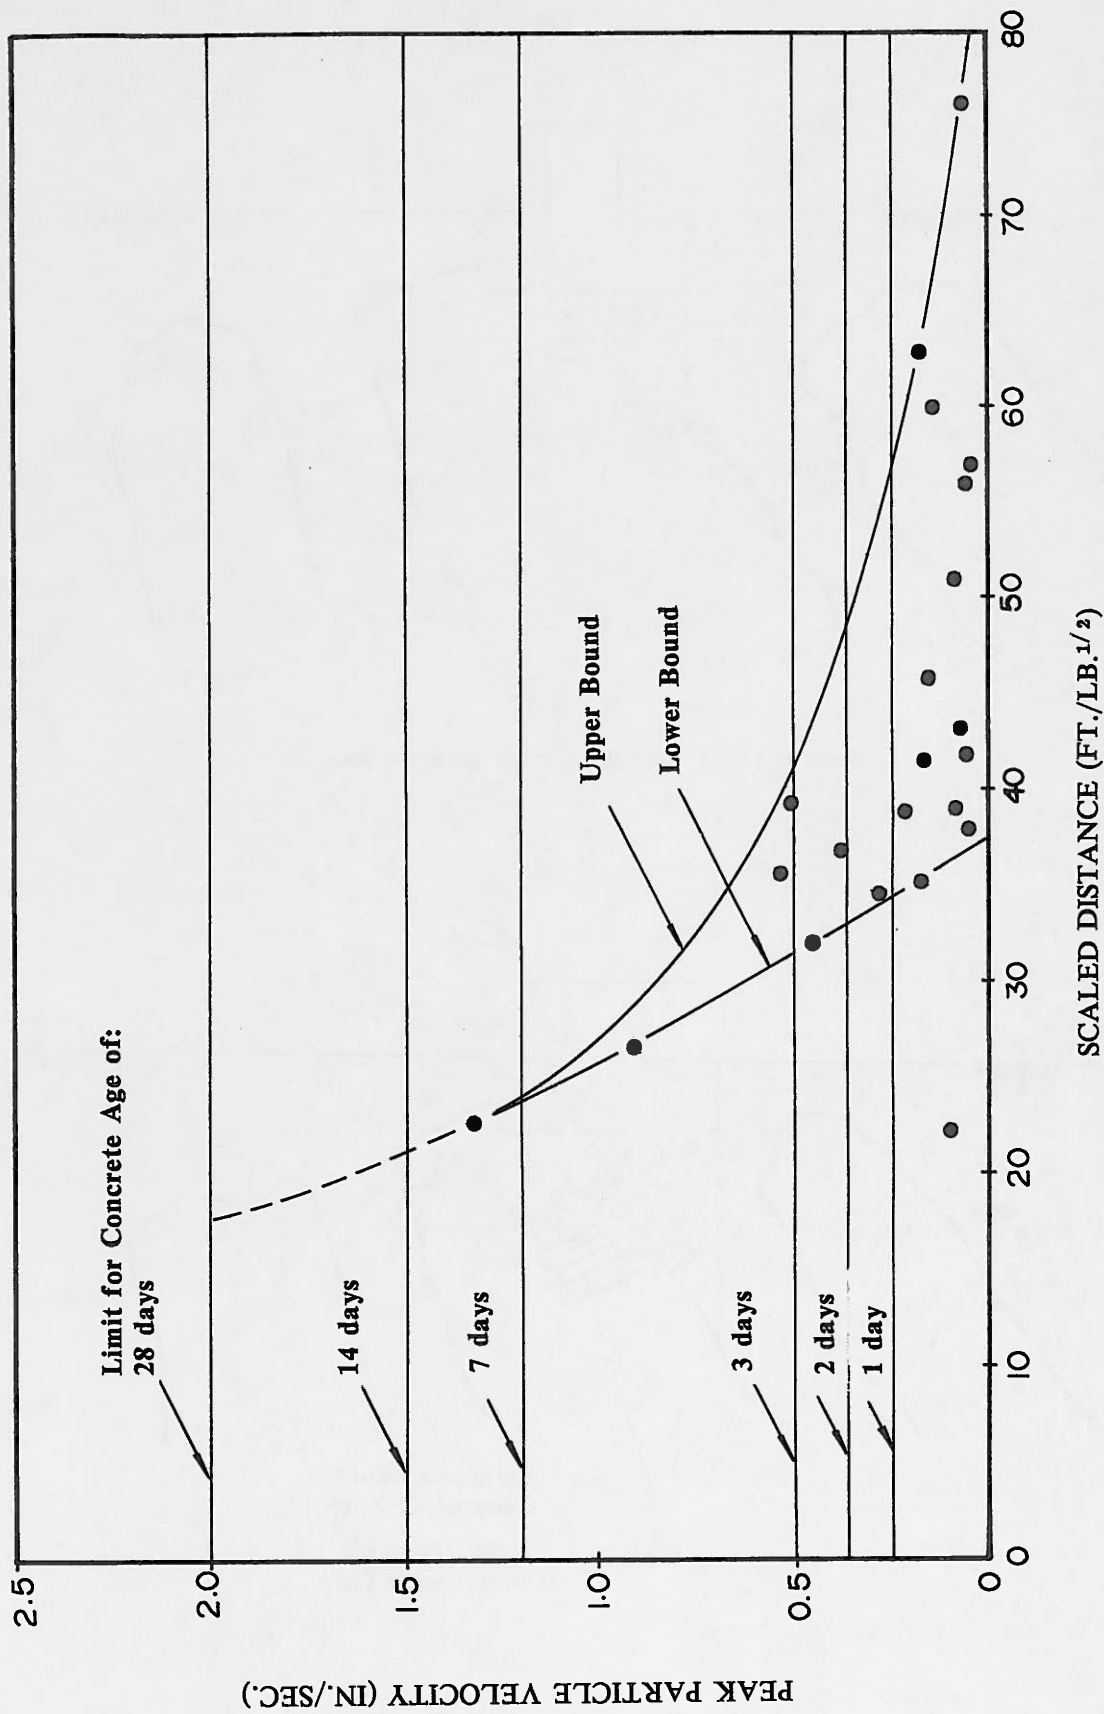
Figure 13. Relationship of Peak Particle Velocity and Scaled Distance.

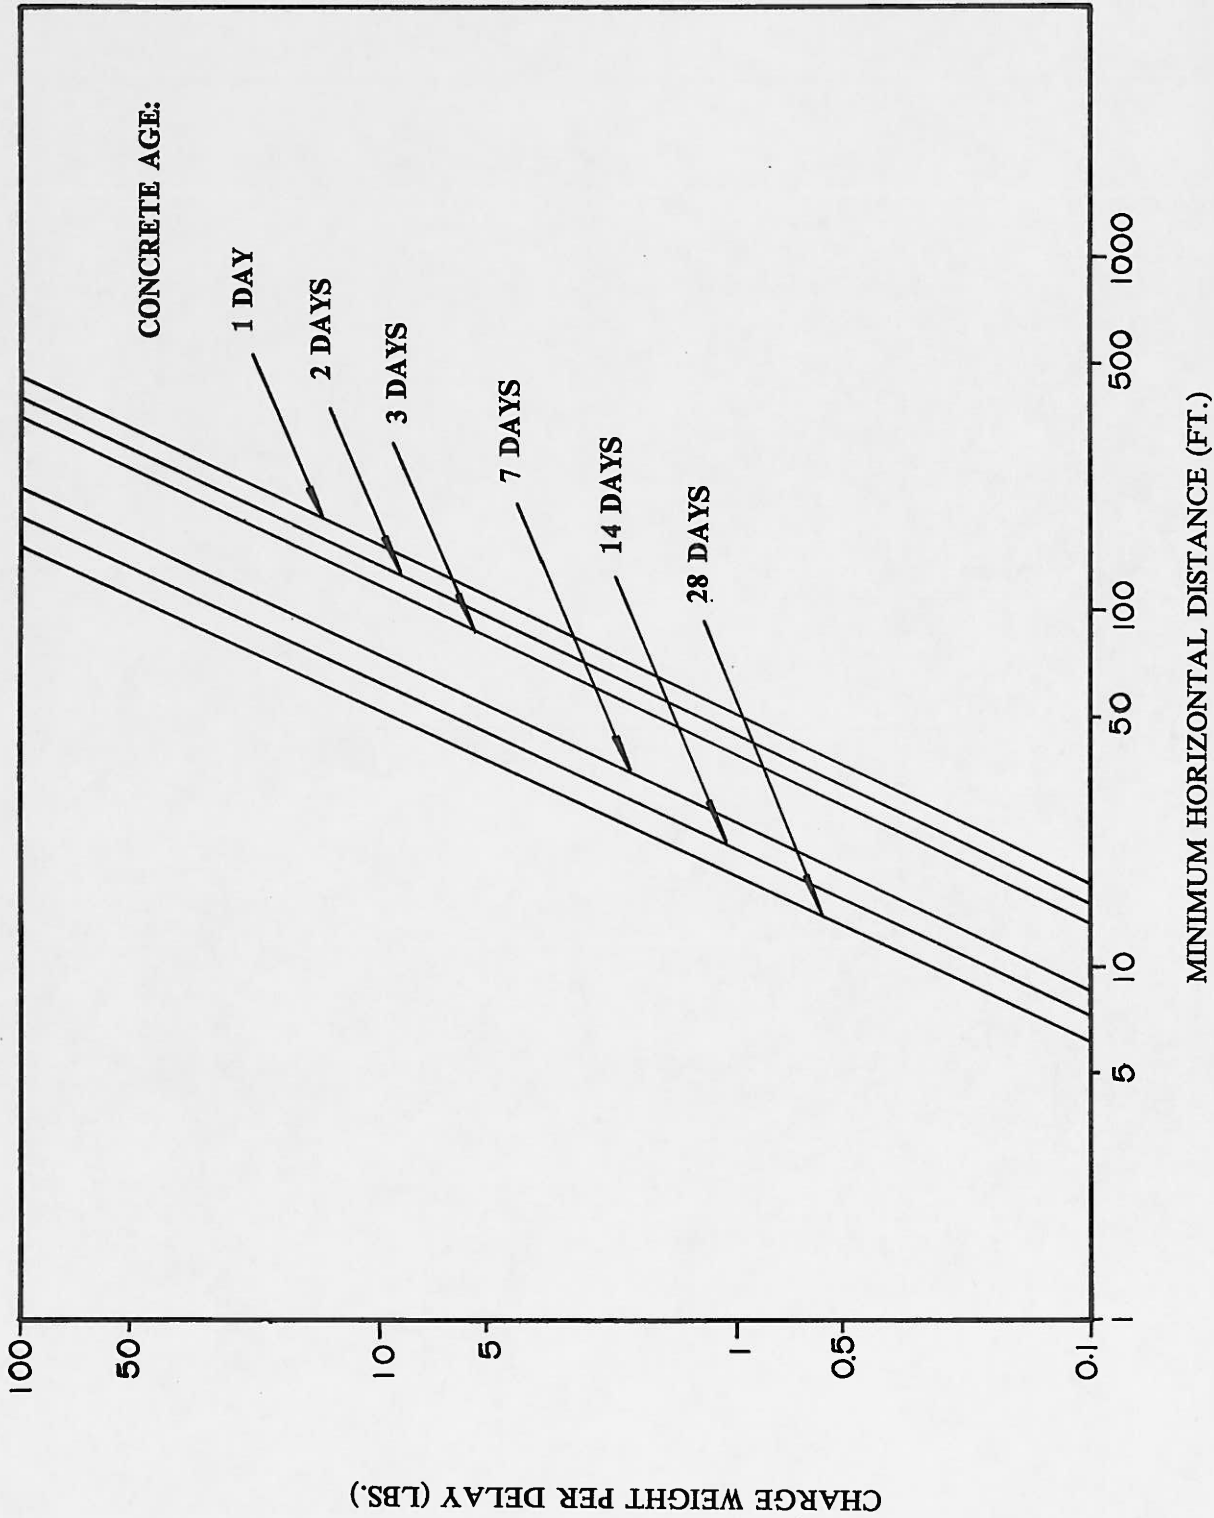
Figure 14. Blast Criteria: Relationship of Charge Weight and Minimum Horizontal Distance.

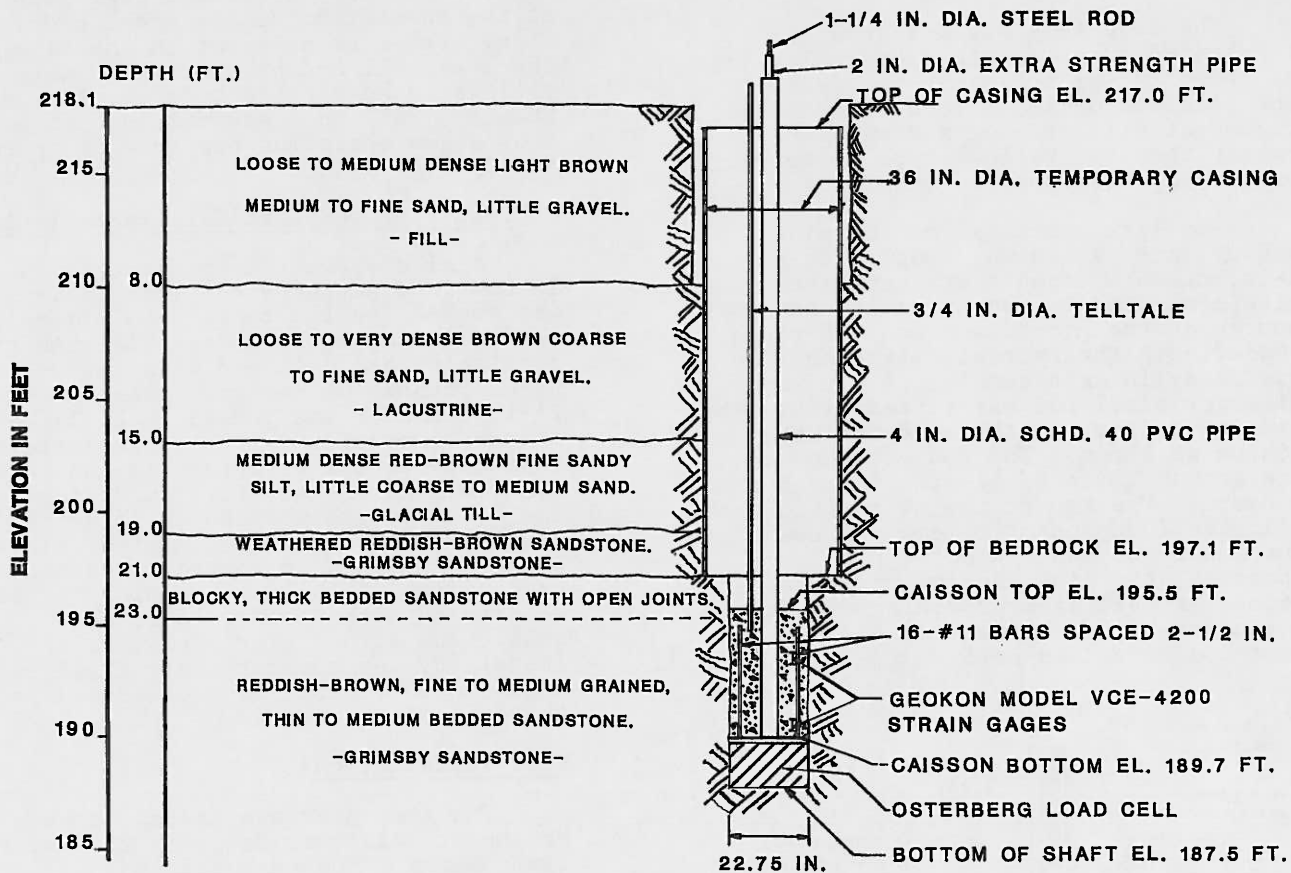
Figure 2. Generalized subsurface conditions and test pier installation details.

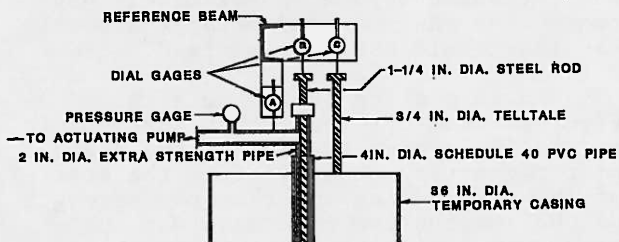
Figure 3. Schematic diagram of load test instrumentation.

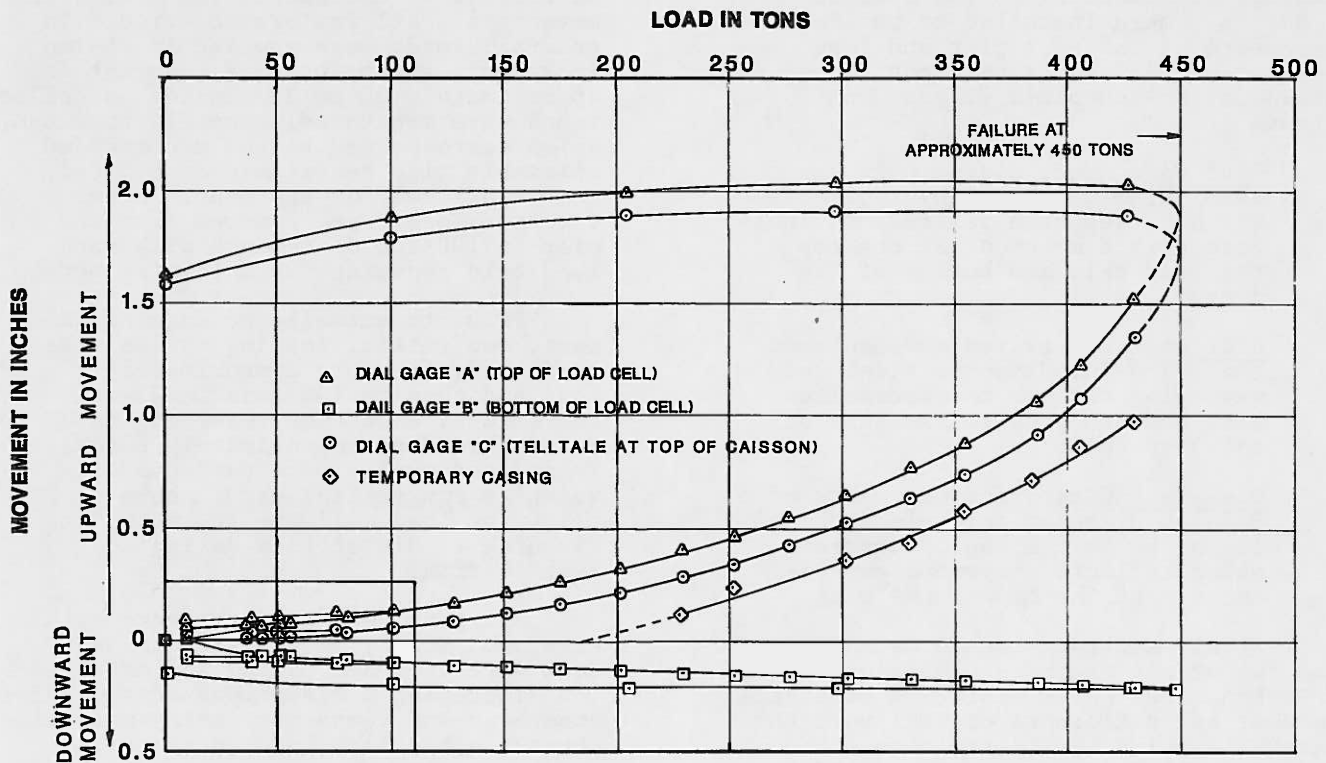
Figure 4. Telltale and casing deflections.

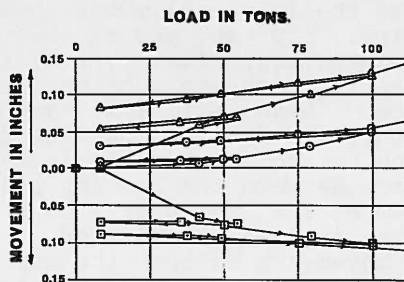
Figure 5. Telltale deflections during initial load cycles.

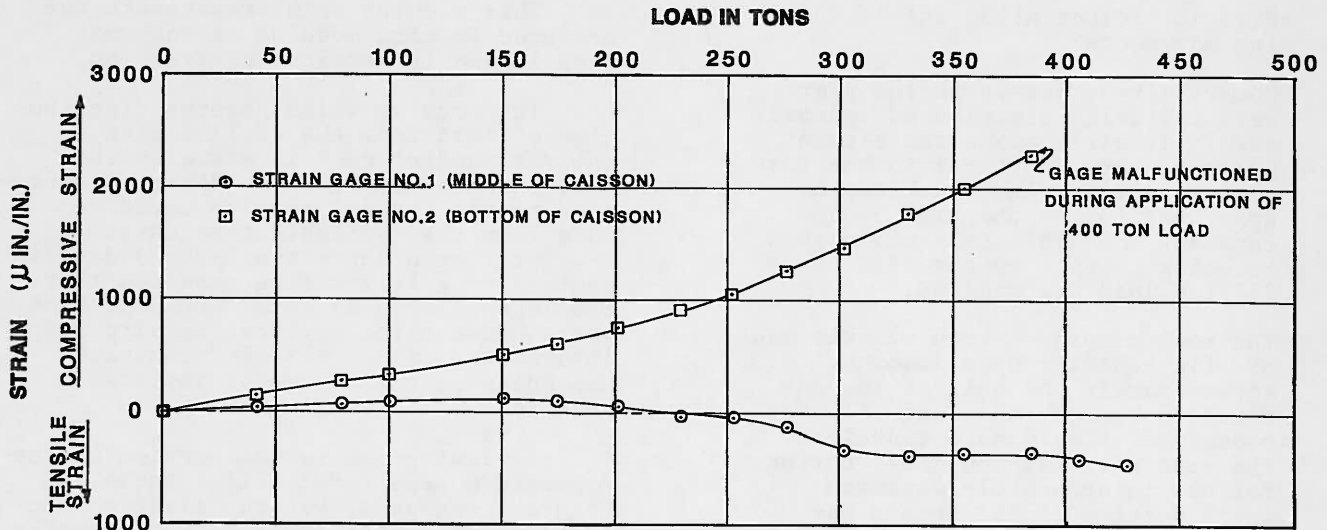
Figure 6. Vibrating wire strain gage measurements.

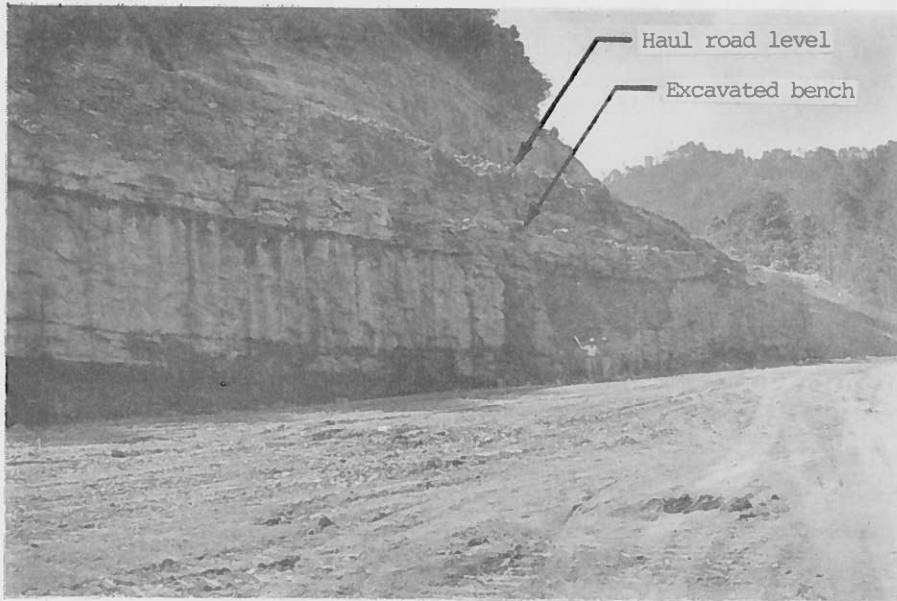
Figure 2. Photograph of highwall showing haul road and excavated bench.

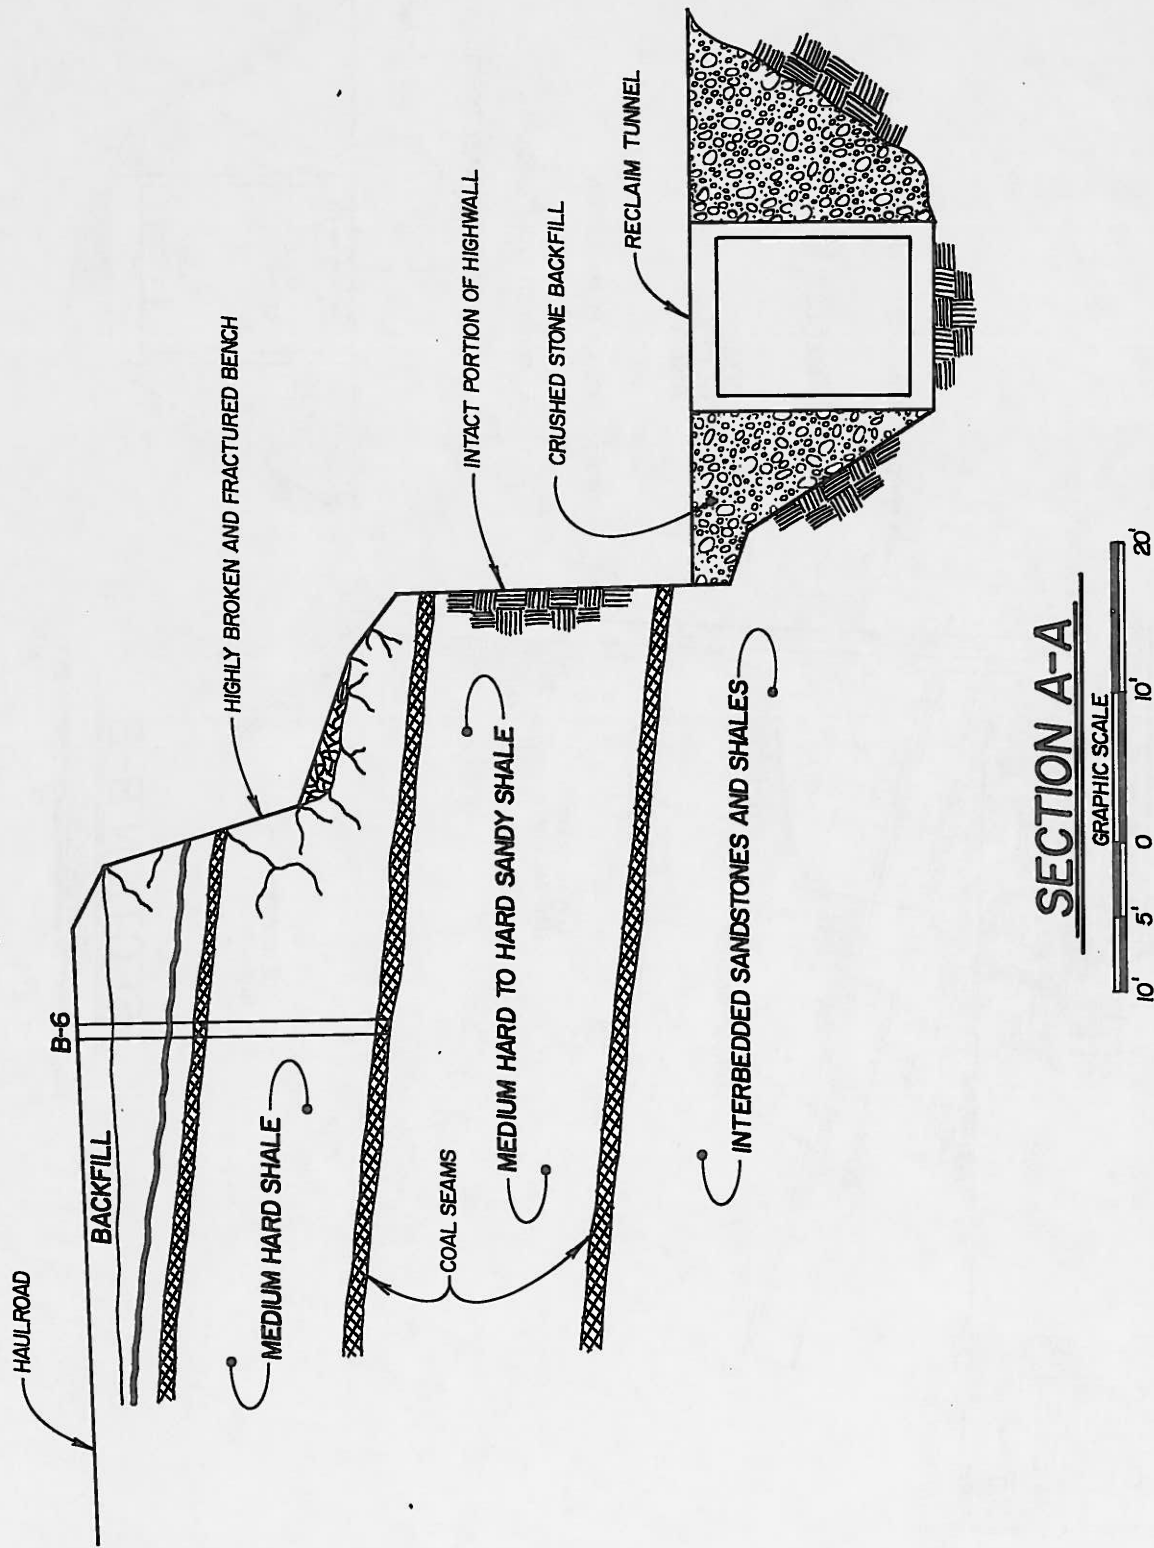
Figure 5. Generalized geologic Section A-A through highwall.

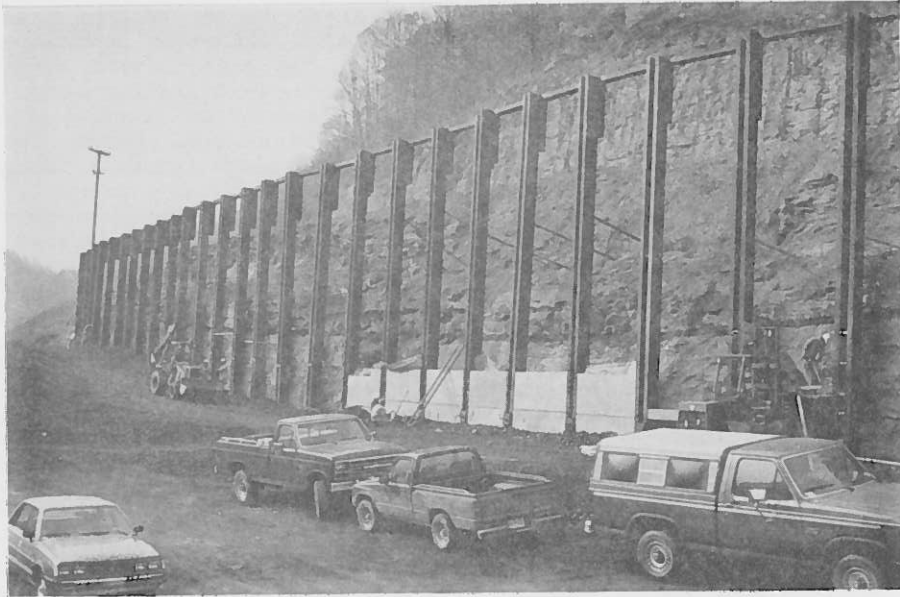
Figure 8. Photograph of erected double beam sections and initial precast concrete panel placement.

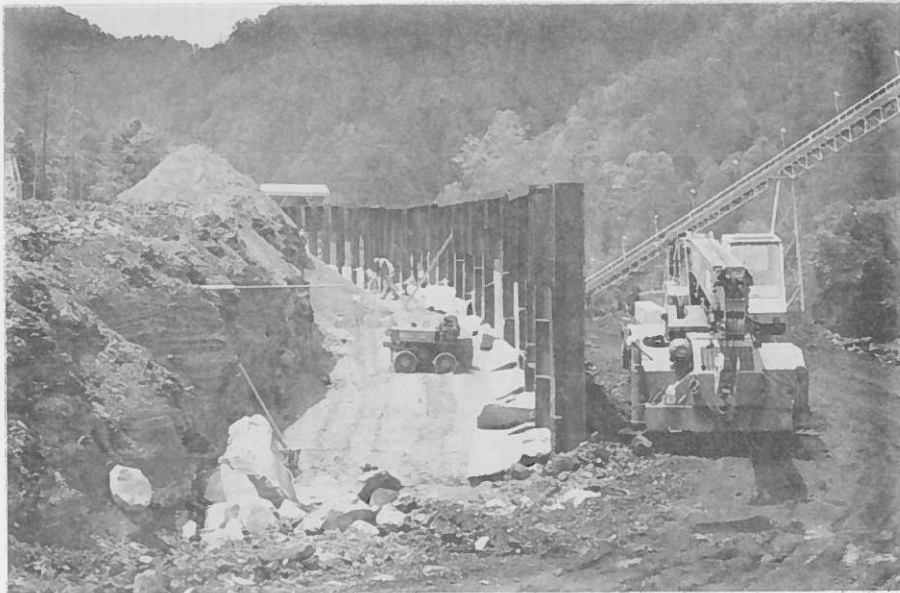
Figure 9. Photograph of backfilling operations behind wall and coal pile access in front of wall.

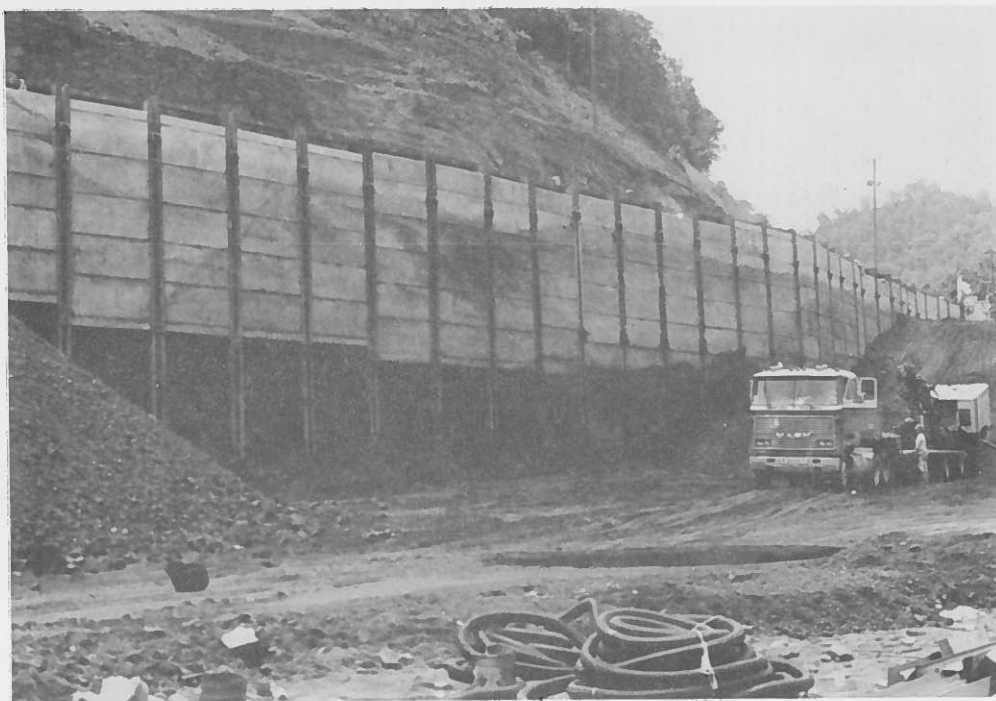
Figure 12. Photograph of completed tied-back coal dumping wall.
