# OHIO RIVER VALLEY SOILS SEMINAR XXXVI OCTOBER 14, 2005

| Authors | Title of Paper |

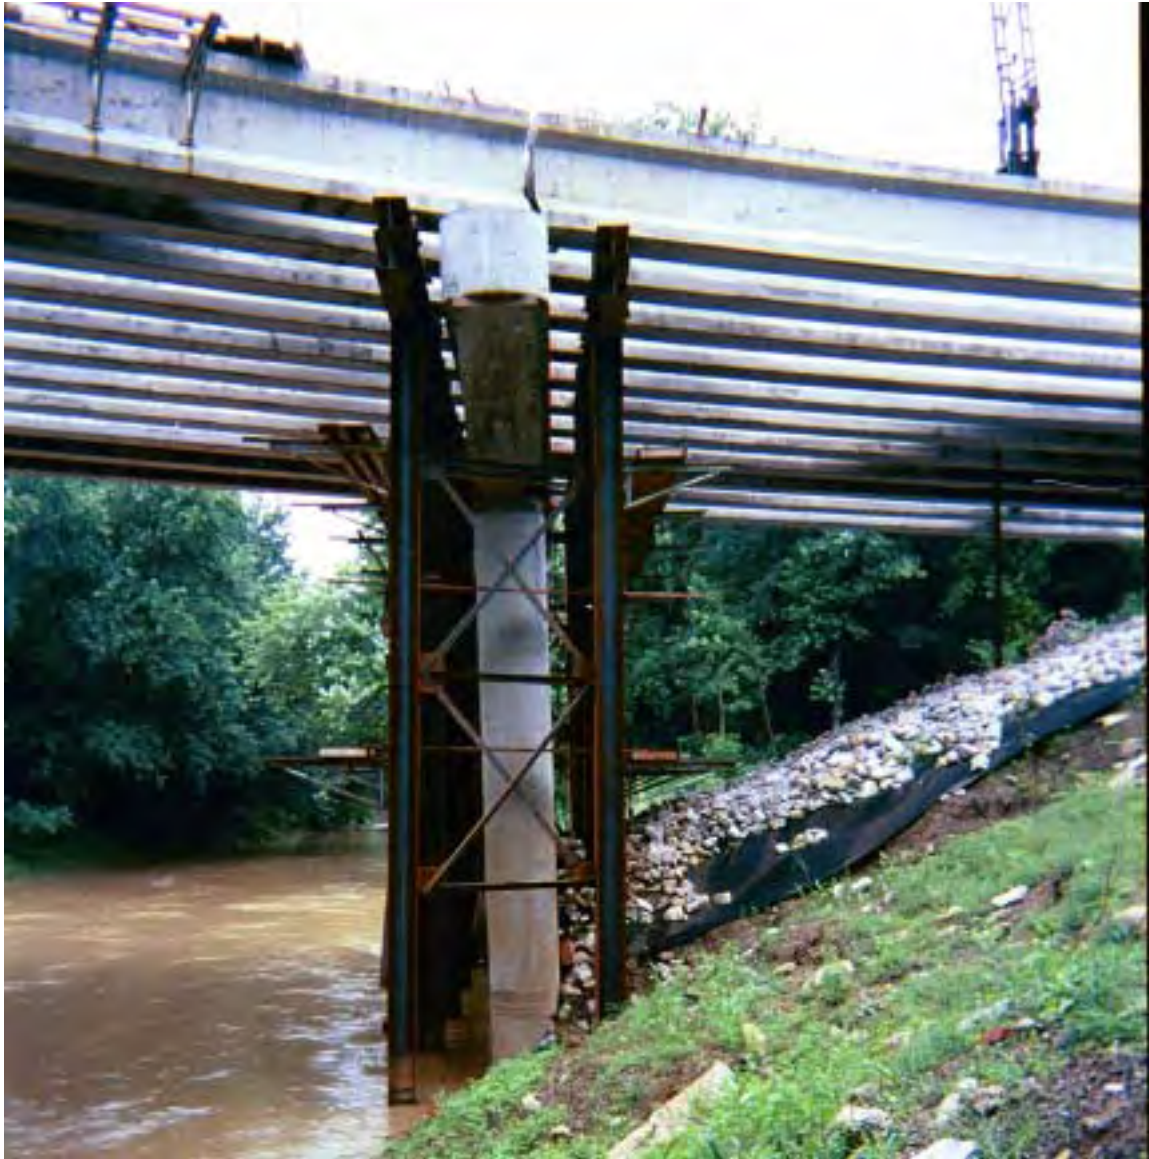
Photo. 1. Interior pier (No. 3), looking west (taken after temporary support of the pier was provided)

Noticeable movement of the interior pier (No. 3) closest to the north abutment was observed shortly after the previous elements were constructed. Refer to Photograph 1. By the time the author was involved with the project, the interior pier was 8 in. from vertical, and the abutment and beams were collectively skewed to the west less than  $\frac{1}{4}$  of one degree over an 80-ft long span. The “I” beams were approximately 3 in. from the edge of the pier cap, i.e., in the closest direction, and the elastomeric bearing pads were racked. The skew was such that the beam pockets of the interior pier were spalling, and the length of the bridge had shortened by approximately  $2\frac{3}{4}$  in.

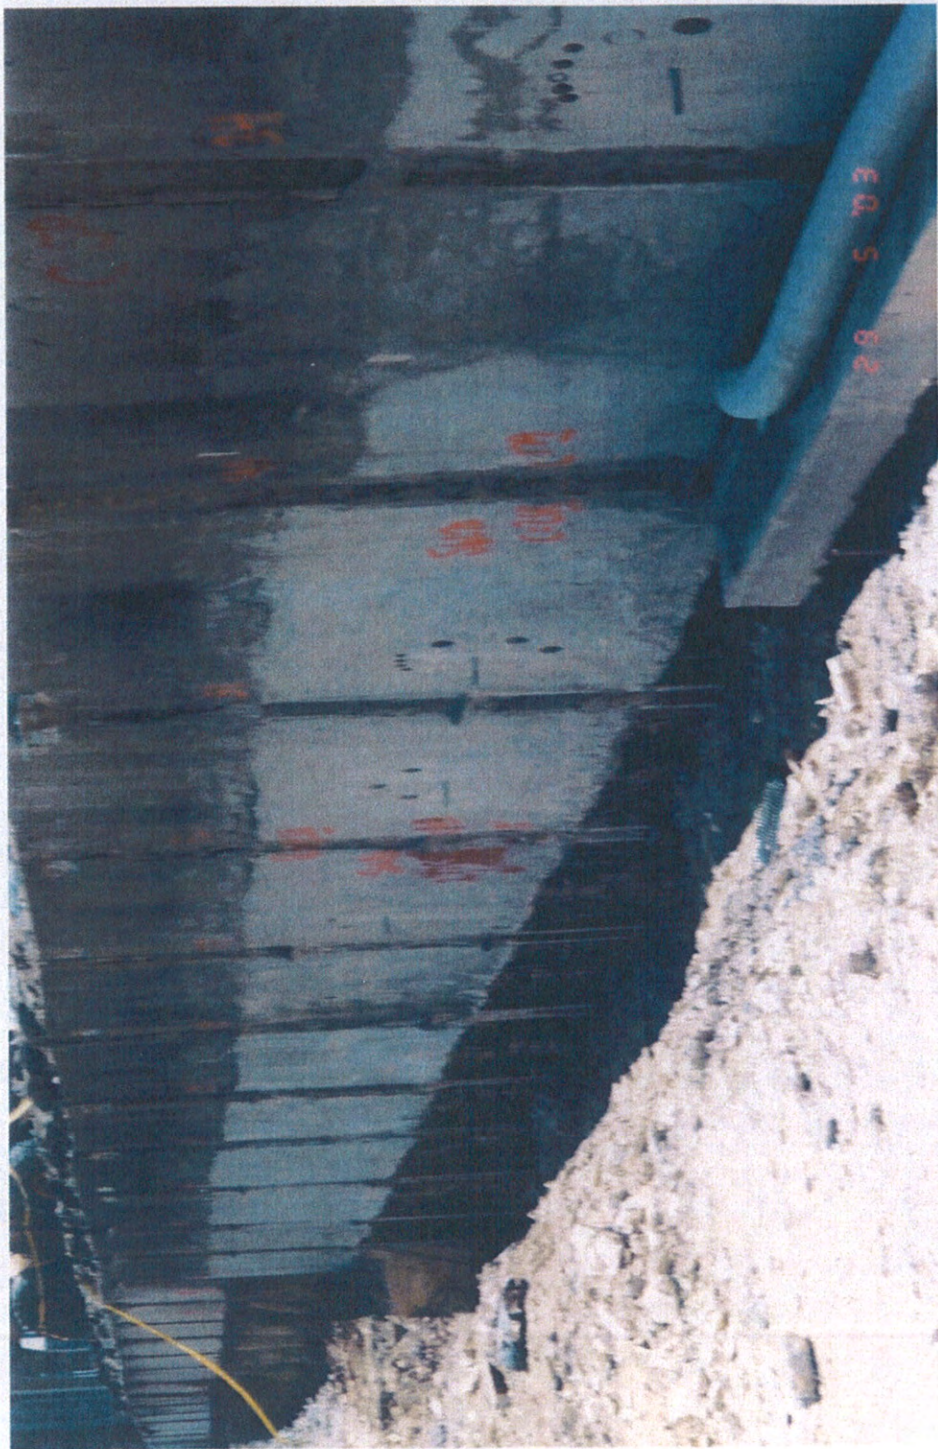
FIG. 2 TIED-BACK SOLDIER PILE WALL SHOWING CIP CONCRETE LAGGING

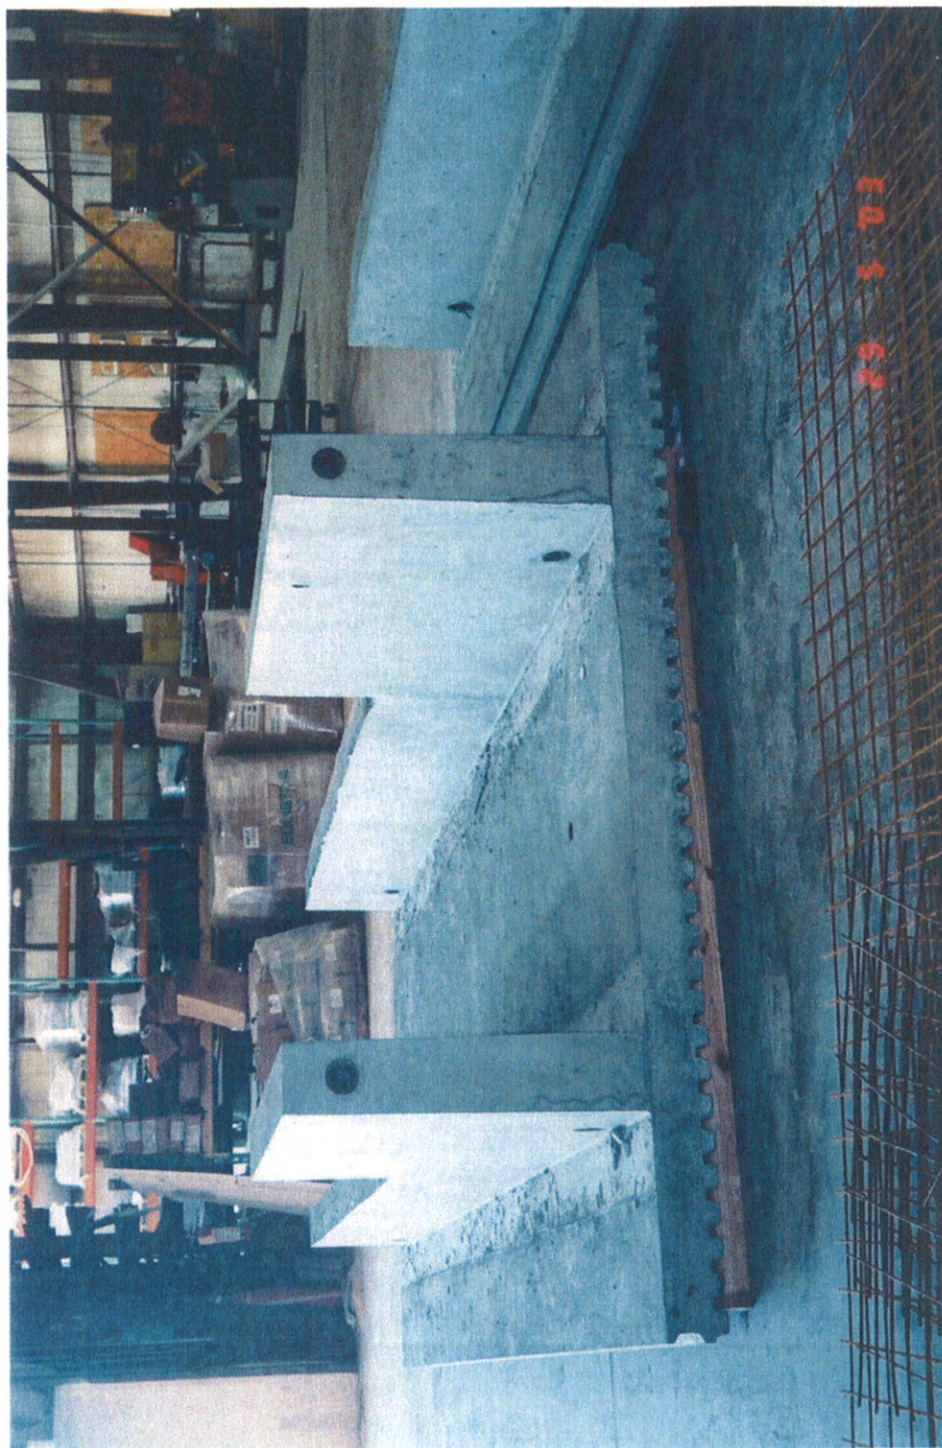
FIG. 6 TYPICAL DOUBLE-T PANEL

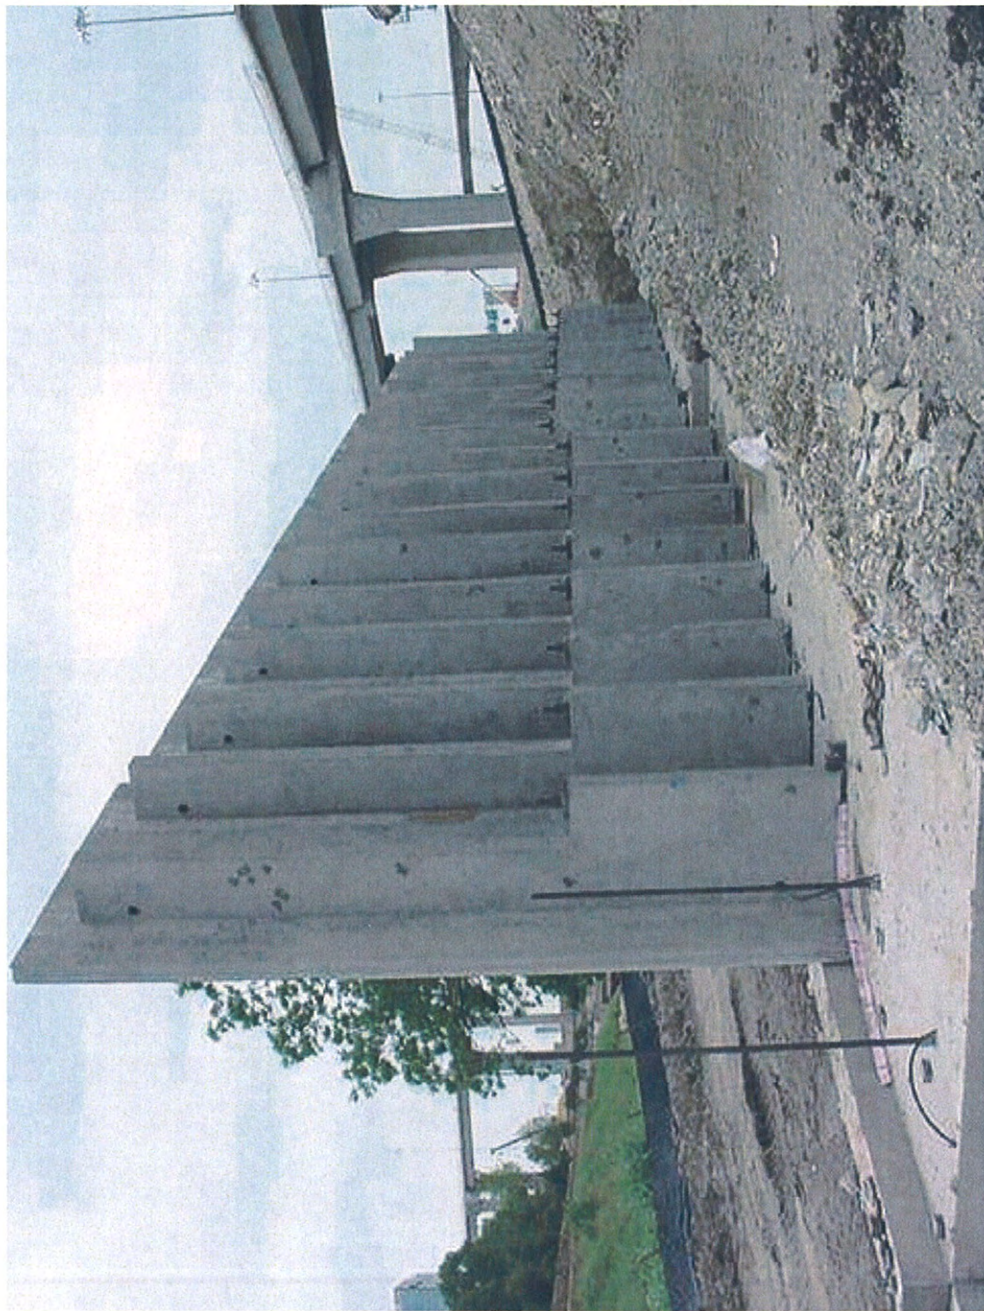
FIG. 7 ERECTED DOUBLE-T PANELS

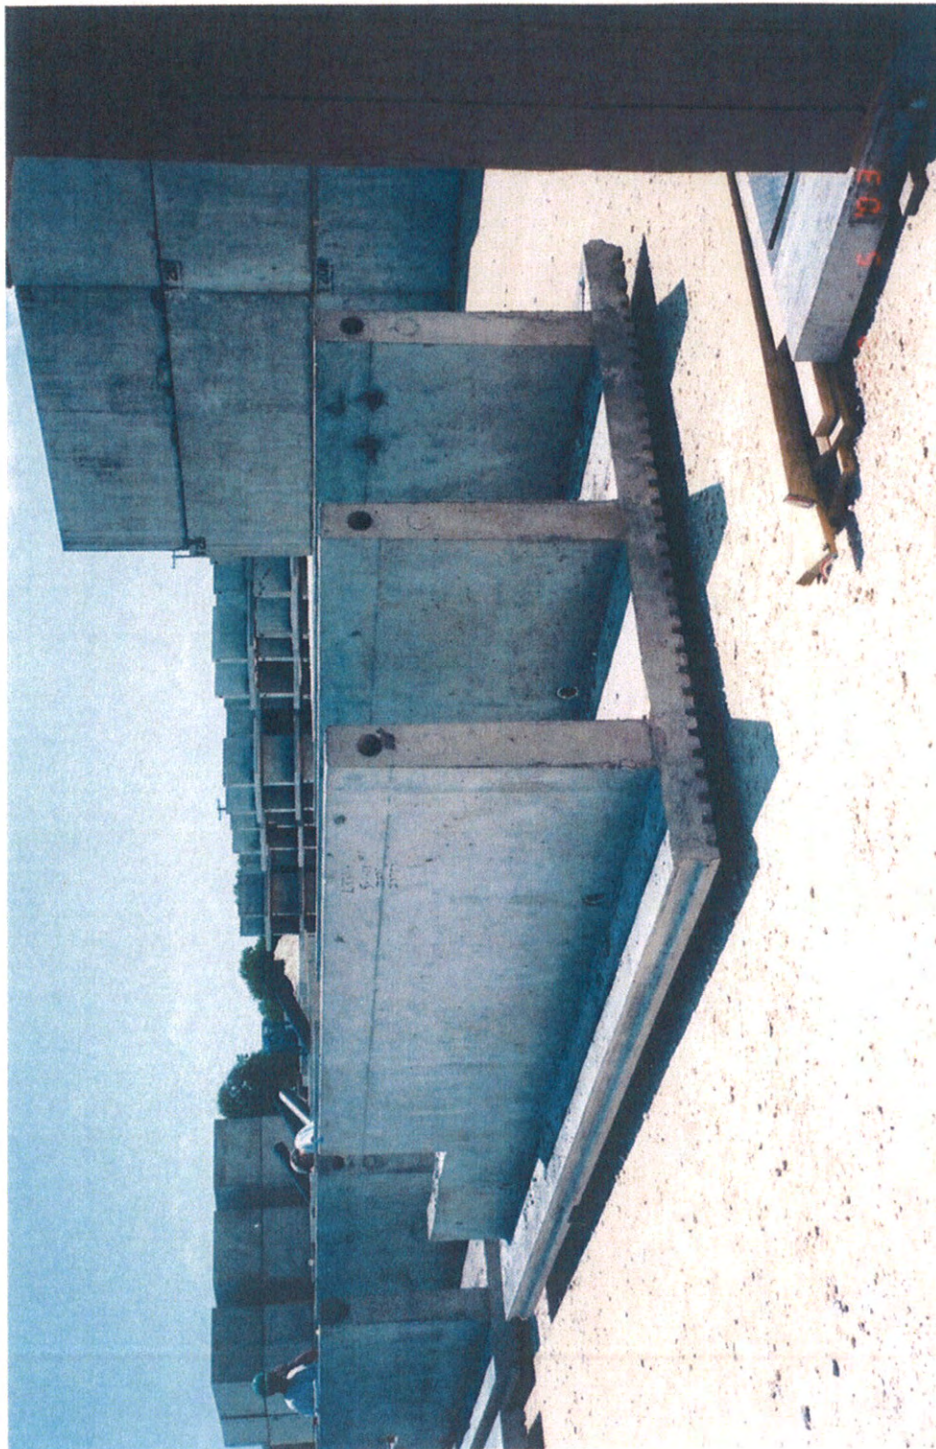
FIG. 8 TYPICAL TRIPLE-T PANEL

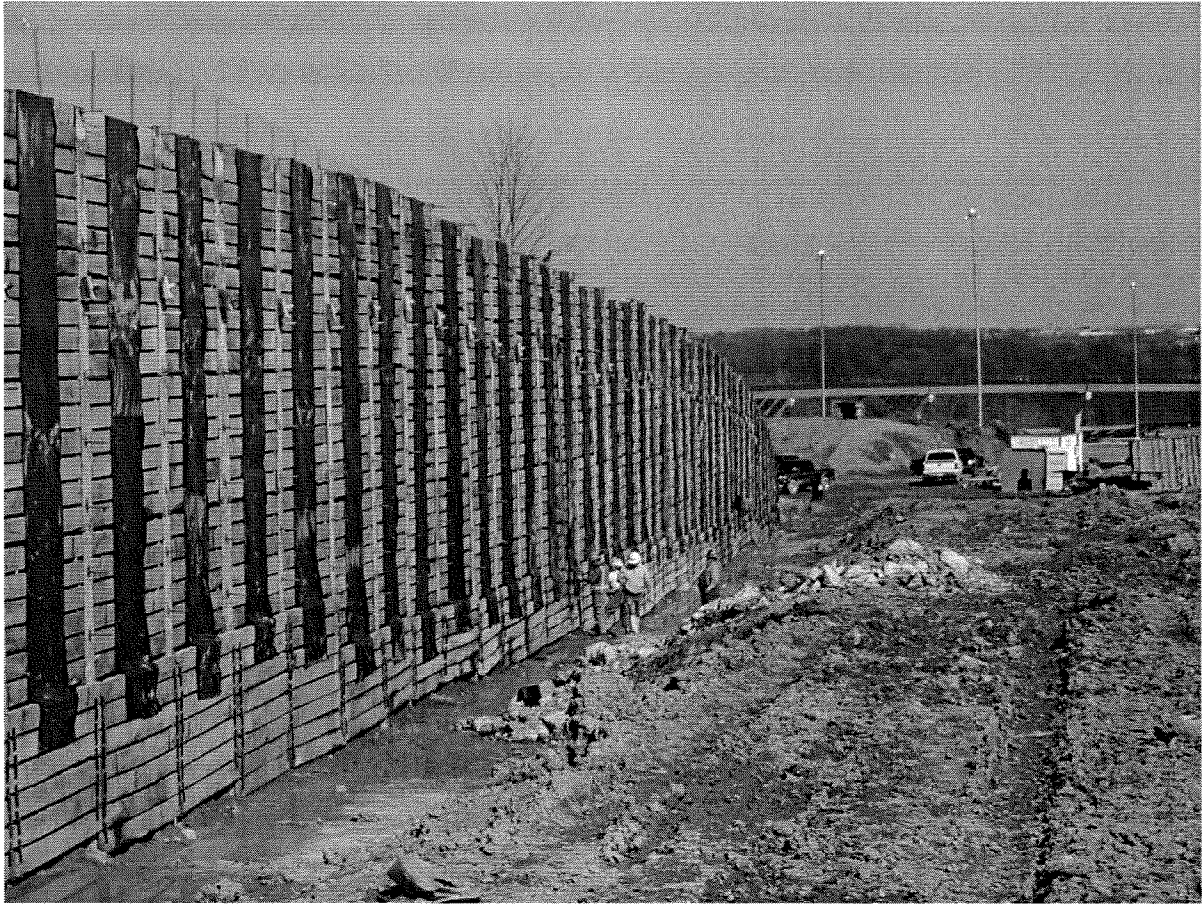
Figure 3 – Placing drainage mats to full temporary height.
