# FORENSIC STUDIES IN GEOTECHNICAL ENGINEERING

PROCEEDINGS  
*of the*  
TWENTY-SEVENTH  
OHIO RIVER VALLEY SOILS SEMINAR  
(ORVSS XXVII)

October 11, 1996  
Sharonville Convention Center  
Cincinnati, Ohio

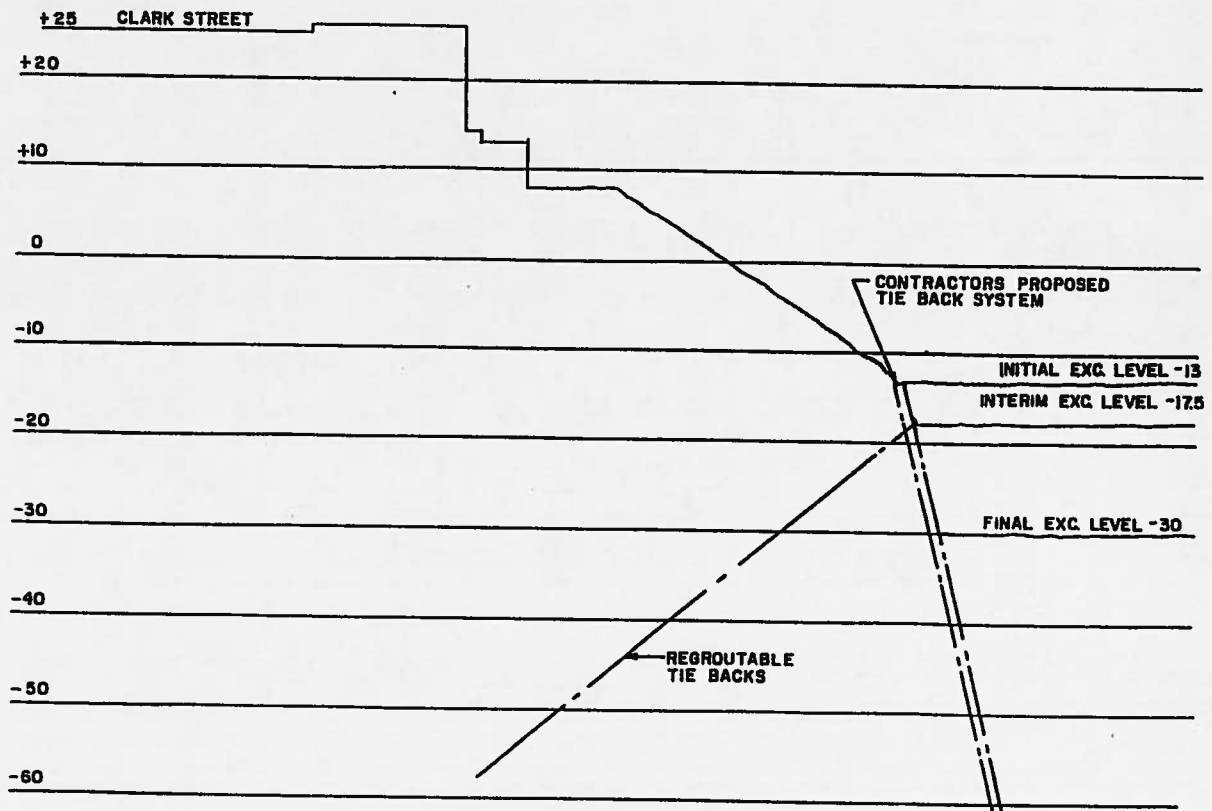
FIGURE 2  
PROPOSED LOWER LEVEL TEMPORARY RETENTION SYSTEMS

7. Methods for reducing the risk of excessive movements and increasing factor of safety were discussed with the contractor. The geotechnical engineer recommended partial excavation and then cross lot bracing to permit the entire mat construction, installing the top raker through the cross lot braced excavation to the mat, and then proceeding as before. See Figure 2. The contractor countered with replacing the cross lot bracing system with a tied back wall on one side, using regroutable ties and with an open cut on the other noncritical side of the excavation where there was ample room for open cut. The geotechnical engineer agreed and the owner and contractor negotiated a price for the additional work. See Figure 3.

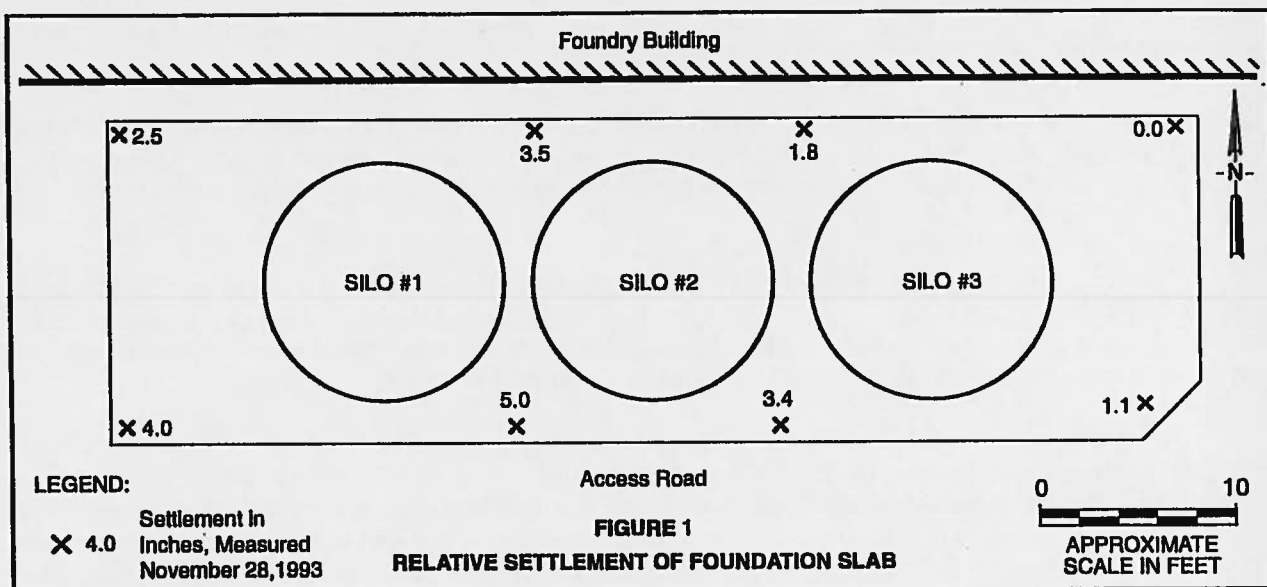
The immediate concern was to establish if movement was continuing and when or if the situation could get critical. The owner arranged for a survey, which indicated that the top of the common foundation slab had settled up to 5 inches relative to its northeast corner (see Figure 1). The absolute settlement is not known as no elevation data were recorded when the foundation slab was constructed. Tilting of the silos, as calculated by the surveyor, is shown in Figure 2.

The failure investigation began by developing a chronology of events and an analysis of the information that affected design. As shown in Figures 1 and 2, all three silos shared a common concrete slab foundation, 17 feet wide by 56 feet long, and 3 feet thick. Each silo was 12 feet in diameter, 71 feet high, and had a total sustained live load of 295 tons. The approximate date each silo was initially loaded is shown in Figure 2. The common concrete foundation slab was founded on compacted structural fill 8 feet deep, constructed over stiff silty clay. So what went wrong?

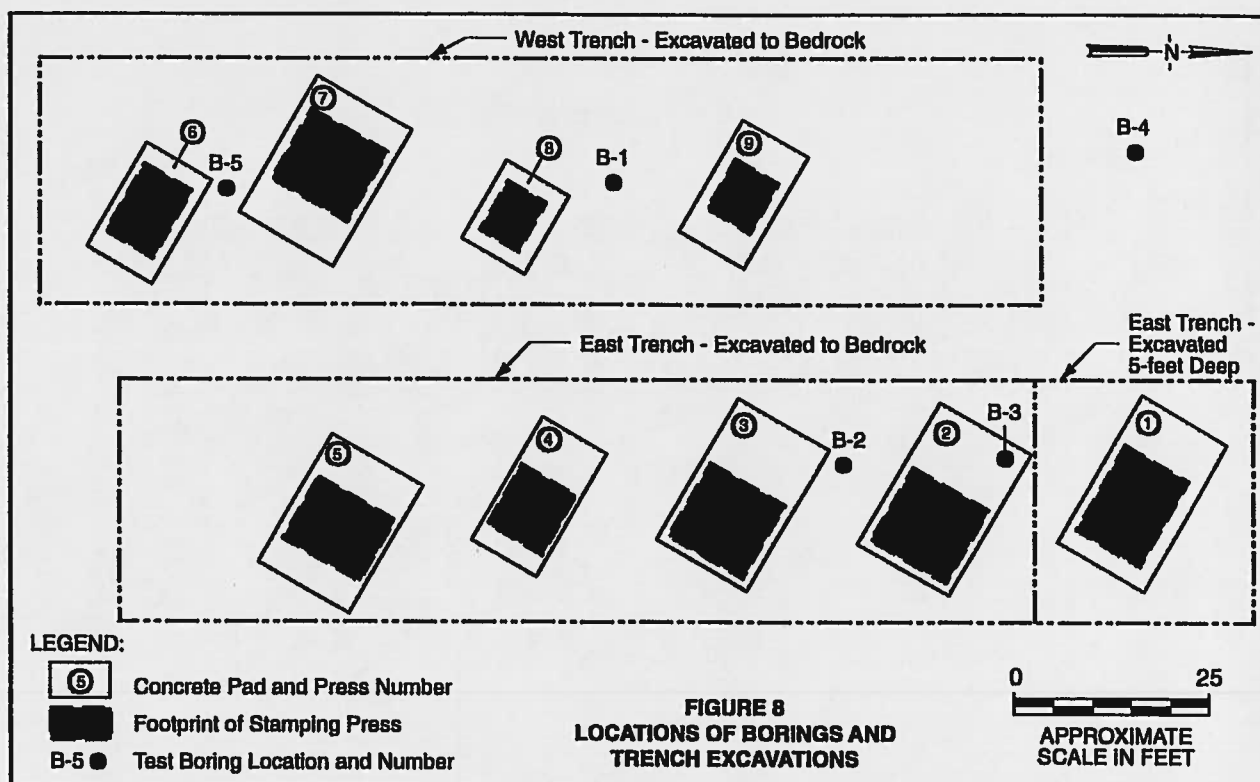
The failure investigation next led to interviews with the design/build contractor. It was discovered that two trenches were excavated as a consequence of encountering soft soil during site preparation. Each trench was 30 feet wide and encompassed the stamping press foundation areas as shown in Figure 8. The western trench was 135 feet long and was excavated to bedrock, 11 to 12 feet deep. The eastern trench was 145 feet long; most of it was excavated to bedrock, except for 30 feet on the northern end, which was only excavated to a depth of 5 feet. The trenches were backfilled with coarse crushed limestone, up to 3 inches in maximum dimension. The contractor claimed to have used a vibratory roller and to have compacted the granular backfill as specified in the geotechnical report—but, there were no compaction test results or inspection records available. However, photographs did show the presence of a vibratory roller working on the structural backfill, just as the contractor had claimed!

Five test borings were drilled, two in the east trench (B-1 and B-5), two in the west trench (B-2 and B-3), and one outside of the trench area (B-4), as shown in Figure 8.

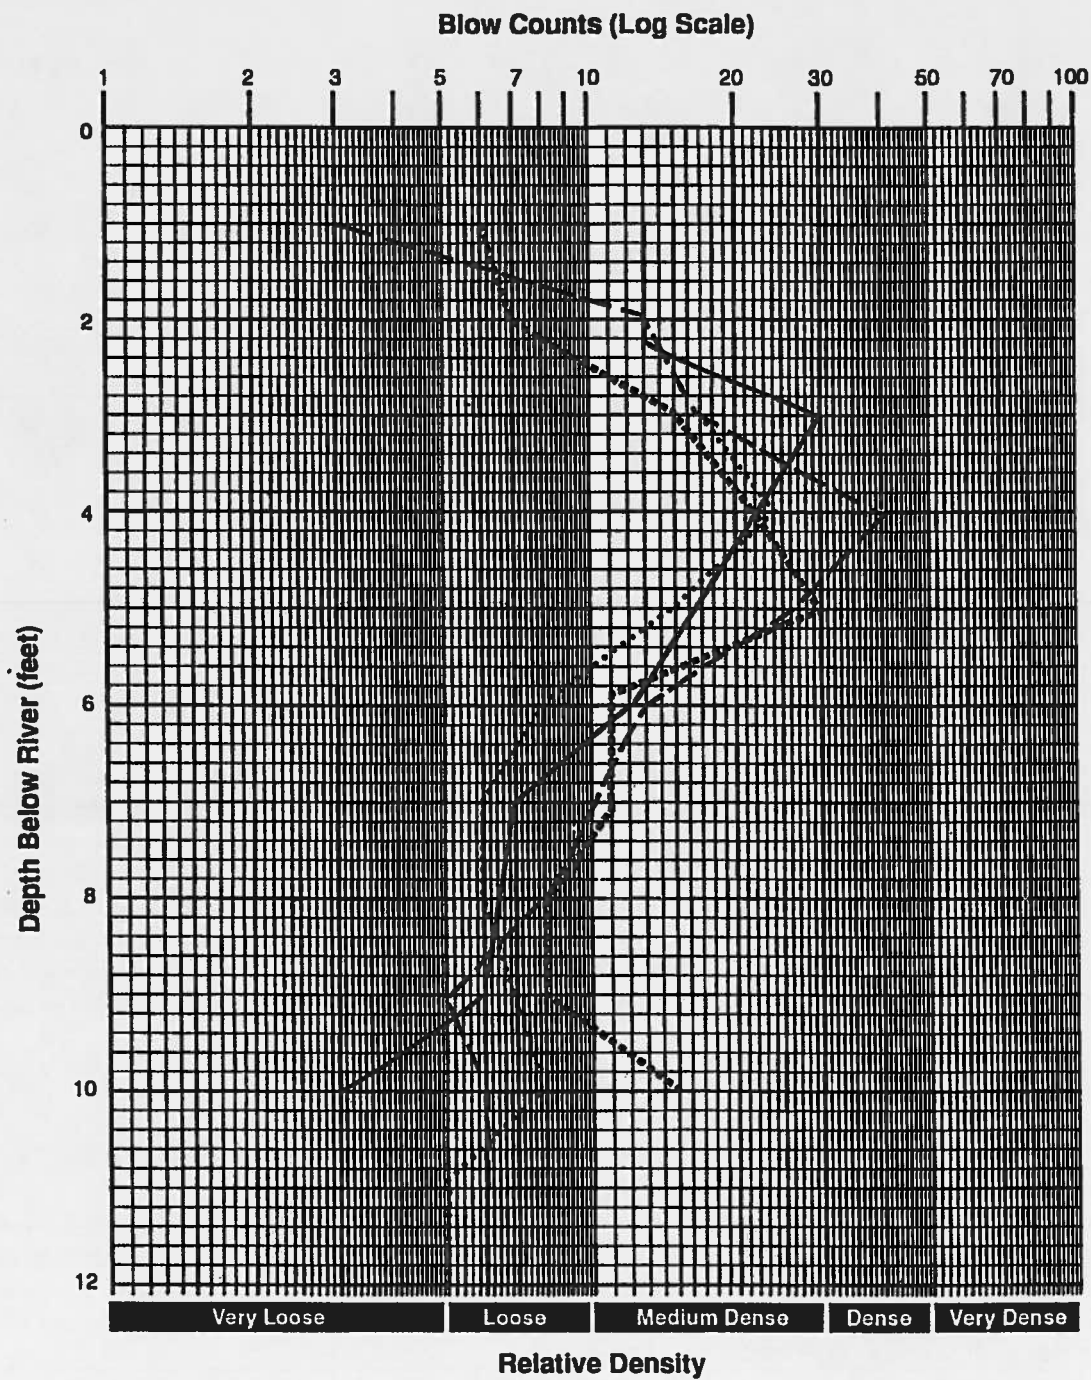
**FIGURE 9**  
**STP BLOW COUNTS**  
**IN TEST BORINGS**

All four of the test borings drilled in the excavated and backfilled trenches showed a dramatic decrease in blow count with depth. The bottom 3 to 5 feet of soil was loose, with relative density increasing towards the surface. Except for one boring (B-3) that was drilled directly through a machine foundation, the soil became looser near the surface. When the drill holes were started, gaps several inches thick were observed under the concrete floor, especially adjacent to the machine foundations. It soon became apparent that the damage due to settlement could affect the entire floor slab, as well as the machine foundations.

Blow count profiles shown in Figure 9 proved that the granular backfill was never compacted, except for perhaps its surface before the machine foundations were poured. At this point, the design/build contractor "fessed up" and took responsibility for repairing the failure. The stamping presses could not be operated out of plumb for very long, and it was clear that the subgrade was not dense enough to sustain more impact loading without inducing additional settlement. The focus then shifted on how to permanently repair the problem at a minimum cost.

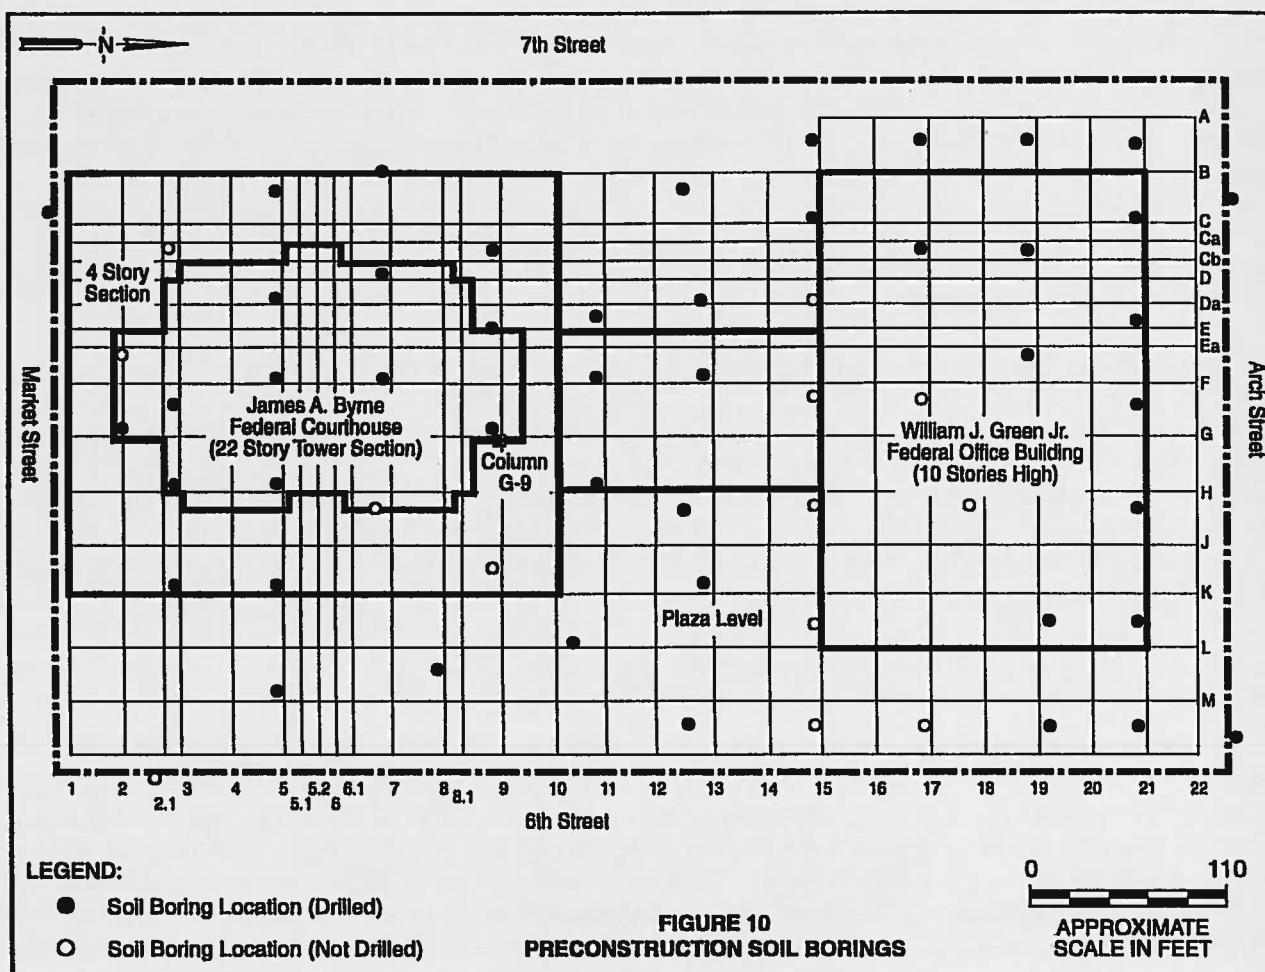
The site was originally investigated by a local geotechnical consulting firm to develop foundation design criteria for the proposed buildings. Fifty-nine borings were originally planned but 47 were actually drilled. The locations of these borings are shown in Figure 10.

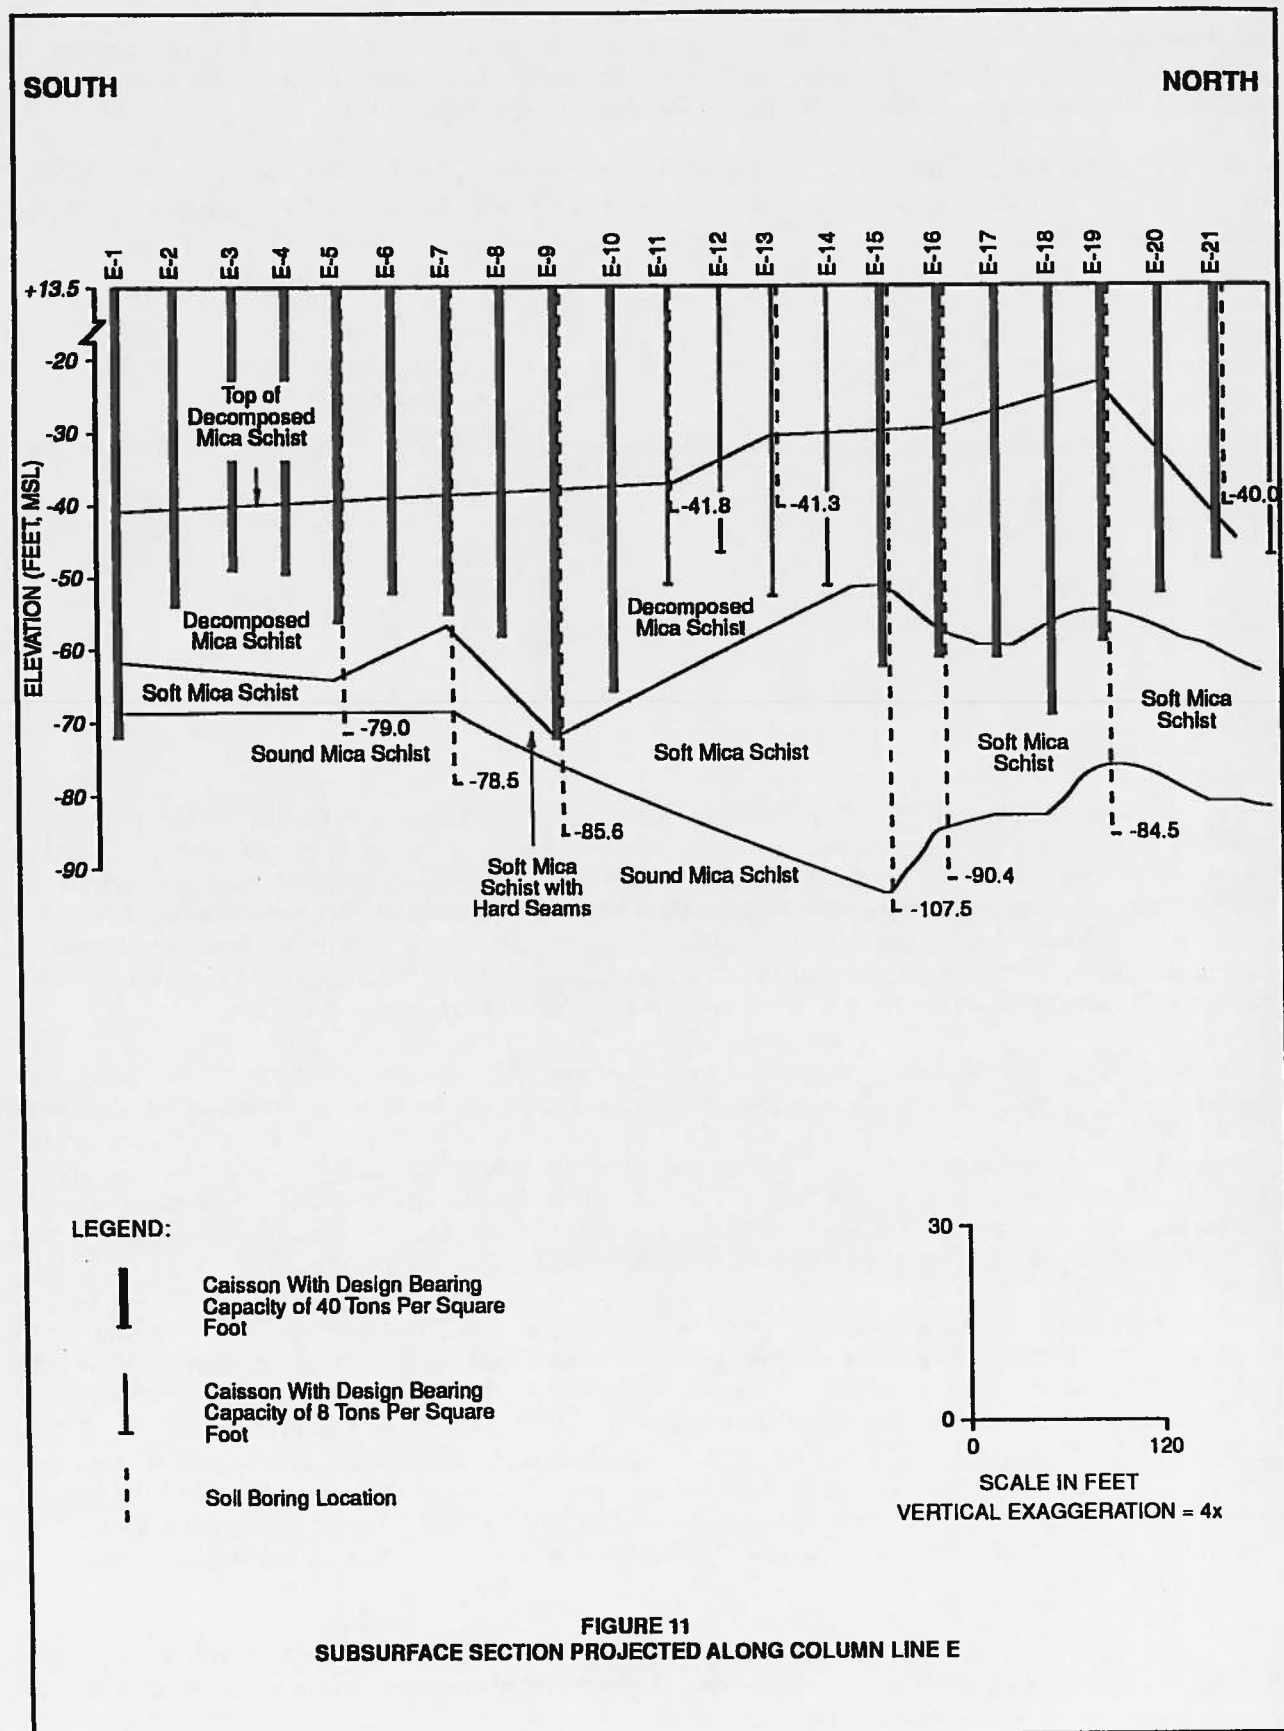
The post construction borings were drilled adjacent to 28 of the 186 caissons that were designed for a bearing capacity of 40 tons per square foot. Using results of these borings, it was estimated that of these 28 caissons, 20 were established on decomposed mica schist, seven were founded on soft to medium hard mica schist, and one was founded on sound mica schist. It was further estimated that of the 158 remaining caissons designed for a bearing capacity of 40 tons per square foot, 100 were established upon decomposed mica schist, 40 were founded on soft to medium mica schist, and 18 were founded on sound mica schist. Using these data, Dames & Moore developed subsurface sections in the building areas. One typical subsurface section is presented on Figure 11.

that most of the caissons were established 10 to 20 feet above the originally proposed elevation and that caisson G-19 was apparently installed 45 feet above the originally proposed elevation. Amendments introduced into the original job specification permitted the contractor to determine the elevation of each caisson bell at the time of construction, based on a field and laboratory testing program. Errors in conducting the laboratory testing program translated into improper placement of the caisson bells because the rock was much weaker than what the testing results had indicated.

This combination of events caused many of the heavily loaded caissons to be founded on material other than sound mica schist. Marginal bearing capacity and potential downward movement of caisson foundations should have been considered when it was decided to establish the caissons designed for a bearing capacity of 40 tons per square foot, especially when the bell elevations were moved to a level above those originally recommended by the geotechnical engineer.

Three treatment modalities were considered to underpin or support the columns, including use of H-piles, drilled-in caissons, or grout to increase the bearing capacity of the supporting strata. Jacking of Column G-9 after completion of a remedial grouting program demonstrated the ability of the weathered schist to carry the design load with negligible settlement. An illustration of the grouting pattern at Caisson G-9 is presented in Figure 12. Subsequently, a combination of resin and cement grouting was used, both to repair poor concrete in the caissons and to strengthen the weathered schist below them.

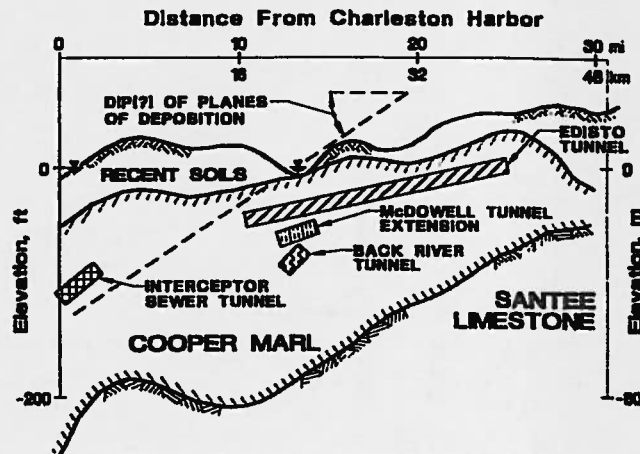
FIG. 2. Section A-A, Down-Dip in Cooper Marl

The design team then decided to set up contracts for the tunnel to be unlined, with support only at shafts, portals, and certain safety areas. The test tunnel appeared to be perfect, but 8 months after excavation its walls began to slab off, failing in a classic unconfined compression. By then contracts had been let for major sections of unsupported sewer tunnel. As the tunnel deepened going downgradient compressive stresses at the Springline increased from 18 to 20 to 22 ksf (900 to 1,000 to 1,100 kPa). Concurrently, standup time decreased from weeks to days to hours. Excavation was by road header, and as standup time decreased the installation of horseshoe ribs and lagging became more urgent, placed closer to the heading. This dramatic change in stability was ac-

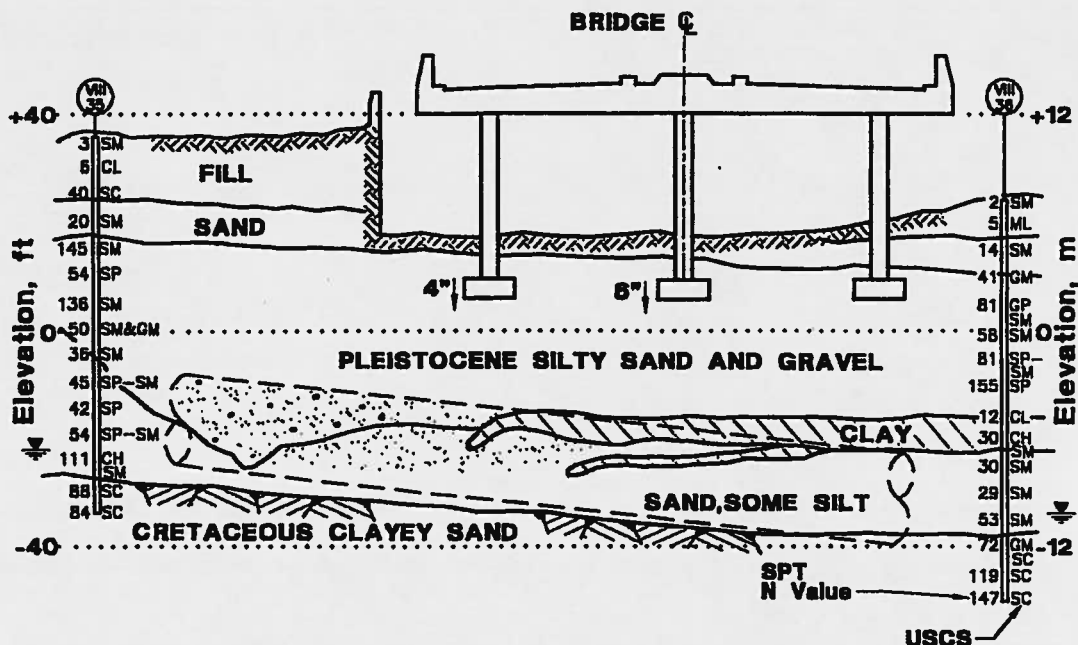
FIG. 3. Metro Tunnel beneath 10th St. Mall Bridge

Fig. 3 shows a geological profile for Section D004. Twin, 21 ft (6 m) diameter subway tunnels were to cross beneath railroad tracks and the Tenth Street Mall Bridge. That bridge is founded on spread footings in terrace sands that contain scattered clay lenses. The two nearest borings showed chiefly very compact SM sands with 14–20% fines passing the No. 200 sieve. A gradation of prebid samples is shown in Fig. 4.

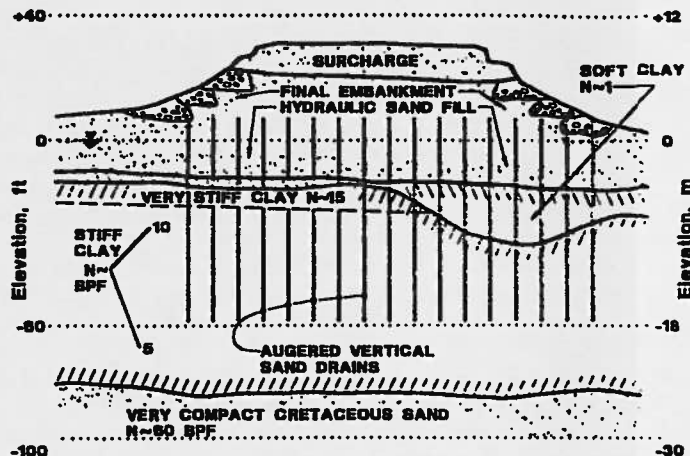
FIG. 5. Approach Fill Cross Section, Baltimore Bridge

A bridge constructed in the 1970s in Baltimore Harbor required a mile-long (1.6 km) approach embankment, filled 25–30 ft (8–9 m) above tide flats. The underlying soils consisted of 70 ft (21 m) of late Pleistocene clay overlying very compact Cretaceous sands. Fig. 5 is a cross section of the embankment and subsoils; Fig. 6 is a longitudinal section. This clay, laid down in initial postglacial drowning of the waterways, is ubiquitous in Mid-Atlantic estuaries. Later fluctuations in sea level exposed and desiccated the crust, overconsolidating the deposit. Its history and properties are similar to Boston blue clay. Its undrained shear strength is 2–3 ksf (100–150 kPa) in the dried crust and 1–1.5 ksf (50–75 kPa) below. When the clay was last exposed, channels were incised in its surface. With the most recent rise of sea level, those channels were filled with soft clay of 0.2–0.5 ksf (10–25 kPa) shear strength.

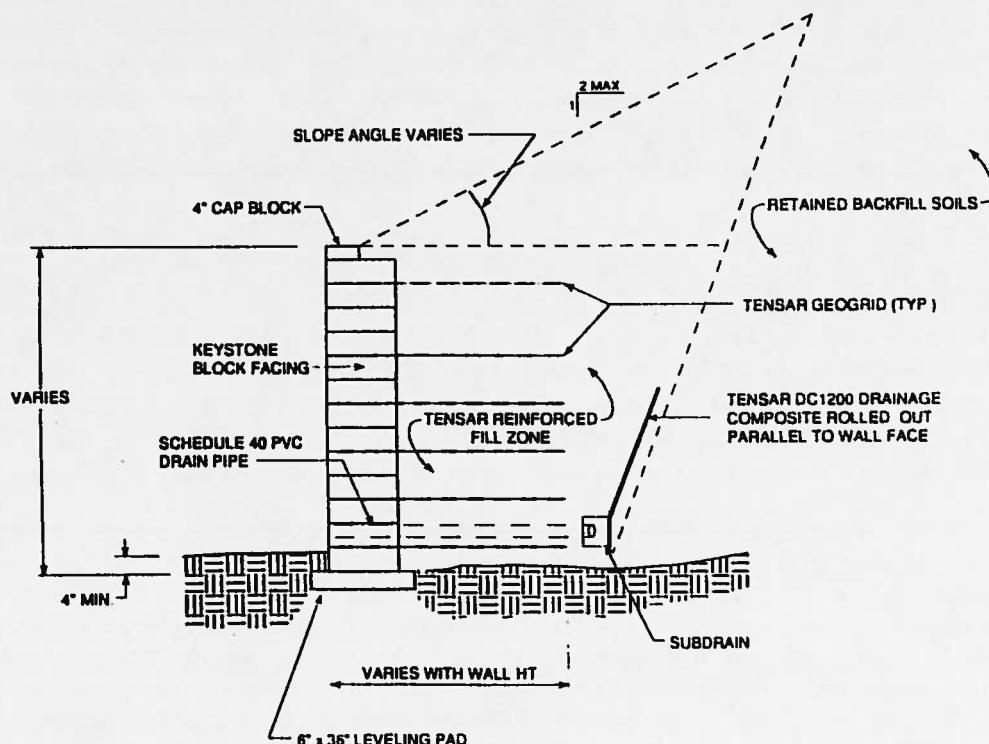
FIG. 1. Typical Section through As-Designed Retaining Structure

To provide the necessary grade separation between the rear of the stores on the northeast side of the shopping center and the property boundary with the city park, a geogrid-reinforced retaining wall with a sloping backfill was proposed. A typical cross section, reproduced from the drawings issued for construction, is shown in Fig. 1. A front elevation of the wall showing

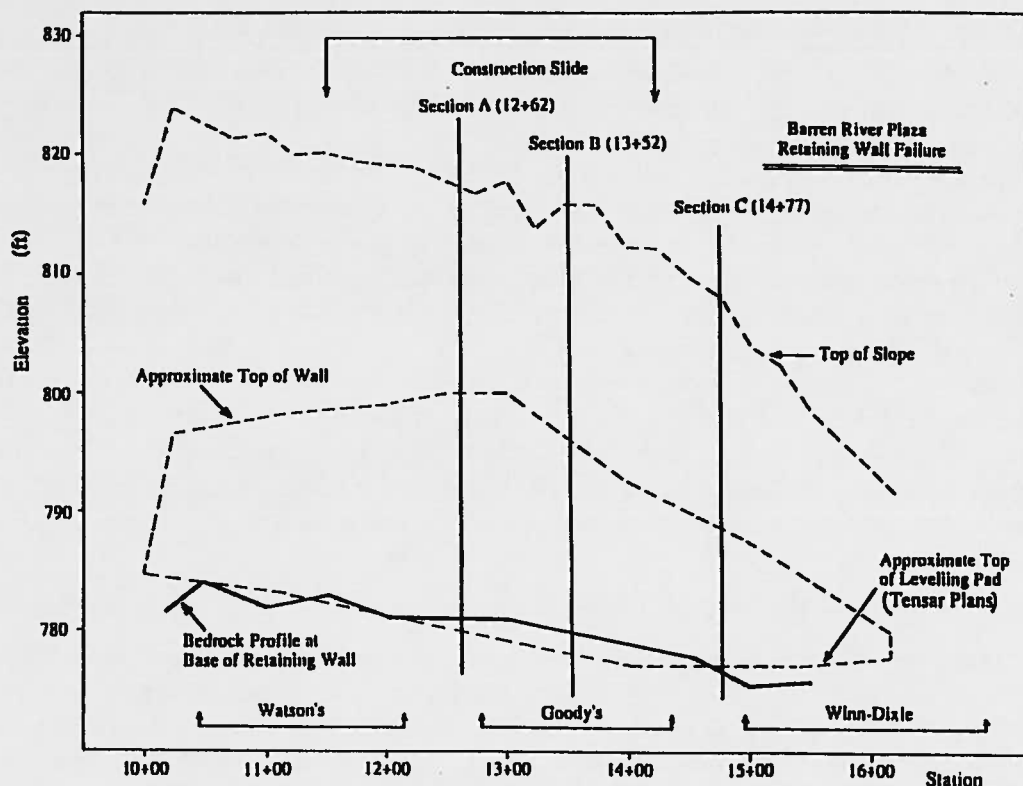
FIG. 2. Front Elevation Profiles of Retaining Structure

leveling pad, top of wall, and top of slope profiles is given in Fig. 2. Bedrock elevations at the base of the wall were obtained directly from borings. For the most part, the wall height varied between 3.0 and 6.0 m (10 and 20 ft), with the maximum height in the vicinity of Station 13 + 00 being 6.4 m (21 ft). The height of the slope above the top of the wall ranged from 8.2 m (27 ft) at the western end to 6.0 m (20 ft) in the center and tapered down to about 3.0 m (10 ft) behind the store at the eastern end. Given the constraints imposed by the location of the wall and the property boundary, this resulted in constructed slopes typically varying between about 1.7H:1.0V and 2.0H:1.0V, as determined from construction surveys. Relevant construction details are summarized next.

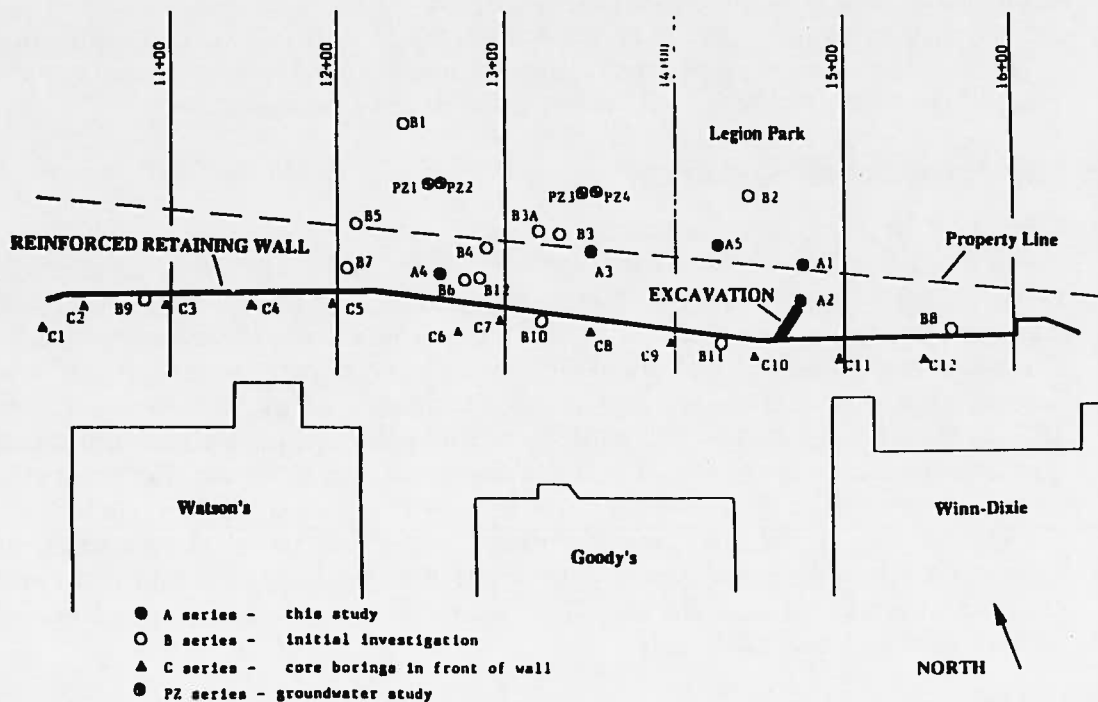
FIG. 5. Boring Location Plan

to A5, as shown in Fig. 5. Also shown in this figure are the locations of borings made by others: B series (borings advanced in January 1991 as part of a preliminary failure investigation); C series (borings advanced in July 1991 to determine bedrock elevation along the proposed alignment of a replacement wall); and PZ series (borings advanced in April 1991 as part of a piezometer-installation program). In general, continuous sampling was performed in all borings performed as part of the present study using a split-spoon sampler. The only exception was boring A3, where a 1.5 m (5 ft) long drive sampler was used. On completion of the drilling and sampling operations, a combined inclinometer-piezometer was installed in each of borings A1 to A4 and a piezometer was installed in A5. Measurements of wall and slope deformations and ground water conditions were made during the period September to December, 1991.

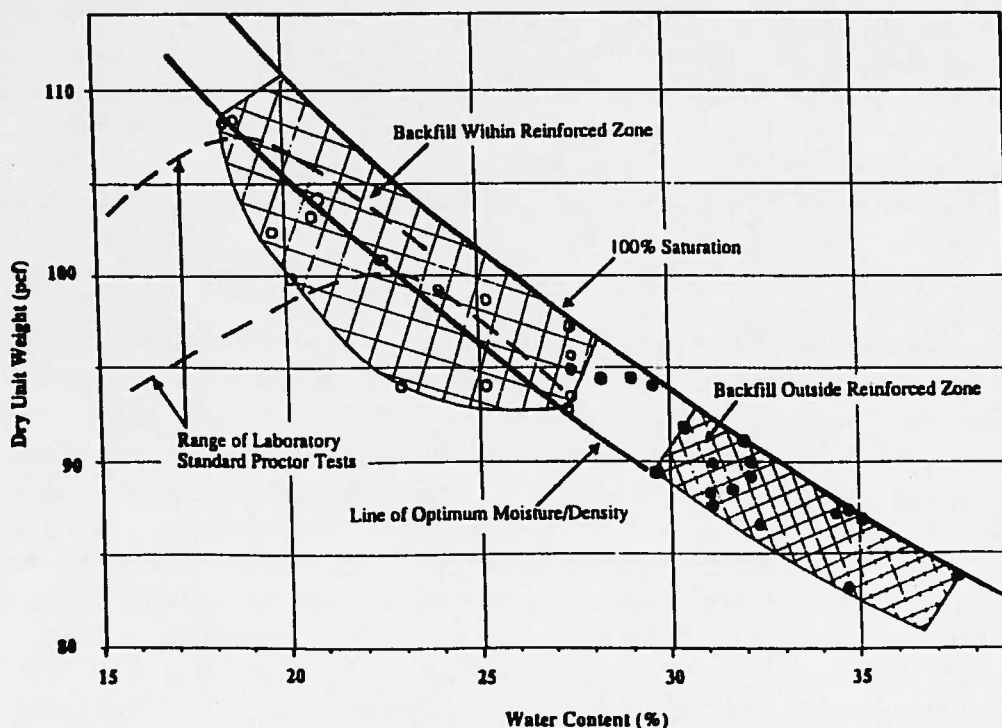
FIG. 7. Postfailure Moisture-Density Conditions

An extensive evaluation of as-compacted moisture-density conditions versus postfailure moisture-density conditions was conducted. The results of this study are presented in Figs. 7 and 8. The dashed curves in Fig. 7 show the bounds of laboratory standard Proctor tests based on 11 samples obtained at various locations behind the wall. The range in optimum densities of about 1,600–1,730 kg/m<sup>3</sup> (100–108 pcf) and optimum moisture contents of about 18–23% are representative of the variable soil conditions encountered. Also shown are the lines of optimum moisture/density and of 100% saturation. Postfailure moisture/density conditions are shown plotted as open circles and solid dots and are seen to fall within two distinct zones (which are x-hatched in Fig. 7). Tests performed on samples taken from within the geogrid reinforced zone (open circles) showed moisture contents ranging from 18% to 27% and dry densities between 1,490 and 1,650 kg m<sup>3</sup> (93 and

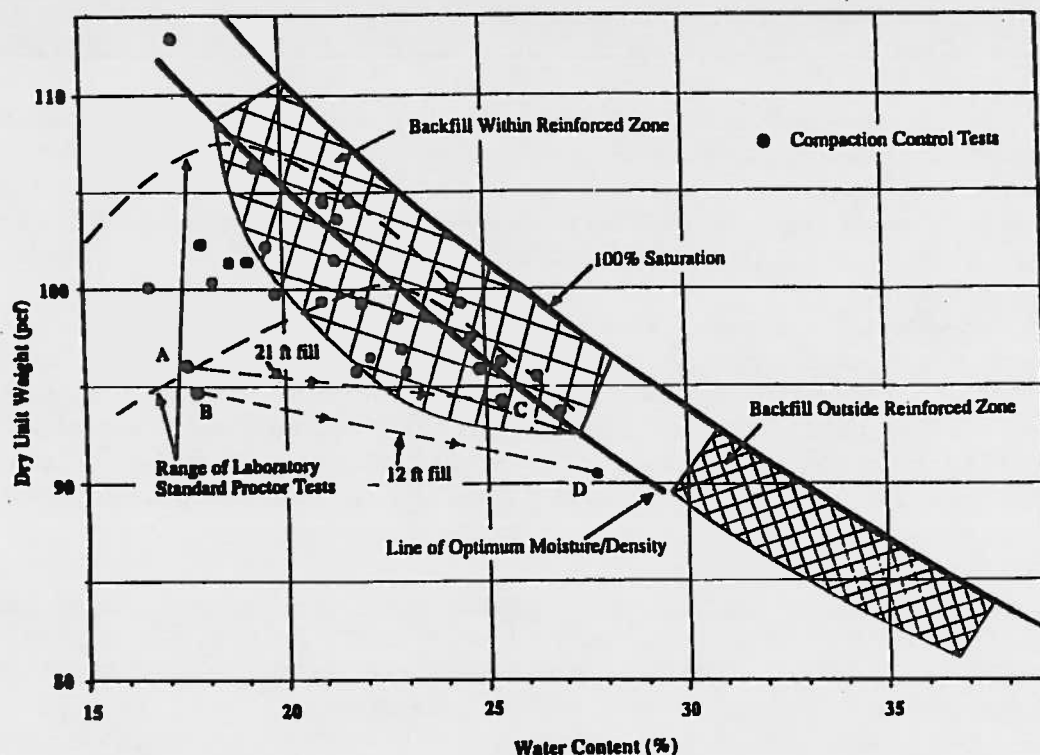
FIG. 8. Compaction Control Moisture-Density Conditions

The lines of optimum moisture/density and 100% saturation, and the x-hatched zones in Fig. 7 are reproduced in Fig. 8 along with data points representing the compaction control tests. It can be seen that many of the data points indicate compaction being performed dry of optimum. In addition to the field compaction control data, two additional points (A and B) are shown in Fig. 8. These points correspond to soil samples having the highest plasticity compacted at standard Proctor energy and about 7–8% dry of optimum. When samples A and B were subjected to mean confining stresses corresponding to 6.4 and 3.6 m (21 and 12 ft) of fill, respectively, and were then allowed to imbibe water and swell, the moisture-density conditions changed to points C and D, respectively. The initial conditions A and B correspond to the most plastic samples at the driest recorded as-compacted conditions and hence those likely to undergo the most swell on exposure to moisture. It is clear from Fig. 8 that even under these extreme circumstances the moisture-density conditions of the soil did not reach the x-hatched zone, which represents postfailure values for backfill outside the reinforced zone. Based on this evidence, it is concluded that the only explanation for the measured postfailure moisture-density conditions in the backfill behind the reinforcement is that the soil was not initially compacted to the specified 95% of standard Proctor by a large margin. Using mean values of standard Proctor optimum density of 1,670  $\text{kg/m}^3$  (104 pcf) and postfailure in-situ density of 1,430  $\text{kg/m}^3$  (89 pcf), it is concluded that, on average, soil outside the reinforced zone had a density of about 86% of standard Proctor optimum.

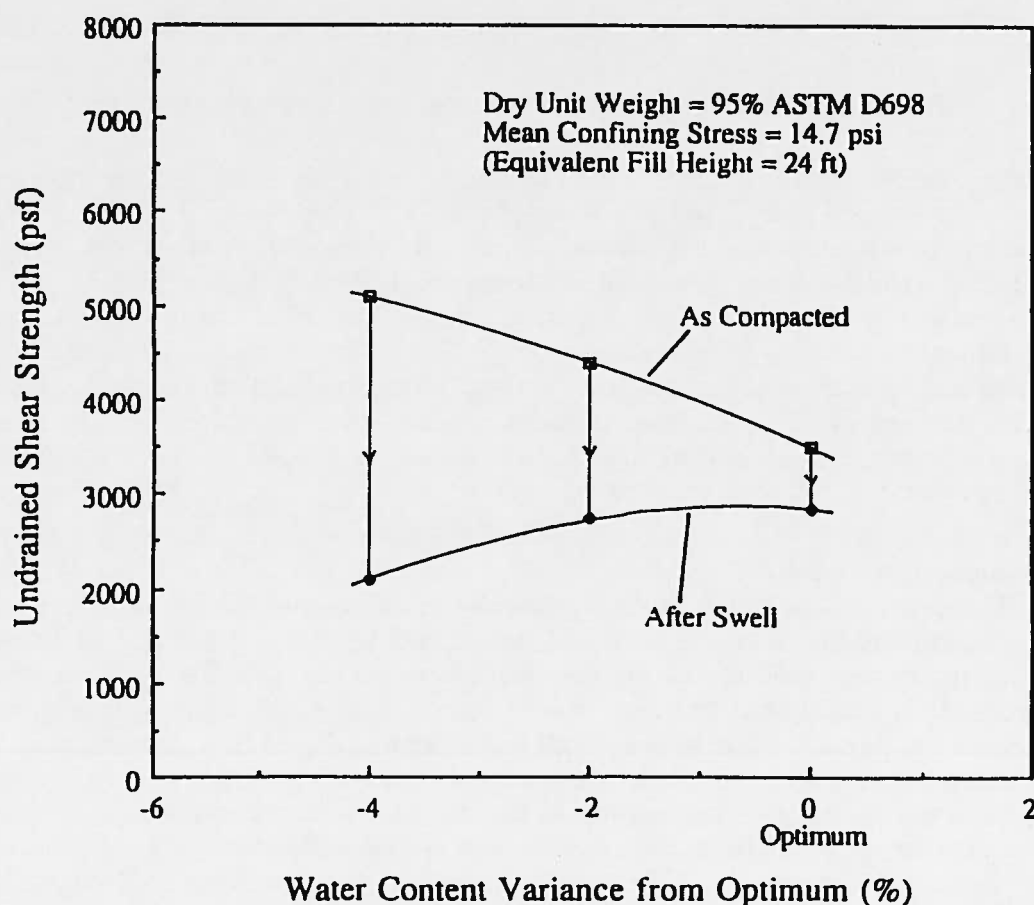
FIG. 9. Effect of Compaction Water Content on Shear Strength after Swell

The effect of compaction water content on the undrained shear strength after swell at a confining pressure equivalent to a fill height of 7.3 m (24 ft) is shown in Fig. 9. It can be seen that a larger loss in strength occurs as the sample's initial moisture content becomes increasingly drier of optimum. The ratio of as compacted to swelled strength varies from approximately 1.2:1 for specimens with an initial moisture content close to optimum to about 2.5:1 for specimens initially 4% dry of optimum. Moreover, the post-swell strength for a specimen compacted to 95% of standard Proctor maximum and a confinement corresponding to 7.3 m (24 ft) of fill was about 1.41 kg/m<sup>2</sup> (2,900 psf) if compacted at optimum water content and 0.98 kg/m<sup>2</sup> (2,000 psf) if compacted 4% dry of optimum.

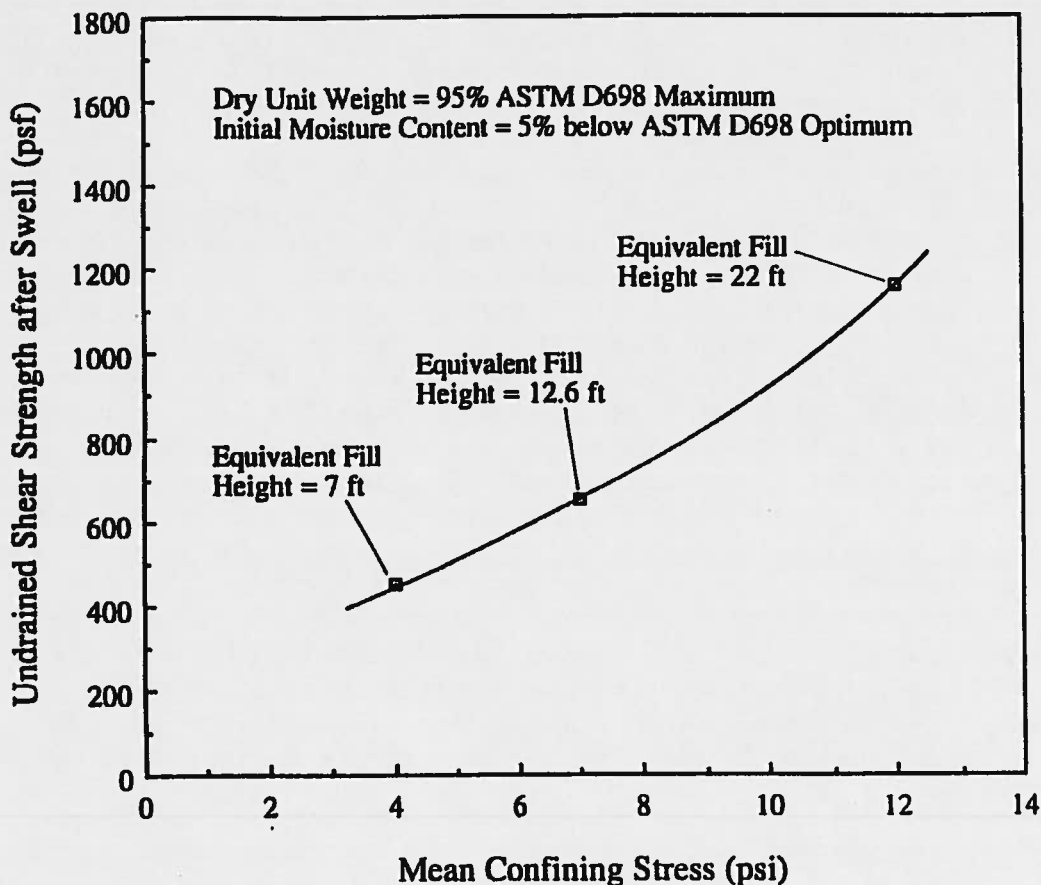
FIG. 10. Effect of Confining Stress on Shear Strength after Swell

The effect of confining pressure on shear strength after swell is shown in Fig. 10. It can be seen that, at 5% dry of optimum, a reduction in confinement corresponding to a decrease in backfill height from 6.7 to 2.1 m (22 to 7 ft) reduces the undrained shear strength after swell from about 0.58 to 0.22 kg/m<sup>2</sup> (1,180 to 450 psf) for specimens compacted at 95% standard Proctor maximum density. A correspondingly lower curve would be obtained for specimens at an initial compaction ratio of about 89% as indicated by the data in Fig. 11, which shows the results of several tests performed under similar moisture-content and initial-confining-stress conditions but at

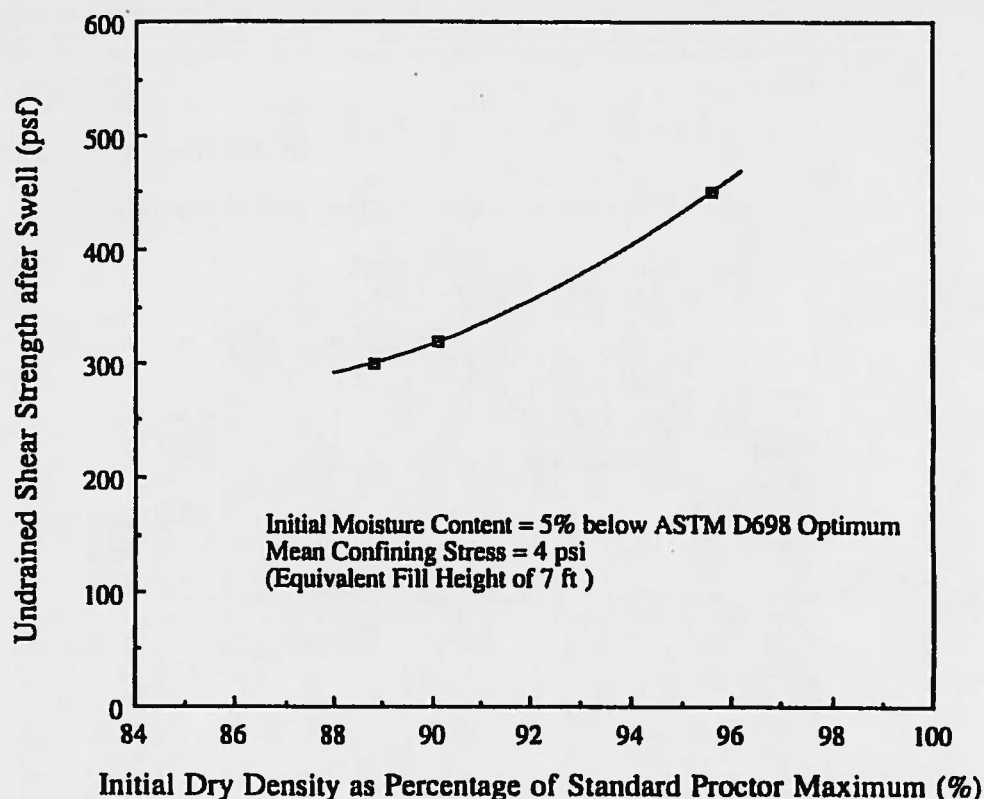
FIG. 11. Effect of Initial Dry Density on Shear Strength after Swell

different initial dry densities. As expected, the initially looser samples had lower postswell strengths. For example, at a fill height of 7.3 m (24 ft), a sample compacted at optimum moisture content and 95% standard Proctor density would have a postswell shear strength of  $1.41 \text{ kg/m}^2$  (2,900 psf) as shown in Fig. 9; on the other hand, at a fill height of 2.1 m (7 ft), a sample compacted 5% dry of optimum and 89% standard Proctor density would have a postswell shear strength of only  $0.15 \text{ kg/m}^2$  (300 psf) as indicated in Figs. 10 and 11. The decisive influence of compaction water content, confining pressure, and initial dry density on the strength of compacted clay after imbibing water is evident in Figs. 9–11.

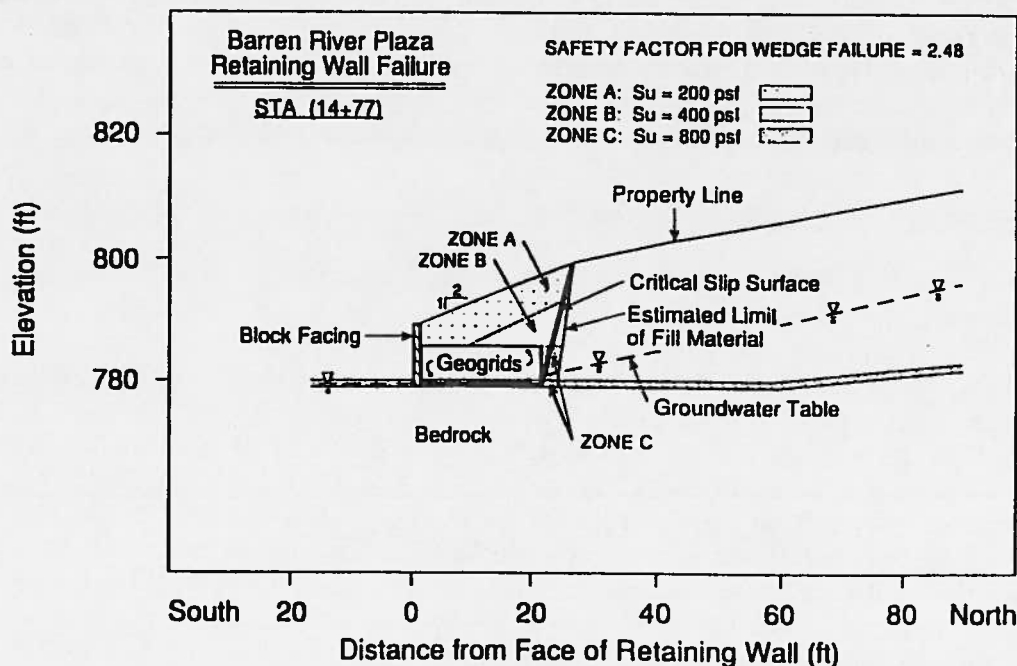
**FIG. 13. Stability Analysis of Retaining Structure at Station 14 + 77**

A series of stability analyses was performed by the writers for the three cross sections discussed earlier (Fig. 6) in a manner illustrated in Fig. 13, and the results are summarized in Table 3. Analyses were performed to examine both shallow backfill slopes and deep-seated wedges at each of the sections.

14 + 77 is directly responsible for toppling of the facing wall, despite the lower slope height. The topography in the city park aggravated the conditions at the latter section also because much of the rainfall runoff was directed toward this area.

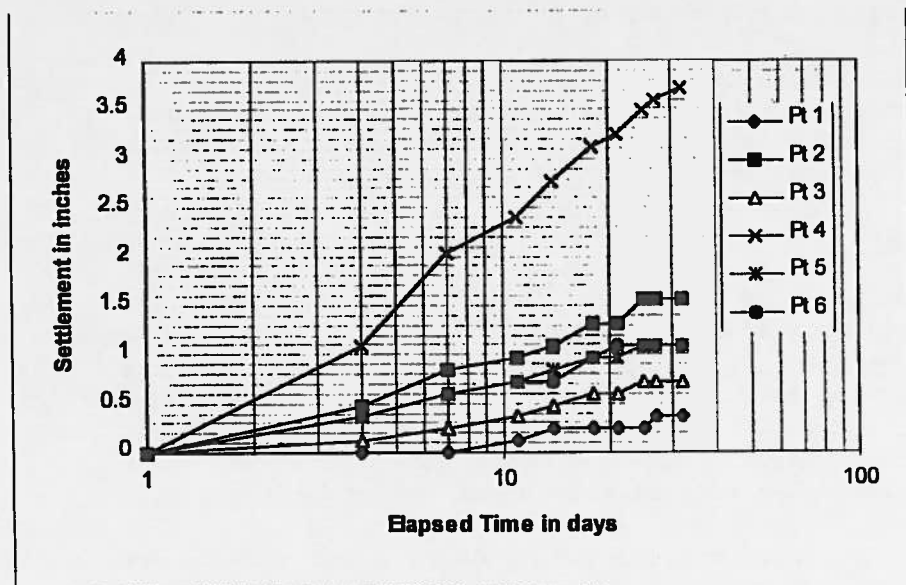
Site Surcharging The surcharging program was performed as outlined in the geotechnical report between the period of April 29 and May 31, 1994. During this period of time, elevation surveys were conducted to gauge the rate of movement (see Figure 2, below).

The surcharge was removed after a period of 32 days, when the geotechnical engineer of record judged that the majority of primary consolidation was complete. As may be noted, settlements of nearly 4 inches were measured as a result of the application of only about 1000 psf of area load. This was clearly not compatible with the predicted settlement of only 1 inch under a mat foundation load of over 3 ksf.

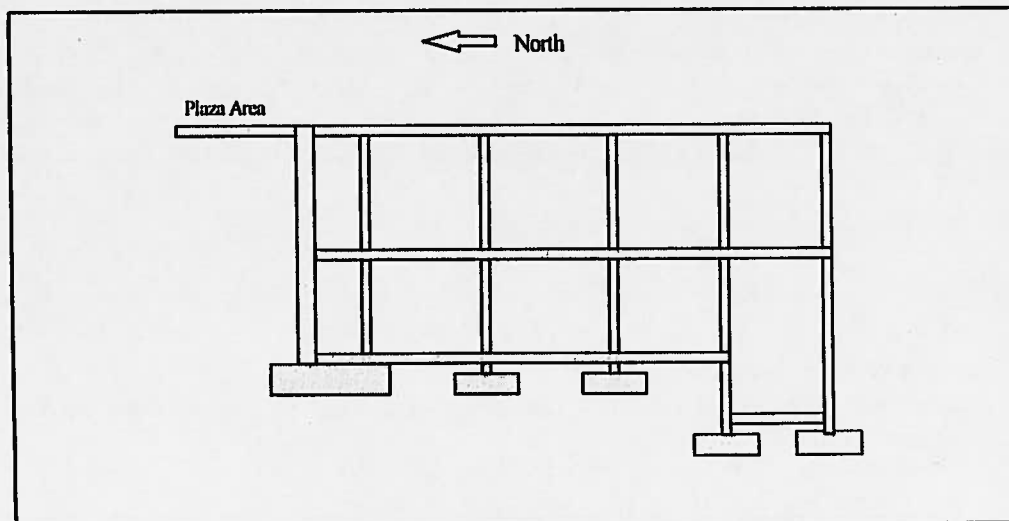
Figure 2: Cross-section through Building C

The differential settlement noted in Building C was attributed to the significantly different loading conditions on the north and south sides. On the south side, the site had been excavated 10 to 12 feet below original grade. Consequently, the net loading on the footings was far less than the 4 ksf design. The large strap footing on the north side of the building was influenced not only by the structure above, but by the area load induced by the mass of fill placed exterior to the building (see Figure 2 below). When these factors were considered, the magnitude of differential settlement which was actually measured was found to be predictable from soil and structure characteristics.
