# FORENSIC STUDIES IN GEOTECHNICAL ENGINEERING

PROCEEDINGS  
*of the*  
TWENTY-SEVENTH  
OHIO RIVER VALLEY SOILS SEMINAR  
(ORVSS XXVII)

October 11, 1996  
Sharonville Convention Center  
Cincinnati, Ohio

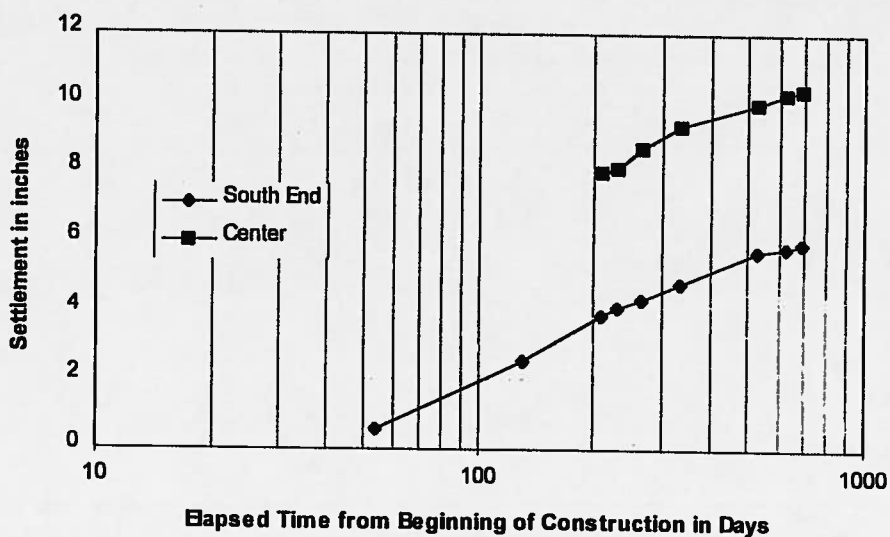
Figure 3: Settlement Trends - Building B

Building B has shown continued movement consistent with secondary compression since initiation of the monitoring program. Figure 3, presented below, indicates the trends of settlement of this building since the mat foundation was poured in June of 1994. For reference, the structural frame was completed on about day 180 on the graph. Exterior brickwork was completed by day 360.

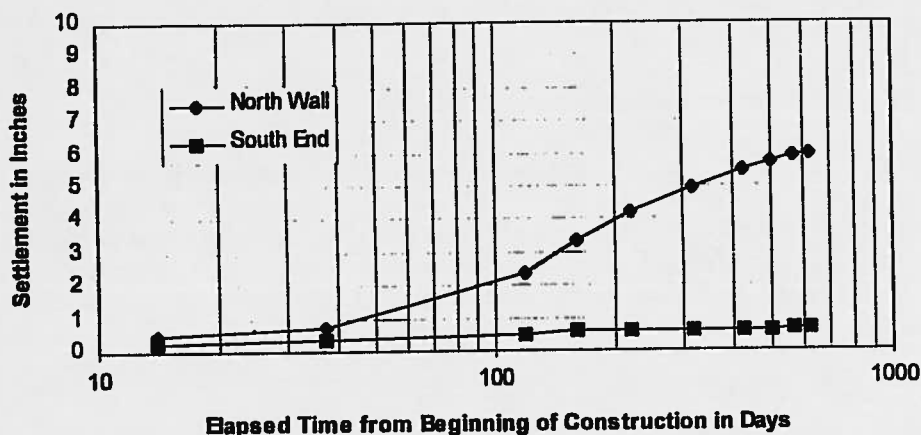
Figure 4: Settlement Trends - Building C

Building C has also shown continued movement during the monitoring period as indicated on Figure 4, below. Again, the rate of movement appears to be consistent with the coefficient of secondary compression determined during from consolidation tests.

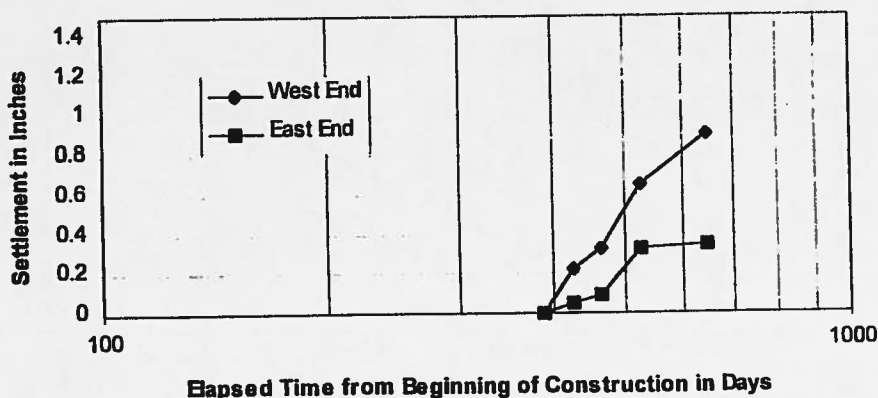
Figure 5: Settlement of North Wing - Building D

As Building D was supported on piles, little movement was anticipated. However, surveys of the 5-story north wing of the building revealed that the western side was settling at a significant rate when compared with the eastern side (see Figure 5). After researching design and construction documents, it was discovered that up to about 15 feet of new fill had been placed within the western end of the wing immediately prior to pile installation. The piles extended to a total depth of 50 feet below final grade, which left up to about 30 feet of compressible soil beneath the pile tips. Calculations indicated that the magnitude and rate of settlement were predictable as a result of area fill loads and the loads induced to the soil from the pile groups.

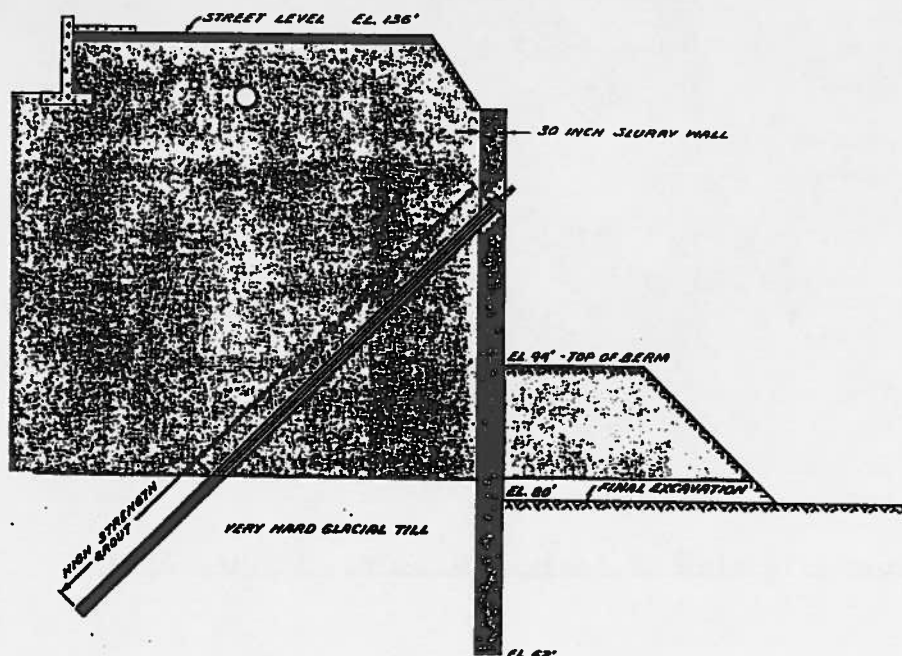
Figure 1 Tieback System before Addition of Support From Permanent Floor Members and Removal of Berm

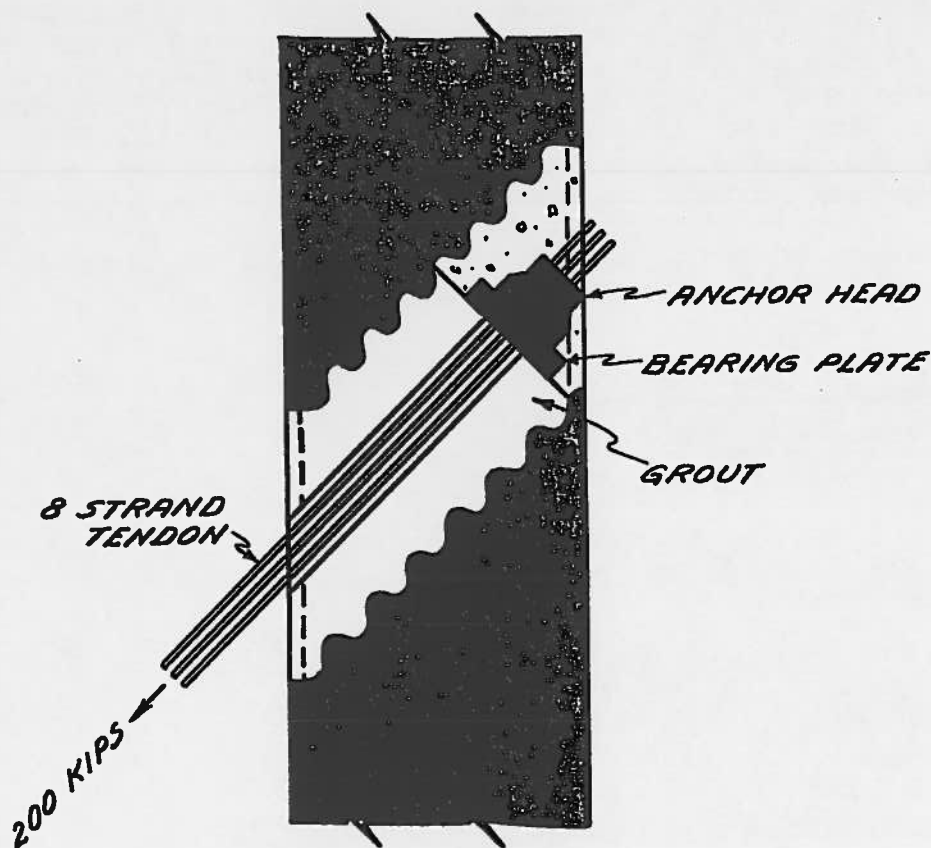
Figure 2 Detail of Anchorage Through Slurry Wall

Details of how the anchorage was held in the wall are shown in Fig.2. Each anchor was designed to hold 100 tons and was prestressed to 125 tons and locked into the wall by a three segment wedge grip. After installation the soil was to be excavated to the final depth leaving a berm as shown in Fig. 1.

Why did the wall fail? Evidence was clear that the grouted anchorage in the glacial till did not fail nor was there any evidence that the tendons failed although they should have been stressed to approximately the failure load. Clean shiny teeth marks on the otherwise partly rusted tendons and shiny marks on the teeth of the three piece wedge grips indicated that the tendons slipped through the grips. The load in excess of that tied in by preloading could not be taken by the wedge grips because they could not slide in the cone shaped grip holders since they were rusted in the holder. Thus the grips could not slip in the holder and dig deeper into the cable tendons to take the increased load.

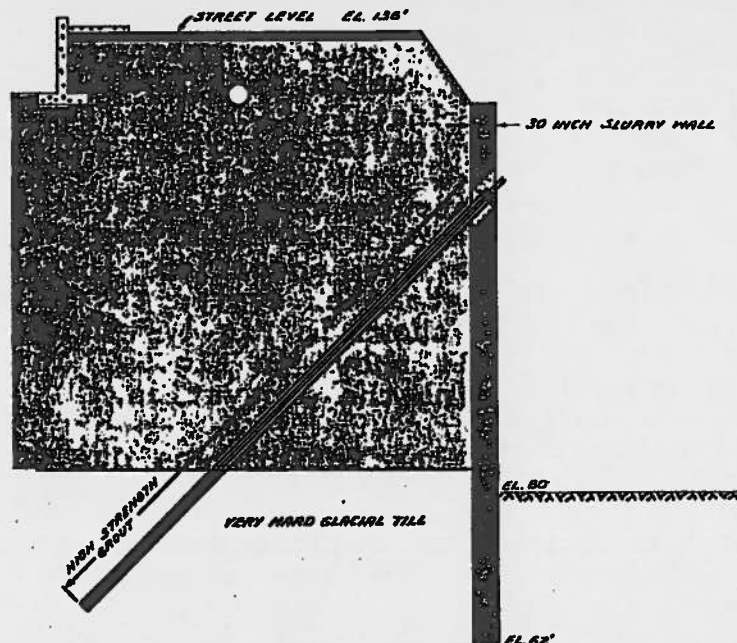
After installing two struts extending from the building frame as shown in Fig.3, The berm was then to be removed. The contractor did not follow the specified installation and excavation procedure and instead excavated to the final depth without leaving the berm as shown in Fig.4. Shortly after the wall fell in with the result shown in Fig.5. This broke the sewer and water main, flooding the excavation.

**Figure 4 Actual Construction Procedure - Soil Removed to Final Depth Before Lateral Support From Floor Beams Are Placed**

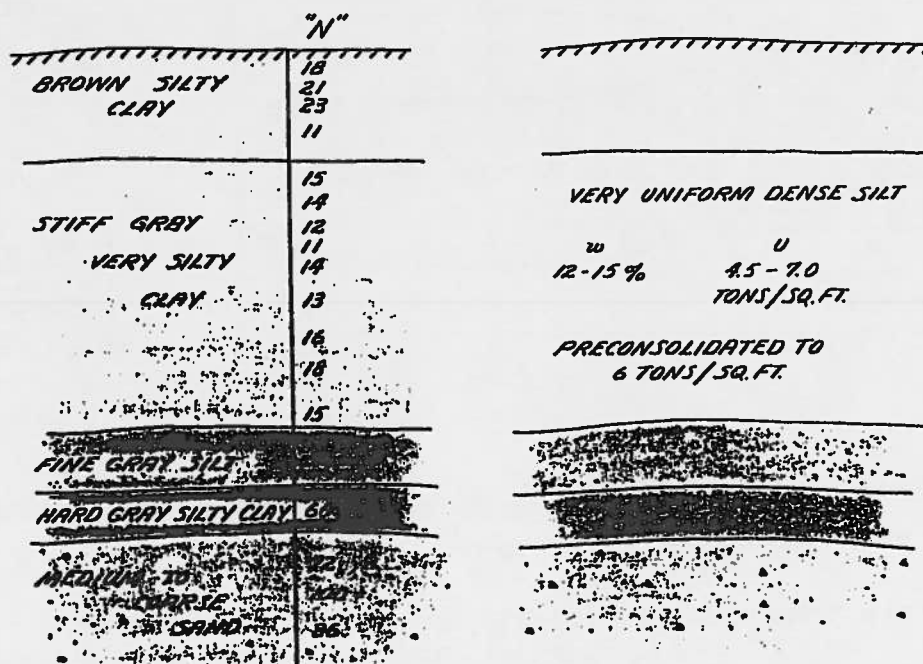
samples were not inspected by any one in the architect's or design engineer's offices. On the left side of Fig. 8 is a composite of the borings with the classifications as given by the driller. A sufficient number of borings were made to indicate that the conditions over the site were quite uniform. It was decided that the structure should rest on piles. A contract was let for mandrel-driven shell piles to be driven an estimated 15 m (45 ft.) into the hard glacial till. The piles could only be driven 4 to 5 meters (14-16 ft.) into the "stiff gray very silty clay" before they met refusal! After two weeks of frustration at not being able to drive the piles to the required depths, the writer was asked to make a geotechnical investigation. Additional borings were made in which undisturbed samples were taken. Water content, unconfined compression and consolidation tests were made. A composite profile of the information obtained is shown on the right side of Fig. 8.

Figure 8 (a) Complete Boring Log on Which Design Was Based,  
(b) Profile Determined One Year Later From Undisturbed Samples

It became apparent that the "stiff gray very silty clay" with SPT's of 11-18 was in fact a very uniform dense silt with water contents of 12-15%, unconfined compressive strengths of 440-660 kN/sq m (4.7-7.0 tons/sq ft.). and preconsolidation stresses of about 560 kN/sq m (6 tons/sq ft.) It had been known that the soil had been consolidated by the weight of at least 1,000 m (3,000 ft) of ice during the glacial age. It was obvious that the structure need not rest on piles but could be placed on spread footings resting on the silt using high bearing loads. Though the recommendations of the writer were accepted

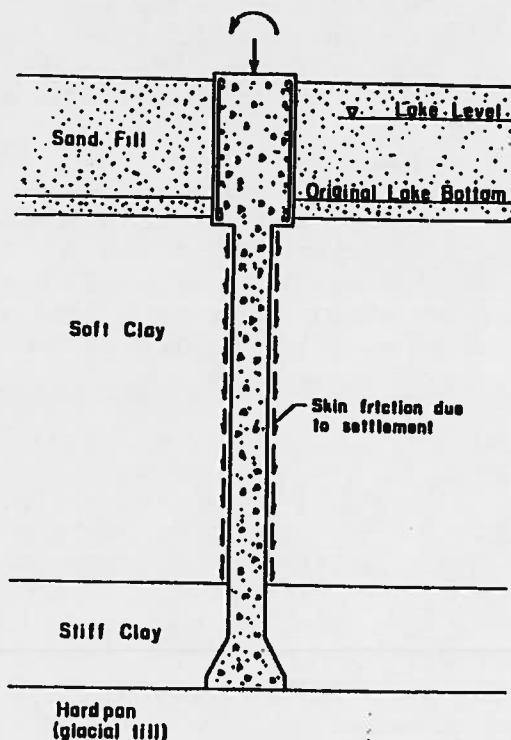
Figure 13 Bored Pile 30M Long

Fig. 13 shows a large diameter bored pile, one of many to support the columns for a large steel mill on the shore of Lake

Michigan. The shafts were over 30 m ( 100 ft.) long and were designed with reinforcement to take large vertical and overturning moments. Shortly before installation of the bored piles, the lake was filled with 8 m (26 ft.) of sand fill to bring the floor level of the steel mill to above lake level. Shortly after completion of the piles and before any column loads were placed, settlements of up to 12 cm (5 in.) were observed. A geotechnical analysis showed that the designer had failed to take into account the large drag down forces due to the consolidation of the soft clay caused by the weight of the sand fill. The estimated drag down amounted to 600 tons which resulted in end bearing unit values far in excess of the design and allowable for the hard glacial till. After considering the alternatives for rectifying the problem, the owner decided to live with the continuing settlement and to jack up the columns and place shim plates as needed.

Was this a geotechnical design failure? Yes, since the designer failed to take into account the large drag down force. It is interesting to note that there was not an end bearing capacity failure even though the unit load indicate there should have been ultimate failure. This however was due to the fact that as the shaft moves down, the skin friction tends to reduce, and not until additional settlement causes a tendency

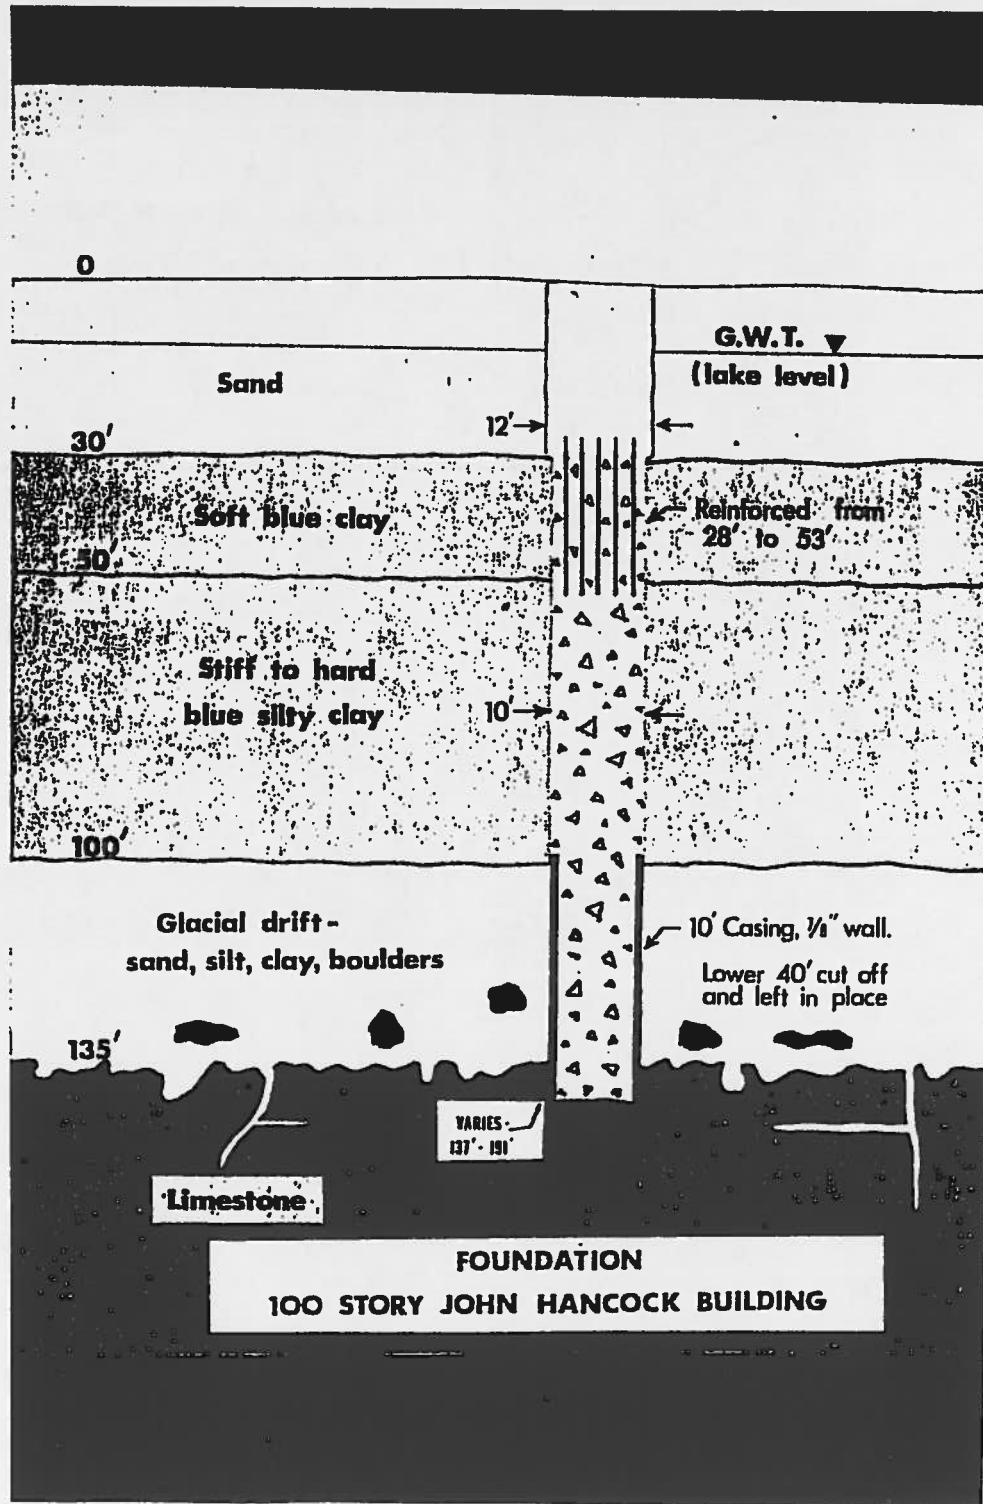
a) The case involves the failure of a bored pile (drilled shaft) for a 100 storey building. The building columns are supported on 3 m (10 ft.) diameter shafts cored into the underlying limestone with the shafts bearing at 42-58 m (137-191 ft.) from the street level. The soil profile and finished shaft dimensions are shown in Fig. 14. When the shafts and concrete caps were completed and the structural steel was finished to the third storey, it was noticed that one of the column had settled 10 cm (4 in.). In order to investigate the cause, the steel frame was removed and the concrete in the drilled shaft was cored. At about 8 m (26 ft.) below the cap the drill bit dropped suddenly. Mud and clay was recovered and it was not until 4.3 m (14 ft.) deeper that concrete was reached (Fig. 13). What caused this cavity or void in the shaft?

To understand the cause it is necessary to understand the method of construction. Referring to Fig. 14, the upper sand was drilled using drilling mud to stabilize the sand. Then an oversized casing 3.6 m (12 ft.) was lowered into the mudded hole

Figure 14 Soil Profile and Completed Bored Pile As Designed

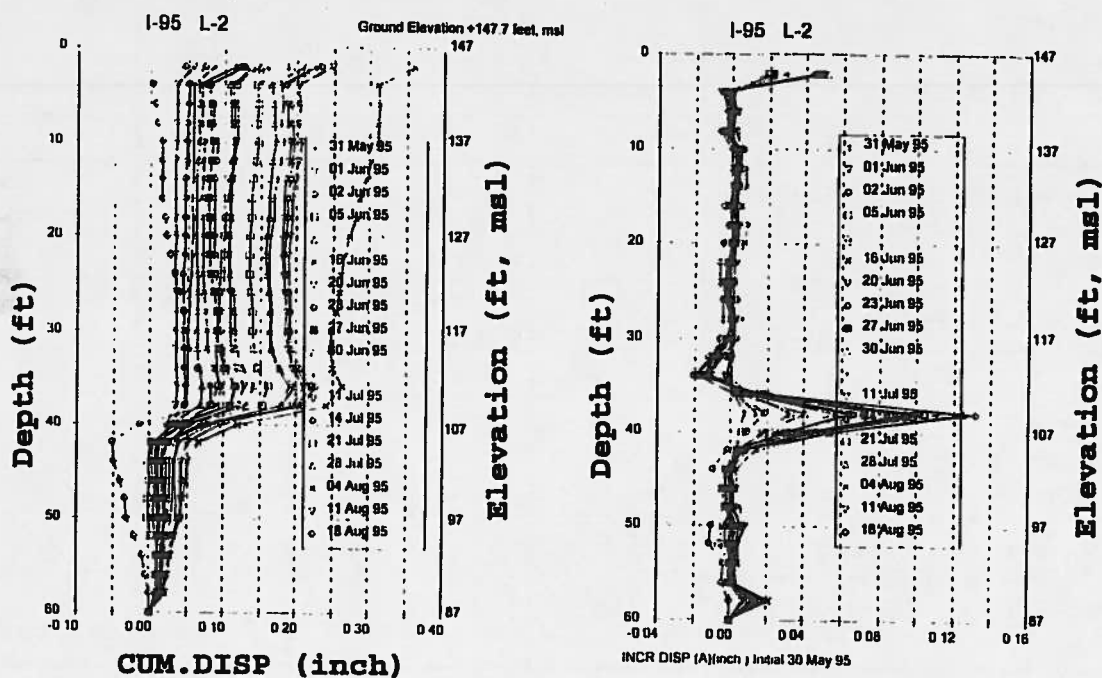
Eleven inclinometer casings were installed at various locations on and around the project to monitor slope movement. The casing depths varied from about 30 feet to 150 feet. Inclinometer readings were taken during design and construction, and bi-monthly thereafter. Depth versus displacement plots were generated for each inclinometer. A typical set of inclinometer readings is shown in Figure 2.

Figure 2. Typical Plots of Inclinometer Readings

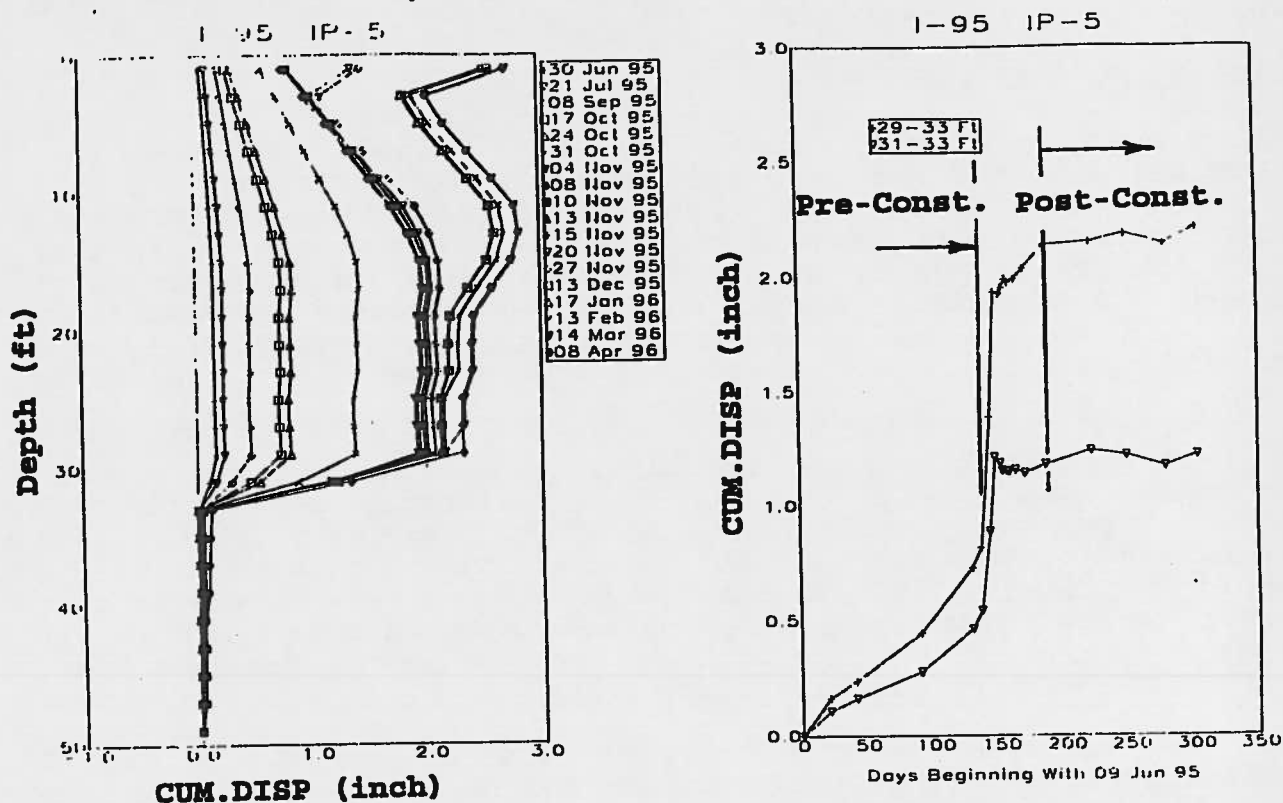
Further monitoring of the slope inclinometers indicate that ongoing movements and settlements in the embankment have been stabilized and the system is functioning as designed. (See Figure 4).

Figure 4. Inclinerometer Displacement vs. Time
