The Kentucky Geotechnical Engineering Group Presents
The 55th Annual Ohio River Valley Soils Seminar

**55th ANNUAL OHIO RIVER VALLEY SOILS SEMINAR
NOVEMBER 12, 2025**

Levee Case Histories: Failures and Incidents Prior to Overtopping

Levee Case Histories: Failures and Incidents prior to Overtopping

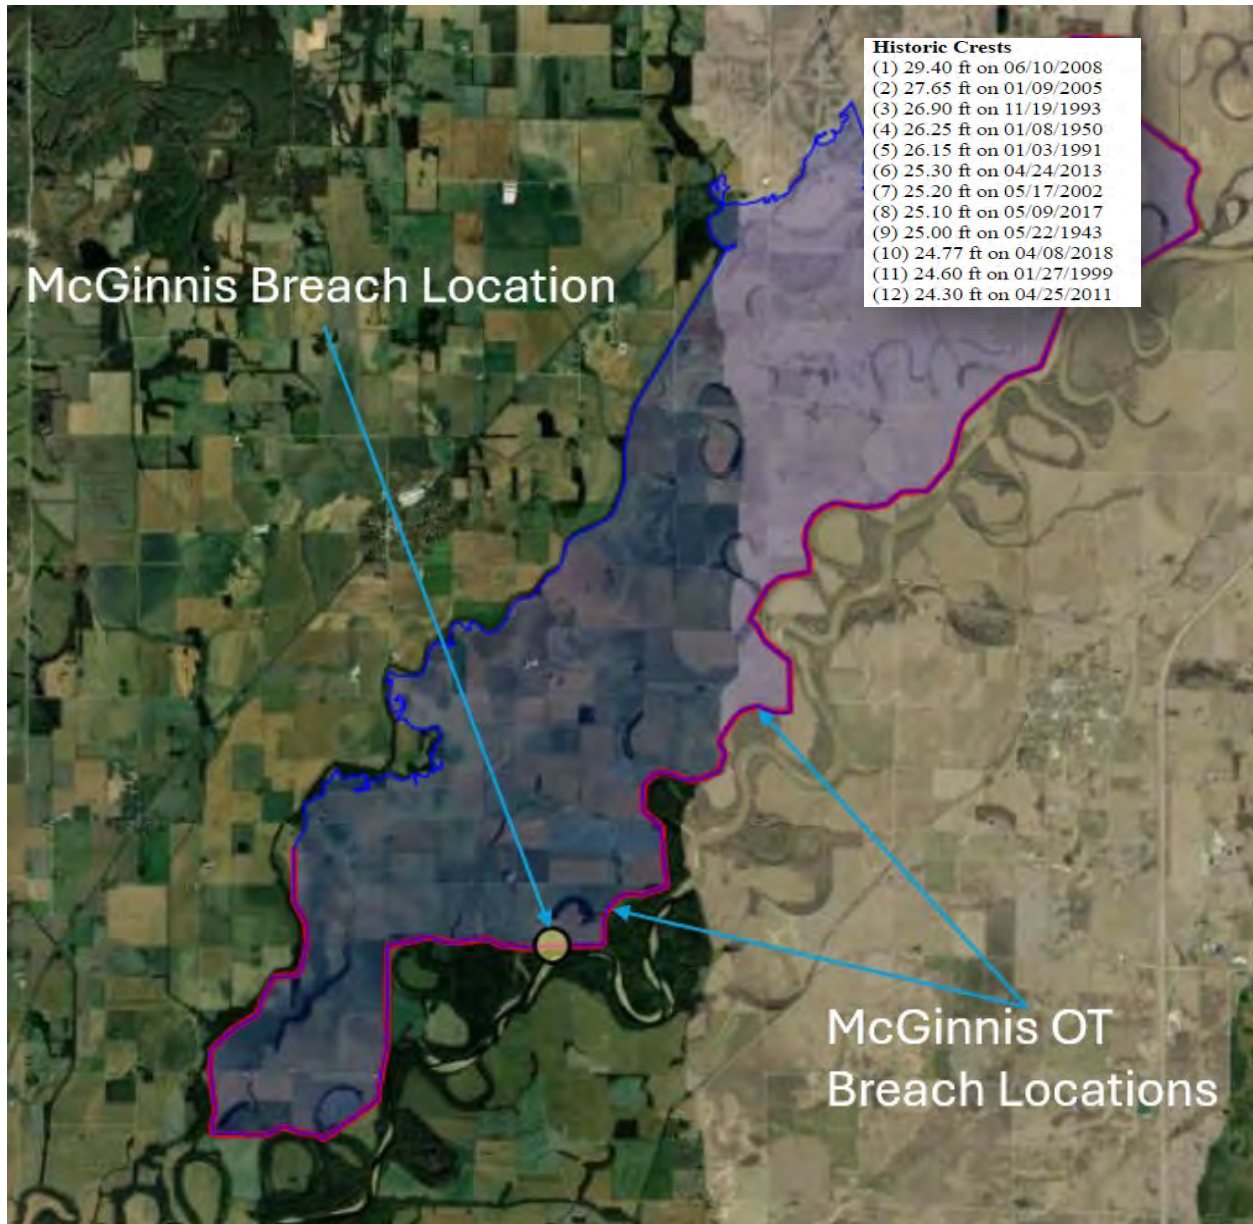
The McGinnis Levee is located on the White River near Edwardsport, IN and experienced three breaches during the 2008 flood. Two overtopping breaches occurred at low spots in the embankment. A third breach toward the downstream end of the project (Figure 4) failed directly over a concrete culvert. Following the flood event, USACE representatives met with the local sponsor at the site to observe the damage. Photos of the breach are seen in Figure 5, Figure 6, Figure 7, and Figure 11.

Figure 4. McGinnis Levee 2008 Breach Locations (USDA 6/2008 Aerial Imagery) and Edwardsport Gauge Historic Crests

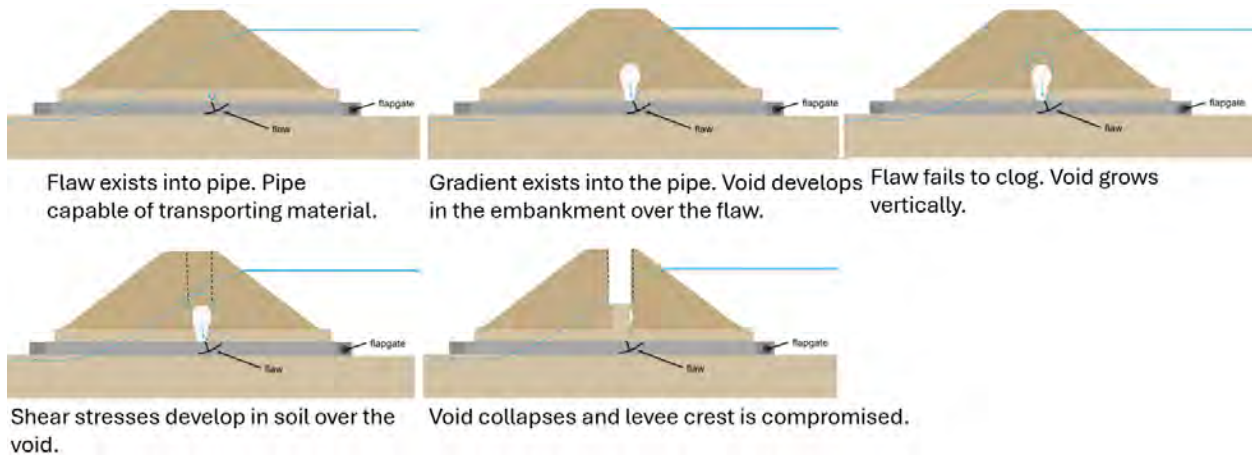
The progression of internal migration at this location is depicted in Figure 9.

Figure 9. Internal Migration Development over a Flaw in a Conduit

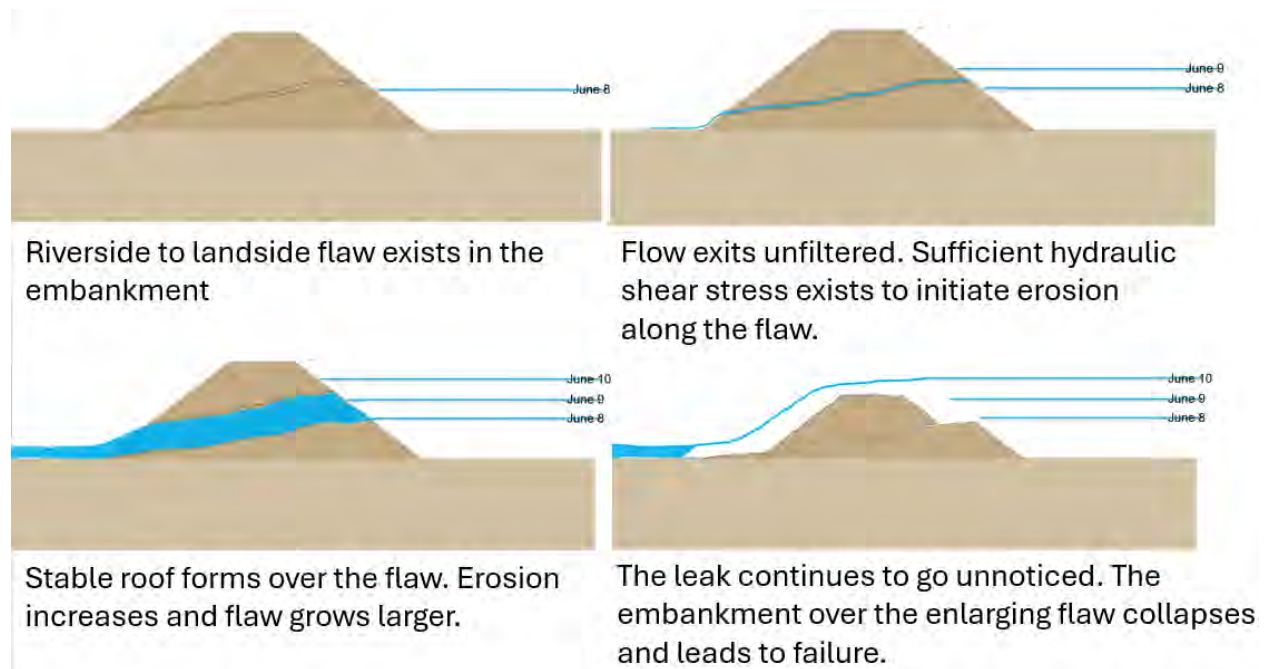
While the precise cause of this breach carries uncertainty, available evidence suggests that the most plausible PFM was the internal erosion mechanism of concentrated leak erosion (CLE). A notable observation supporting this hypothesis was the documented presence of animal burrows in this area during past inspections. Further evidence of animal burrowing was observed upstream of the breach location during the subsequent repair efforts. Although the sponsor levee inspection conducted earlier that morning did not reveal any indications of distress, given the time of day, there was likely low daylight during this inspection.

A theorized sequence that could have led to the breach by concentrated leak erosion is shown in Figure 14.

Figure 14. Concentrated Leak Erosion Sequence

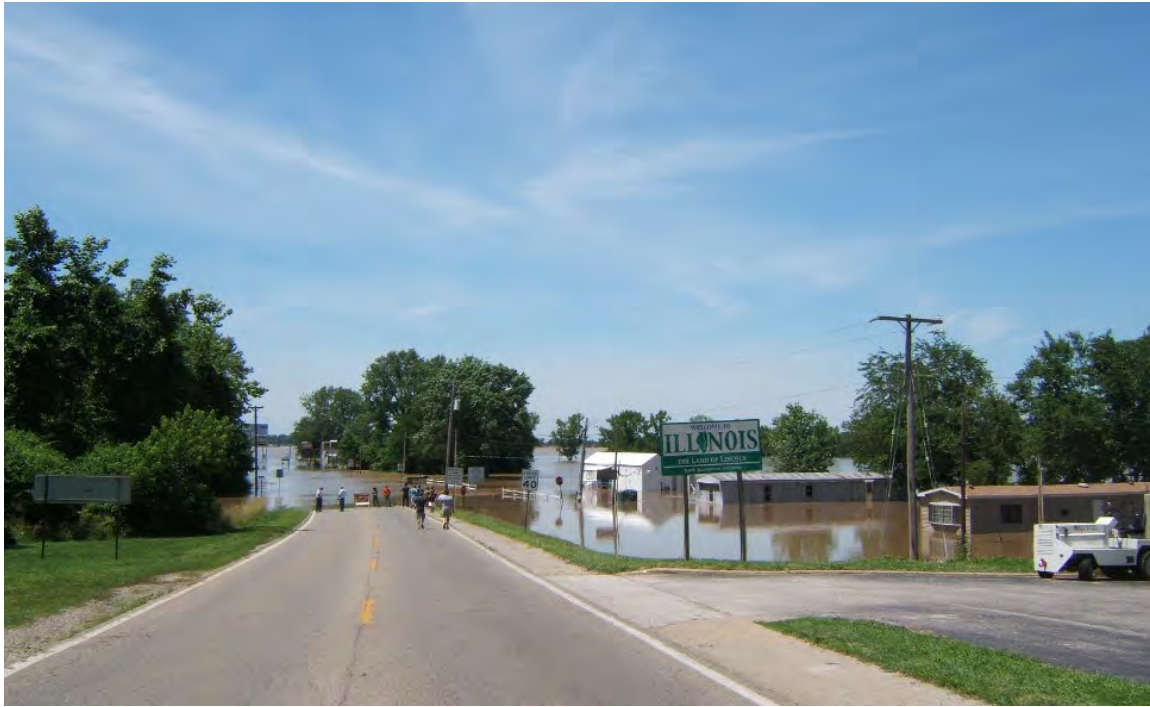
The breach at the Russell Allison Levee exacerbated flooding within the leveed area. Due to its upstream location relative to the overtopping breach locations, the breach resulted in both increased flood depths and a larger inundated surface area within the protected zone. Figure 16 is a photograph taken from a

vantage point just over the bridge into Illinois from Vincennes, with the Russell Allison levee alignment extending to the left (downstream) and right (upstream) of the photographer's position.

Figure 16. Photo of Illinois Flooding within the Russell Allison Leveed Area

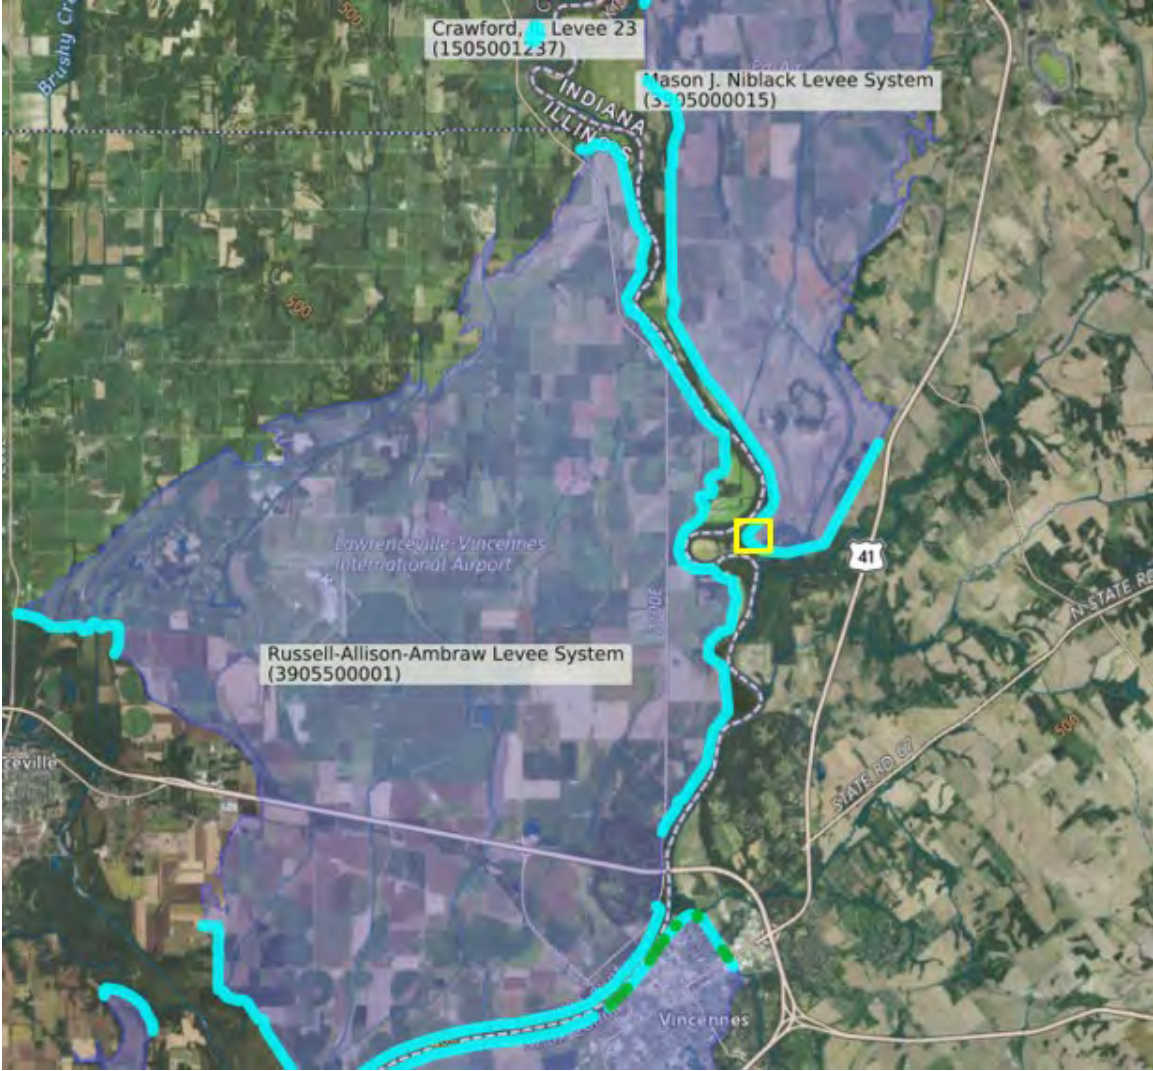
The Niblack Levee, a federally constructed levee system, is located across the Wabash River from the Russell Allison Levee. The primary area of distress on the Niblack Levee is delineated by the yellow box in Figure 17. As part of the federal project, selective raising and enlargement of the levee embankment were undertaken, including a segment situated within the aforementioned area of distress. The design details of the embankment and the associated relief drain are illustrated in Figure 18.

Figure 17. Niblack Levee System Distress Location

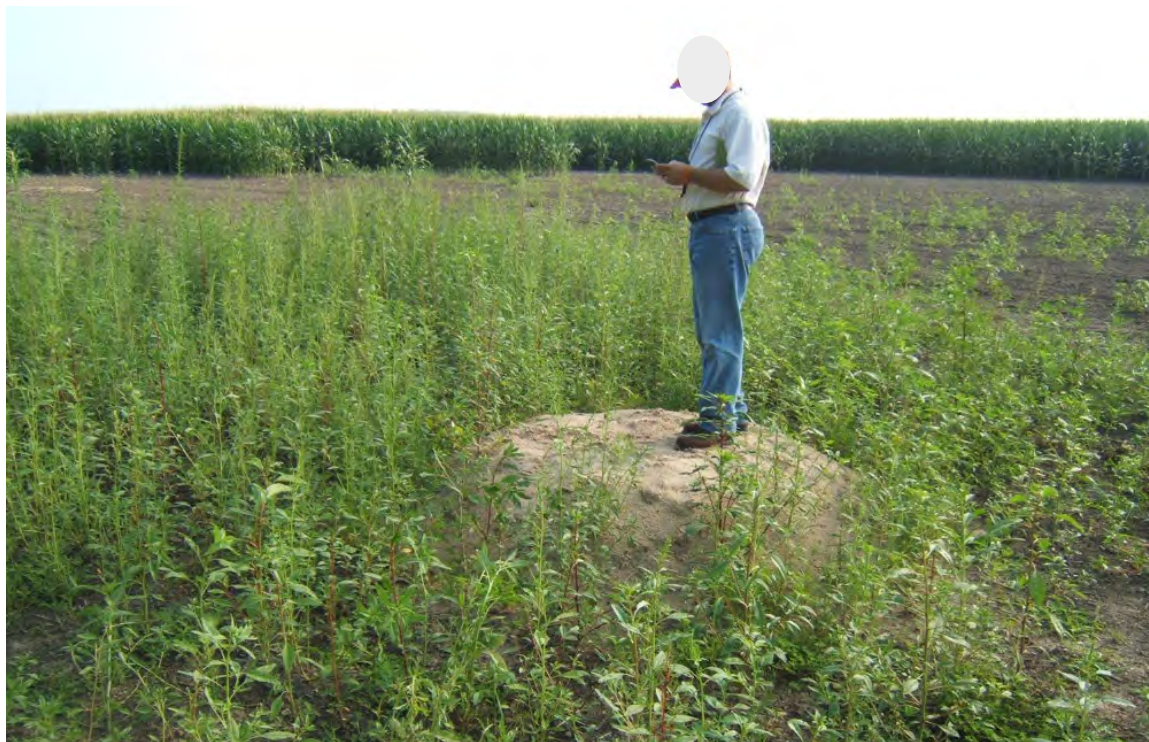
Figure 18 aerial imagery shows several sand boils of notable size and discharge volume that were observed during the post-flood site visit. Contrary to initial expectations, the area incorporating the relief drain did not exhibit a demonstrably lower level of distress compared to the area on the opposite side of the bend. Representative photographs of the observed sand boils are presented in Figure 19 and Figure 20.

Figure 20. Typical Boil at Niblack 2008

The primary concern associated with sand boils is the potential for the internal erosion mechanism of backward erosion piping (BEP). Sand boils located directly at the levee toe, such as the one illustrated in Figure 19, are of particular concern to flood-fighting personnel because of their potentially shortened

In response to the distress from the 2008 flood event, USACE constructed a sand berm on the landside toe of the levee in 2009. This berm was 150 feet wide and approximately 5 feet thick. The berm proved effective in suppressing sand boils near the levee toe during the 2011 and 2013 flood events. However, significant sand boils did develop beyond the landside toe of the berm. An example of such a boil from the 2016 flood is shown in Figure 24, and multiple large boils are visible in aerial imagery captured after the 2013 flood, as presented in Figure 22.

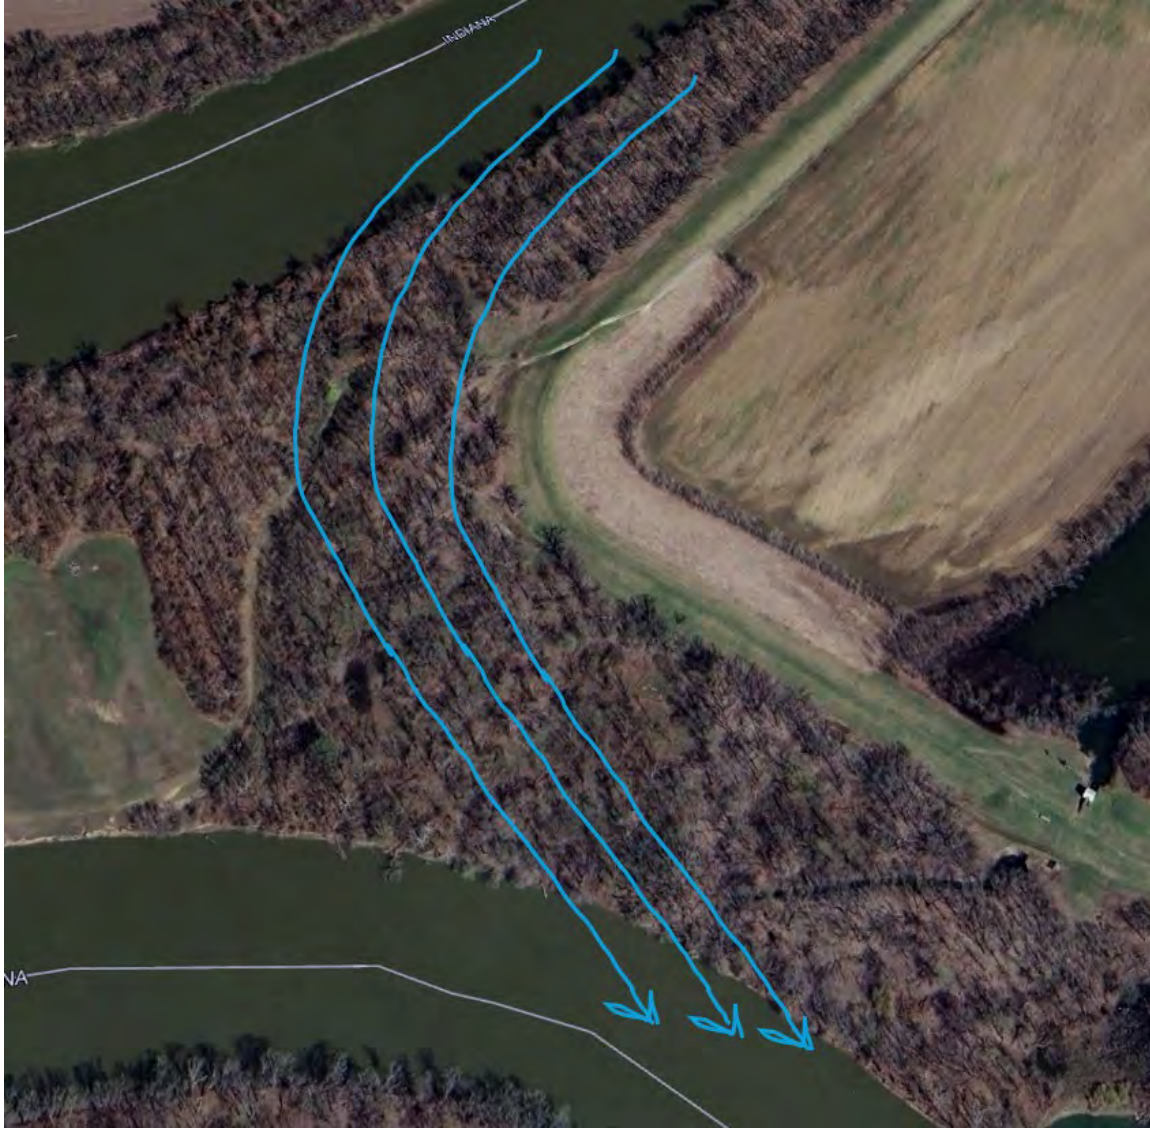
Compounding the potential for seepage at this location, the river channel exhibits a tendency to meander and shorten its course by cutting across the bend just west of the levee. The resulting flow across the peninsula adjacent to the levee, as illustrated in Figure 23, induces erosion, potentially exposing foundation sands and creating a preferential seepage entry point near the levee toe.

Figure 23. High Water Flow Path Adjacent Levee

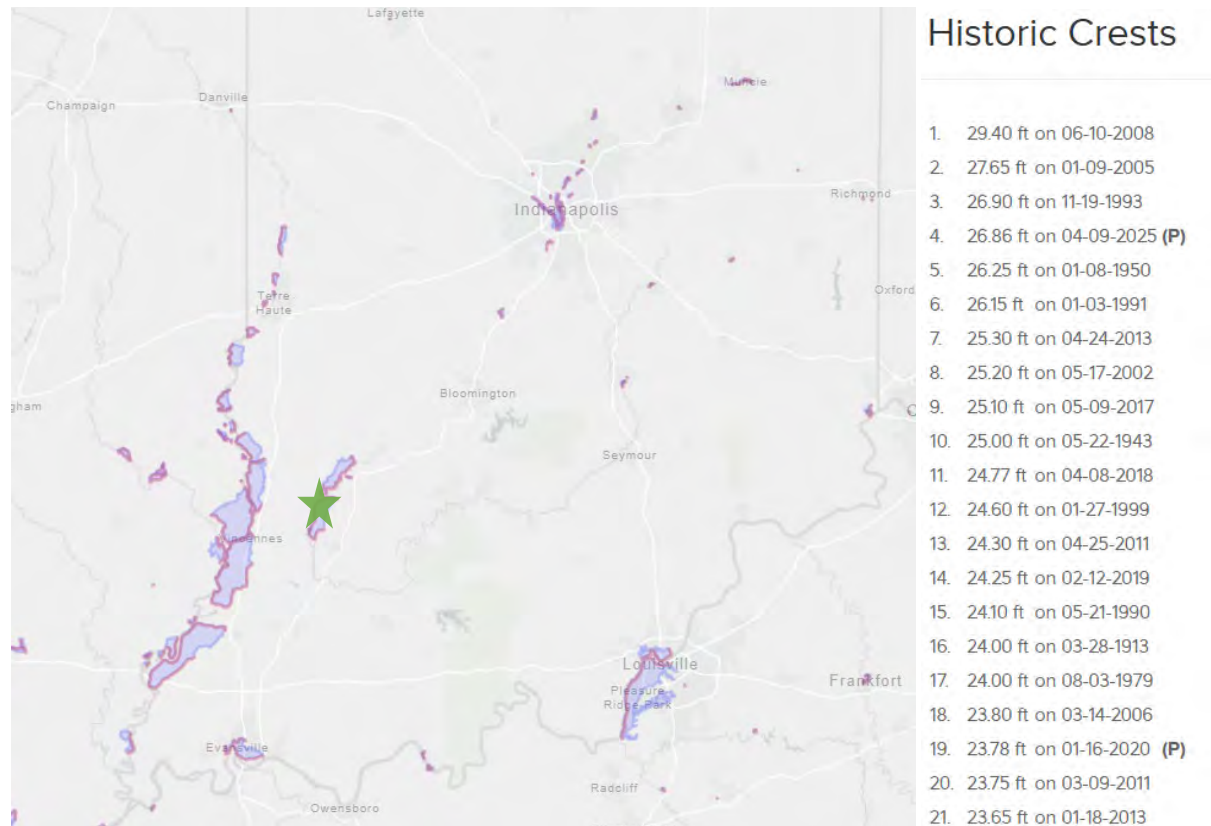
On the morning of Friday, March 4, 2011, a breach occurred at Levee Unit 8, a federally constructed levee located on the White River near Edwardsport and Washington, IN (Figure 25). A photograph of the breach is presented in Figure 26. As depicted in this photograph, the levee was only moderately loaded at the time of the failure, estimated at a maximum of 25% to 50% loaded based on the landside levee toe elevation. The stage elevation during this event was several feet lower than those recorded during previous high-water events (Figure 25).

Figure 25. Levee Unit 8 Location and Edwardsport, IN Historic Crests

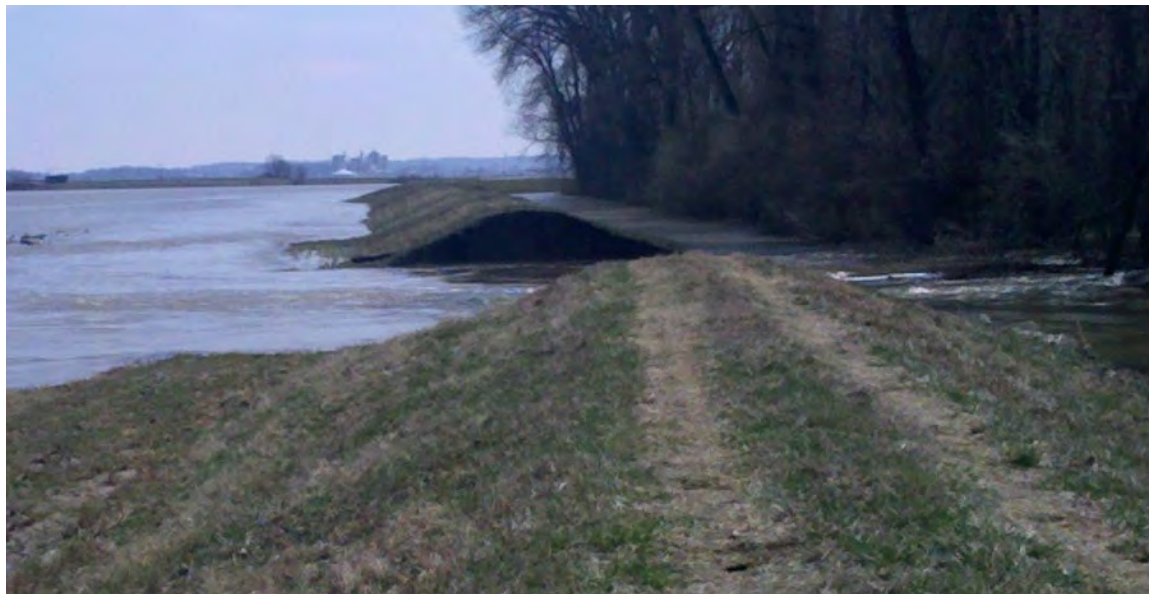
Figure 26. Levee Unit 8 Breach March 4th 2008 Looking Downstream

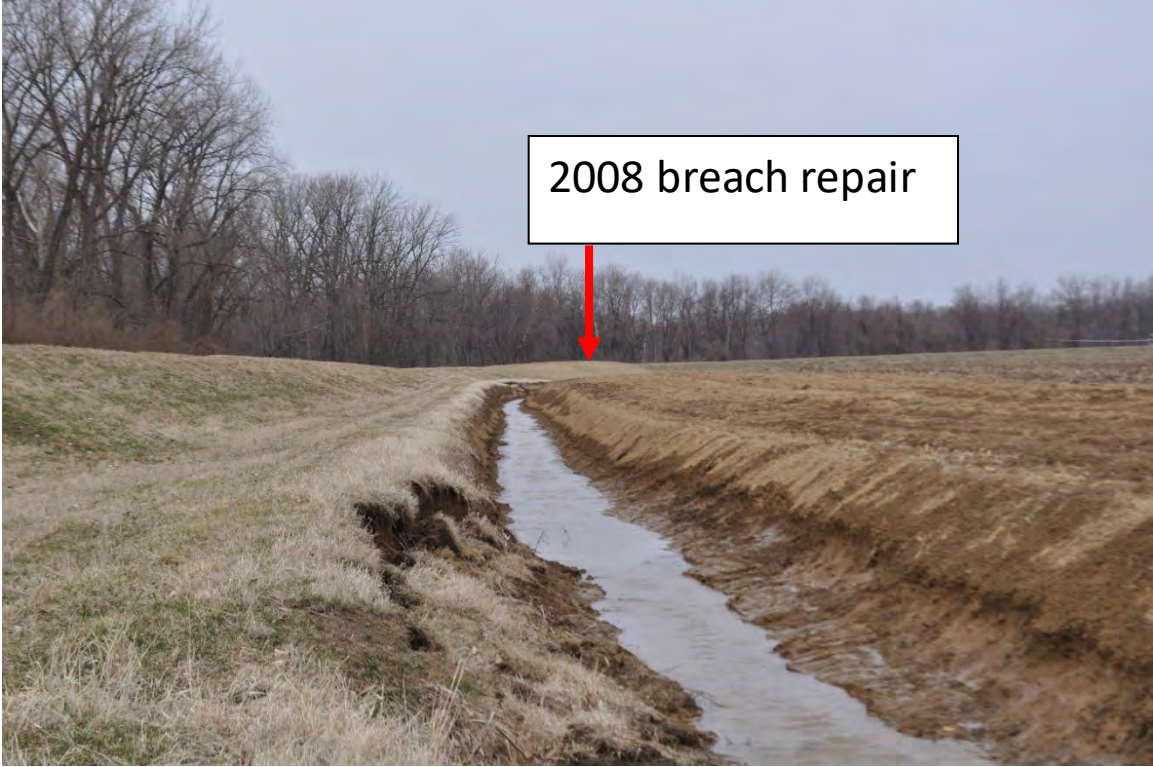
Figure 27. Levee Unit 8 with Sloughing in Landside Ditch

A drainage ditch situated landside of the levee embankment, likely just outside the levee easement, was exhibiting sloughing along its edges as shown in Figure 27. Seepage was observed within the sidewalls of the ditch, primarily manifesting as horizontal flow along both sides of the ditch and active boiling with cloudy discharge was noted (Figure 28) within the ditch in several locations. While these observations were concerning, they were not dissimilar to conditions observed by USACE personnel during prior flood events and did not, at the time, indicate an imminent failure. Given projections of a limited further rise in river stage, a recommendation was conveyed to the sponsoring agency to attempt to increase water levels within the ditch by ceasing pump operations at the downstream discharge point of the ditch and constructing a temporary dam to impound water within the ditch. The sponsoring agency subsequently installed a berm across the ditch near the pump station, but this may not have increased the water depth upstream where the breach occurred. During the March 3rd site visit, the river stage was at the riverside levee toe, resulting in an estimated hydraulic head differential of only a few feet in relation to the ditch bottom. The river stage continued to rise and crested with approximately 5 feet of freeboard remaining. Figure 29 presents a photograph taken from the levee crest, likely in close proximity to the eventual 2011 breach location. A previous breach repair from the 2008 flood event is shown just upstream.

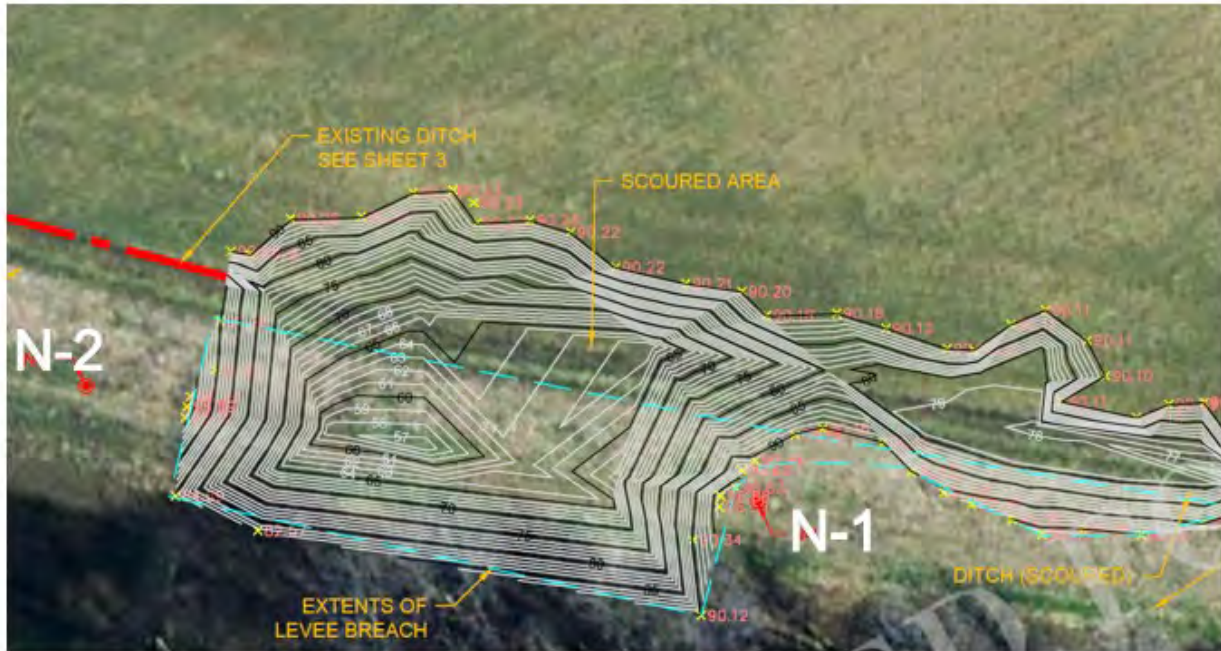
In response to the failure, the local sponsor hired an engineering firm to design a repair. The firm drilled two borings, N-1 and N-2, on either side of the breach through the crest as shown in Figure 30 and Figure 31.

Figure 30. Levee Unit 8 Boring Location Plan

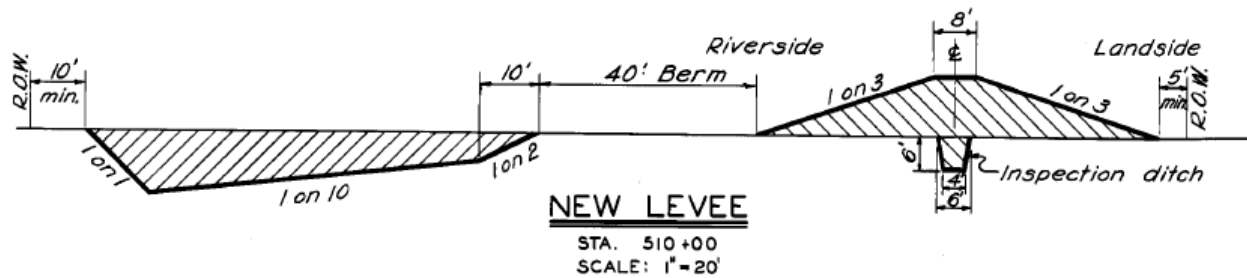
Boring N-1 and N-2 both encountered approximately 11 feet of clay fill (the levee embankment), then clay overburden. Both borings were potentially drilled through the inspection trench as seen in Figure 32. N-2, closer to the 2008 breach, encountered SP-SM fine sand at 16 feet in depth (about 5 feet below the natural ground surface) where N-1 encountered SP-SM fine sand closer to 24 feet in depth. The fine sand encountered below the very loose silt in N-2 had a coefficient of uniformity of 2.2 in gradation testing with a fines content of 5.7%. A team of USACE Engineers visited the site in October 2011.

Following the breach, additional high water occurred in April and May 2011, and the breach had been further eroded from water flowing in/out of the leveed area during these events. The original as built cross section is shown in Figure 32.

Figure 32. Typical as-built Cross Section

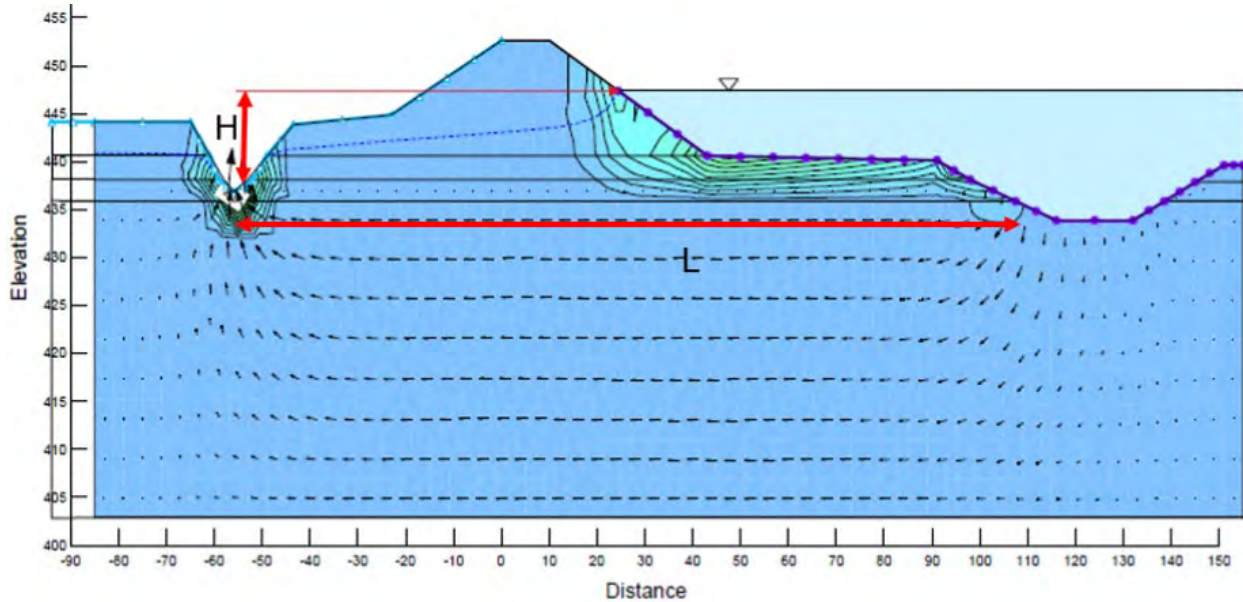
The failure at Levee Unit 8 is hypothesized to have been caused by the internal erosion mechanism of BEP. Geotechnical investigations at boring location N-2 revealed the presence of fine sand with a low coefficient of uniformity, which would likely have been situated near the base of the ditch. Under these conditions, the development of a sand boil or concentrated seepage through the ditch bottom would have resulted in a horizontal hydraulic gradient (H/L) of approximately 0.06 to 0.08. This range is based on the estimated seepage entry point, variations in the ditch elevation, water level within the ditch, and

the headwater elevation. Figure 34 presents a schematic representation of the cross-section used in the post-failure seepage modeling.

Figure 34. Seepage Model Cross Section

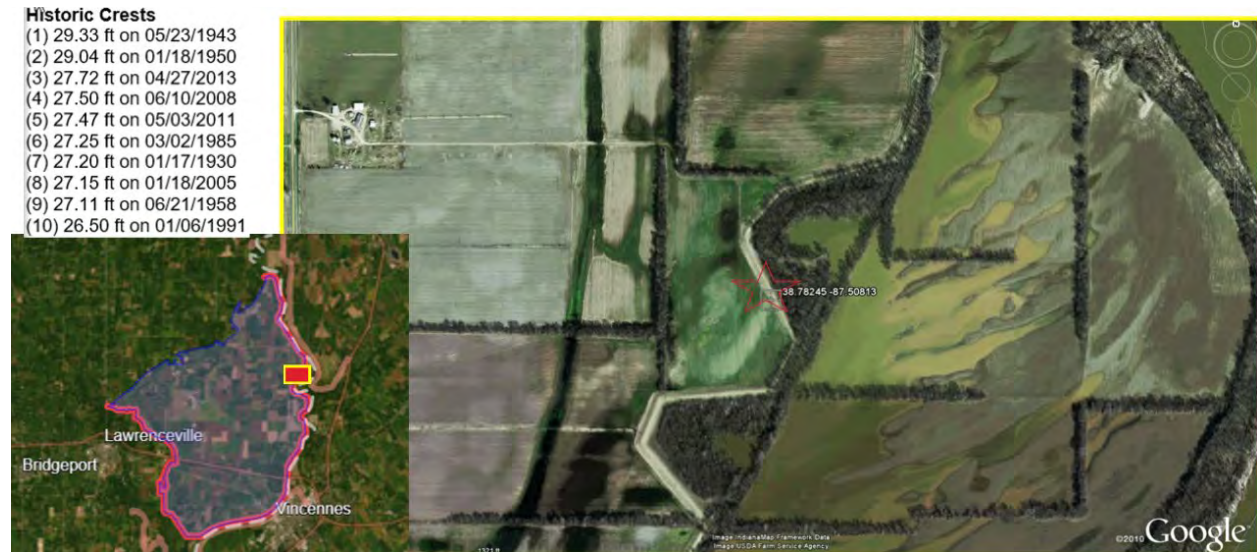
The Russell Allison levee again experienced severe distress in 2013 at a new location shown in Figure 37. The levee alignment at this distress location exhibits a complex geometry characterized by the presence of two setback levees. There are no records that indicate incidents at this location during the 1943 or 1950 flood events; however, the presence of two large scour features on the riverside suggests a pattern of levee breaches followed by the construction of the setback levees on the landside of the resulting scour. The 2013 distress was located on the upstream setback embankment.

The 2013 Wabash River flood event was the third highest on record at this location, with stage elevations marginally exceeding those observed during the 2008 flood (approximately 0.2 feet) when sand boils were also documented at this location.

Figure 37. Russell Allision 2013 Distress and Historic Crests

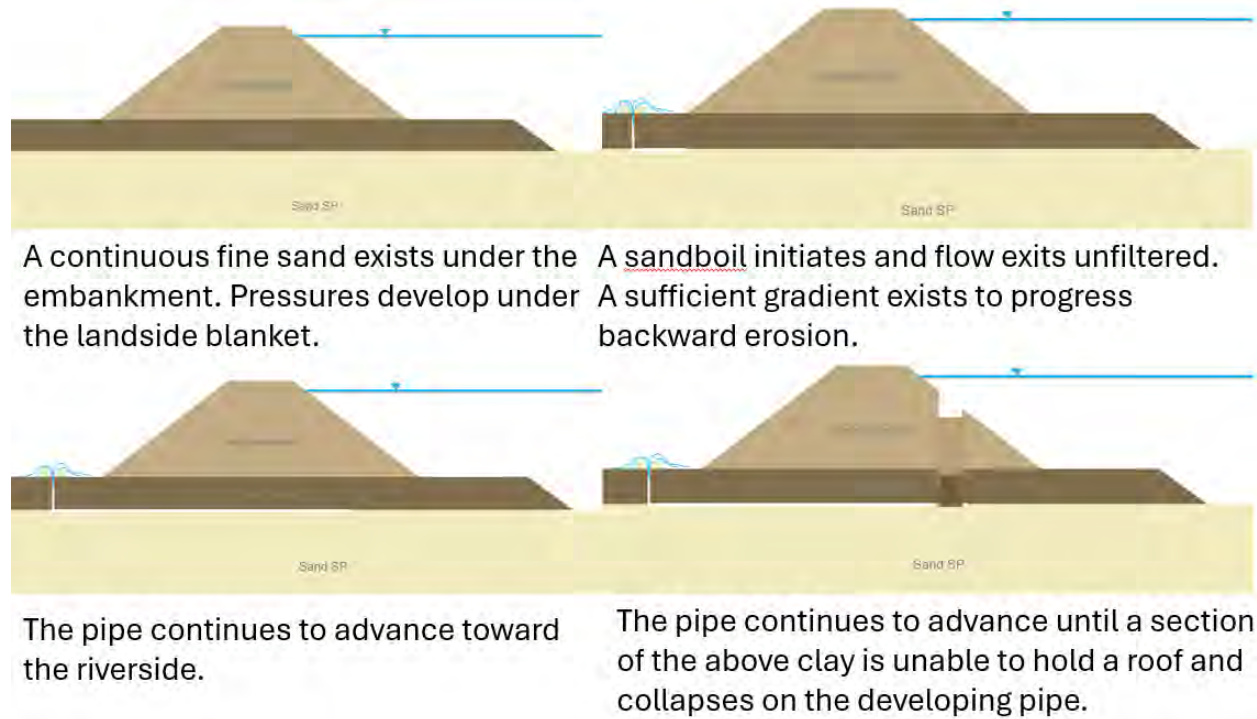
The observed subsidence in the riverside slope and the abrupt cessation of flow from the third sand boil during the peak of the flood event presented unexpected phenomena. The characteristics of the boils, including their size and discharge rates, were consistent with those observed in other case histories where BEP was confirmed and, in some instances, led to levee breaches. In this particular scenario, the sudden stoppage or reduction in flow may be attributable to a roof collapse over the developing pipe beneath the levee embankment. A schematic representation of this potential mechanism is shown in Figure 41.

Figure 41. Sequence of Potential Roof Collapse

During the summer of 2013, the local sponsor initiated repairs to the area affected by the sand boils. The repair procedure involved excavating the boils down to the underlying sand layer and compacting the existing clay blanket back into the excavation. A photograph of one of the boils during excavation is shown in Figure 42, which the sponsor reported was representative of the general condition of the other boils. The excavated boils exhibited vertical throats of similar dimensions, approximately 6 inches in diameter, and all were found to be filled with sand. Notably, no voids or other anomalies were encountered beneath the boils during the excavation process. The riverside slope subsidence was also excavated; however, the sponsor reported that this excavation likewise revealed no apparent voids or other anomalous features. Representatives from USACE were not present during the riverside excavation.

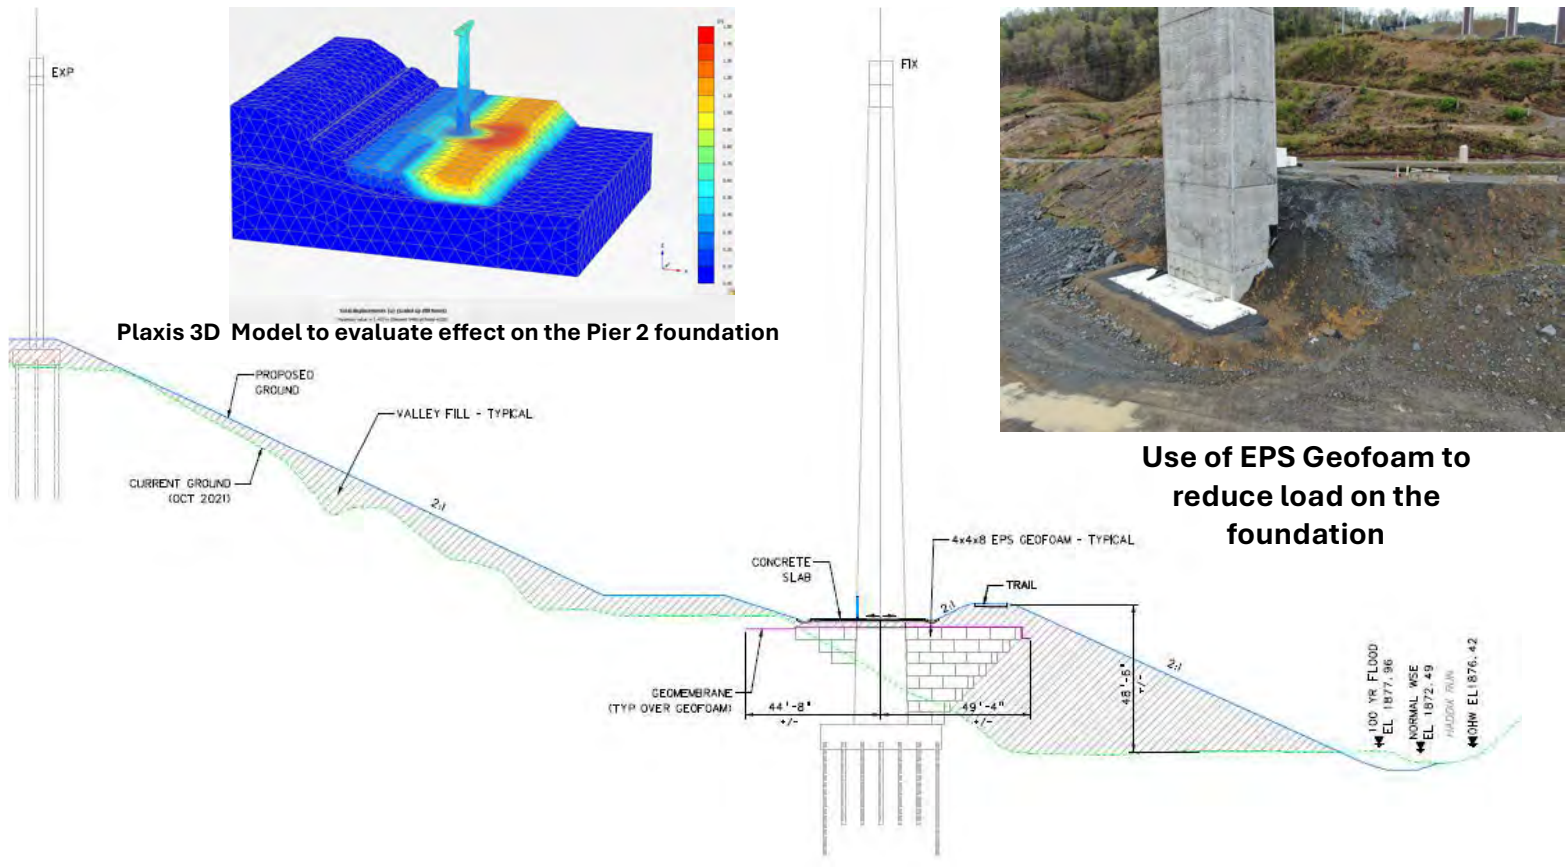
Pier 2 Changes

- Abutment and Pier Grading for Buttress Fill
- Pier 2 Foundation Changes Due to Grading. Use of Lightweight (GEOFOAM)
- Span 2 Length Modification. Shortened Span 2 by approximately 2 ft
- Girder Modifications

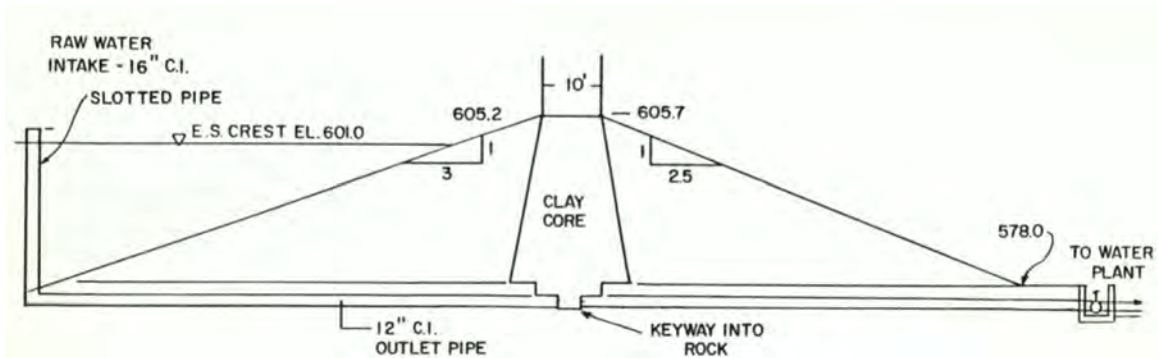
The original design drawings show a 12-inch CIP installed at the base of the embankment with a submerged inlet, downstream valve, and outlet end discharging into the downstream creek. However, the 1979 Phase 1 Inspection Report showed a vertical perforated riser pipe extension at the intake location, and a pipeline connected to the outlet to route water directly to the treatment plant approximately one half of a mile downstream. It is assumed modifications to add the perforated riser and downstream water supply pipeline were performed between original construction and 1979. A conceptualized cross-section of the dam along the outlet pipe system alignment (from the 1979 Phase 1 Inspection Report) is included as Figure 2.

Figure 2. Cross-Section along Outlet Pipe from 1979 Phase 1 Inspection Report

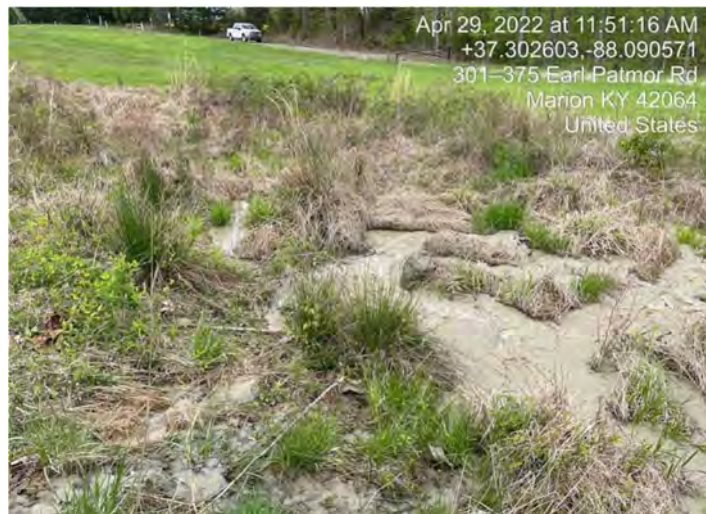
On April 29, 2022, the seepage became more turbid (see Figure 3), followed by development of a sinkhole mid-slope along the downstream face (see Figure 4). The sinkhole was above and near the alignment of the 12-inch CIP. Emergency pumping operations were performed to draw the reservoir level down as the sinkhole continued to increase in size (see Figure 5). Drawdown efforts made little impact to the reservoir level, and the City initiated a breach of the dam at the left abutment in late afternoon on April 30, 2022 (see Figure 6). Detailed documentation of the events leading up to the controlled breach are included in DOW Certification of Inspection (COI) reports dated April 27 to May 4, 2022.

Figure 3. Turbid Boils and Seepage near Toe of Dam

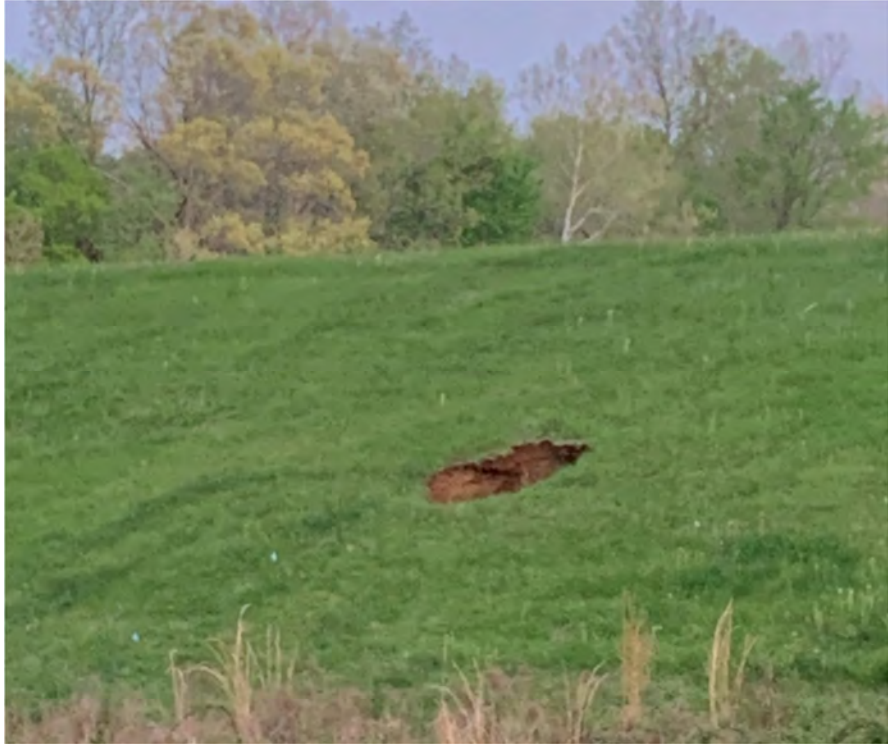
Figure 4. Sinkhole Immediately after Initial Development

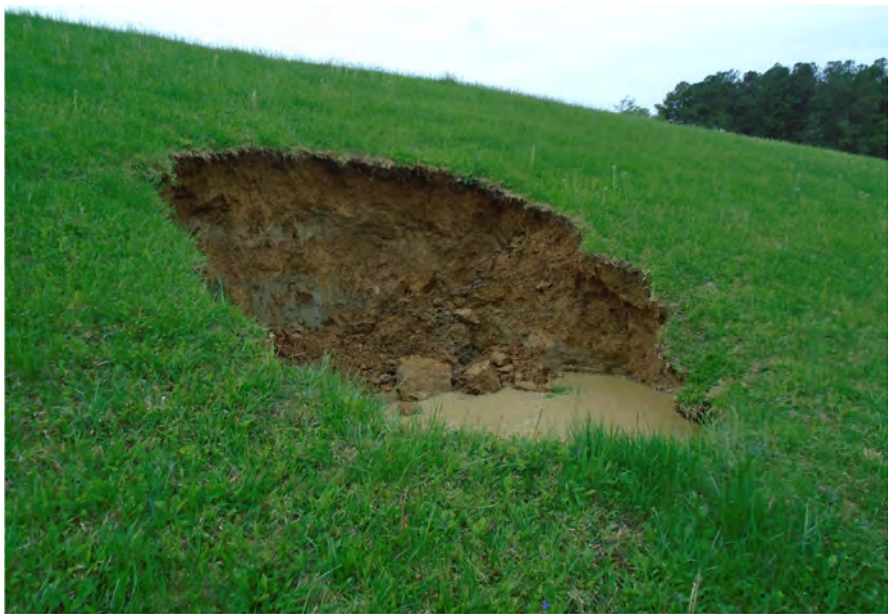
Figure 5. Enlarged Sinkhole after 24 Hours

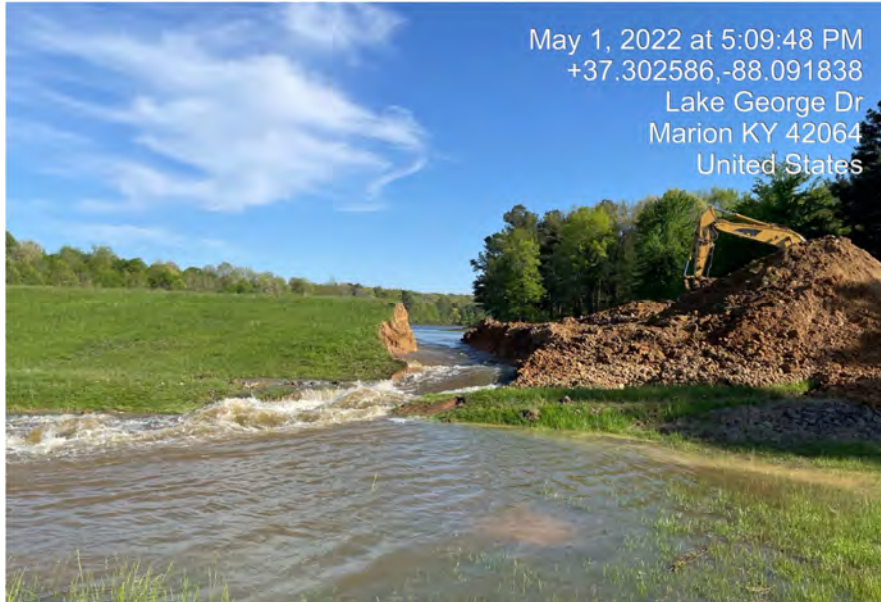
Figure 6. Breach Channel at Left Abutment

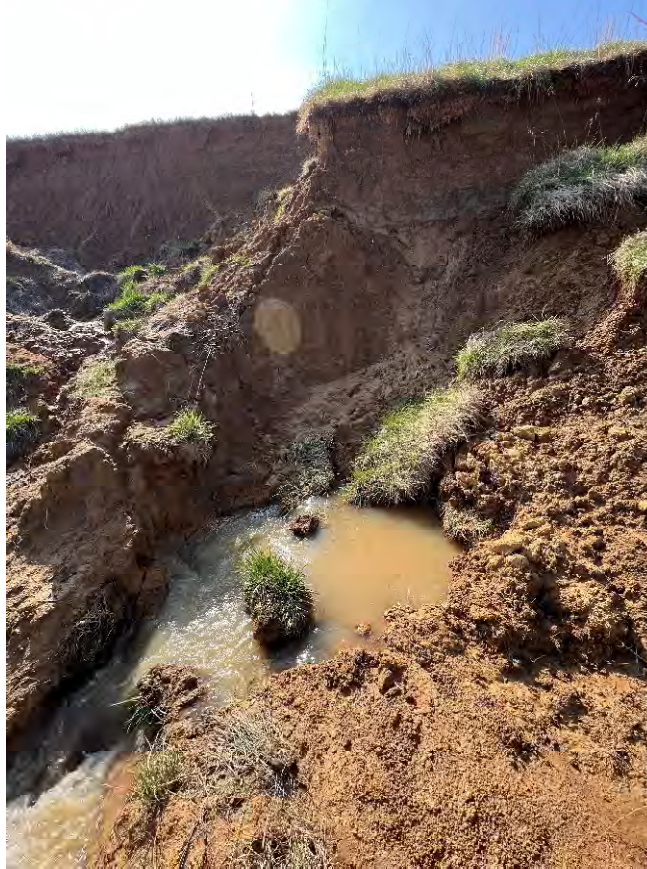
to City residents. Early engineering efforts related to assessment and repair planning were performed in late 2022 by Bacon Farmer Workman and consisted of geotechnical exploration and conceptual repair design. In March 2023, Schnabel was retained by the City to perform an assessment of existing dam conditions, which were largely unchanged from that shown in Figure 7, except that the Lake George Reservoir level had reached the invert elevation of the left abutment breach and was flowing through the channel. As a function of the higher lake level, water was observed flowing from the excavated area within the downstream slope, as shown in Figure 8.

Figure 8. Seepage in Excavated Area (March 2023)

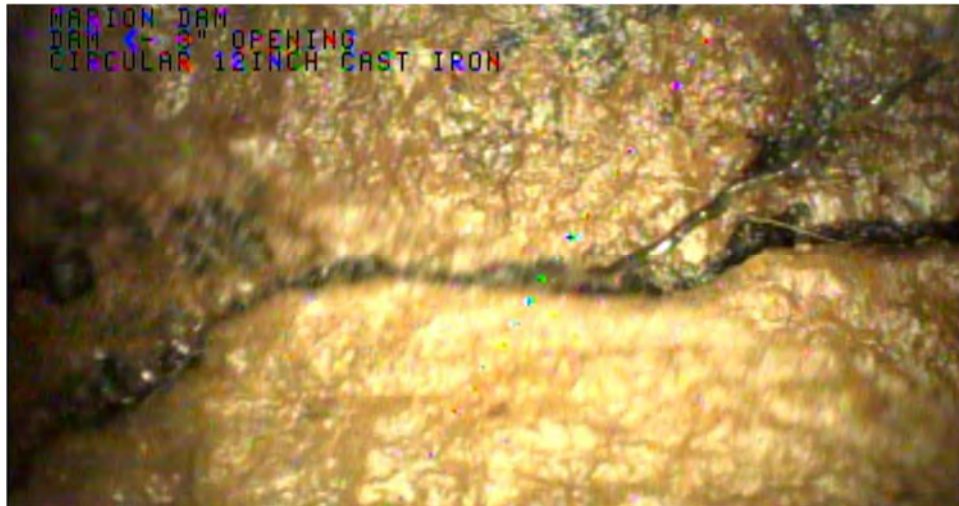
With the pipe now largely dewatered, a camera inspection was performed to observe the interior of the 12-inch CIP On May 18, 2023. The inspection revealed a crack within the sidewall of the pipe at a location corresponding closely with the sinkhole. Apparent root growth was observed within the crack, indicating that it had likely existed for many years. A screenshot showing a portion of the crack is included as Figure 9.

Figure 9. Crack in 12-inch CIP Interior Sidewall

Based on the review of available historical information, and the studies and efforts in the year following the dam safety incident, it is theorized that the seepage boils and sinkhole development in April 2022 were likely associated with gradual seepage of water from the pressurized 12-inch CIP over time. The water slowly eroded the embankment material from around the pipe and mobilized it downstream, likely along the exterior of the conduit. Over time, the internal erosion led to stoping (i.e., upward progressive collapse of material into a subterranean void) within the embankment and resulted in sinkhole development. The persistent seepage near the toe of the dam that had been observed for decades was likely a sign of the internal erosion process that occurred over decades.

- Fully grouting and abandoning the damaged 12-inch CIP.
- Installation of a dual siphon system. A 20-inch (OD) self-priming siphon to serve as principal pool control to maintain normal pool at a level 10-feet below the former normal pool. An additional 6-inch (OD) siphon to be used in times of low flow to convey water to the downstream creek, and ultimately to Old City Lake for withdrawal at the City's water treatment plant.
