The Kentucky Geotechnical Engineering Group Presents
The 55th Annual Ohio River Valley Soils Seminar

**55th ANNUAL OHIO RIVER VALLEY SOILS SEMINAR
NOVEMBER 12, 2025**

Levee Case Histories: Failures and Incidents Prior to Overtopping

Levee Case Histories: Failures and Incidents prior to Overtopping

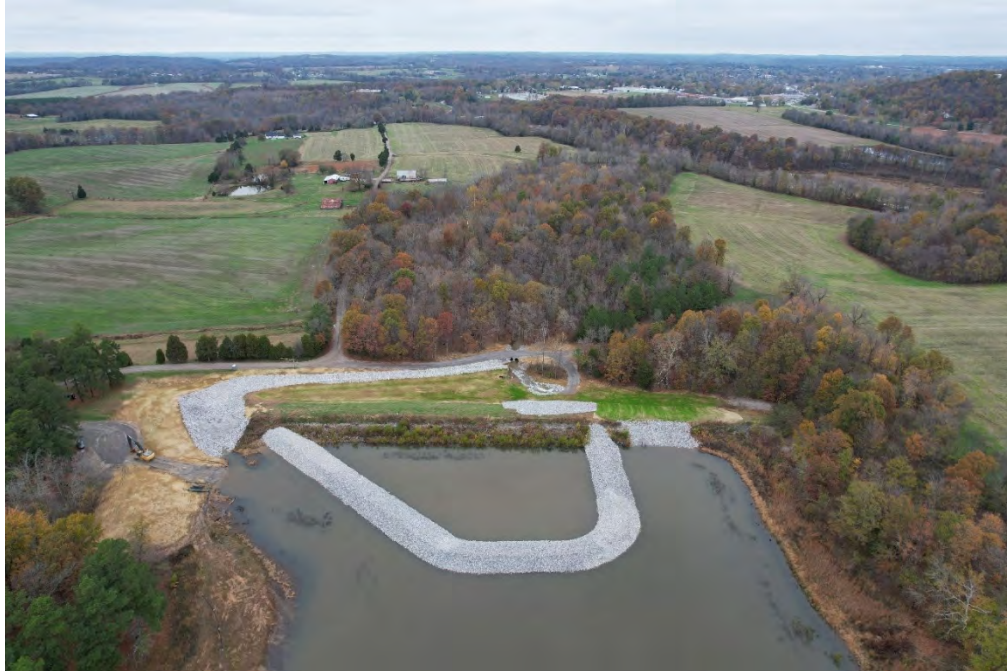
Figure 10. Completed IRRM Project Looking Downstream

1. Construction of the Rock Berm
2. Abandonment of the 12-inch CIP via fully grouting the interior of the pipe under in-the-wet conditions.
3. Backfilling the excavated section in the downstream slope, and installing a trench filter along the downstream toe of the dam.
4. Installation of the siphon system, including an outlet control structure, plunge pool, thrust blocks, concrete cradle, and a diaphragm filter.
5. Raising the left abutment breach controlling elevation with grouted riprap, and lining the outlet channel with riprap.

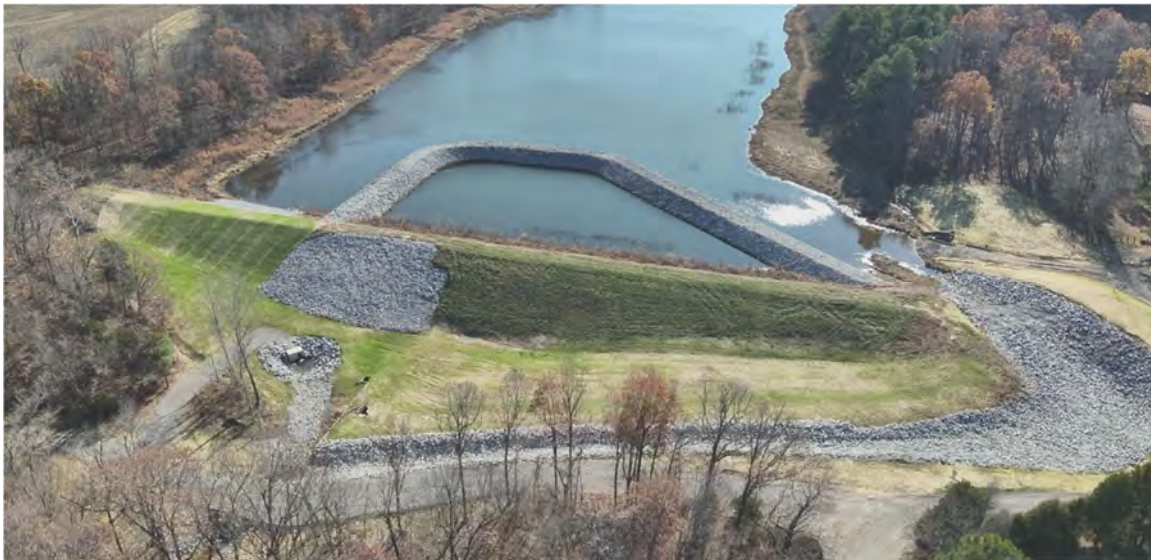
Figure 11. Completed IRRM Project Looking Upstream

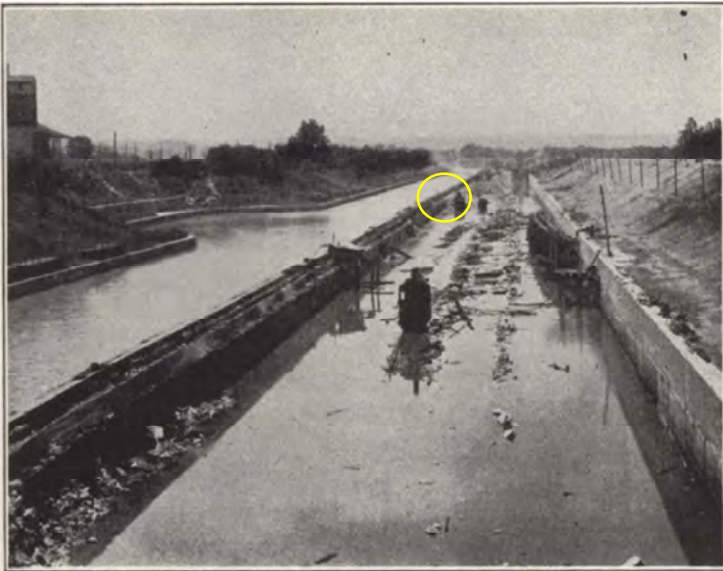
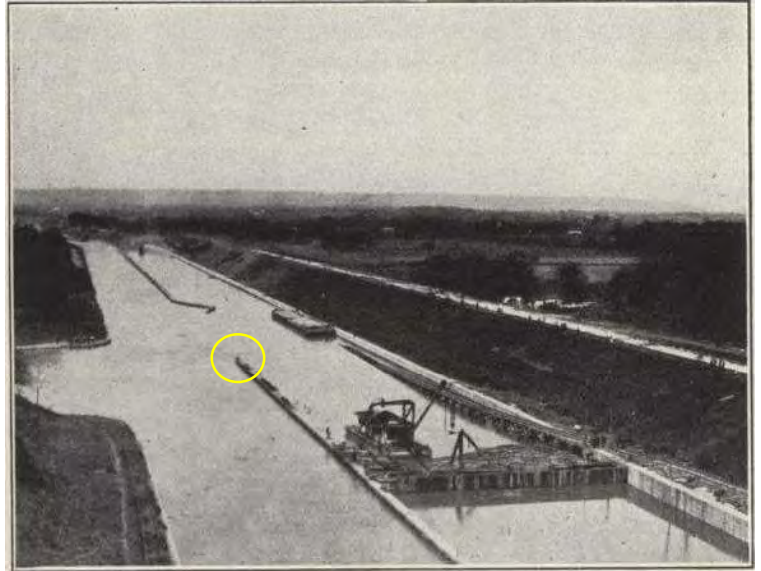
L & P CANAL – COFFERDAM FAILURE

- Failure occurred 2 June 1961
- 1 person was killed

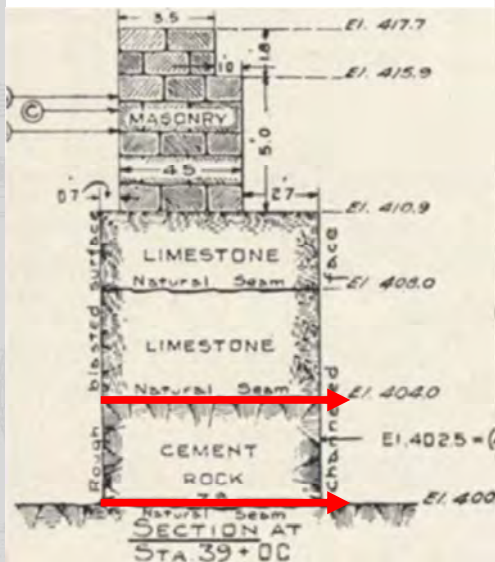
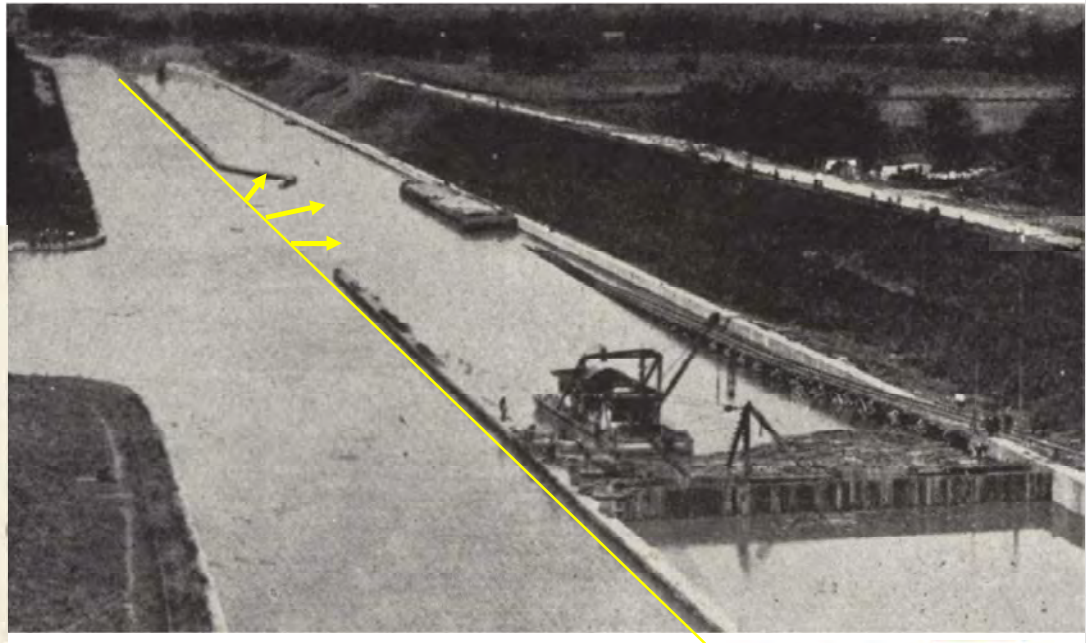
L & P CANAL – COFFERDAM FAILURE

- Slid 34 feet
- Two sliding planes

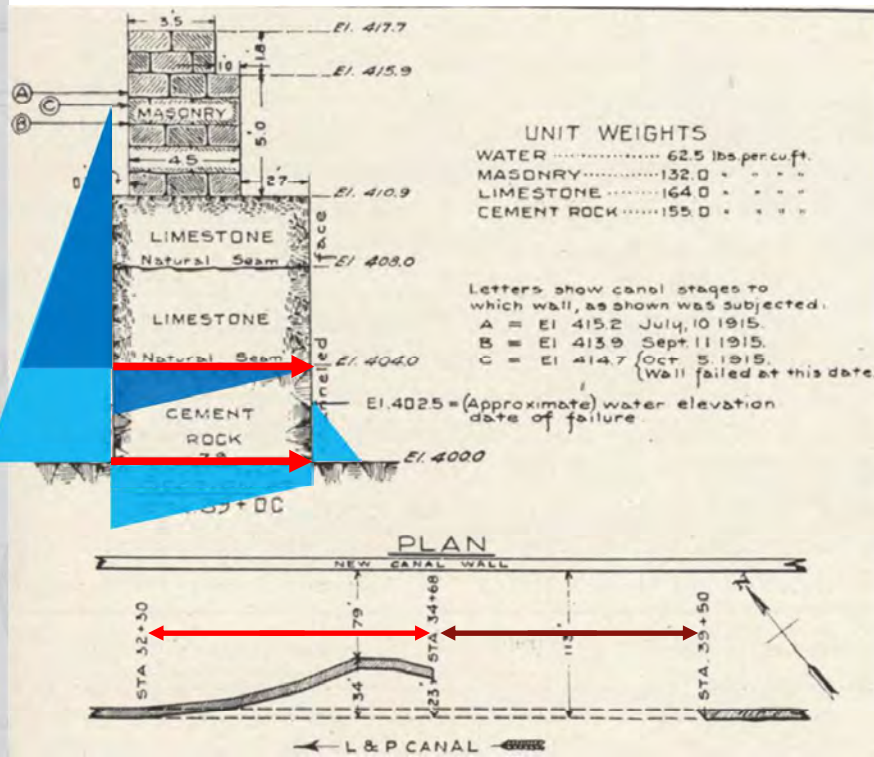
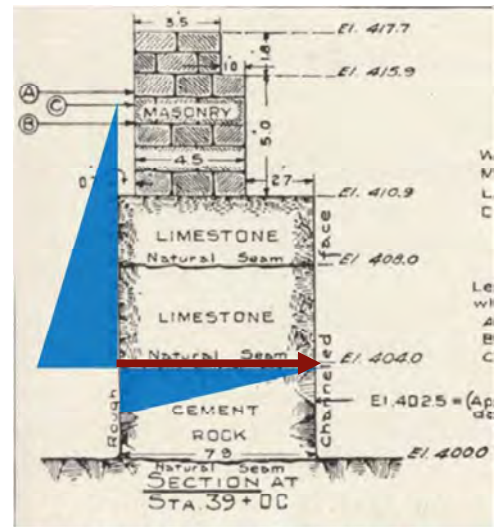
L & P CANAL – FAILURE DETAILS

- Blasting may have damaged rock ledge leading to post-peak rock strength.
- Attempts to stop seepage from exiting on dry side would have increased uplift pressure.

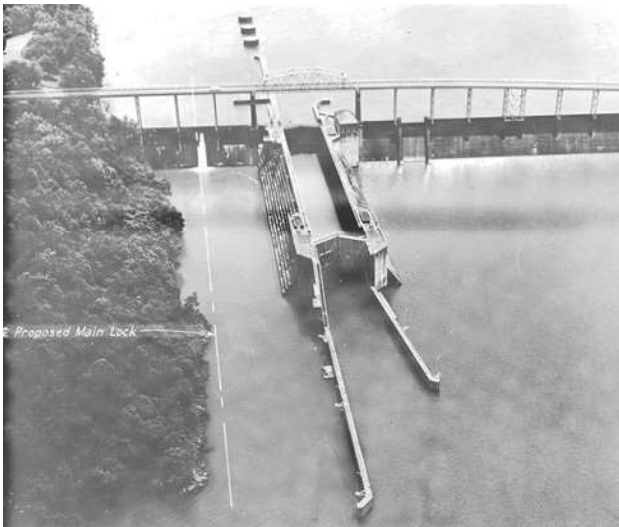
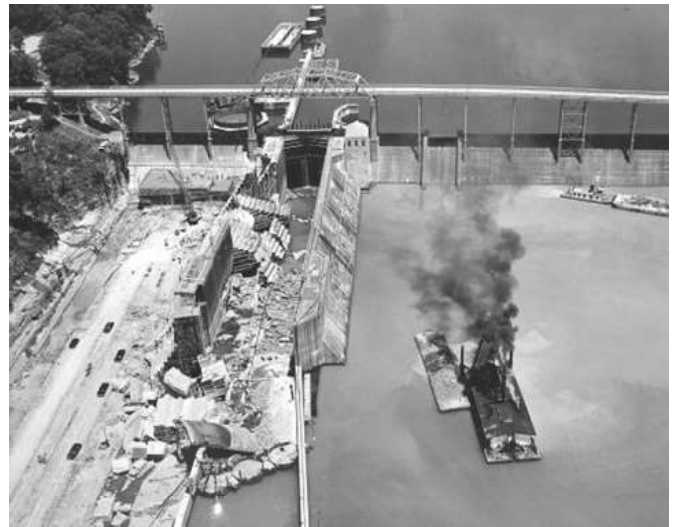
WHEELER LOCK FAILURE

- Failure occurred 2 June 1961
- 2 people were killed

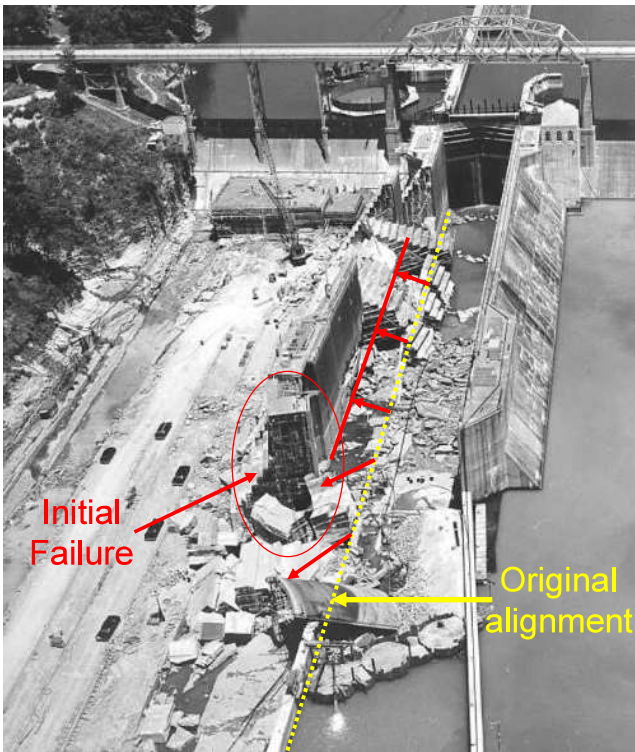
WHEELER LOCK FAILURE DETAILS

- Slid on clay seam 1/16" to 3/8" thick at base of shale
- Failure initiated at downstream pintle block
- Downstream guide wall monoliths followed almost immediately
- Failure then propagated rapidly upstream

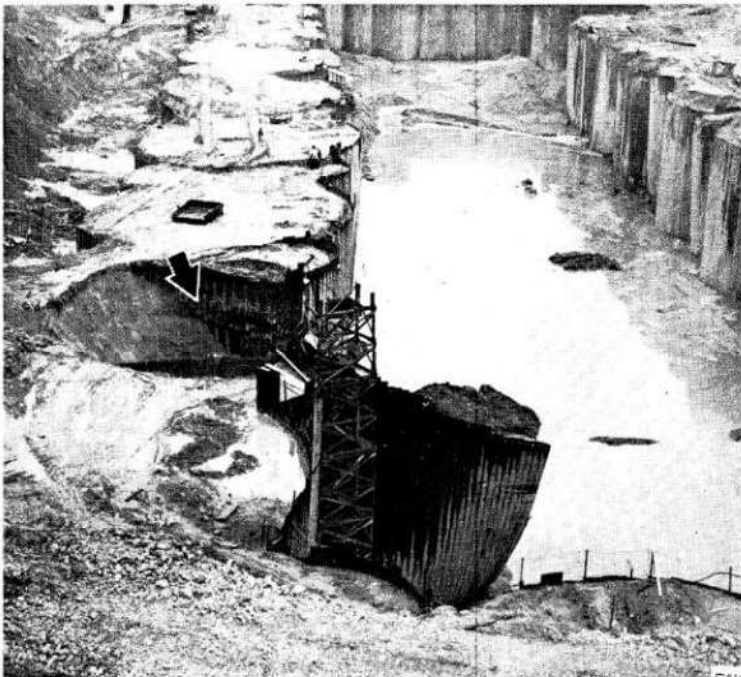
CANNELTON COFFERDAM FAILURE

FAILURE AFTERMATH (arrow). Flooding and sand dumping stabilized cells.

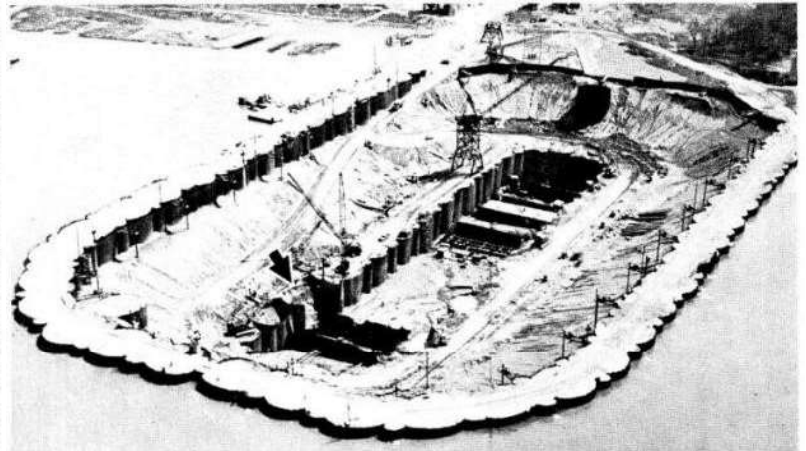
COFFERDAM in the Ohio River is a 20-acre, 160-ft hole; arrow marks ruptured cell, slippage area.

- Failure occurred 1 Nov 1967
- No fatalities (crew on break)

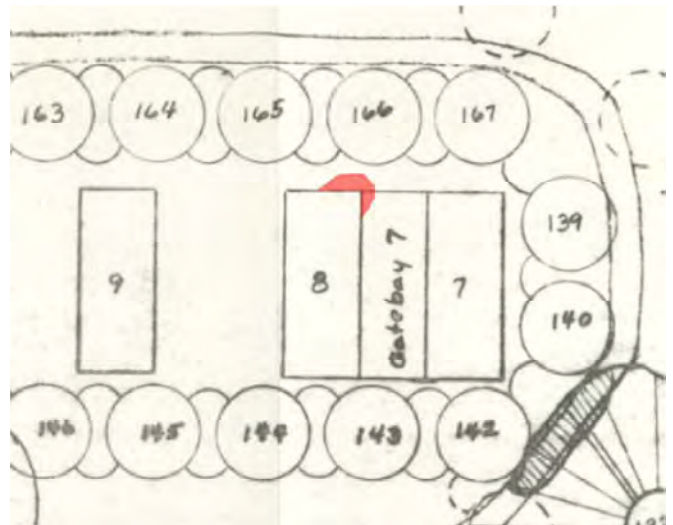
CANNELTON COFFERDAM FAILURE TIMELINE

- 21 OCT
 - Sloughing reaches toe of cell 166
 - Cracks observed in unexcavated area between Pier 7 & 8, and toe of cell 143
 - Shale between Pier 7 & 8 moves laterally 2-3 feet into Pier 8 excavation (along previously observed cracks)
 - Crack at toe of cell 143 extends to arc 143/144 and opens to width of 2-4"

- 24 OCT: Crack at toe of cell 143 widens, depth increases to 6-8'
