Natural Slope
Stability and Instrumentation

PROCEEDINGS OF THE SEVENTEENTH
OHIO RIVER VALLEY SOILS SEMINAR

NATURAL SLOPE STABILITY
AND INSTRUMENTATION

October 17, 1986
Sheraton Lakeview Hotel
Clarksville, Indiana

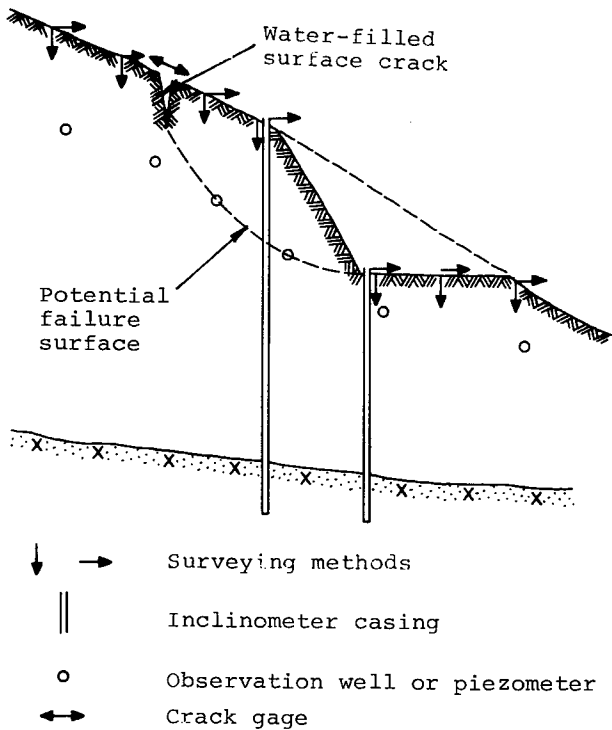
Figure 1. Possible layout of instrumentation for monitoring an excavated slope in soil when there is evidence of instability.⁶

Methods of instrumentation have been described in the previous section. Possible layouts for determining how much ground is moving in excavated slopes are shown in Figures 1 and 2. It must be stressed that these layouts are only examples, and many other configurations are possible. Other configurations are indicated by the case histories described later in this paper.

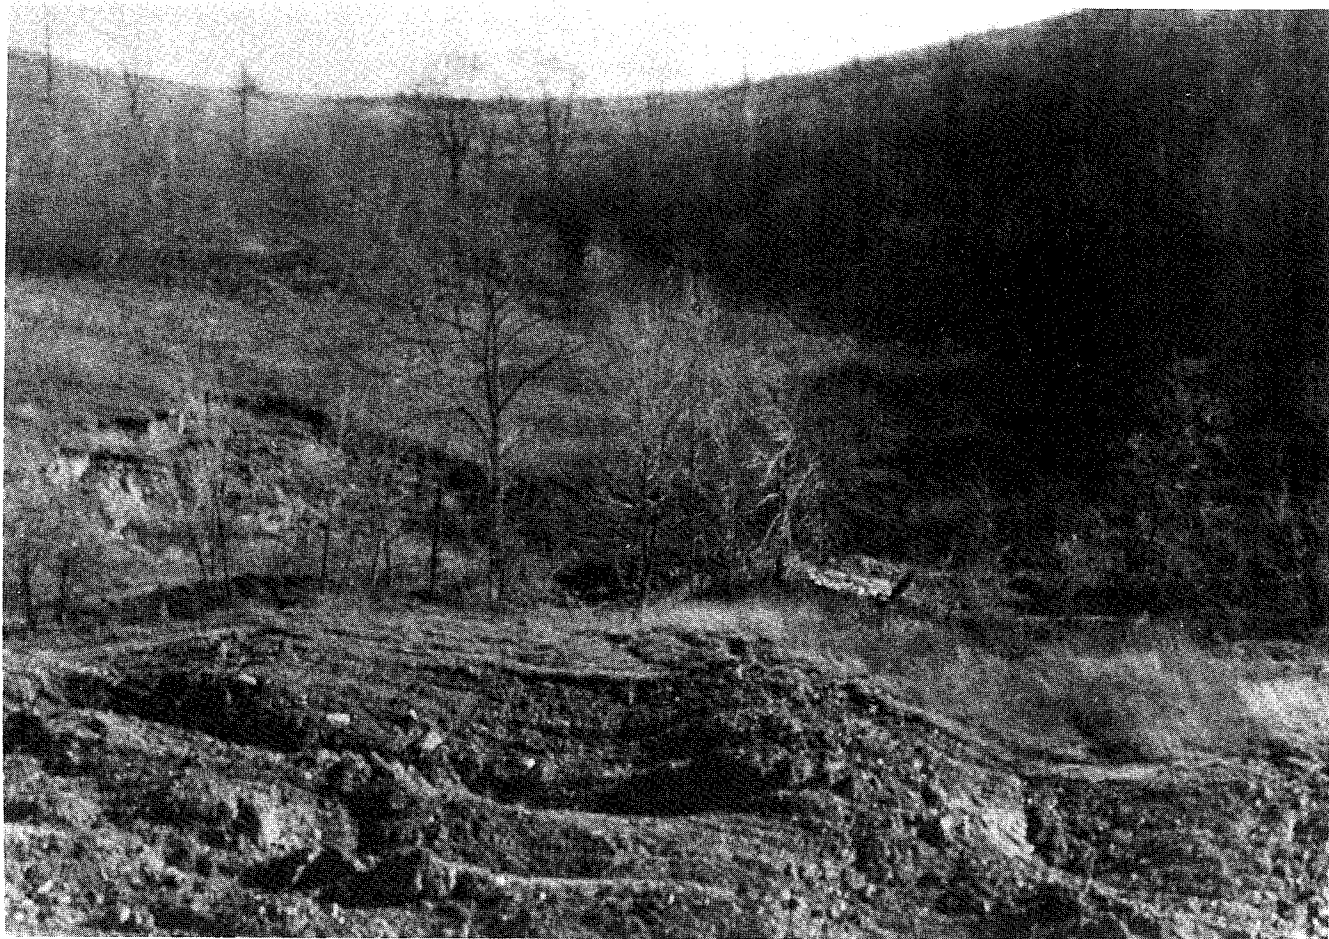
Figure 2. Characteristic Slide in
Hillside Drainage Channel

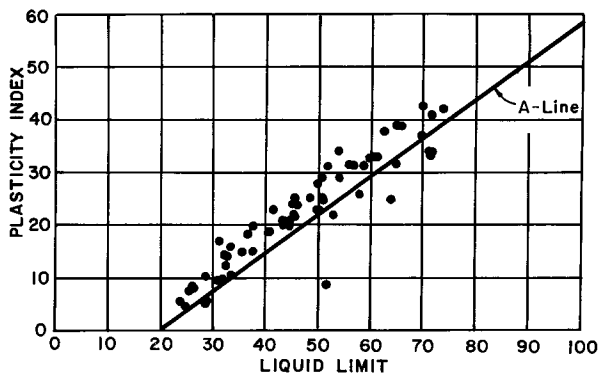
FIGURE 2. ATTERBERG LIMITS FOR COLLUVIAL SOILS

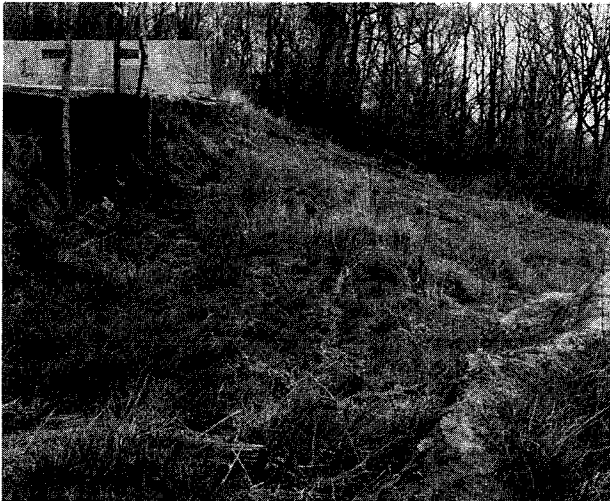
FIG. 3. Retreat of Scarp Under
Demolished House.

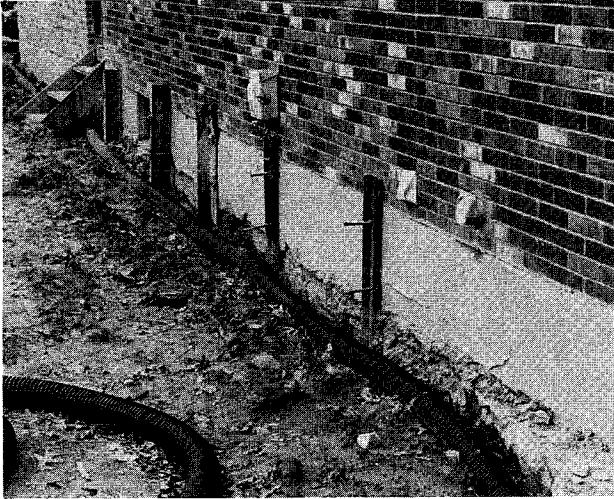
FIG. 5. Homeowner's Remedial Measures at Toe of Slide Area.

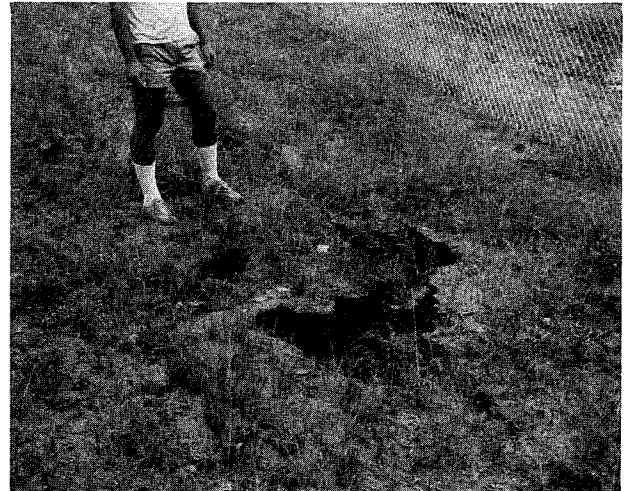
FIG. 8. Tension Crack in Failed Slope (typical).

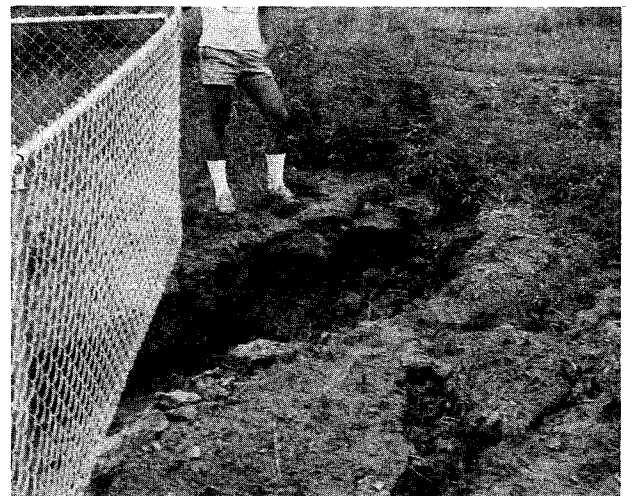
FIG. 11. Seep Near East End of Toe.

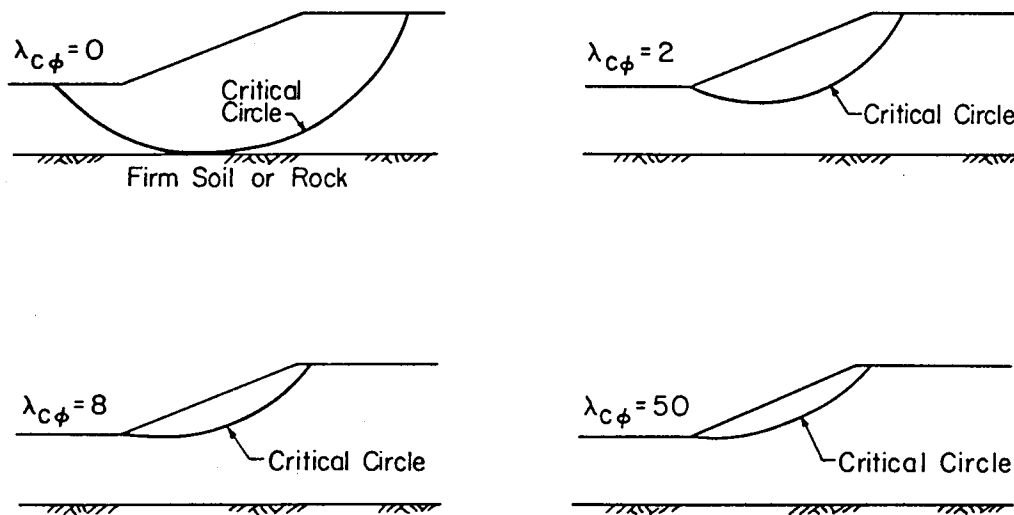
Fig.2. Critical circle locations for four values of $\lambda_{c\phi}$.

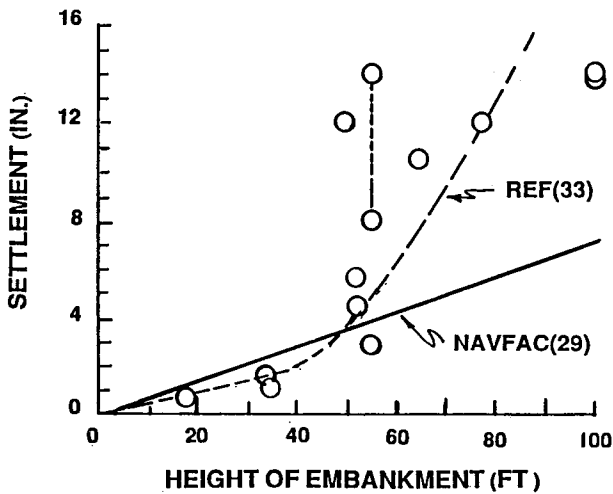
FIGURE 5. Long-Term Settlement as a Function of Embankment Height (after Hopkins (33)).

Secondary compression and settlement due to shear strain may occur even for well compacted fills. These settlements may amount to approximately 0.3 to 0.6 percent of the fill height over a period of 15 to 20 years (according to NAVFAC (29)). As shown in Figure 5 (33), estimated settlements due to secondary compression and shear strain for embankments constructed of fine-grained plastic soils (CL, CH, OL, MN) become significant for embankment heights greater than about 50 feet. Long-term settlements from field measurements and reported elsewhere (33) are compared to the criteria from NAVFAC in Figure 5. Embankments constructed of clays and clayey shales and greater than about 50 feet in height exhibited the most settlement. Large embankment settlements (10) observed on I 75 also confirm these observations. Many of these fills in excess of about 50 feet had settled several inches in a 20- to 25-year period after construction.

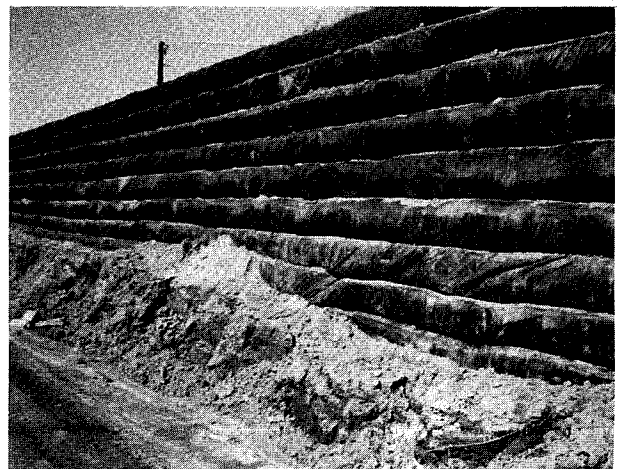
Figure 5. Completed section of the fabric reinforced wall.
