# Ohio River Valley Soils Seminar XLV

Geotechnical Aspects of  
Waterfront Development

October 17, 2014

# Ohio River and Tributary Local Protection Projects: Adjacent Bank Erosion and Failure-Related Endangerment after Action Report

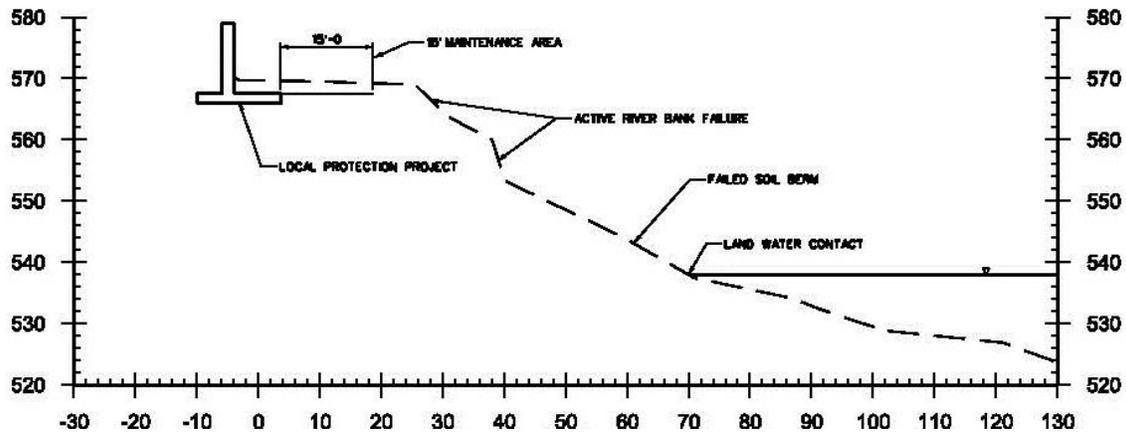
**Fig. 1. Typical cross section displaying the LPP, foundation, 15-foot maintenance easement area, and riverward bank failure conditions**

After evaluating bank topography adjacent to several of the Huntington District local protection projects, this report was prepared to identify reaches of threatened river bank that, with timely protection, would result in significant reductions in cost to construct. Referring to Point Pleasant as an example, if the river bank had been protected from initial erosion impacts, the cost of the 2011 upper bank protection project would have been reduced. These lower bank erosion features were located channelward of the project defined 15 foot maintenance and monitoring areas. Additional information, which was included during the development of these after action reports, established that the local entity responsible for the maintenance and operation of the LPP had not been obligated to maintain nor inspect beyond the 15 feet channelward area adjacent to the riverward toe or foundation of the structure or embankment (see Fig. 1). This monitoring limitation is significant since flood-related processes continue to erode adjacent river bank areas and thereby affect the stability of the local protection project embankment and structure foundations.

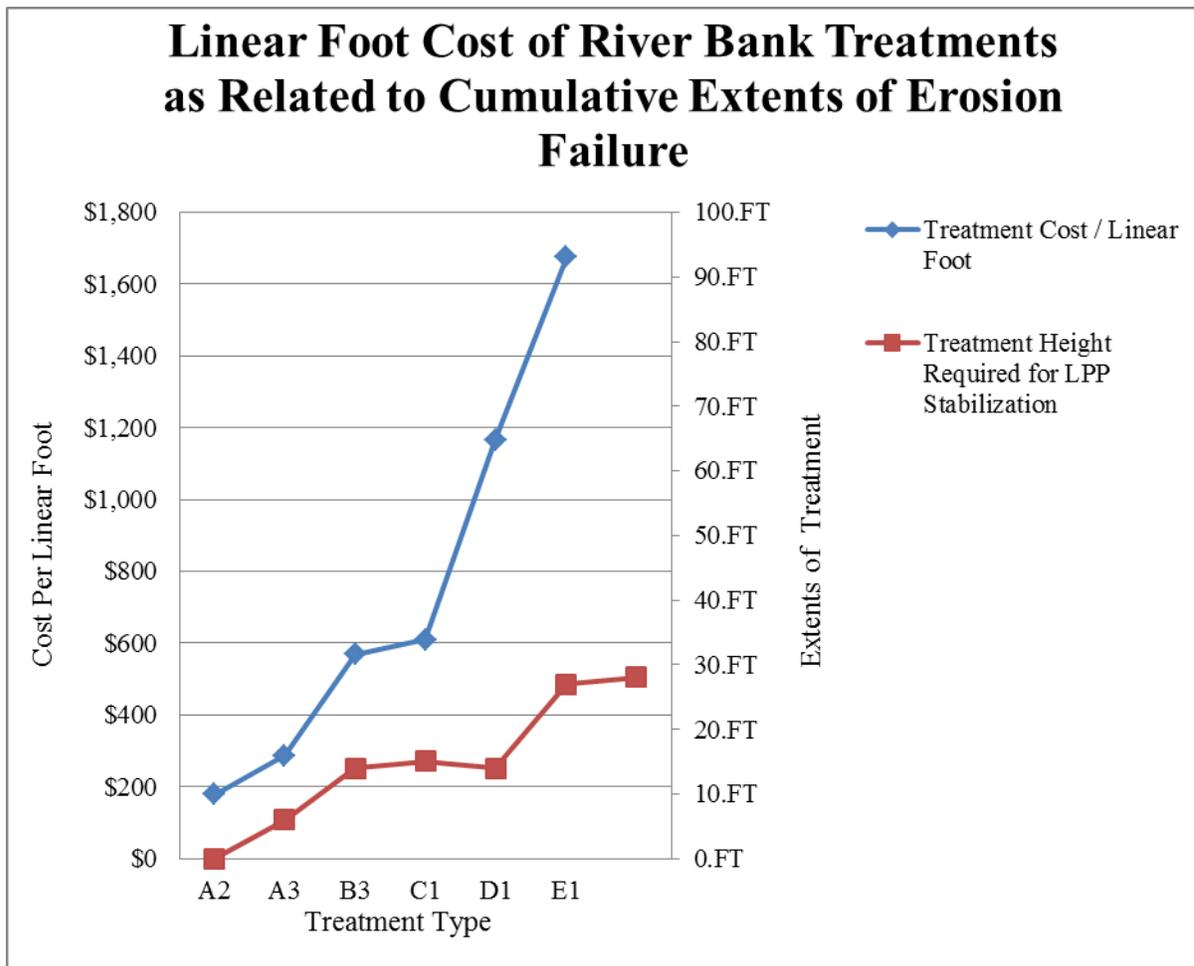
**Fig. 2. As extents of bank erosion and failure increase, the cost and height of treatment required for stabilization would increase as a nonlinear component.**

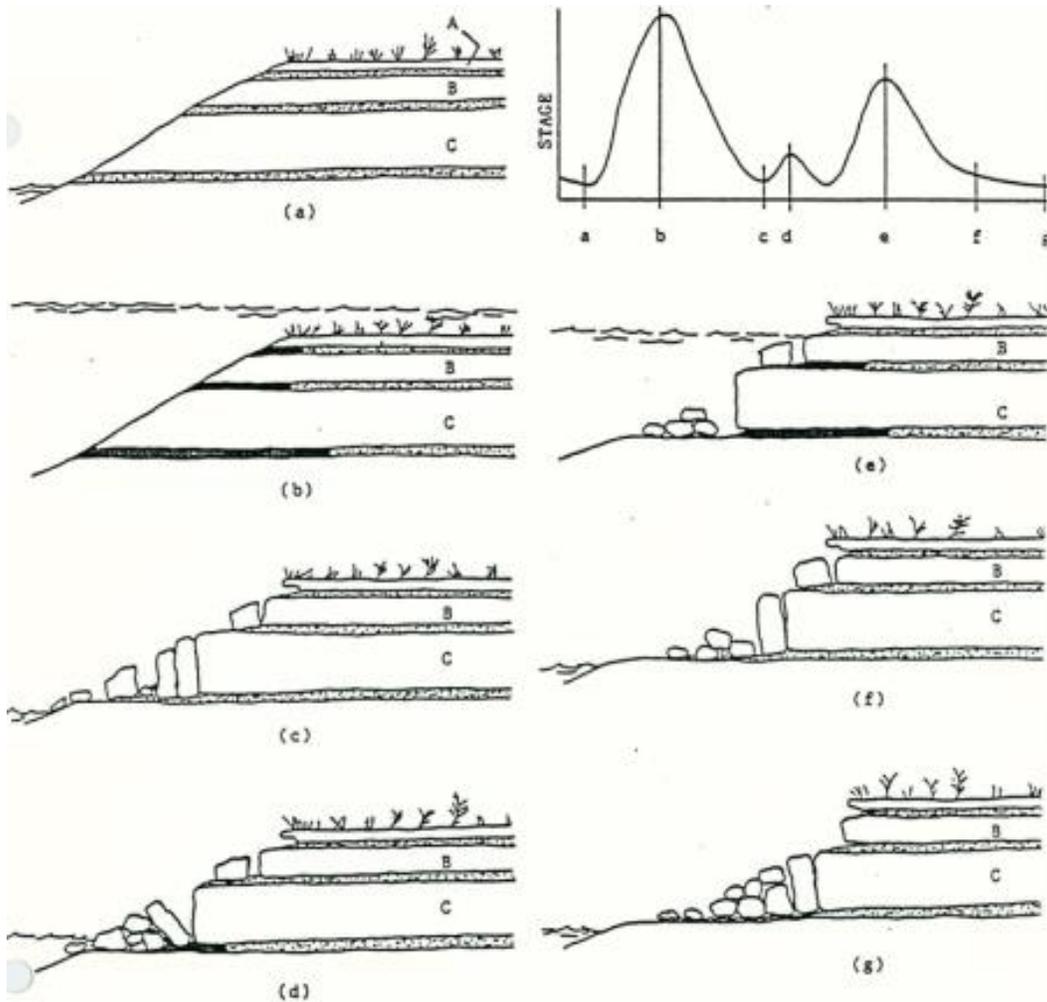
FIGURE 5 - IDEALIZED SEQUENCE OF BANK SAPPING AND

**Fig. 3. Idealized Sequence of Bank Sapping and Erosion from Clough & Duncan, 1986, page 40**

Other significant bank and terrace erosion and failure conditions, which were encountered along the Ohio and Tributary Rivers, are as follows (Fig. 3):

The Ohio River reach of riverbank at the Point Pleasant LPP had progressed from Fig. 3c to Fig. 3g during the period of observation. The continued process of high water and bank groundwater recharge and discharge with erosion of sandy bank materials by piping, then

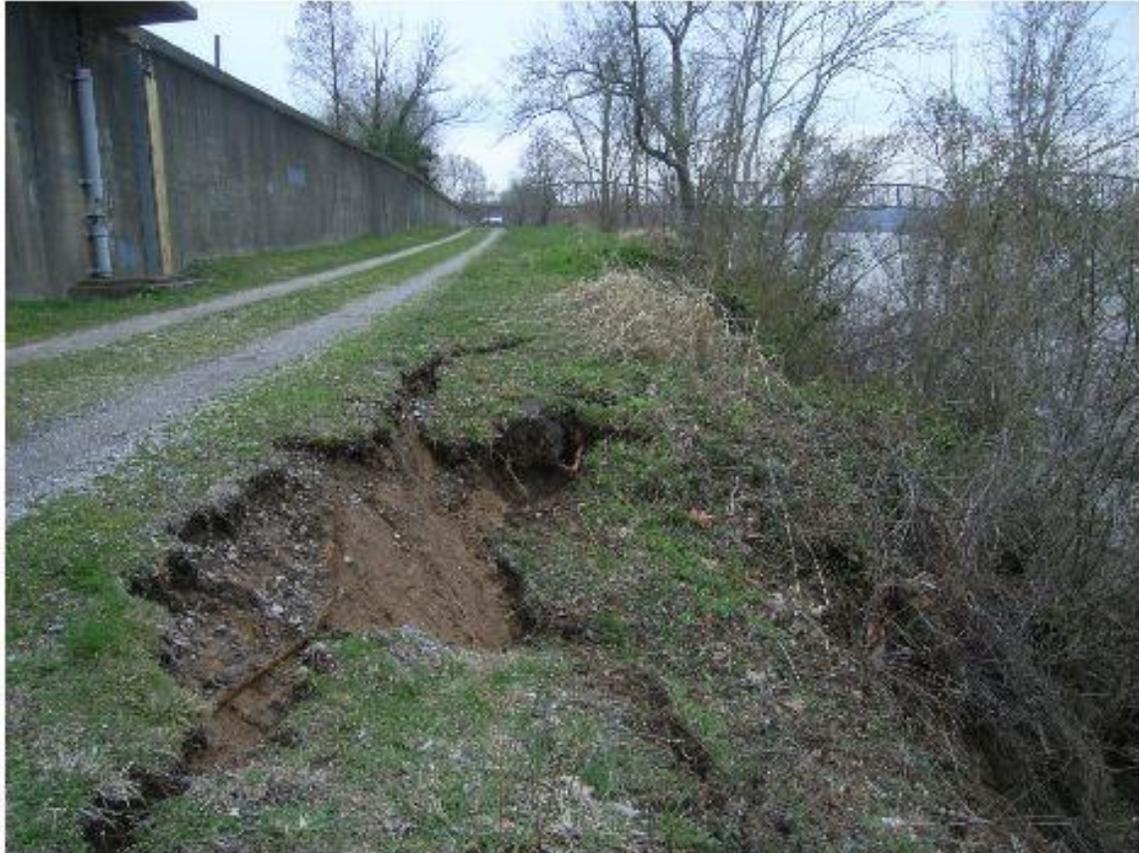
**Fig. 4. Point Pleasant pre-emergency construction depicting the 15-foot maintenance zone, looking down river (Humphreys, 2010, 1)**

the successive upslope collapse of the more cohesive soil layers, and the rework and transport of the failed soils re-exposing sand layers and removed the riverbank materials. However, years ago, the bank erosion features were located channelward of the project defined 15-foot maintenance and monitoring areas and were, therefore, not eligible for repairs (Fig. 4).

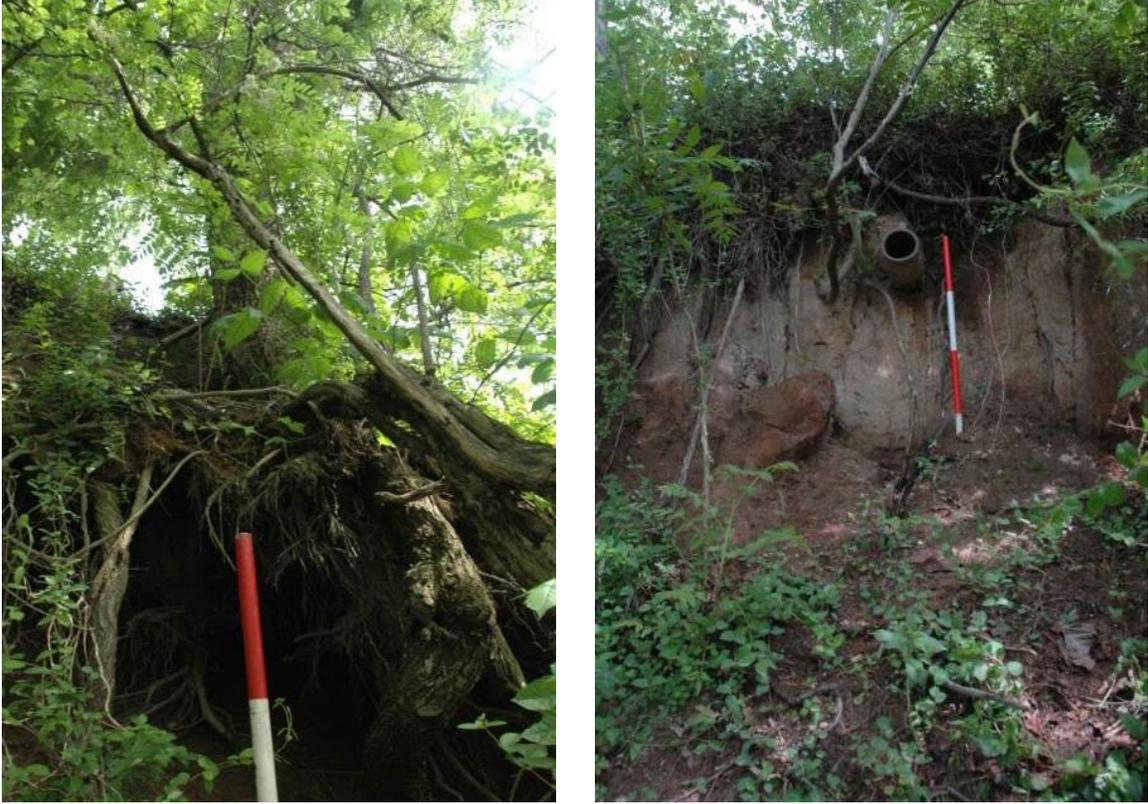
**Fig. 5. Point Pleasant, West Virginia LPP from toe of bank pre-construction**

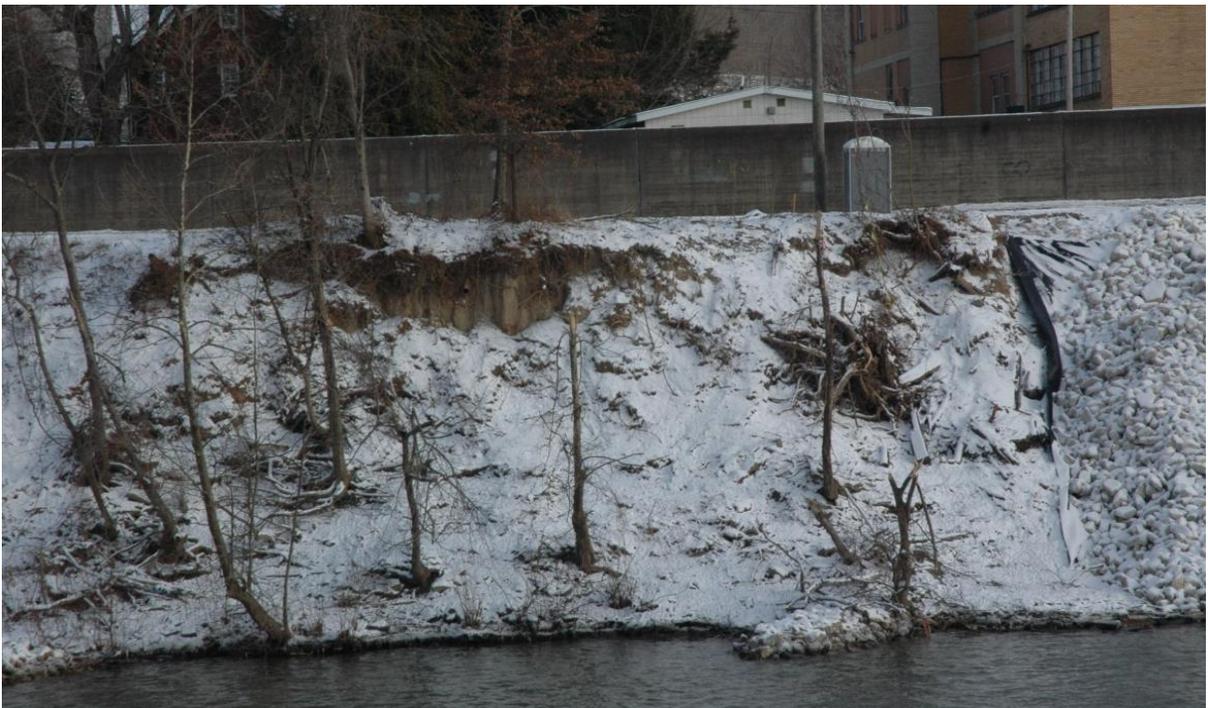
**Fig. 6. Point Pleasant, West Virginia LPP from toe of bank during construction**

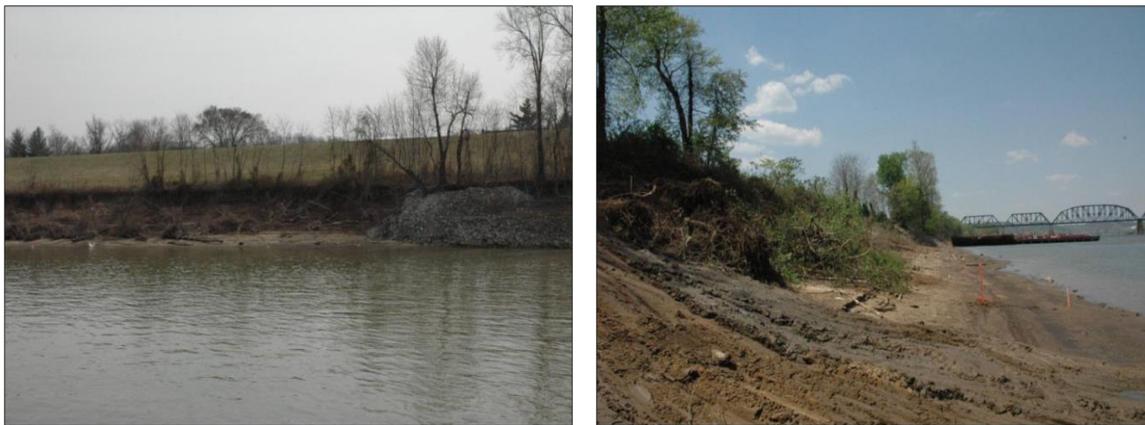
**Fig. 7. Ceredo-Konova, West Virginia LPP Emergency Flood Recovery project pre-construction 2005**

The Ceredo-Kenova, West Virginia LPP was recently re-evaluated. Bank, terrace, and slope areas within the LPP reaches adjacent to the Big Sandy River were relatively stable. Mowing-related rutting and limited interior drainage outfall and ditch erosion were observed. Two 400-foot reaches and one 2,000-foot reach of Ohio River bank, terrace, and slope erosion and failure, which had exposed the adjacent LPP embankment stability berm were stabilized during 2004 to 2005. Construction included excavation of in-place soil to stable slopes and the placement of stone dikes, granular fill, geotextile filters, and tied-back structures together with up and down channel keys and transitions. These treatments remain functional and have stabilized adjacent LPP berms and embankments. Additional project maintenance and repairs have not been required. Limited up-river bank reaches contain bank, terrace, and slope scarp features, which are adjacent to the LPP. Barge mooring areas within these reaches may limit moderate and low river stage near bank erosion and failures and increase extents of lower terrace sediment mantling. These conditions have been monitored and evaluated after Ohio and Big Sandy River high stage and flood events to better determine cumulative erosion and failure extents within this 6,000-foot bank reach adjacent to the LPP. Reaches of this LPP are presently threatened (Fig. 7).

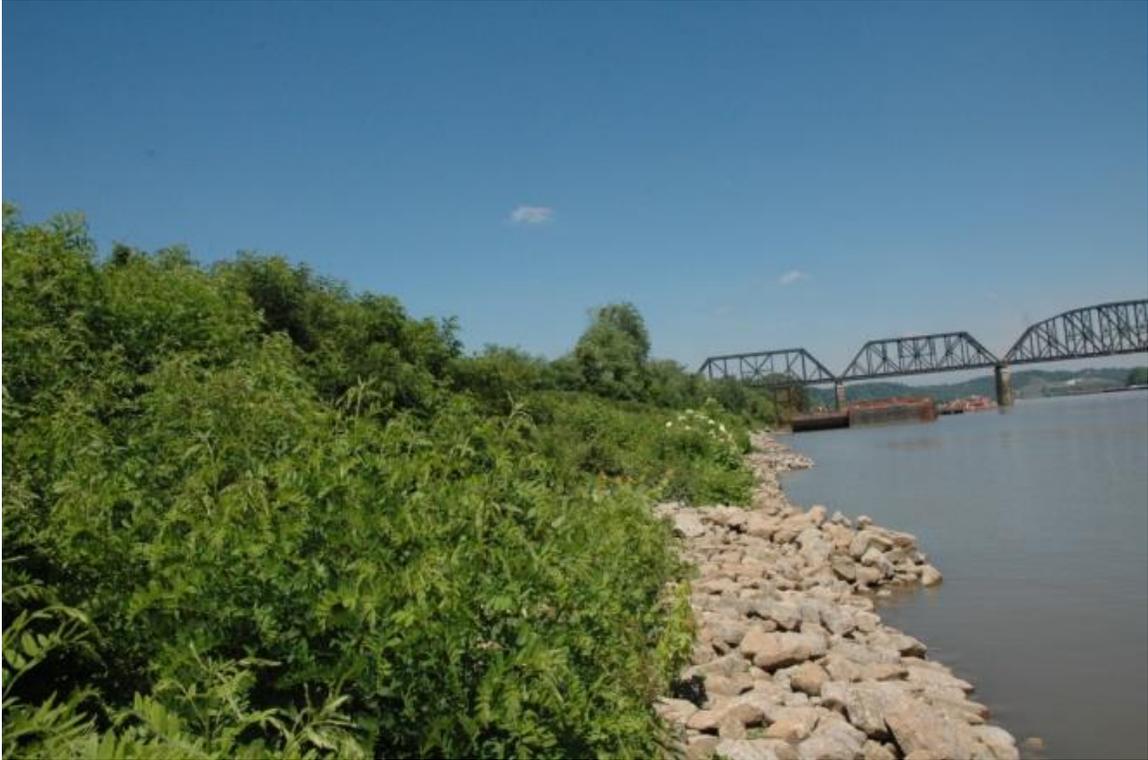
**Fig. 8. Ceredo-Kenova, WV LPP Emergency Flood Recovery project post-construction**

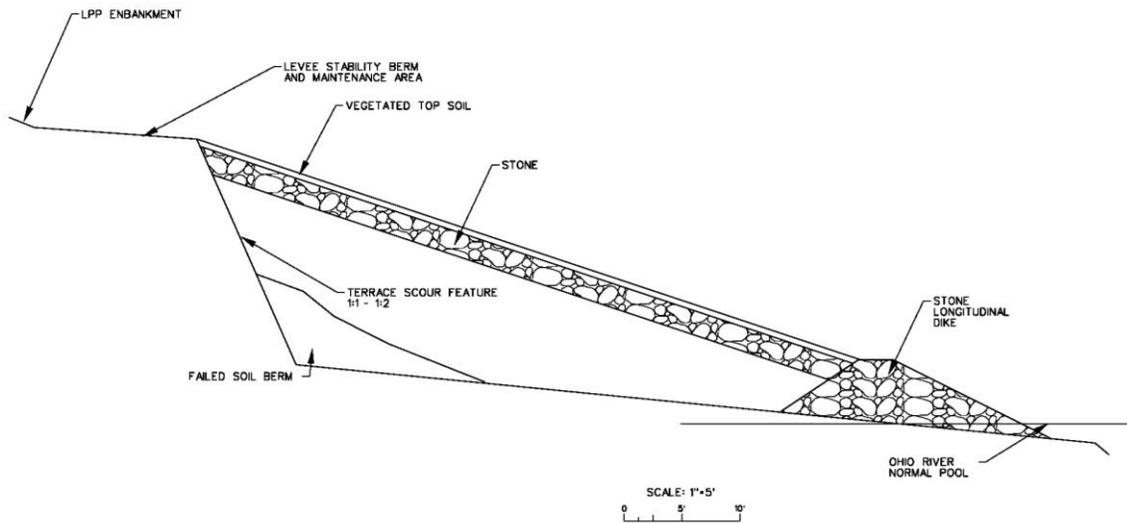
**Fig. 9. Ceredo-Kenova, West Virginia LPP Emergency Flood Recovery project design cross-section**

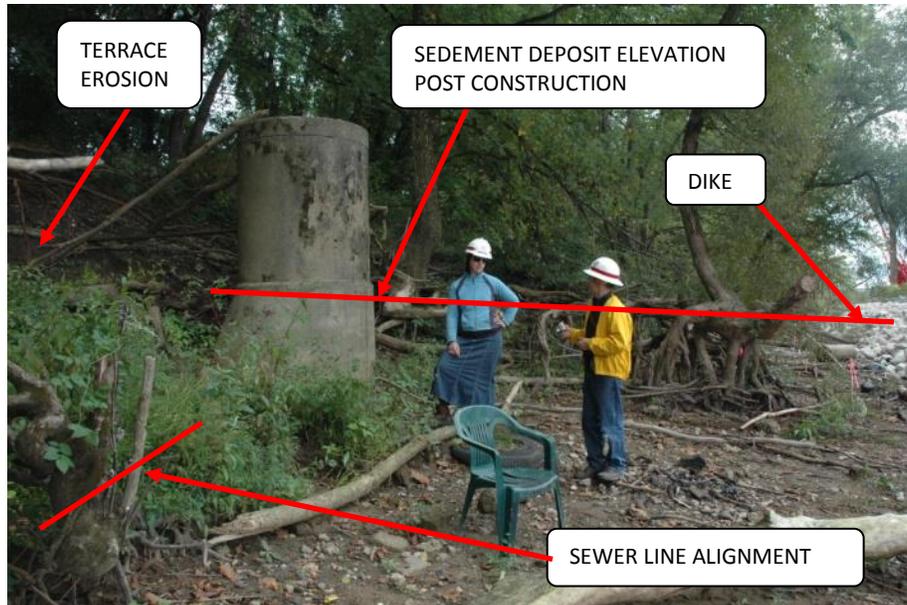
**Fig. 10. 7th Street West Emergency Sewer Line Stabilization during construction (Huntington, West Virginia LPP is on left past the tree line)**

As previously referenced, two bank and terrace reaches adjacent to the Huntington LPP have been partially stabilized by completion of Section 14 Projects, which were constructed to protect channelward sewers. These limited treatments precluded the more extensive placement of stone slope protections, which would have been required had bank, terrace, and slope erosion and failure continued. Additionally, combined sewer systems were grout stabilized along a 3,000-foot, eroding, and failing bank, terrace, and slope defined reach of the Guyandotte River located up-channel from the Pats Branch Pump Station. These treatments limited flood stage-related underseepage, internal erosion, fill and bank alluvium failures and assured long-term LPP functionality (Figs. 10 and 11).

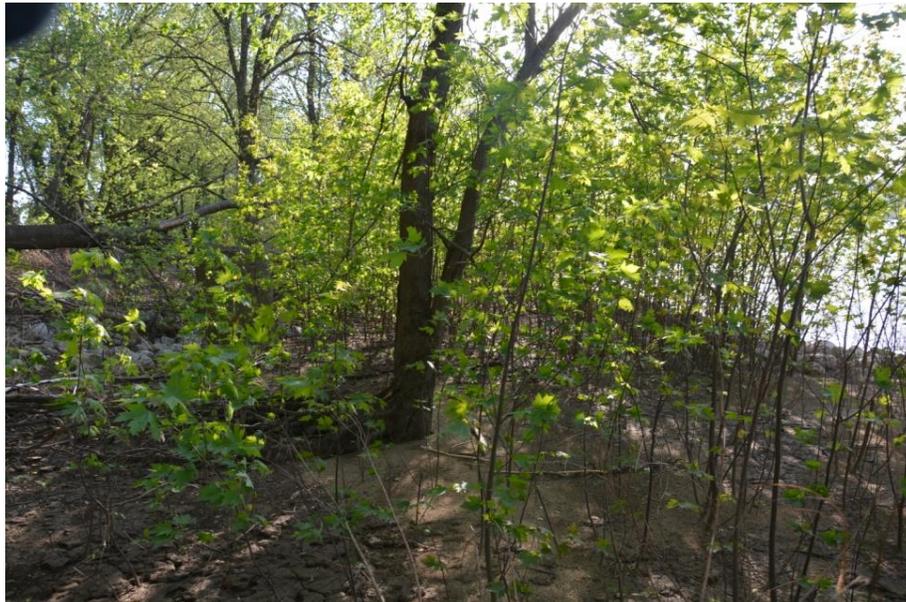
**Fig. 11. 7th Street West Emergency Sewer Line Stabilization sediment deposits post construction (Huntington, West Virginia LPP is on left past the tree line)**

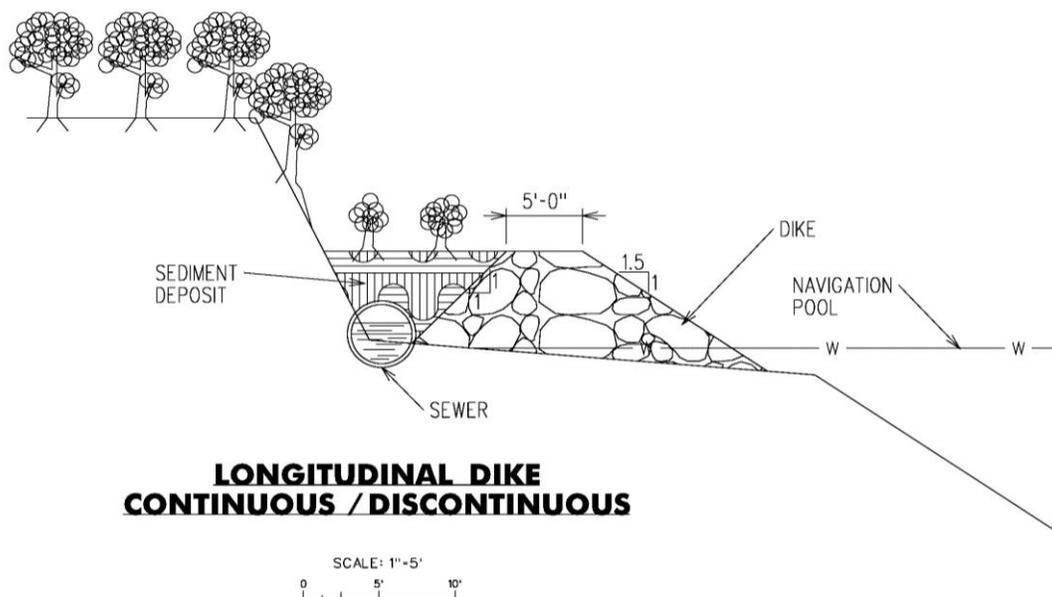
**Fig. 12. Cross section of treatment alternative constructed at 7th Street West Emergency Sewer Stabilization project**

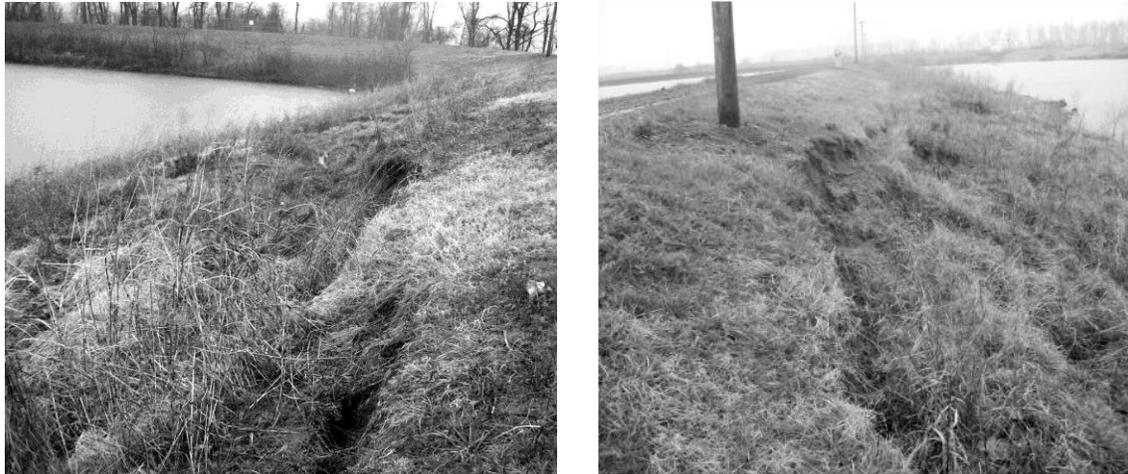
**Fig. 1. Slope failures in New Madrid Power Plant levee**

The coal-fired New Madrid Power Plant in New Madrid, Missouri has a 23-acre raw water pond to store water for use in plant operations. A rectangular-shaped levee surrounding the pond retains the water, which is collected from the nearby Mississippi River. A series of three slope failures occurred over several years along a 1,000-foot long stretch of the levee's embankment (see Fig. 1).

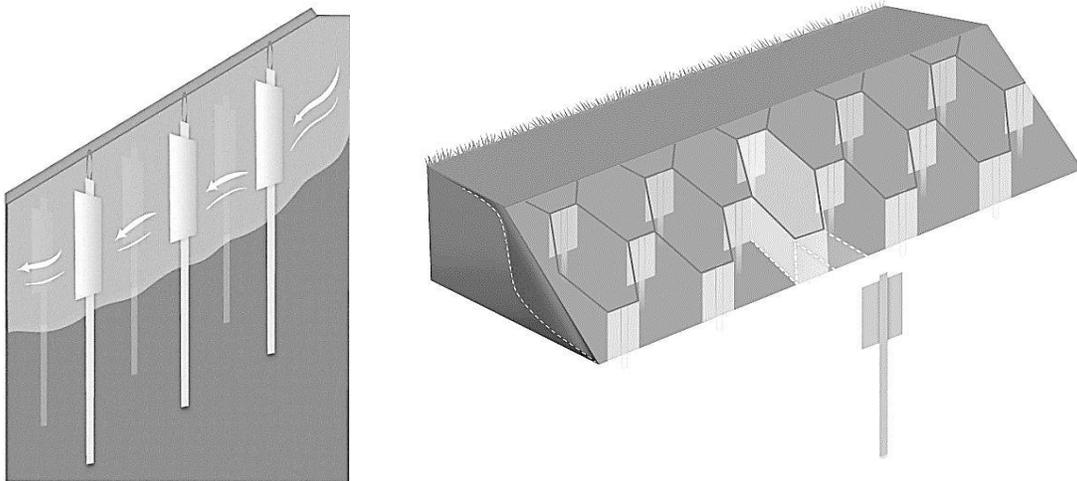
**Fig. 2. Illustration of (a) Plate Piles in section view; (b) Plate Piles in plan view**

The Plate Piles are driven through the unstable layer to penetrate the underlying stable materials, as shown on Fig. 2a. Plate Piles are installed in a staggered grid pattern, as shown on Fig. 2b. Plate Piles mobilize the strength of the soil through arching and transmit slide forces to the underlying stiffer soil. The downslope force on each Plate Pile is resisted by the shear and bending strength of the Plate Pile shaft in combination with the passive resistance of the soil behind the plate.

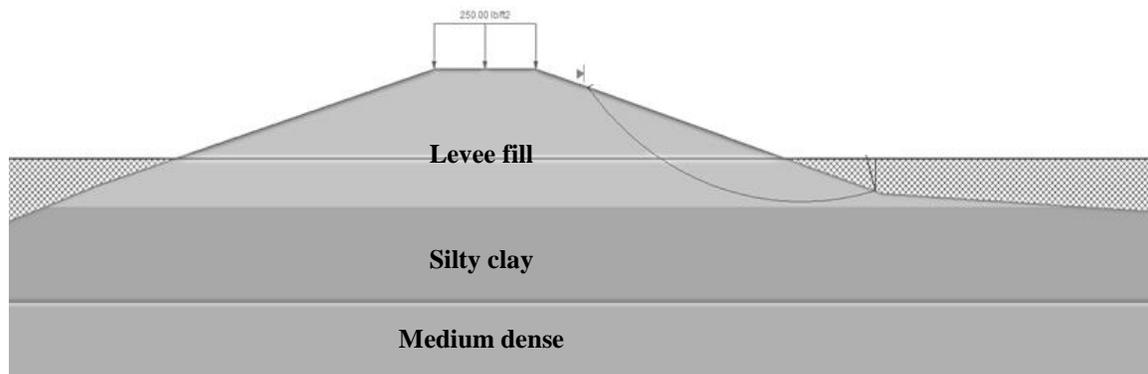
**Fig. 3. Back-calculated failure surface**

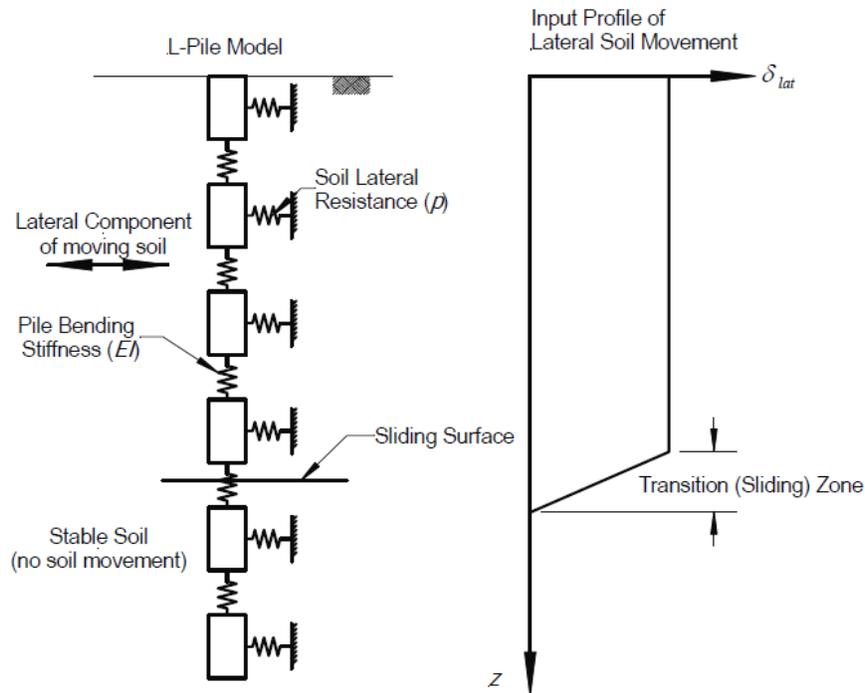
**Fig. 4. Conceptual illustration of LPILE model used to compute lateral response of piles subjected to lateral soil movements (from Loehr & Brown 2007)**

The Plate Piles are loaded in LPILE by lateral soil movements over the depth of the slide plane until a limiting state is reached. The displacement value is transitioned to zero over a distance of 12 inches at the approximate location of the failure surface (Loehr & Brown 2007), as illustrated in Fig. 4. This approach is empirical but has been verified by instrumented case histories and numerical analyses, and is supported by Kourkoulis et al. (2012), Loehr & Brown (2007), and White et al. (2008). The limit state of the Plate Pile may be equal to the ultimate bending moment or the allowable lateral soil movement. Using the ultimate bending moment as a limit state is supported by FHWA (2005) and Loehr & Brown (2007). The shear force at the sliding depth when the first limit state is reached is considered to be the mobilized resistance for that sliding depth (Loehr & Brown 2007, FHWA 2005).

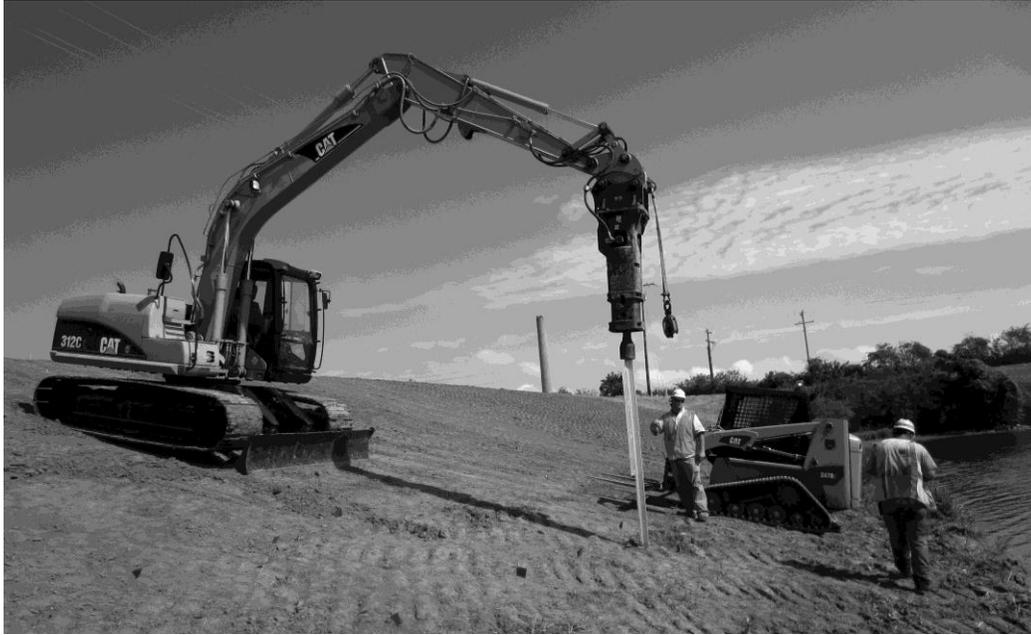
**Fig. 5. Installation of Plate Piles at the New Madrid Power Plant**

The final design for the levee stabilization included six rows Plate Piles driven into the failed slope. The Plate Piles were fabricated from 3 x 3 x 3/8 steel angles with 12 x 48 x 1/4 inch steel plates; lengths of 10, 12, and 14 feet were used.

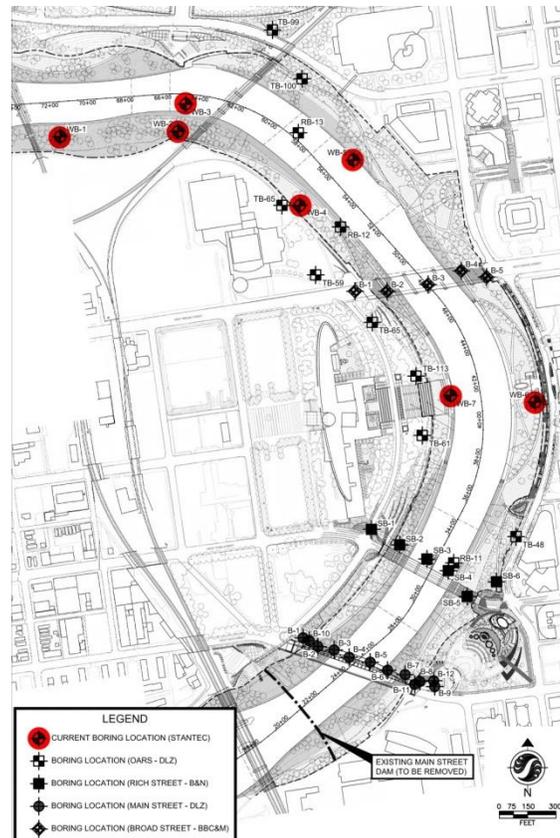
**Fig. 3. Boring Locations within Scioto Greenways Project Limits**

Significant geotechnical information was available from publically available document archives, as several downtown bridges crossing over the Scioto River within the project limits had been replaced within the past 20 years and the alignment for a new major trunk sewer tunnel passed beneath portions of the project. This existing base of subsurface knowledge provided significant information with regard to the underlying bedrock consistency and topography, resulting in the requirement for only a few additional isolated borings to be performed at select locations in order to better define support

conditions for key structures (see Fig. 3). However, securing the additional geotechnical information of the soil overburden within the river channel required drilling and sampling within the active water limits of the river. Since the water level was considered too deep in most locations to permit drive-on drill rig access, but also too shallow in many locations to depend on barge support for a floating drilling plant, Stantec mobilized a Marsh Buggy unit, from Louisiana, to the site and mounted our drill rig on the Buggy. The Marsh Buggy permitted free movement of the rig between borings within the river, no matter the depth to river bottom.

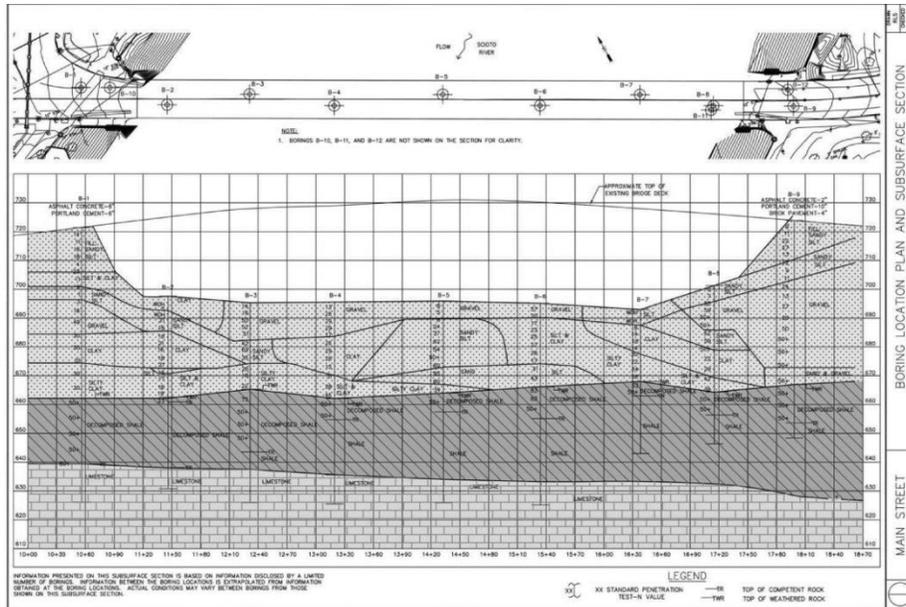
**Fig. 4. Subsurface Schematic Section – Main Street Bridge, Columbus, OH**

In general, the underlying bedrock within the Scioto River Basin consists of weak shale overlying fractured limestone. Fairly strong till overlies the bedrock, having been consolidated by the glaciers which advanced and then retreated over this region. The deposits overlying the till exhibit the most variation, since these deposits are the product of river-influenced deposition. The borings performed for this investigation generally confirmed the findings of previous investigations but allowed for better definition of the nearer river bottom deposits which would impact soil-structure interaction analyses. In general, the subsurface stratigraphy within the existing river limits consists of about 20 feet of recent alluvium overlying about 10 feet of the till, which is underlain by about 25 to 30 feet of weak shale over the limestone (see Fig. 4).

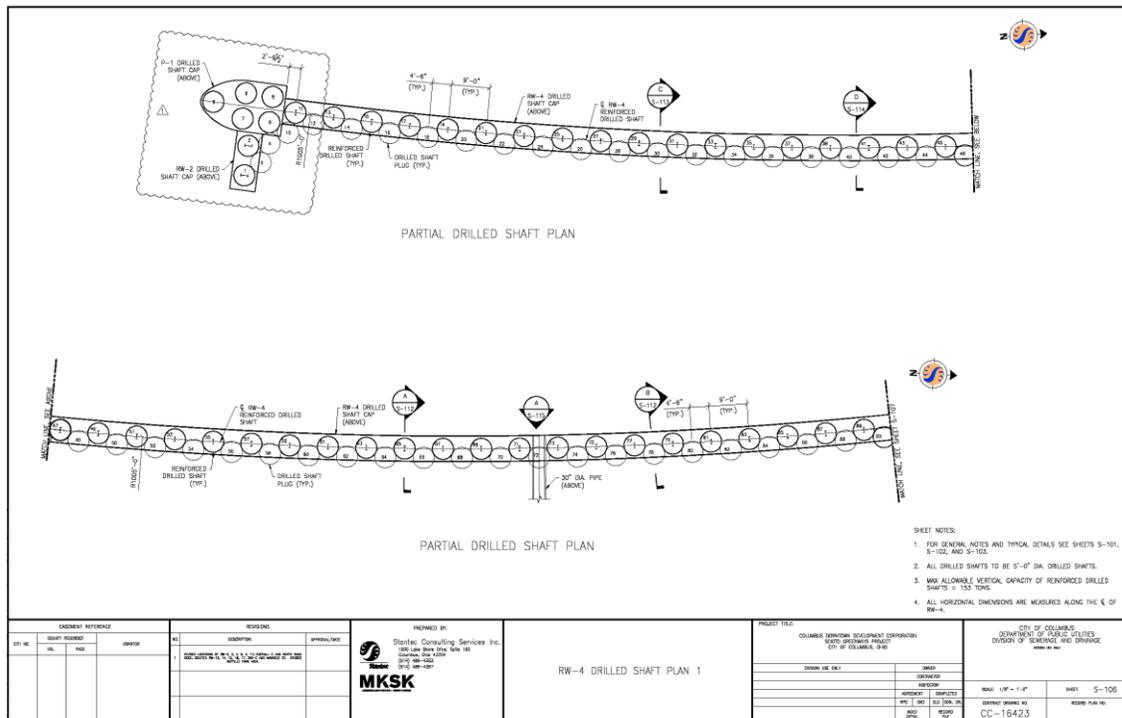
**Fig. 5. Drilled Shafts Foundation Orientation – Lower Promenade Wall**

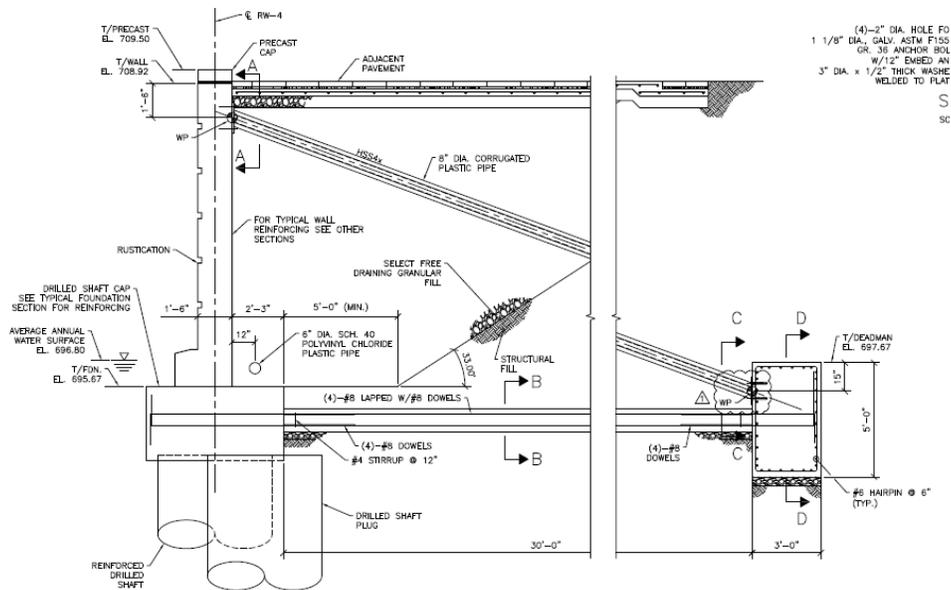
**Fig. 6. Lower Promenade Wall – Deadman – Tieback Arrangement**

the drilled shafts and wall under service loads. The final selected arrangement is shown in Fig. 6, wherein a system of tiebacks anchored to deadmen buried within the new embankment fill was selected. This arrangement offered resistance to lateral loads at the top and bottom of the Lower Promenade Wall as well as at the top of the drilled shafts (at the cap). This system also offered sufficient resistance to maintain lateral deflections to within acceptable limits.

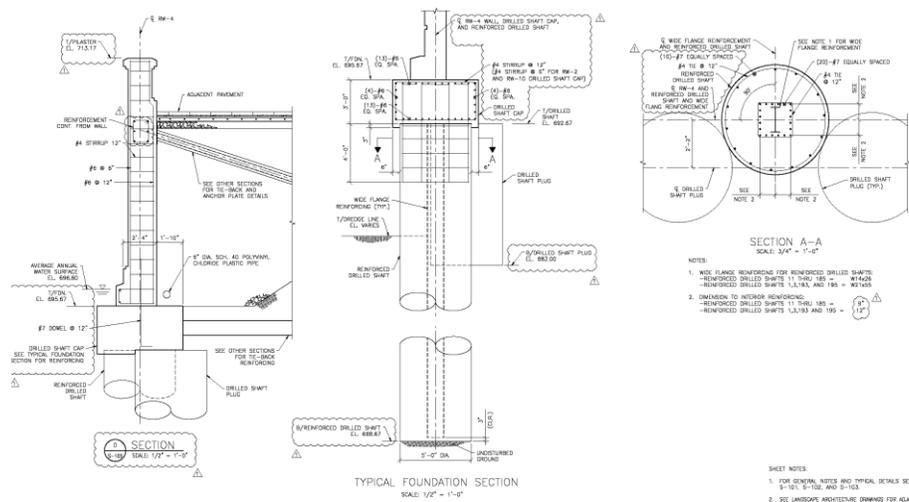
**Fig. 7. Lower Promenade Wall – Drilled Shaft Structural Details**

The soil-structure interaction of the structural drilled shafts was then analyzed under two conditions: 1) during drilled shaft and wall construction (with no excavation of river deposits); and 2) during service (after excavation of the pools within the river). LPILE, V6 was used to assess deflections, bending moments and shear forces within the drilled shafts as part of the drilled shaft design process. Target maximum lateral deflection at the top of the drilled shafts under Condition 1 was elected to be 0.1 inch, with the target maximum lateral deflection at the top of the shaft under service load (Condition 2) was elected to be 1.0 inch. The resultant structural drilled shaft design meeting both of these conditions included a W14X26 steel member for the majority of shafts supporting the wall and a W21X55 steel member for a few of the shafts positioned at the ends of the wall.

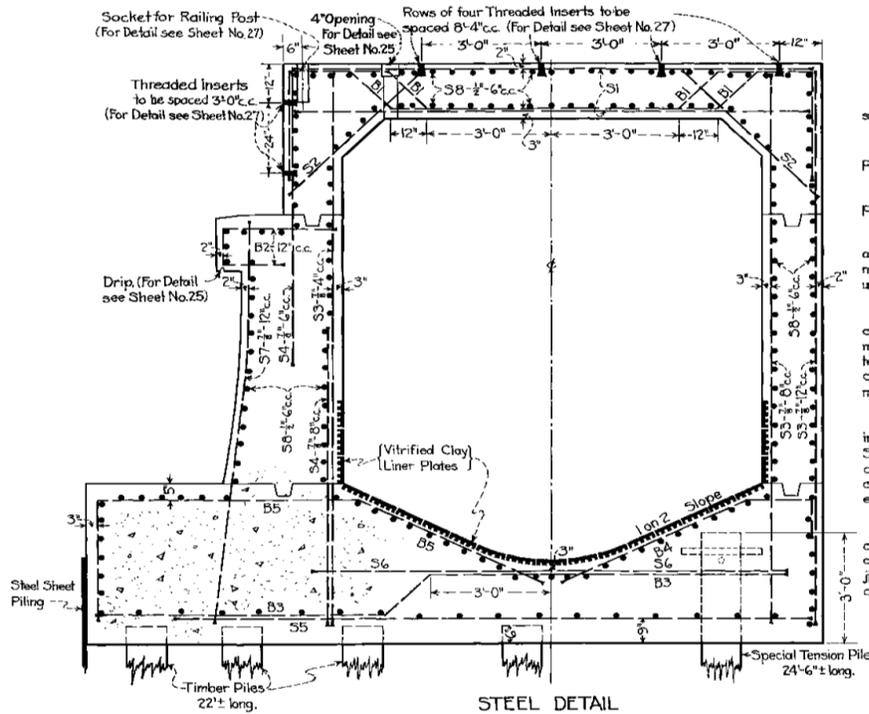
**Fig. 8. OSIS – Typical Section**

The second soil-structure interaction challenge on this project involved the assessment of the impact of new embankment fill, to be placed directly against the west wall of the Olentangy Scioto Interceptor Sewer (OSIS), on the OSIS structure. Up to 35 feet of new embankment fill is to be placed against the OSIS. The OSIS collects and conveys sewer flows from a large tributary area to the east and north of the downtown Columbus area. The OSIS is a heavily-reinforced concrete structure (see Fig. 8) that was constructed in 1928. Subsequent to completion of the OSIS, the Columbus floodwall was constructed on top of the OSIS, and backfill was placed behind these structures, forming the area now termed the Scioto Mile in Columbus. Proposed new embankment fill is to be placed to

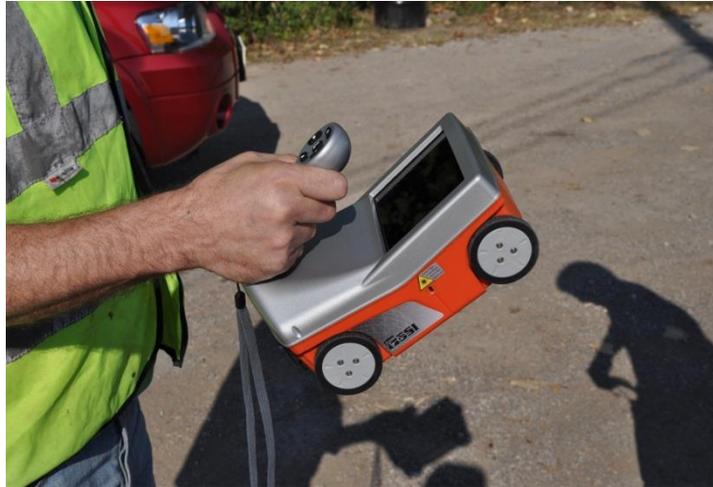
**Fig. 9. Hand-Held GPR Unit (courtesy RII)**

The physical assessment of the OSIS and floodwall included the verification of reinforcing steel placement and size as well as the procurement of concrete core specimens at selected locations along the exposed west wall of the OSIS. Resource International, Inc. of Columbus was retained to provide ground penetrating radar (GPR) field measurement services (see Fig. 9) for this task, and they were supported in the field with personnel from Shelley Metz Baumann Hawk, Inc. (SMBH) structural engineers, since SMBH was knowledgeable of the OSIS/floodwall structure, having been retained for the previous Scioto Mile work. The GPR work was performed from a floating unit, with access restricted to the middle portion of the west OSIS exterior wall. As the GPR displayed/recorded the reflections, the output was also used by the team on site to physically mark the location of prospective reinforcing steel on the exposed concrete surface. Such markings were used to alert the followup coring crew as to the locations of

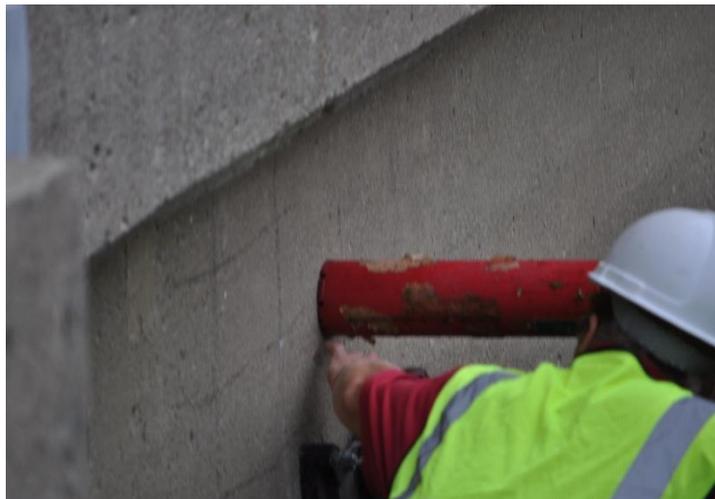
**Fig. 10. OSIS – Concrete Coring**

the reinforcement, with the goal of minimizing any long term negative impacts to the structure as part of our field work. Concrete cores were subsequently procured (see Fig. 10), with these cores used for visual assessment and strength testing purposes.

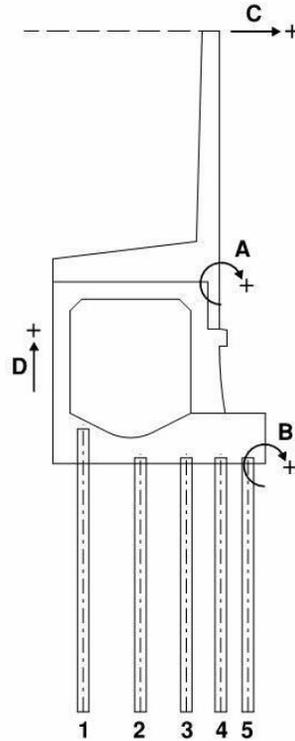
**Fig. 11. OSIS/Floodwall Model**

The FLAC output also provided information with regard to load imparted to the existing piles under the various load conditions previously described. Of particular concern to the City of Columbus Department of Public Utilities (DPU) was the predicted load in Pile 1 (ref. Fig. 11), positioned at the easternmost location along the OSIS back wall, as the piles at this location were subjected to a temporary uplift load during one phase of the construction and the pile butt had been embedded higher into the OSIS foundation. For the loading conditions modeled, the computed pile loadings did display variation from the existing condition; however, no pile was computed to sustain a loading in excess of the maximum pile load (for any pile) computed in the 1928 calculations.

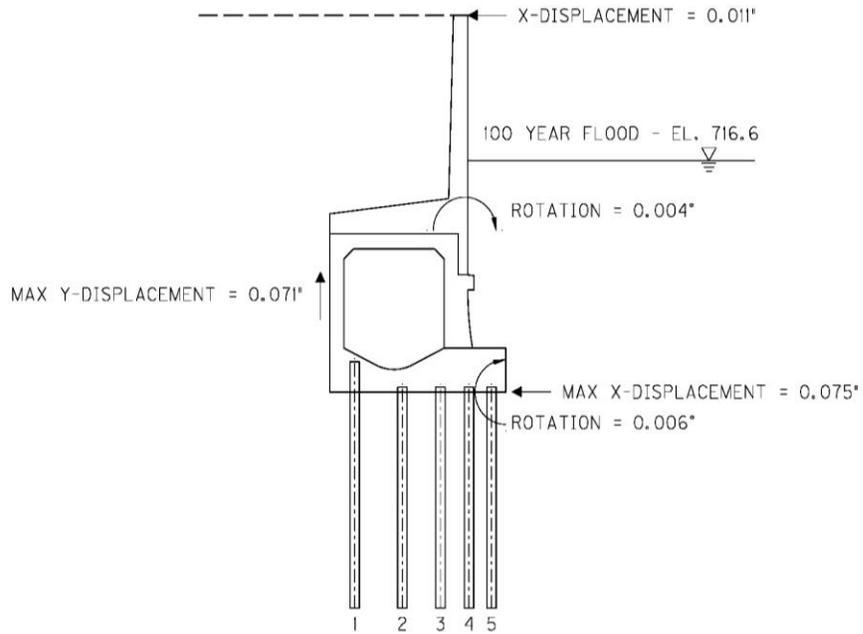
### MAX DISPLACEMENTS

100-YEAR FLOOD - WITHOUT PROPOSED FILL

**Fig. 12. OSIS/Floodwall – FLAC Output Case 2**

The results for two of the analyses are shown in Figs. 12 and 13, with a tabular presentation of the analyses included in Table 1. In general, the most significant movement of the OSIS appeared to occur after the return of the river level to a normal 1-year pool after a 100-year flood event, wherein the east edge of the OSIS structure was computed to deflect downward as much as 0.15 inch. Also under normal loading conditions, the OSIS appears to move in a similar manner, but with smaller deflections/rotations. The addition of Geof foam appears to reduce the computed displacements, but the improvement seemed inconsequential, considering the extra costs associated with the use of Geof foam along several thousand feet of OSIS wall.

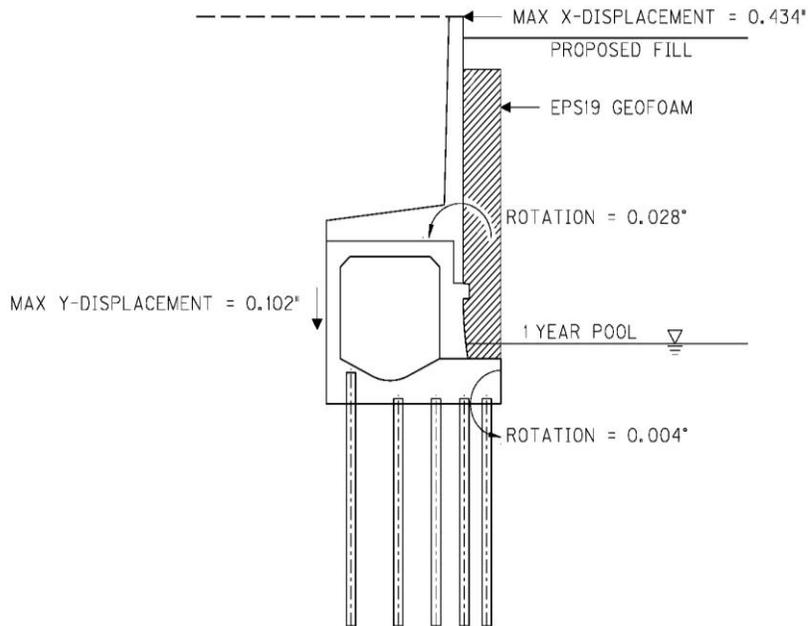
### MAX DISPLACEMENTS

EPSI9 GEOFOAM

POST 100-YEAR FLOOD/1-YEAR POOL

**Fig. 13. OSIS/Floodwall – FLAC Output Case 8**
