# Ohio River Valley Soils Seminar XLV

Geotechnical Aspects of  
Waterfront Development

October 17, 2014

# Ohio River and Tributary Local Protection Projects: Adjacent Bank Erosion and Failure-Related Endangerment after Action Report

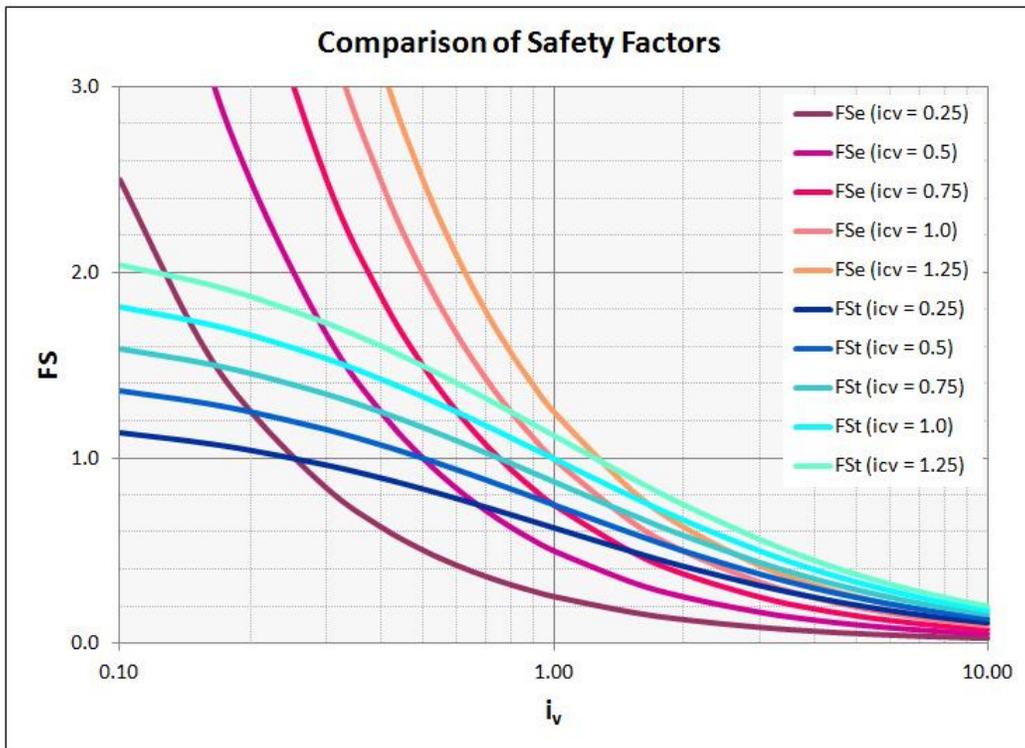
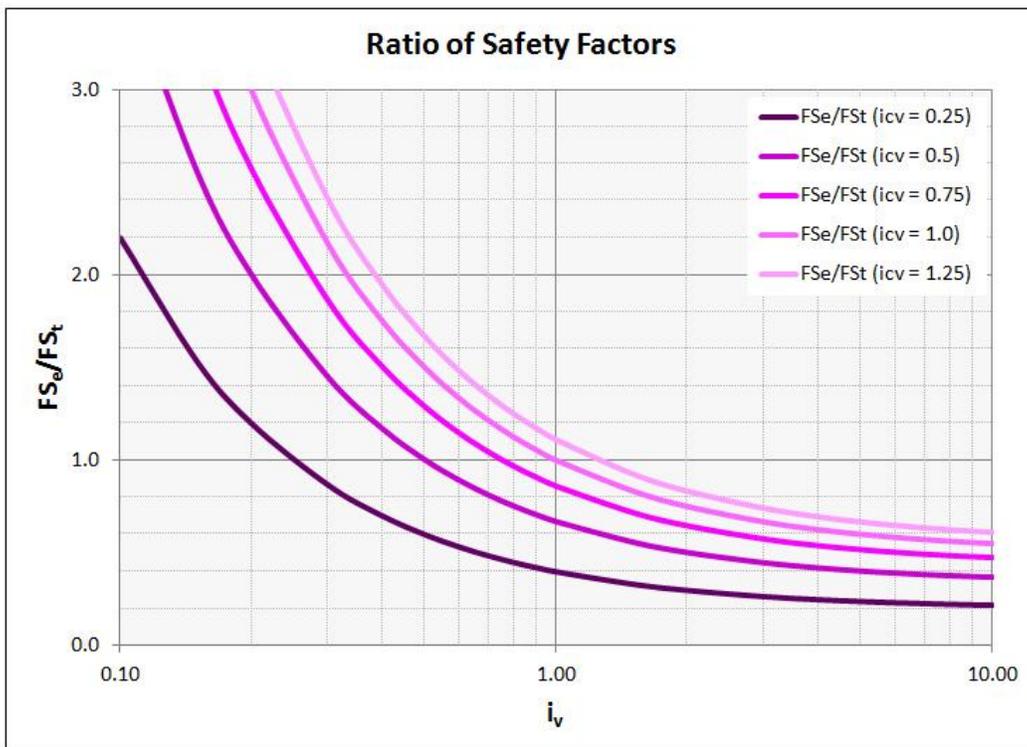
**Fig. 1. Relationship between effective stress ( $FS_e$ ) and total stress ( $FS_t$ ) factors of safety against erosion initiation (for vertical seepage conditions) as a function of critical hydraulic vertical gradient ( $i_{cv}$ ) and actual vertical hydraulic gradient ( $i_v$ ).**

Regarding relief well system (and other seepage control measures) design, effective stress methods typically appear in guidance documents and are widely utilized, whereas little guidance exists regarding acceptable total stress factors of safety. Regardless of the analysis approach (whether evaluating  $FS_e$  or  $FS_t$ ), the above formulations and Fig. 1 illustrate the relationship at a given gradient between  $FS_e$  and  $FS_t$ . For relief well system design, effective stress analysis is typically utilized and appropriate, although a corresponding  $FS_t$  directly calculated or determined using Fig. 1 can be considered if determined to be advantageous. For example, in a situation where  $i_v$  is equivalent to 0.5 and the confining layer has an average  $\gamma_{sat}$  of 124.8 pounds per cubic foot (corresponding to an  $i_{cv}$  of 1.0), values of  $FS_e$  of 2.0 and  $FS_t$  of 1.33 (with  $FS_e / FS_t = 1.5$ ) can be computed using Equations 1 and 2 or directly obtained from their solutions which are plotted in Fig. 1.

For the Lawrenceburg Flood Protection System (Fig. 3), underseepage analyses for different project reaches yielded  $FS_e$  values ranging from 0.6 to 2.2 for the 100-year flood loading condition (pool elevation of 490 feet). Since  $FS_e$  values along two project reaches were found to be below typical design standards, 29 new (10-inch diameter) relief wells, with designed penetrations ranging from 25 to 80 percent, have been designed for future installation in these reaches (Thelen Associates Inc., 2014). The design of the new wells was conducted in accordance with USACE (1992) and to achieve a design loading (pool elevation of 503 feet) maximum exit gradient ( $i_v$ ) of 0.5, which in this case (where  $i_{cv} = 1.0$ ) corresponds to an  $FS_e$  of 2.0 and a  $FS_t$  of 1.3 (Fig. 1). General information on the Lawrenceburg Flood Protection System is provided above.

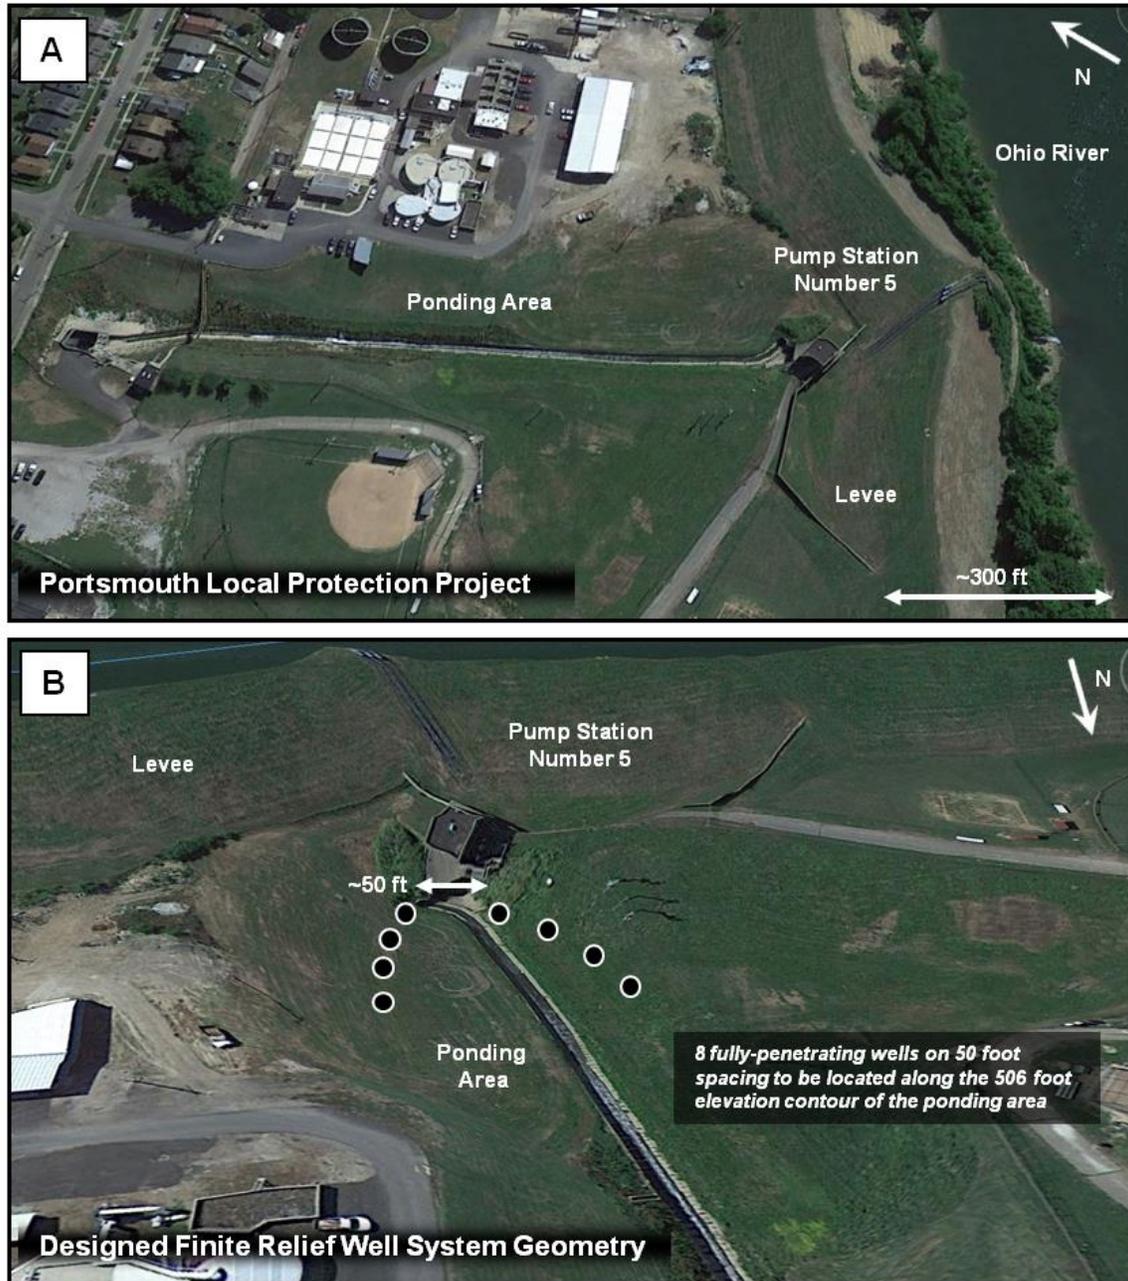
**Fig. 2. Representative aerial photograph (A) of the Portsmouth Levee Pump Station Number 5 reach (looking northeast), and layout of a finite relief well system designed to reduce uplift pressures during the 100-year loading condition (B).**

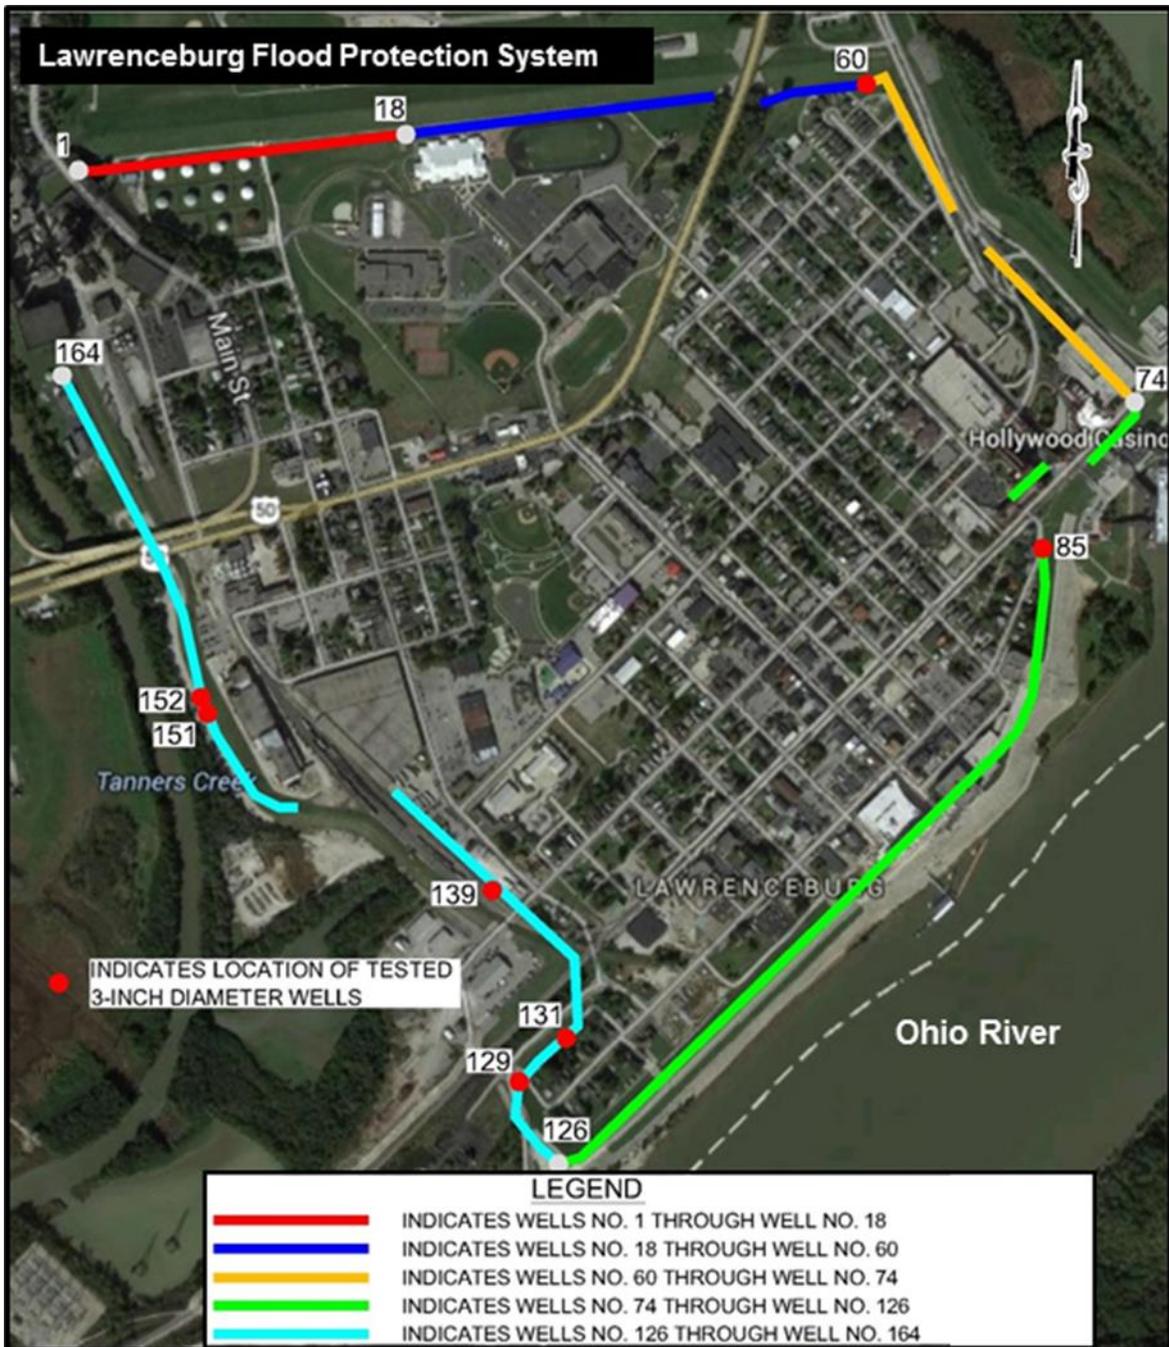
**Fig. 3. Layout of existing relief wells superimposed on an aerial photograph of the Lawrenceburg Flood Protection System. The spacing between Well No. 1 through Well No. 18 is 100 feet; the spacing between Well No. 18 through Well No. 60 is 50 feet; the spacing between Well No. 60 through Well 74 is 150 feet; the spacing between Well No. 74 through Well No. 126 is 100 feet; and the spacing between Well No. 126 through Well No. 164 is 150 feet. See text for discussion.**

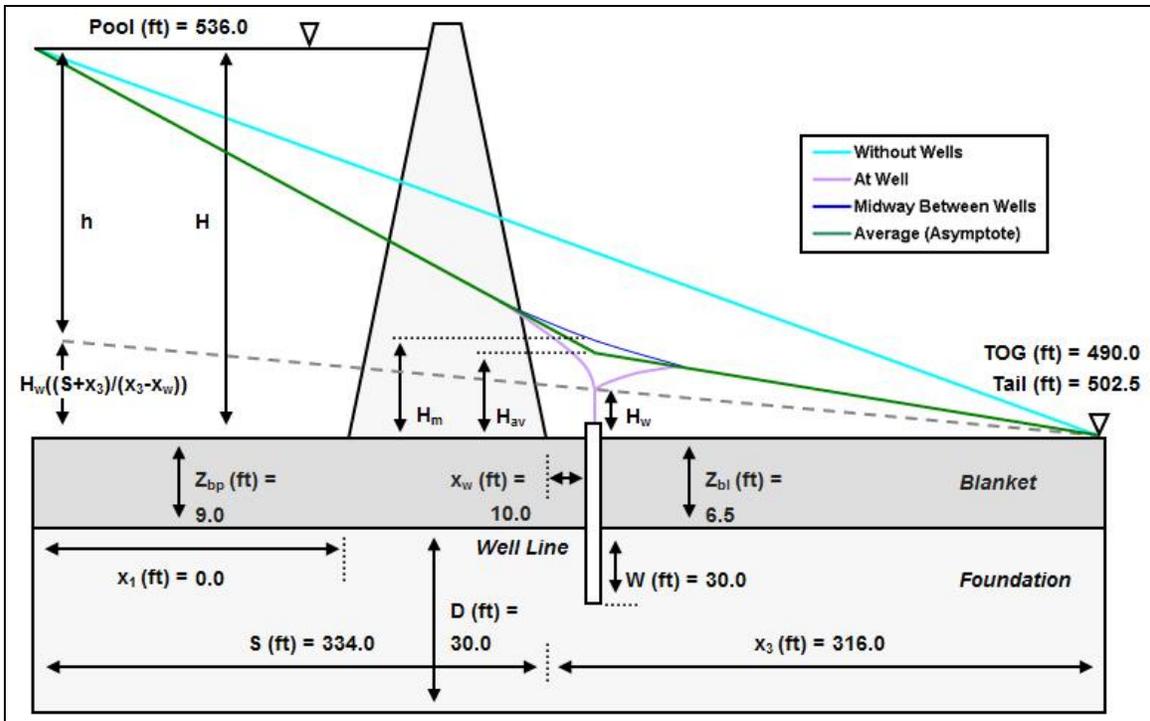
**Fig. 4. Conceptual diagram illustrating relief well system design parameters for an infinite well line; variables are as defined in the text and Guy et al. (2010). Load conditions and parameter values indicated were used for the Portsmouth Pump Station Number 5 system design. This drawing is not to scale and plotted head curves are for illustration purposes.**

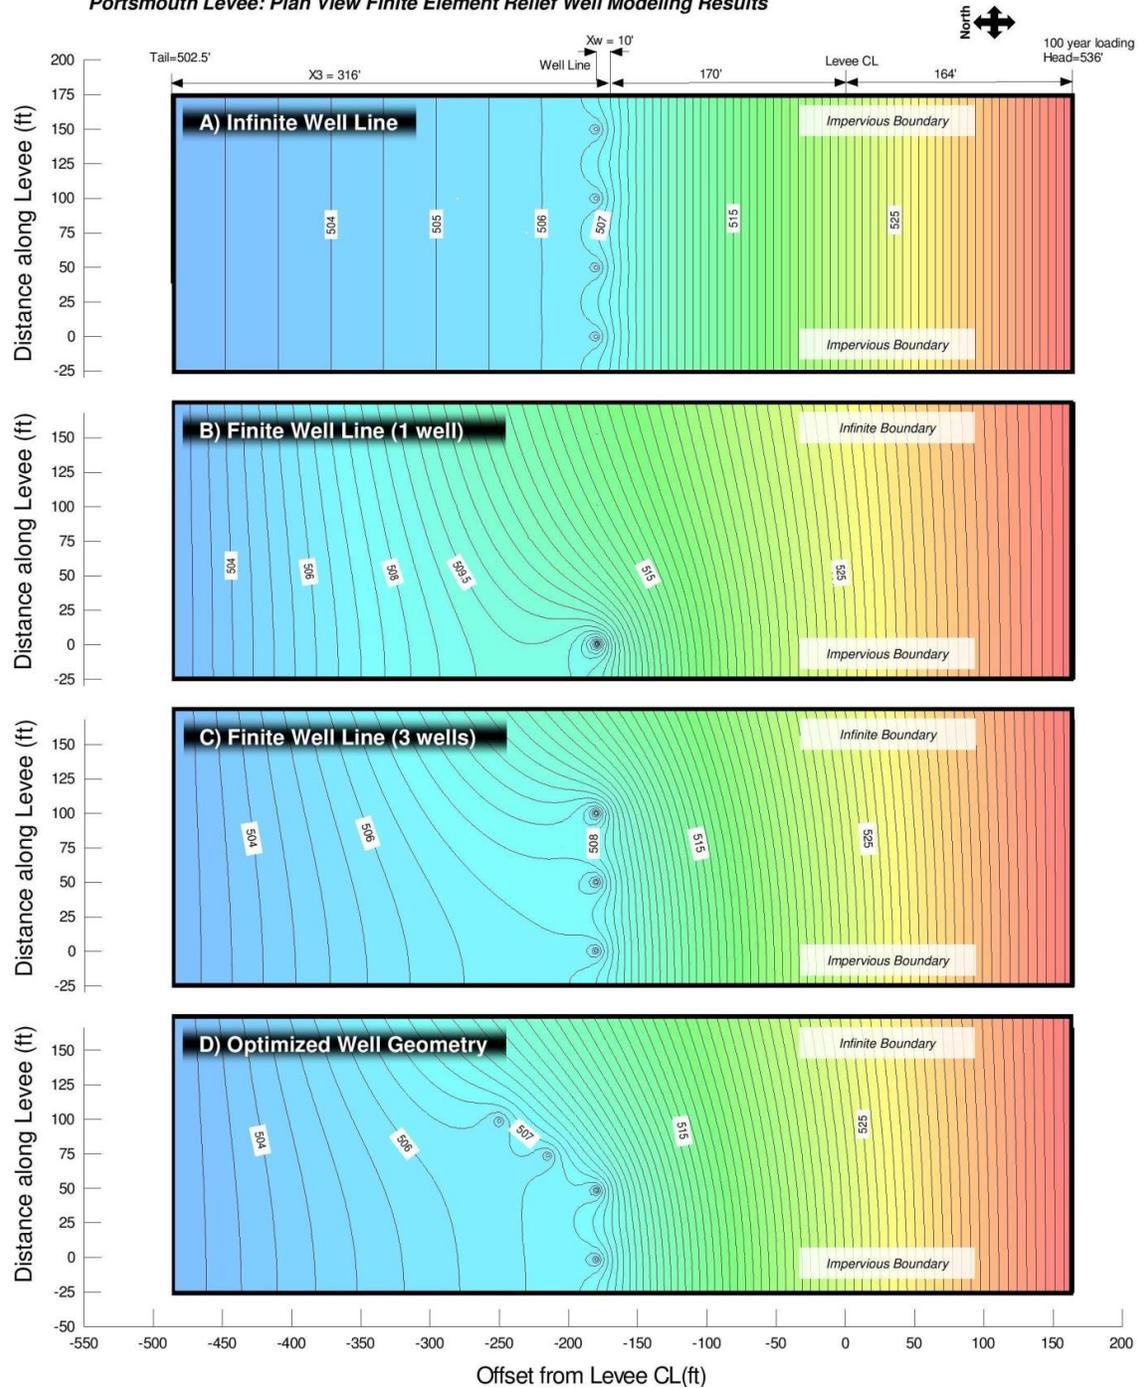
Portsmouth Levee: Plan View Finite Element Relief Well Modeling Results

**Fig. 5. Resultant head distributions for fully-penetrating relief well system geometries (computed by plan view finite element modeling) in the Portsmouth Pump Station Number 5 reach (Fig. 2A). Loading conditions represent the 100-year flood and modeled geometries include: A) an infinite line of wells with 50-foot spacing; B) 1 well simulating a field condition of 2 wells around the lower model symmetry plane; C) 3 wells simulating a field condition of 6 wells; and D) an optimized relief well system layout consisting of 4 wells simulating a field condition of 8 wells (Fig. 2B). See text for discussion.**

Further comparison of resultant head distributions (total head values as measured along the finite element model north-south well line plane) for the above-discussed infinite wells, finite (1 well), and finite (3 wells) cases is shown in Fig. 6. For the infinite case, the net head midway between wells ( $H_{m\_Infinite\ Wells}$ ), when expressed as a total head equivalent (y-axis value), is seen to be below the allowable maximum head of 507 feet. Note the magnitude of  $H_m$  for different modeled scenarios (indicated by vertical arrows in Fig. 6) represents the net head midway between the wells, with  $H_m$  equivalent to  $h_m$  (Equation 7) plus  $H_w$ . When added to tail water elevation (502.5 feet in this case), the  $H_m$  values can be expressed as total head elevation equivalents (y-axis values). For the finite (1 well) case (Fig. 5B), the net head midway between wells ( $H_{m\_1\ Well}$ ) when expressed as a total head equivalent significantly exceeds the allowable maximum head of 507 feet in the ponding area region (Fig. 6). For the finite (3 wells) case (Fig. 5C), the net head

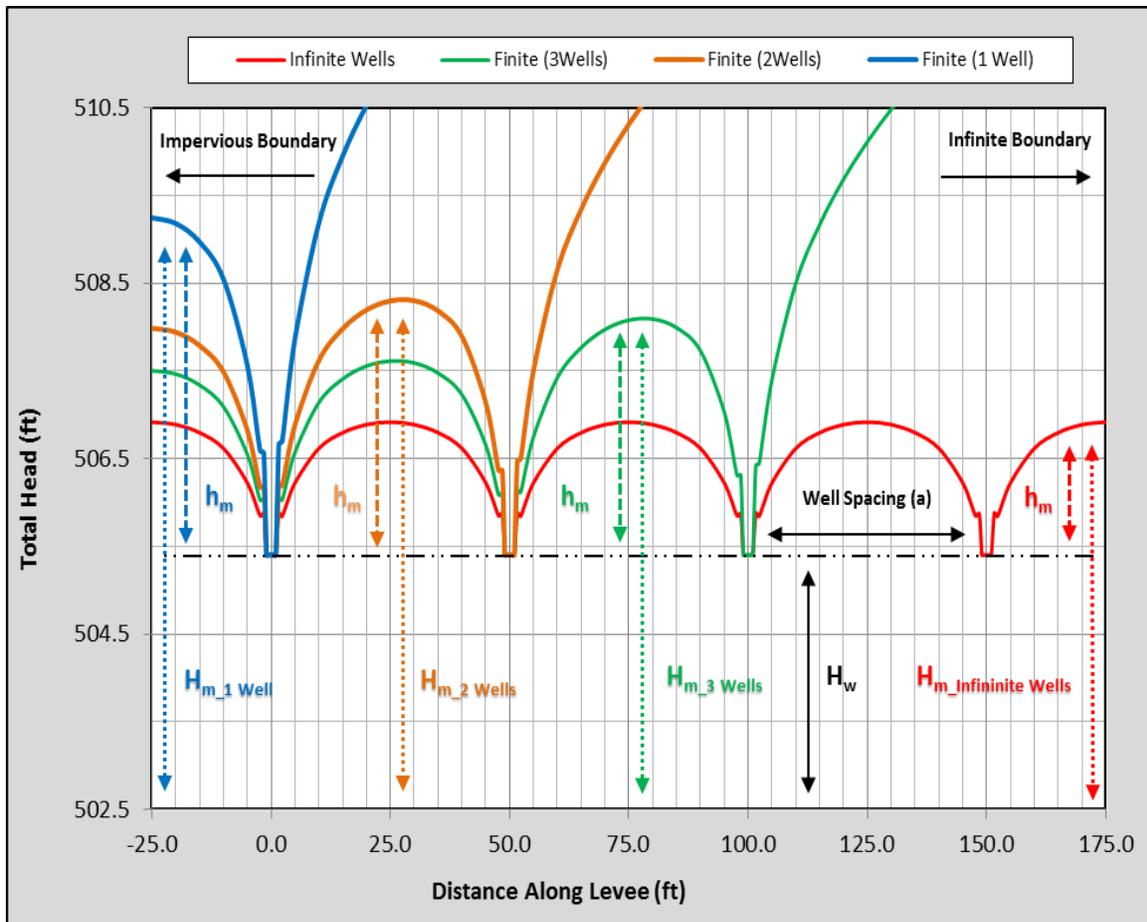
**Fig. 6. Variation of total head along infinite and finite well lines modeled for the Portsmouth Levee Pump Station Number 5 reach. The infinite, finite (1 Well), and finite (3 Wells) curves correspond to node values measured along the well lines in Figs. 5A, B, and C respectively; the intermediate model used to produce the finite (2 Wells) curve is not presented in Fig. 5. Values of  $H_m$  represent net head midway between the wells and are expressed as total head elevation equivalents (by adding  $H_m$  values to the tail water elevation of 502.5 feet). Values for net head midway between the wells corrected for well losses ( $h_m$ ) and total well losses ( $H_w$ ) are also indicated; recall that  $H_m = h_m + H_w$ . The allowable total head in the ponding area just downstream of the well line for the 100-year loading condition is 507 feet. See text for further discussion.**

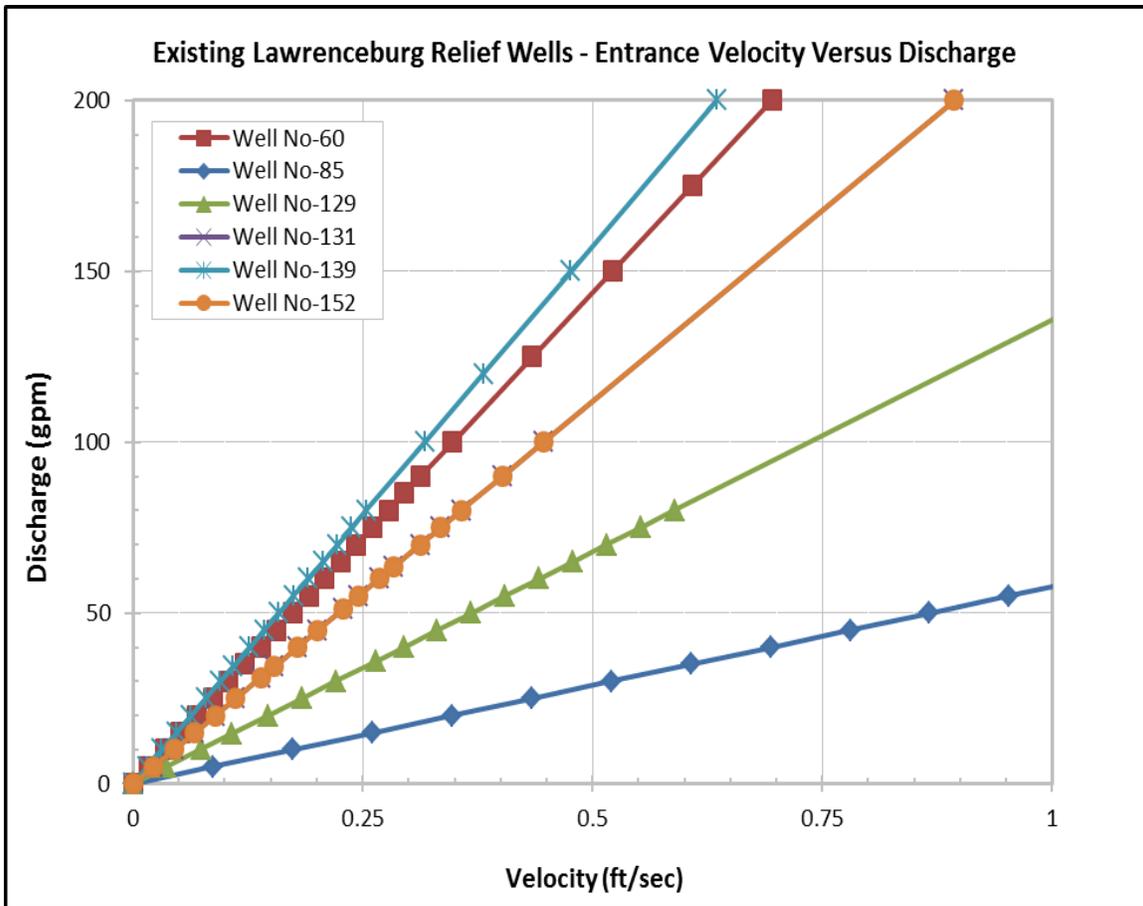
**Fig. 7. Projected well entrance velocities versus discharge rate for existing Lawrenceburg relief wells (Fig. 3). The intake area per foot of screen varies from 4.2 to 5.5 square inches corresponding to open areas of 3.7 to 4.8 percent (Table 1). Entrance velocities were calculated by dividing discharge rate by open area; note results for Well No-131 and Well No-152 are similar, and results for Well No-151 are not presented because the well screen was found to not penetrate the aquifer.**

is capable of reducing relief well discharge (and thus increasing potential along the well line). Laboratory experiments by Clark and Turner (1983) indicate that entrance velocity into a well is governed by intake area up to a value of about 10 percent, and that the performance of screens deteriorates with a decrease in open area below this value due to increasing well losses. Since increased velocity generally leads to increased turbulent losses, design methods (USACE, 1992) often recommend limiting intake velocity to 0.1 feet per second (ft/sec). While Clark and Turner (1983) did not measure significant well losses at entrance velocities up to 0.5 ft/sec, they still recommend designing for a maximum velocity of 0.1 to 0.25 ft/sec as a conservative measure. With respect to these often-recommended design criteria, the projected entrance velocities for the existing Lawrenceburg wells significantly exceed them (Fig. 7); entrance velocities were calculated by dividing discharge rate by the well screen open area. Irrespective of hydraulic testing, the limited penetration, small diameter, low open area, and projected high entrance velocities suggest that well losses associated with the existing Lawrenceburg relief wells will have a negative effect on pressure relief potential for design loading conditions.

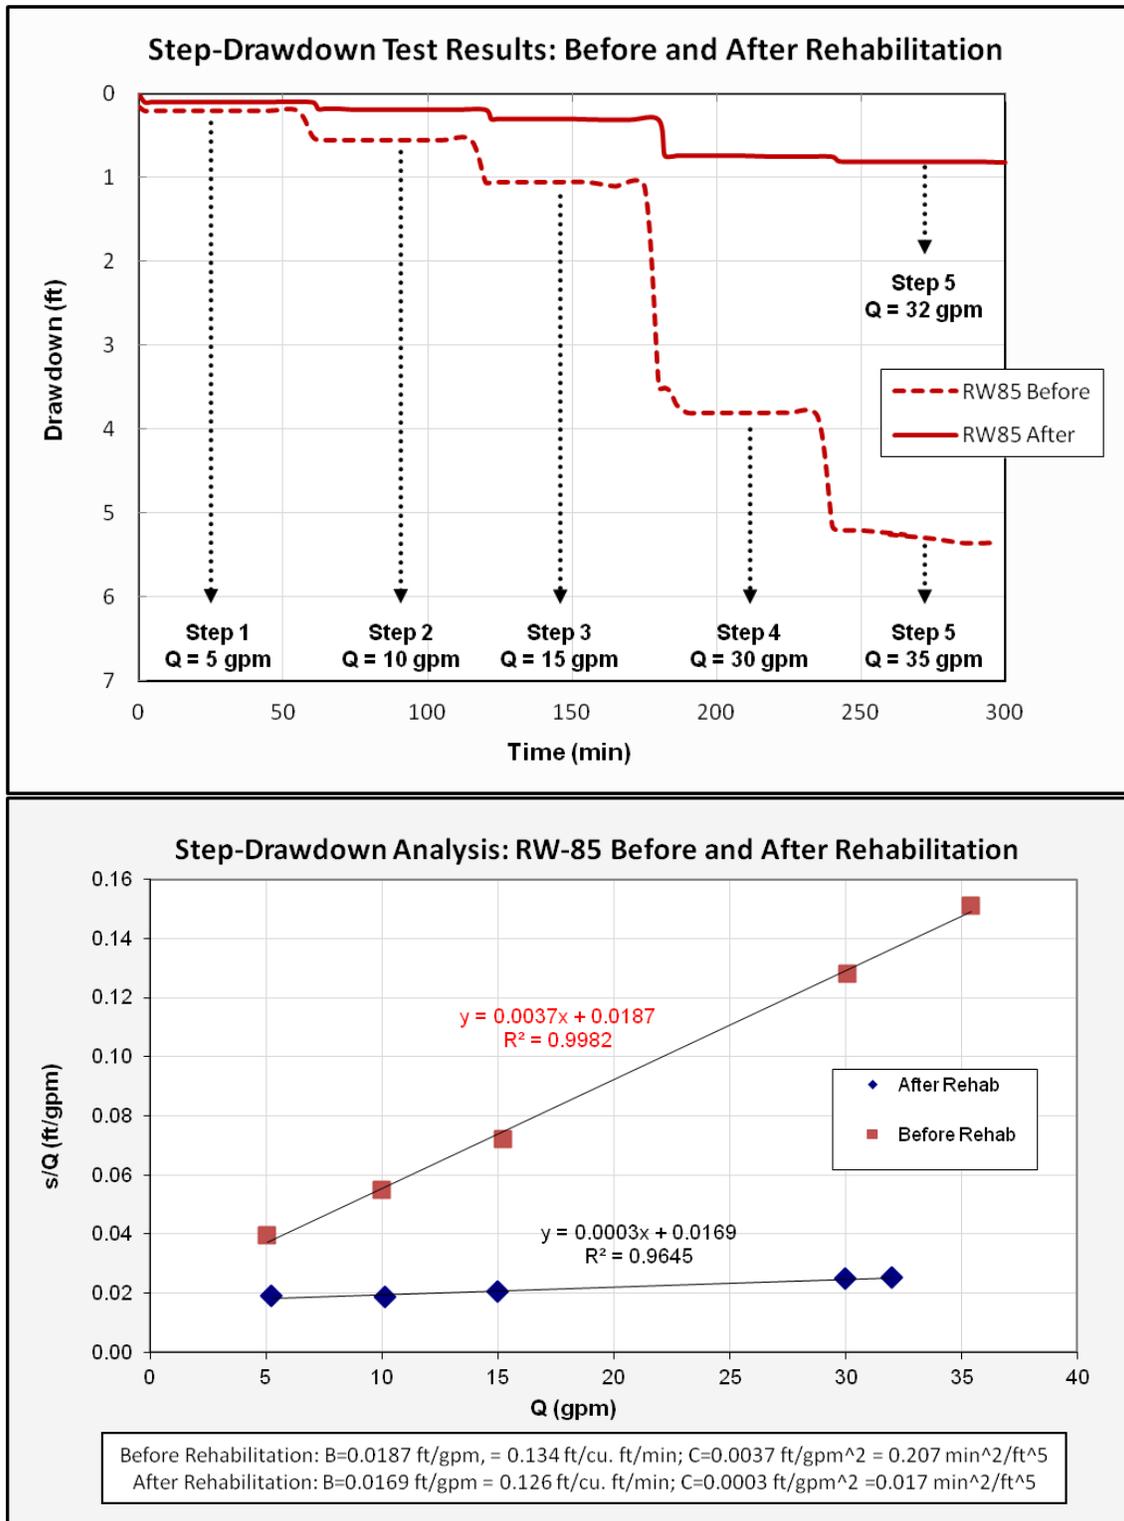
**Fig. 8. Step-drawdown data acquired before and after rehabilitation for Lawrenceburg relief well RW-85 (top) with step-drawdown diagnostic plots and computed B and C loss coefficients (bottom). Values of s/Q represent specific drawdown.**

Shown in Fig. 8 (top) are step-drawdown data acquired before and after the rehabilitation of well RW-85 at Lawrenceburg Levee; data for the other site wells, which were evaluated, are contained in Thelen Associates Inc. (2014). Analyses of the data shown in Fig. 8 (bottom) were performed using the Hantush-Bierschenk method (Kruseman and de Ridder, 1994), which is based on Jacob's (1947) equation. This method of analysis involves plotting specific drawdown ( $s/Q$ ) versus  $Q$ , where  $s$  is the stabilized drawdown at the end of each step and  $Q$  is the step's pumping rate. As seen in Fig. 8, the diagnostic plot data for RW-85 generally exhibit straight lines having positive slope (indicating specific capacity is decreasing with increasing  $Q$ ). Therefore, the linear (B) and nonlinear (C) loss coefficients were able to be estimated using:

coefficients measured from hydraulic testing are shown on Fig. 8 (bottom). From a comparison of the C coefficients before and after rehabilitation, an improvement in well condition due to rehabilitation is apparent. However, according to the criteria of Walton (1962), the degree of well deterioration is still “severe” after rehabilitation, and with a post-rehabilitation C coefficient value of greater than  $40 \text{ sec}^2/\text{ft}^5$  (greater than  $0.01 \text{ min}^2/\text{ft}^5$ ) it is “difficult and sometimes impossible” to restore original well capacity; Kasenow (1998) indicates that well capacity can be difficult to restore when the C coefficient value is greater than  $0.0002 \text{ ft}/\text{gpm}^2$ . The computed  $L_p$  values also illustrate well improvement due to rehabilitation; however, the values also clearly indicate increasingly poor well performance and related head losses as discharge increases, suggesting limited capacity of the well. The specific capacities were increased by rehabilitation, but even afterwards they are still an order of magnitude lower than those of many other relief wells in similar (glacial outwash) foundation materials that the authors have previously tested. Key general differences between the Lawrenceburg wells and these other wells are that the other wells have larger diameters, larger screen intake areas, and larger effective foundation penetrations. Without having accurate estimates of transmissivity and storage coefficient values from constant-rate testing, and without being able to step-test the Lawrenceburg wells at higher discharge rates often employed for this foundation-type (permeability on the order of  $0.1 \text{ cm}/\text{s}$ ), inferences regarding the degree of partial penetration losses to be expected at higher discharge values could not be inferred. However, as the penetrations of all site wells are quite limited (Table 1), it would be expected that partial penetration-related losses could be measurable and significant if testing were performed with an order of magnitude increase in discharge. For this reason and others discussed above, there can be large uncertainty associated with attempting to project  $L_p$  (or well efficiency) values very far upwards beyond the highest field step. In the case of the Lawrenceburg wells, while direct reliable estimation of head losses at design discharge rates was not possible (often the case for most situations in practice), useful judgment regarding capacity of the existing wells at design loading of the levee was able to be made by considering projected  $L_p$  values in conjunction with blanket theory-based well design methodology. By incorporating projected  $L_p$  values into the well design process (Guy et al., 2010), head losses for the Lawrenceburg wells at levee design loading conditions were able to be estimated. However, it is recognized that there is uncertainty in predicted head losses for the above-discussed reasons, and that because  $L_p$  overestimates well efficiency, head losses and uplift pressures would be somewhat underestimated using  $L_p$ . From such estimates resultant uplift pressures from the existing well system were able to be predicted with consideration of well losses (a substantially better approach than one that assumed no well losses, which would be incorrect), and an overall estimate of the potential contribution towards foundation pressure reduction from the existing well system was made. These analyses were useful in determining that the existing Lawrenceburg wells, while they will not provide target stability for design loading conditions, do have some limited transmitting capacity, and will therefore provide some limited future benefit.

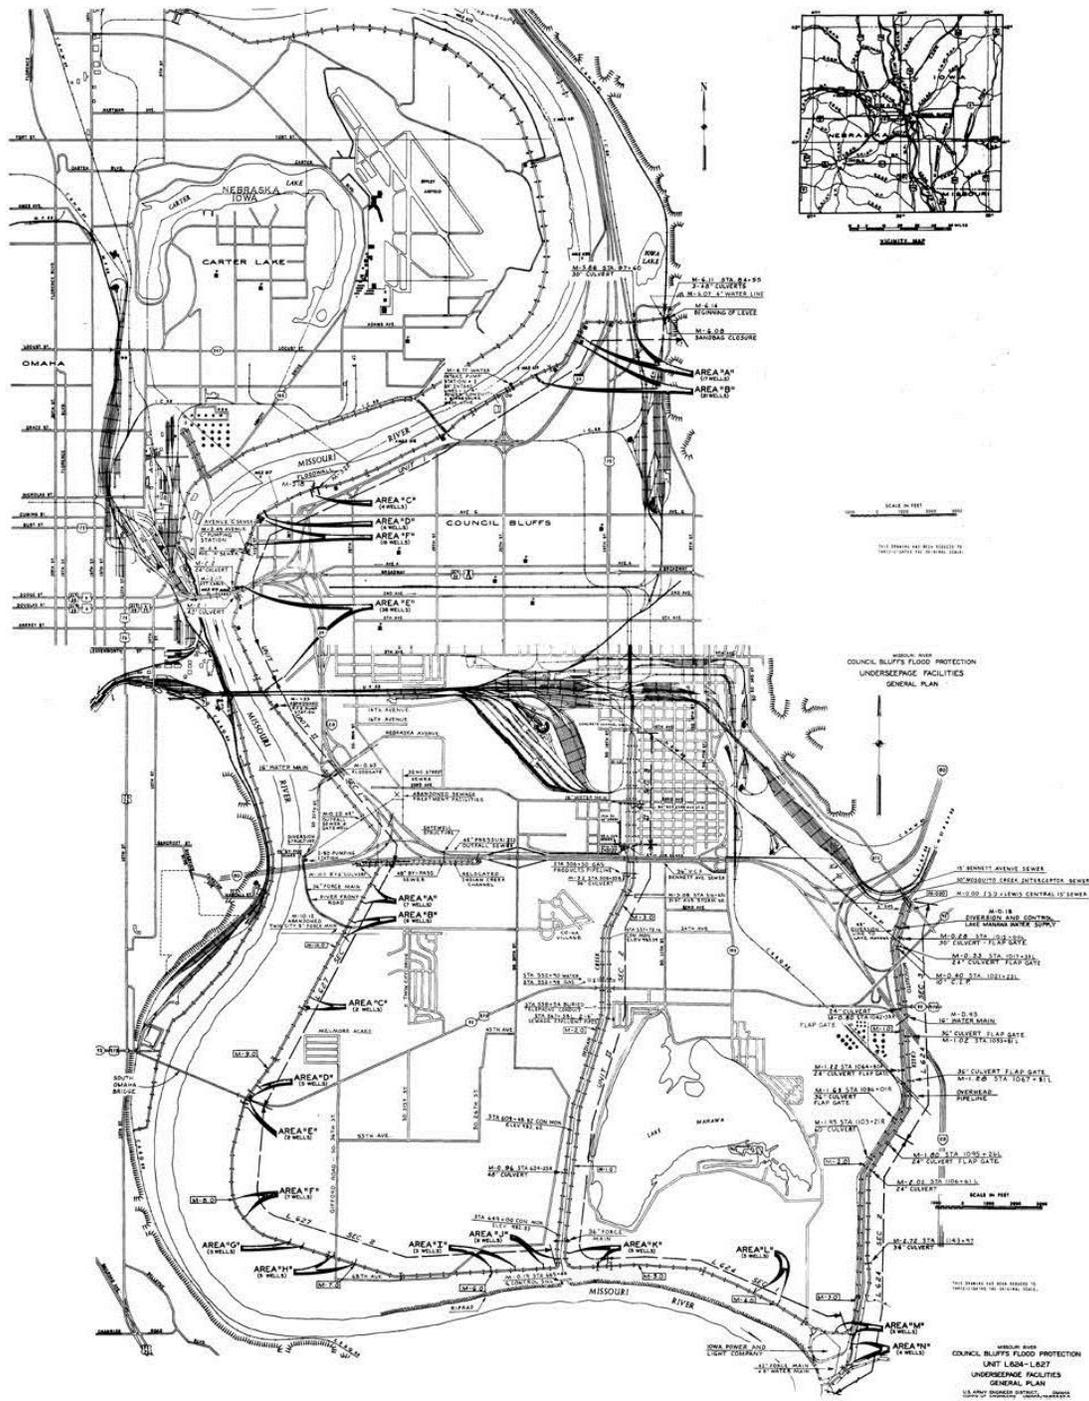
**Fig. 1. Plan view of relief well locations along Council Bluffs Levee (USACE, 1981)**

The Council Bluffs Missouri River Levee System was authorized by the Flood Control Act of 1944 and provides flood protection to the City of Council Bluffs, Iowa. The levee system was designed by the U.S. Army Corps of Engineers – Omaha District. Construction, under the guidance of the Omaha District, began in 1946 and was completed in 1954 (USACE, 1981). The levee consists primarily of a zoned earthen embankment section and is located along the left (east) bank of the Missouri River including tieback levees along Indian Creek and Mosquito Creek (see Fig. 1).

A total of 171 relief wells were installed as a part of the original levee construction. The relief wells are partially penetrating and are spaced at 70 to 270 feet on center. The depth of the relief wells vary from 40 to 50 feet below existing grade. The screened portion of the relief wells is provided by an 8-inch diameter Douglas fir or White pine slotted screen that is about 25 feet in length.

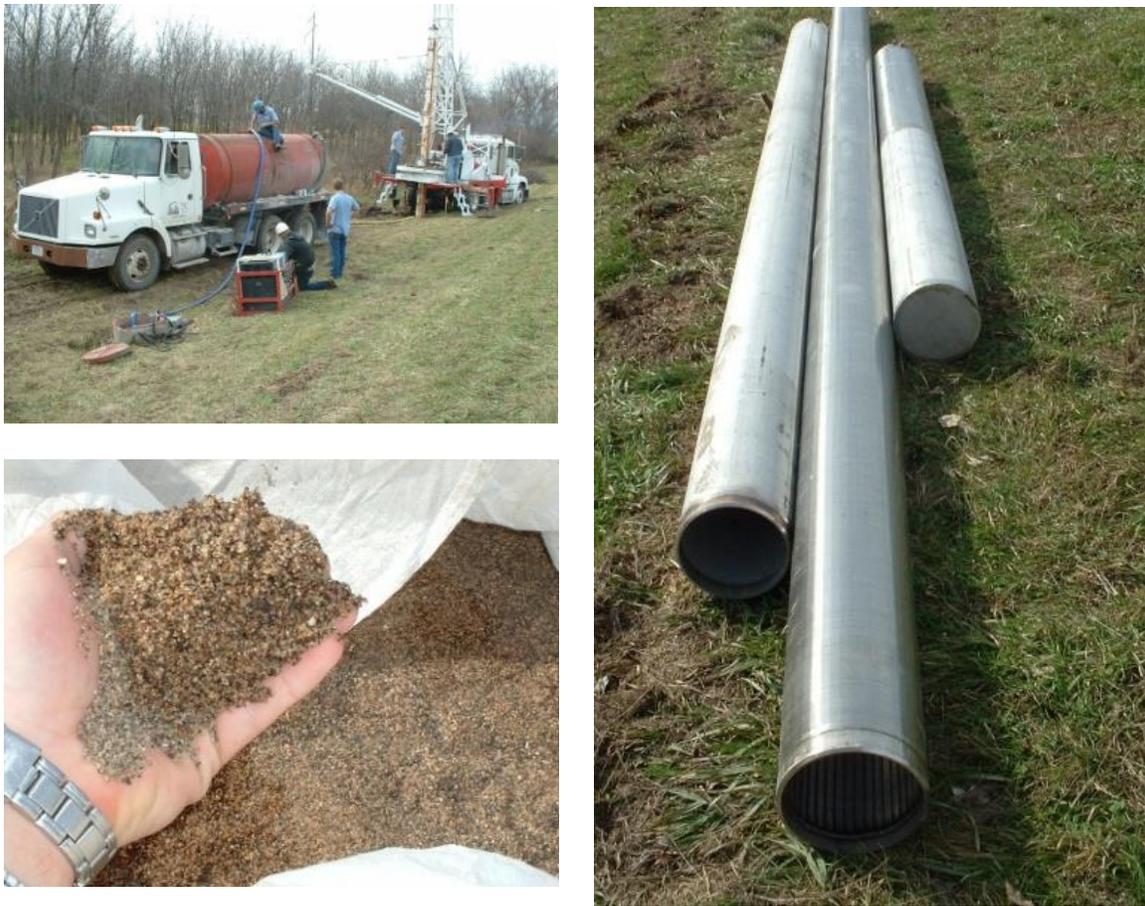
**Fig. 2. Photo of relief wells under construction (upper left – drilling, lower left - gravel for filter pack, and right – stainless steel well screen)**

Replacement of the relief wells consisted of abandoning the existing wood stave relief wells in-place and installing a new relief well adjacent to the abandoned relief well. The new depth, screened interval, diameter, and spacing of the relief wells matched that of the abandoned relief wells. A stainless steel screen and riser were used instead of the wood stave, to meet current USACE guidelines for relief wells. A sand and gravel filter pack was placed around the screen. Design of the filter pack and screen was the responsibility of the contractor and was determined by gradation tests from borings drilled by the contractor.

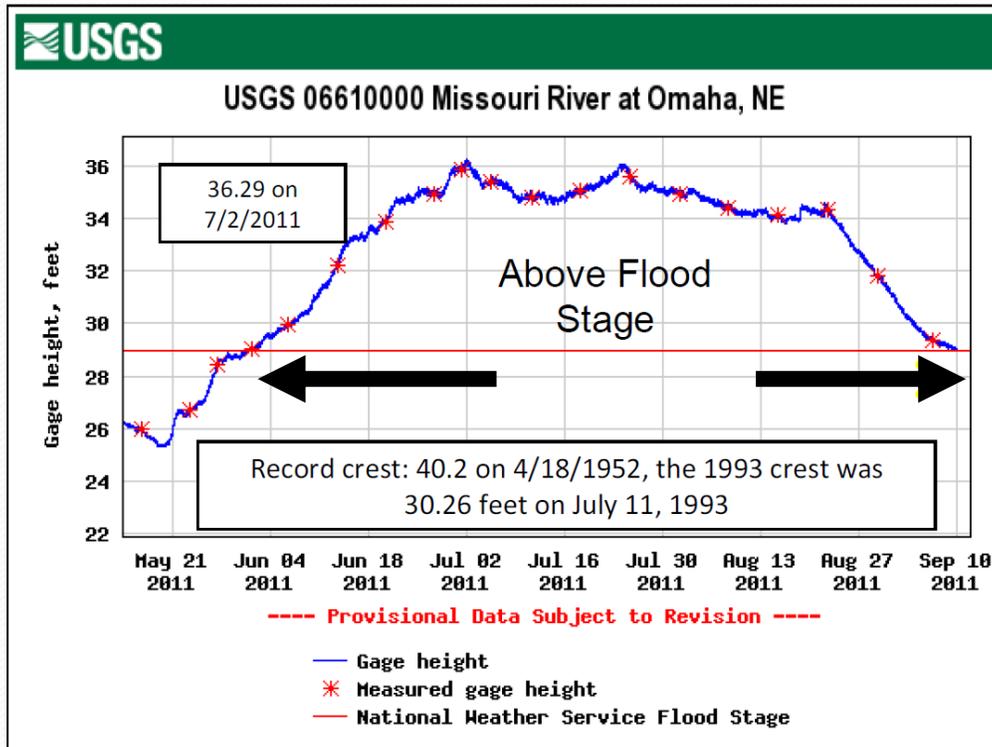
**Fig. 3. USGS Missouri River Gage at Omaha, NE**

During the summer of 2011, a historic flood occurred on the Missouri River. The river was above flood stage for over 100 days and crested at a stage level of 7.29 feet above flood stage (see Fig. 3). This resulted in water up into the levee freeboard. Due to the exceptionally long duration of the flood, many portions of the levee likely experienced a steady-state seepage condition.

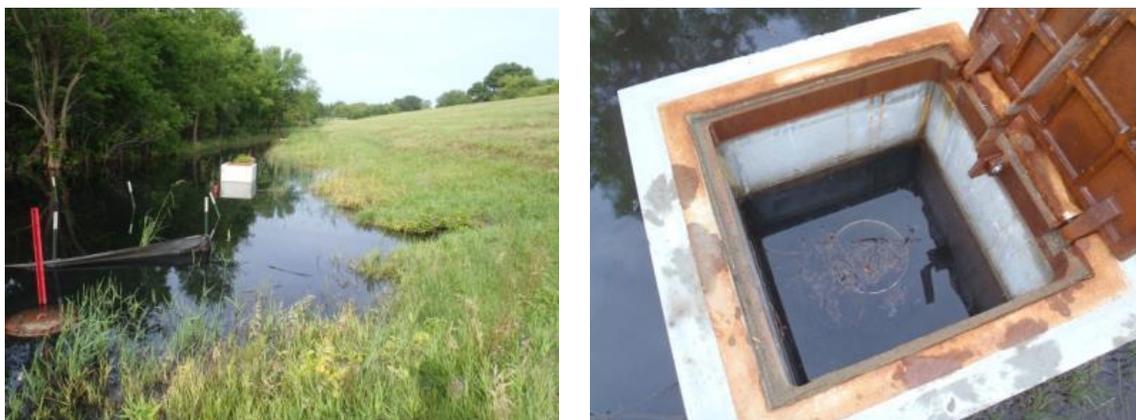
**Fig. 4. Photos of newly constructed relief wells during high water**

Air lifting techniques were used to attempt to clean out the existing poorly performing relief wells. However, many of the poorly performing relief wells did not improve after this attempt. The photos presented in Fig. 4 below were taken along the same section of newly installed relief wells (2009) discussed previously.

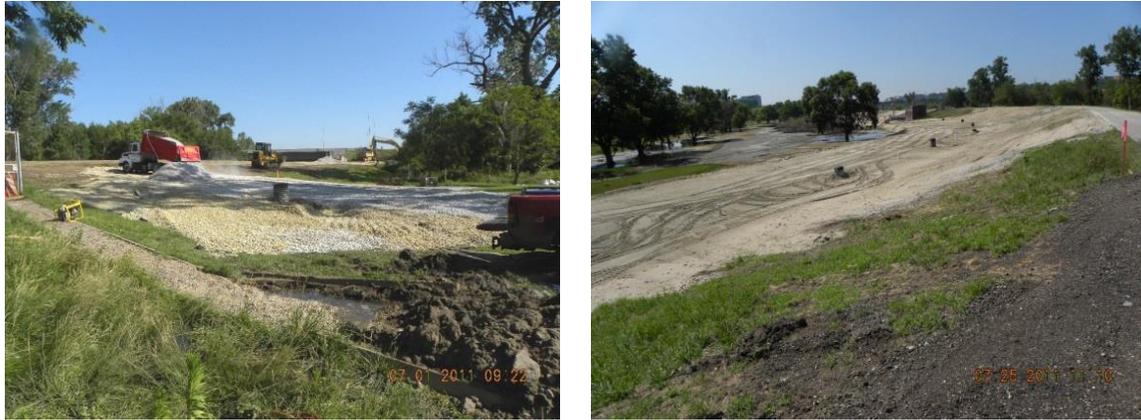
**Fig. 5. Photos of emergency seepage berms constructed around existing relief wells that had not been replaced**

The photos in Fig. 5 below were taken during the flood fight at locations where emergency granular fill seepage berms were constructed near non-functional, or underperforming relief wells that had not yet been replaced prior to the 2011 flood.

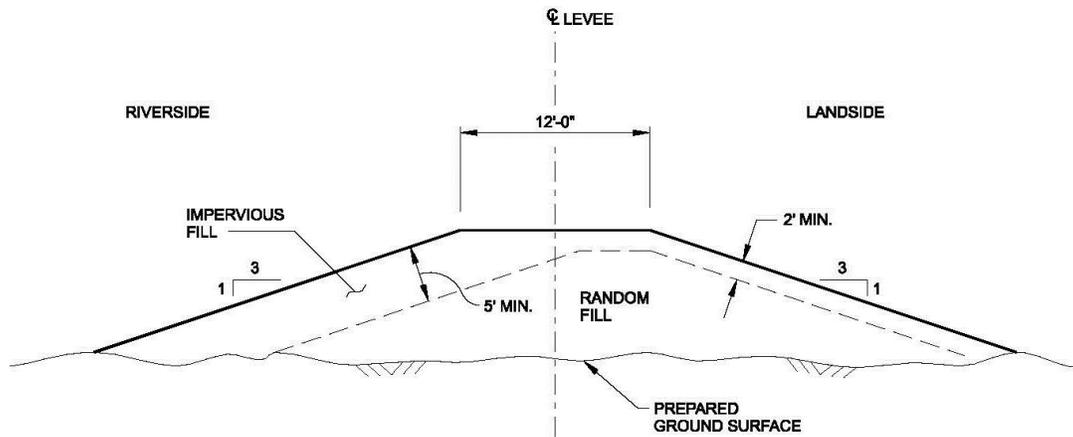
**Fig. 6. Typical embankment fill zoning of proposed relocated South Levee**

The relocated South Levee is about 1,025 feet in length and about 14 to 17 feet above existing grade. The levee crown is about 12 feet wide, and the side slopes are generally at 3H:1V. The levee consists of a zoned clay section with impervious fill (lean clay) on the outer faces and lean or fat clay on the interior random fill zone (see Fig. 6).

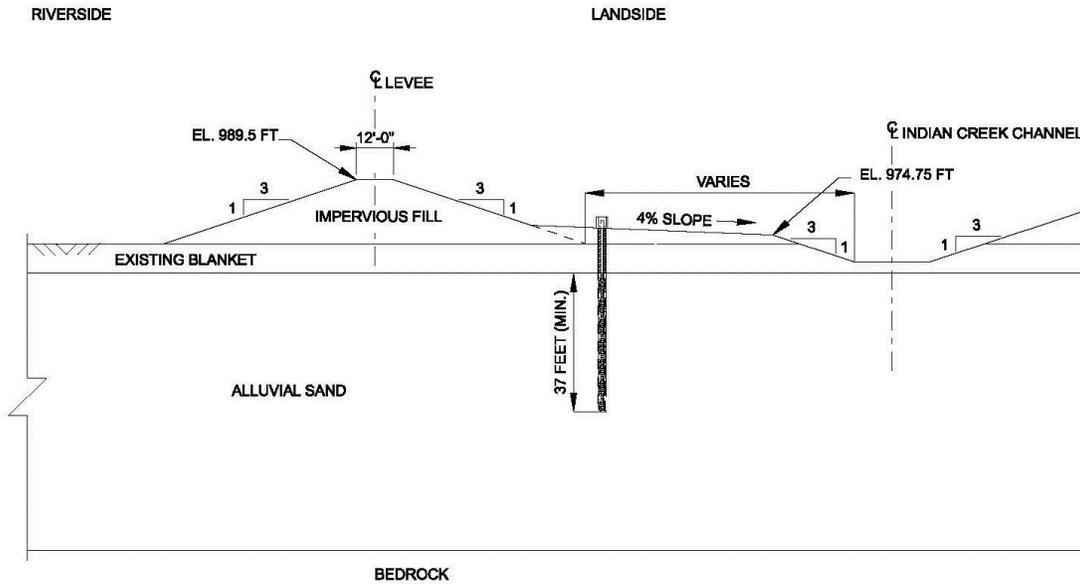
**Fig. 7. Critical design section for underseepage of proposed relocated South Levee**

The cross section of the relocated South Levee is provided in Fig. 7.

The critical analysis was for a situation where the river is sustained at the DWSE for a sufficient time for steady seepage to develop vertically and the drainage ditch at the toe of the levee is dry. The critical analysis resulted in a gradient at the drainage ditch of 1.27, which greatly exceeds the USACE criteria for a maximum allowable vertical

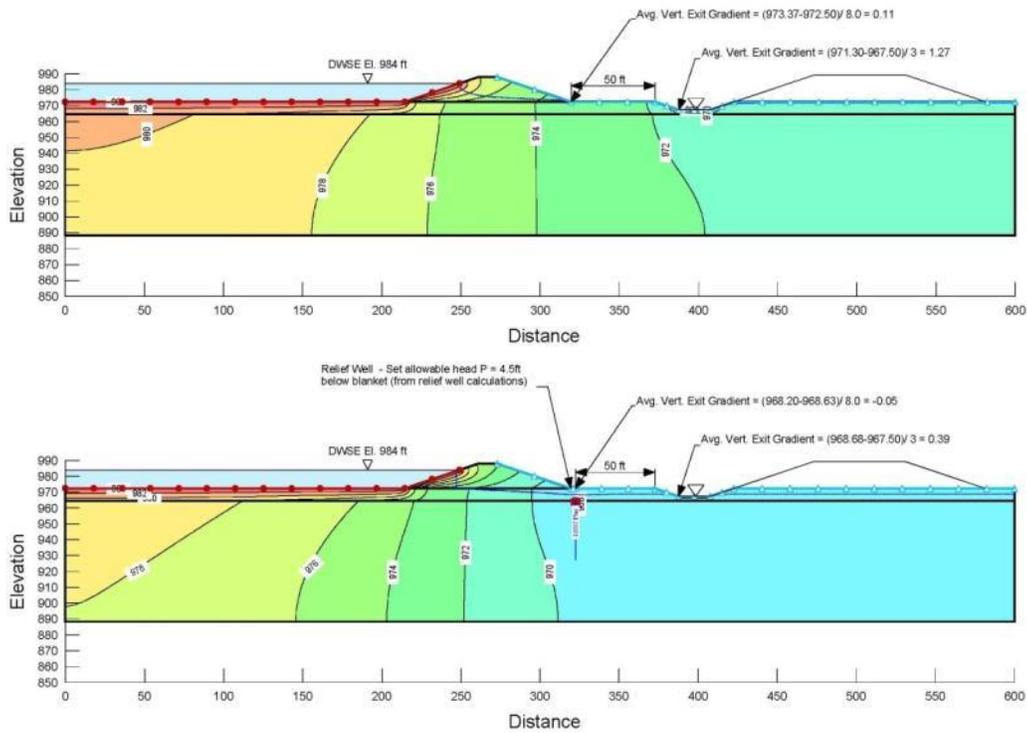
**Fig. 8. SEEP/W analyses for underseepage of proposed relocated South Levee**

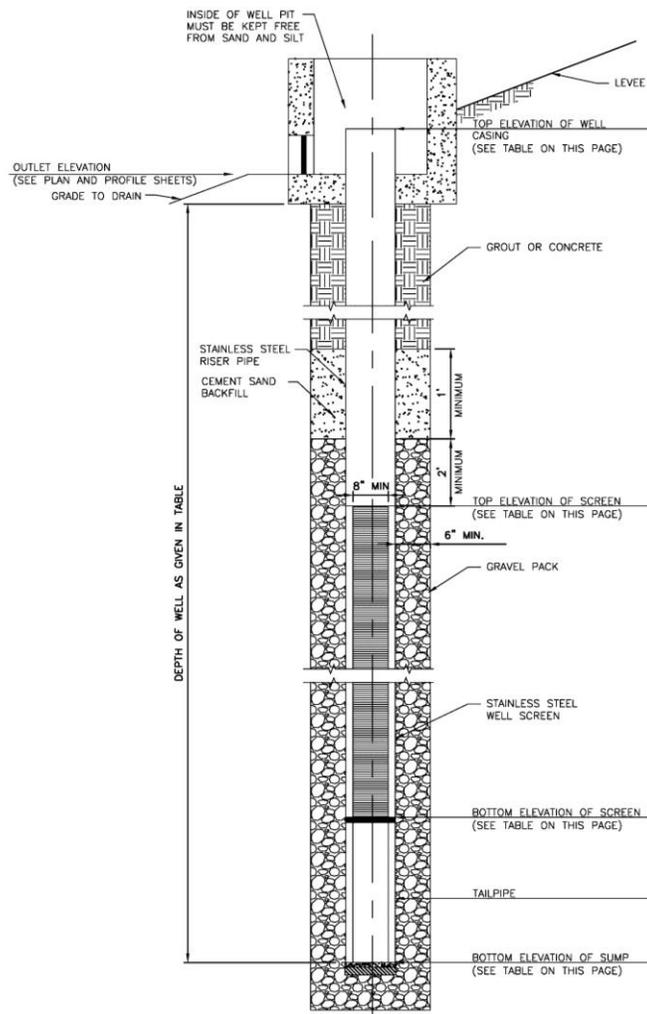
**Fig. 9. Typical relief well detail**

The exit gradient at the DWSE was computed to be 0.39 at the drainage ditch for analyses that modeled an infinite line of relief wells. The partially penetrating relief wells were designed to be about 57 feet deep, have a minimum screened length of 37 feet and a design capacity of 59 gallons per minute (gpm).
