# Ohio River Valley Soils Seminar XLV

Geotechnical Aspects of  
Waterfront Development

October 17, 2014

# Ohio River and Tributary Local Protection Projects: Adjacent Bank Erosion and Failure-Related Endangerment after Action Report

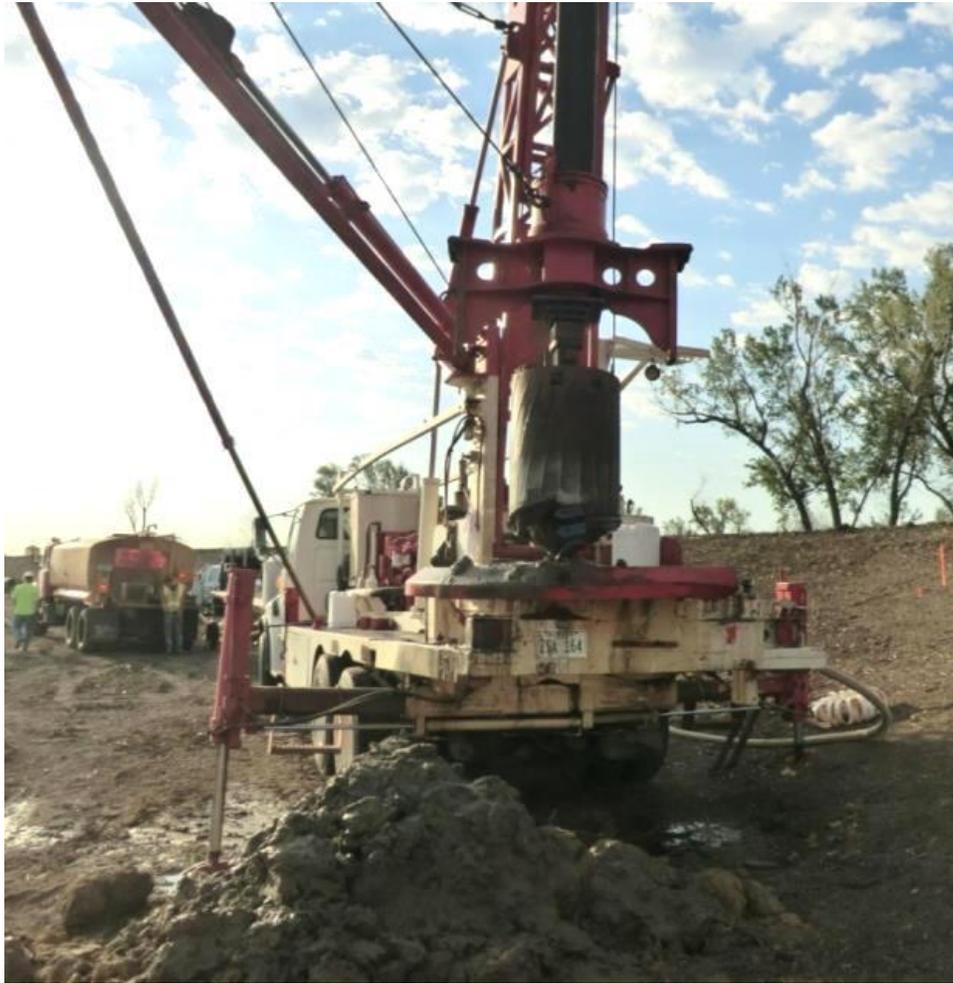
**Fig. 10. Photo of well drilling with bucket auger rig**

The wells were installed with a bucket auger rig, utilizing polymer slurry to stabilize the sidewalls of the borehole during drilling and placement of the relief wells. Upon completion of the excavation, the screen and riser were lowered into the borehole and

filter pack was placed around the screen. The well was finished by placing bentonite cement grout to ground surface.

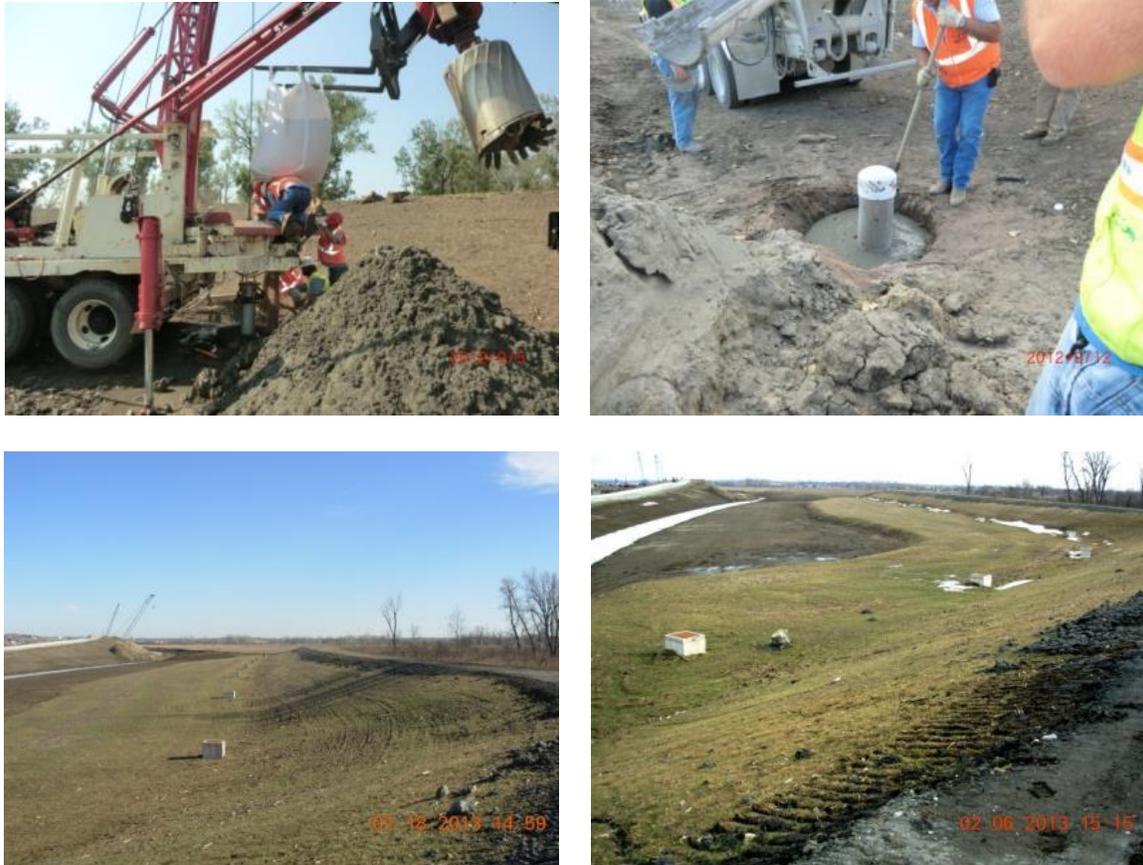
**Fig. 11. Photos of well installation and completed system**

Each relief well was developed using a method called air lift/surging. An air compressor hose is attached to the bottom of a PVC pipe. Air is pumped through the hose which creates a vacuum in the pipe. The vacuum pulls water and sediment through the filter sand. The PVC pipe is lifted and lowered along the well screen for about 30 minutes.

A 6-hour pump test was completed at each well. The pump test consisted of pumping the well at a flow rate of 60 gpm for 6 hours and measuring the drawdown in the well and the two adjacent wells. As part of the pump test, a sand test was completed using a Rossum Sand Tester.

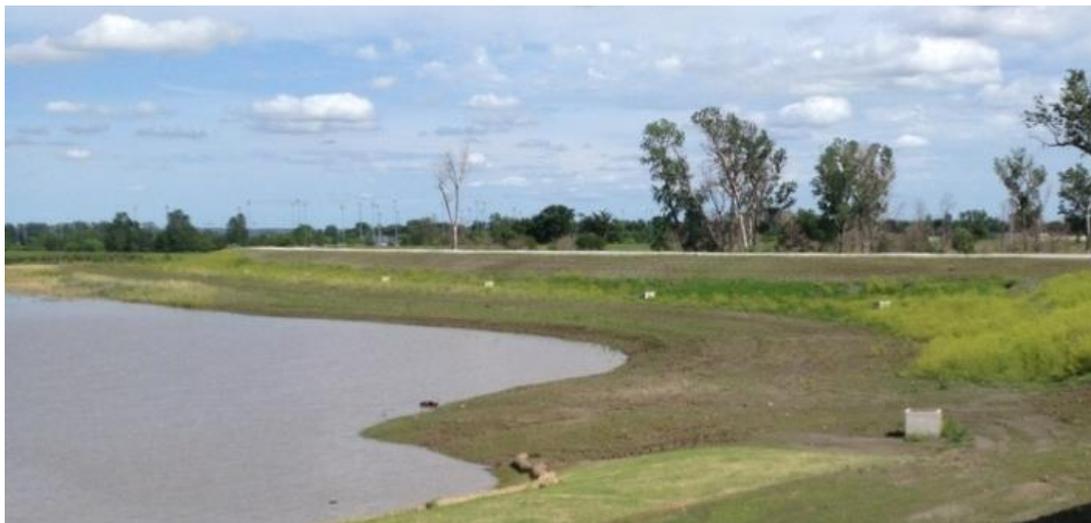
**Fig. 12. Photo of completed south levee**

One year after construction, a high water event occurred in the spring of 2014. A photo of the completed levee during this high water event is provided as Fig. 12 below.
