Geohazards: Challenges to Geotechnical Engineering

Proceedings of the 51st Annual Ohio River Valley Soils Seminar

November 2, 2021
Hilton Netherland Plaza
35 West 5th Street
Cincinnati, Ohio

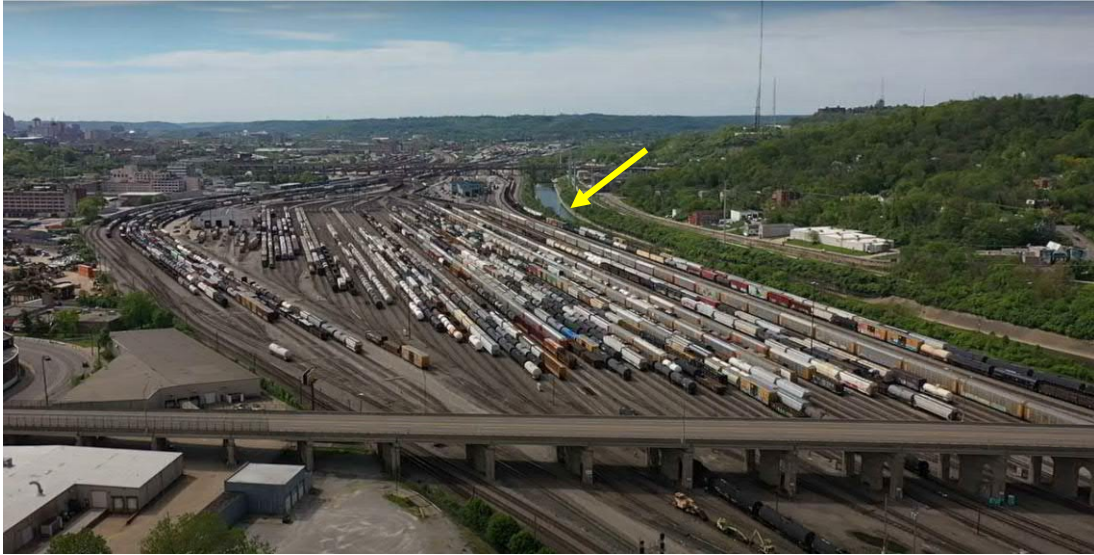
VIEW OF THE QUEENSGATE INTERMODAL CSX RAILYARD LOOKING NORTH.
THE MILL CREEK VALLEY IS AN OVER-SIZED VALLEY.
THE PRESENT-DAY MILL CREEK IS VISIBLE IN THE BACKGROUND

Evidence of the wide Deep Stage channel is shown in the following aerial images of the Queensgate Intermodal CSX Railyard.

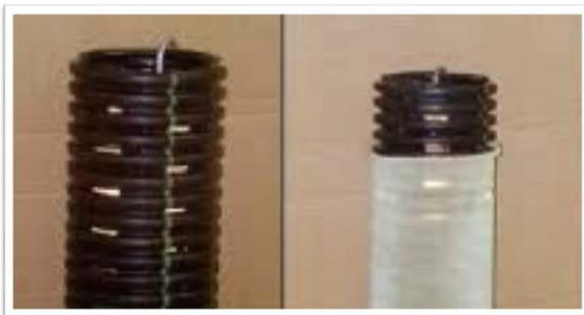
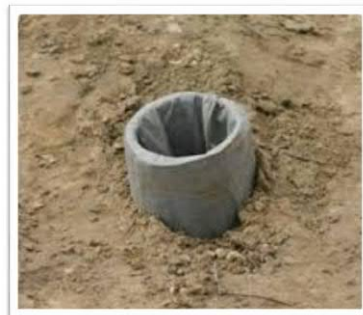
What Are Earthquake Drains?

Corrugated Pipe wrapped in a filter fabric with sufficient discharge capacity (design) installed in a grid pattern. Diameter varies, typically 4 inches.

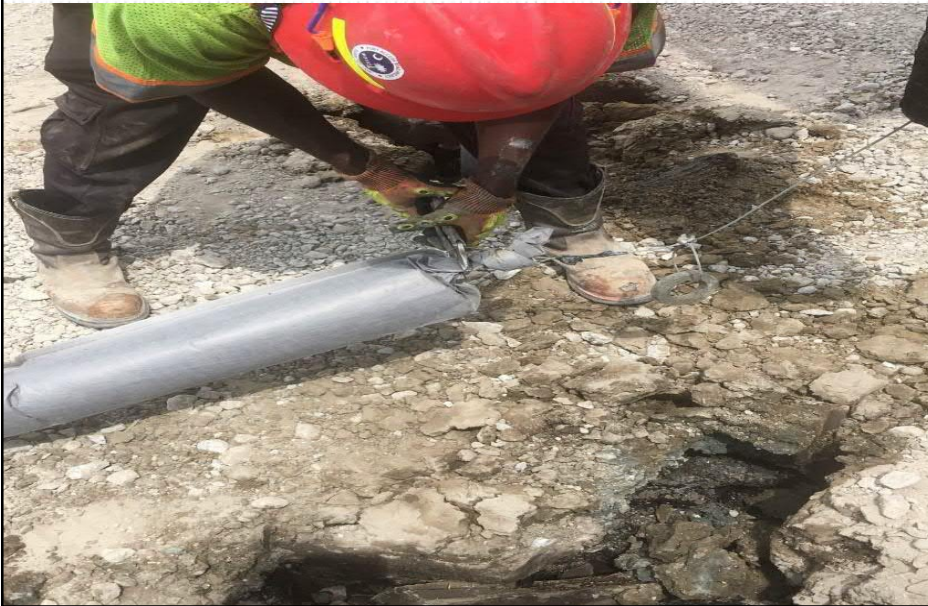
Earthquake Drain Installation

Drains are typically pre-cut prior to being pushed into mandrel and installed

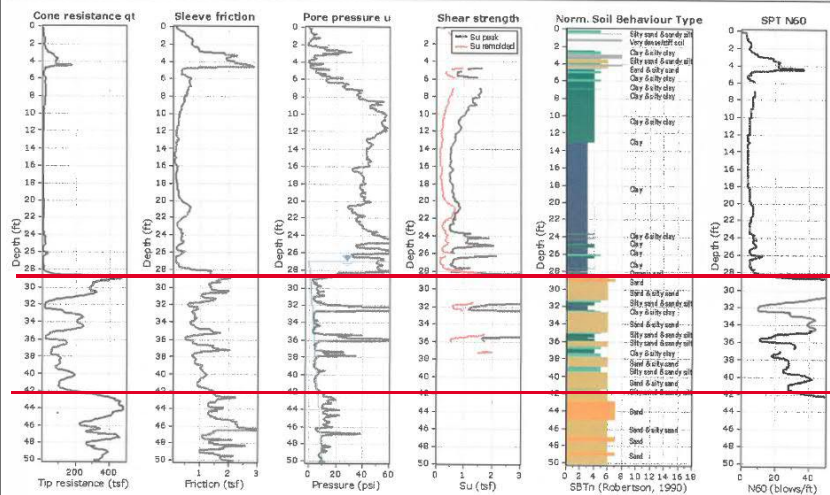
CPT-4
Total depth: 50.07 ft, Date: 3/26/2018
Surface Elevation: 446.00 ft
Coords: 38 50.6984, -90 41.8135
Cone Type: 15cm2
Cone Operator: DWO

§ Soft Clay
§ Static settlement concerns
§ Bearing capacity concerns

§ Loose to Medium Sand
§ Liquefiable

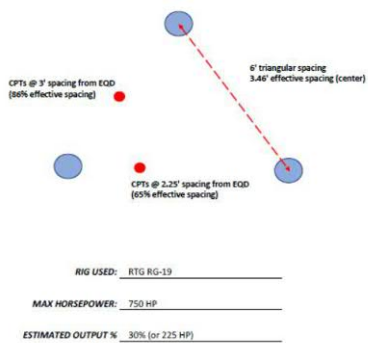
CAMP ROAD PRE & POST CPT ANALYSIS FOR GROUND IMPROVEMENT DUE TO EQD INSTALLATION

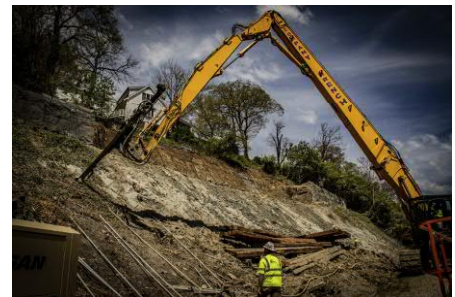
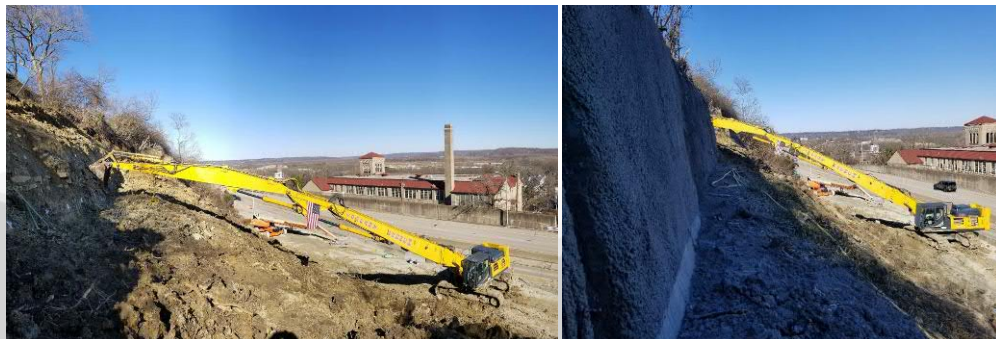
Limited Access

- › Working from above was ruled out because of the private residences along Richwood Avenue being too tightly packed together
- › Constructed an elevated working platform at the toe of the slope so that a high-reach excavator could be utilized to reach the apex of the landslide
- › High reach was utilized to excavate, drill and apply shotcrete

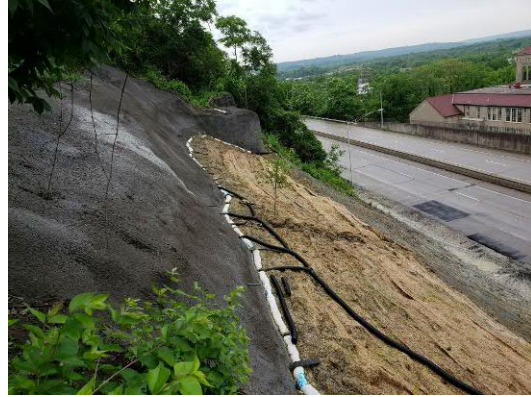
Design-Build Construction

- › Once operations began, drilling and excavation showed some inconsistencies in the information we based our initial design upon regarding rock depths.
- › The design-build nature of this project allowed us to continually confirm design and optimize nail lengths and wall heights to ensure the factors of safety were met.
- › GSI site visit conducted, February 24, 2019
- › Construction began on March 5, 2019
- › Construction completed on May 6, 2019

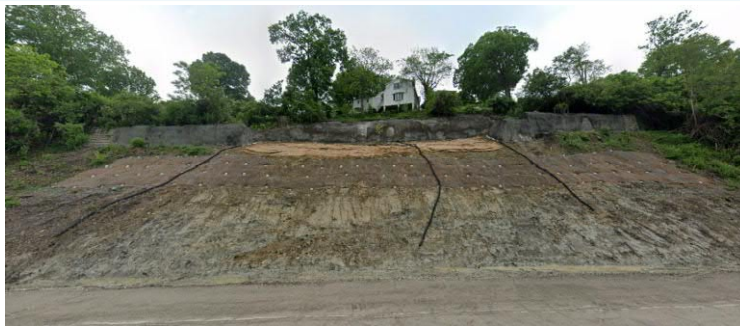
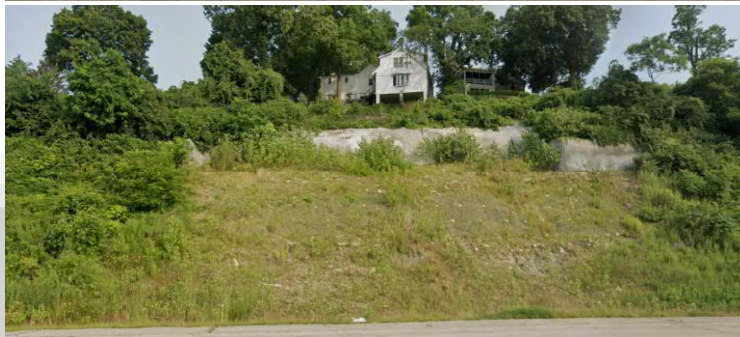
Finished Product – Immediate & Two Years Later

May 2019

July 2021

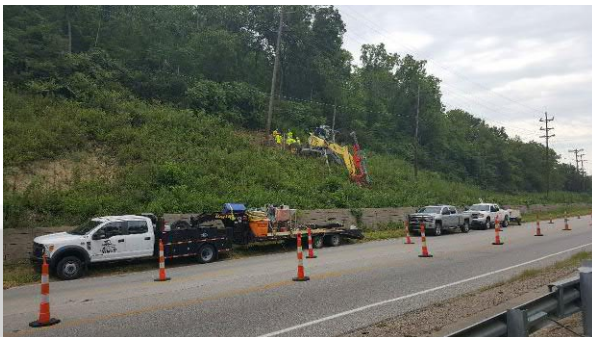
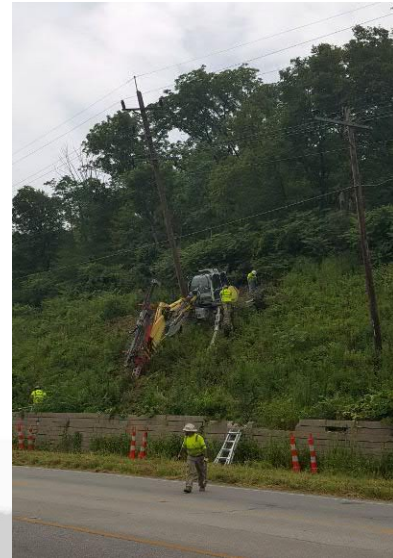
Repair Plan & Limited Access

- › A drill mounted on a walking spider excavator that could be winched and maneuvered on the steep slope allowed all work to be performed on the slope.
- › Spider drill was able to climb over the existing retaining wall to access the slope.
- › Shorter drill mass allowed for drilling without power outages.

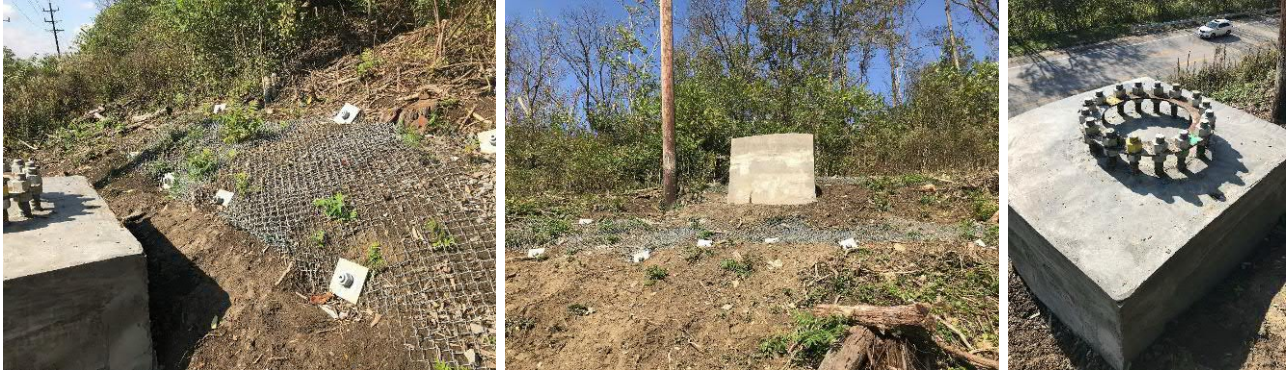
Photos After Construction Completed

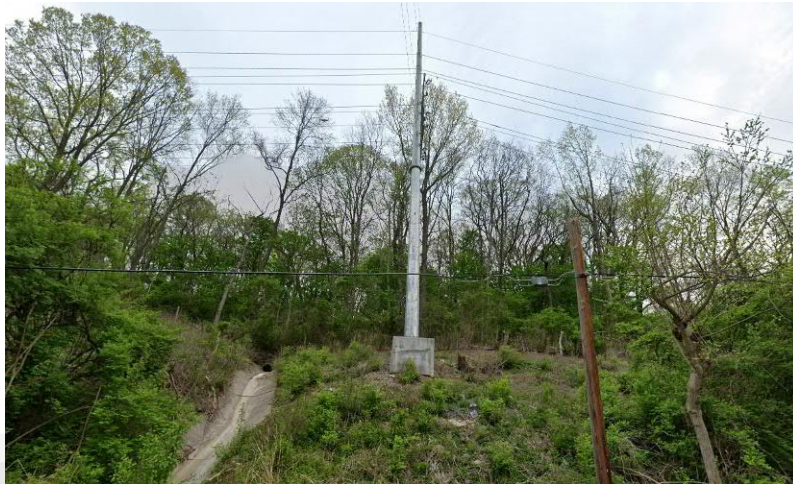
Photos After Construction Completed

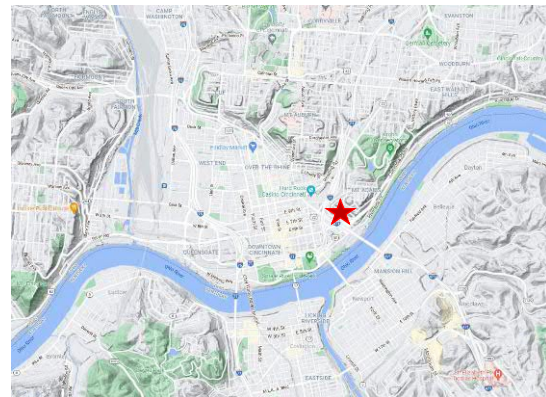
- › From 398 to 406 Baum St. in Cincinnati a landslide impacted several properties from the north side of the slide bridging Oregon St. to Baum St.
- › The slip initiated resulting in a failure of an existing retaining wall
- › Created a head scarp that encroached on the uphill properties
- › The toe bulge punched through a wall in two new townhouses at the base of the slide

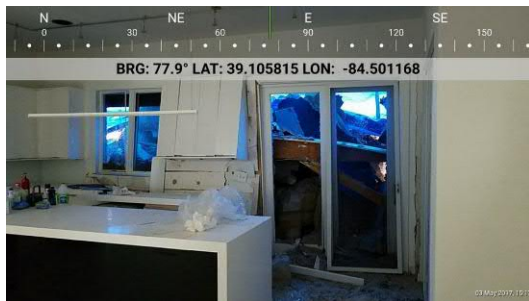
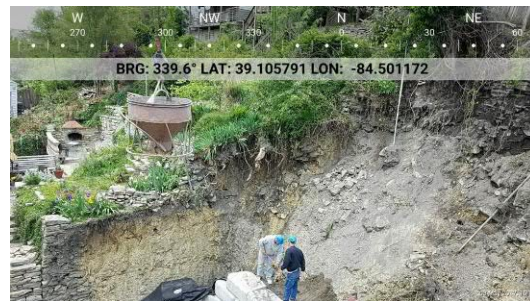
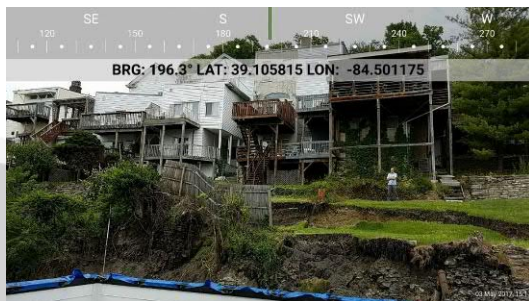
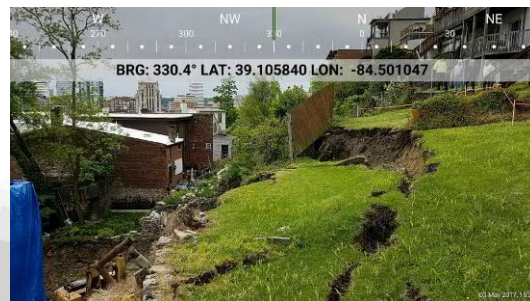
Various views of Damage from the Landslide

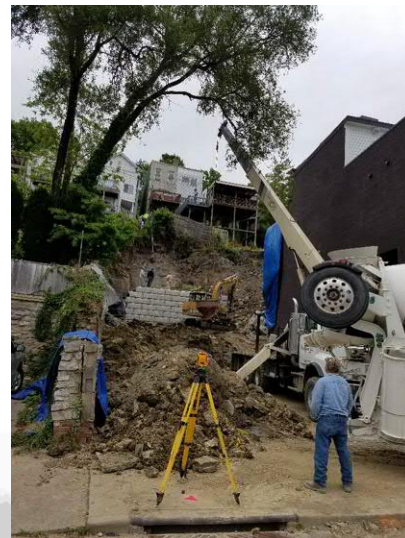
- › This portion of the Cincinnati area consists of a lot of urban land or fill described as clayey substratum over bedrock with a high percentage of sloping areas
- › Without documented plans of the older retaining walls in place and based on the site assessment, it appeared that the existing retaining walls between the properties on Oregon St. and Baum St. were thought to be providing grade separation for shallow shale bedrock, but at the location of the head scarp it was apparent that colluvium was thicker, and the slope did not have the anticipated high shear strengths of the shale.

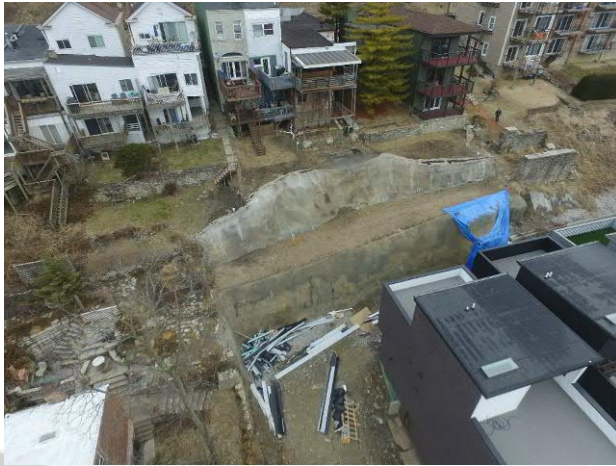
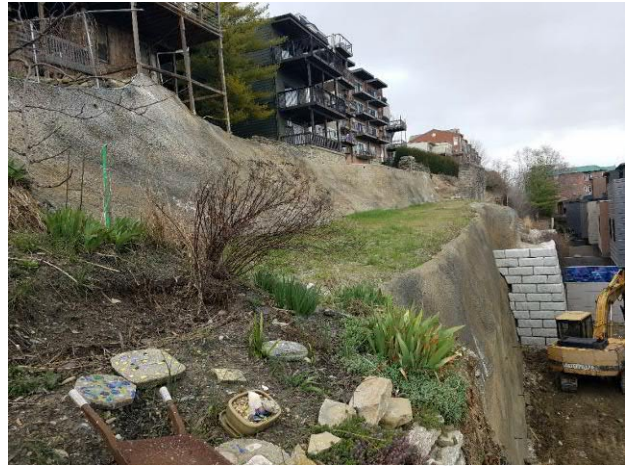
Finished Product – Immediate & One Year Later

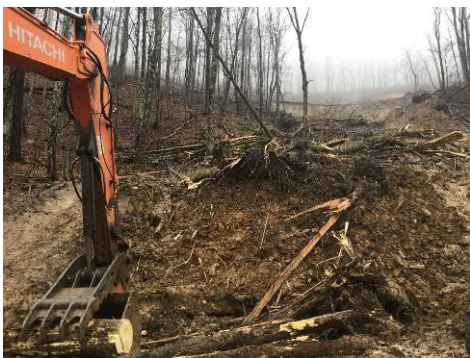
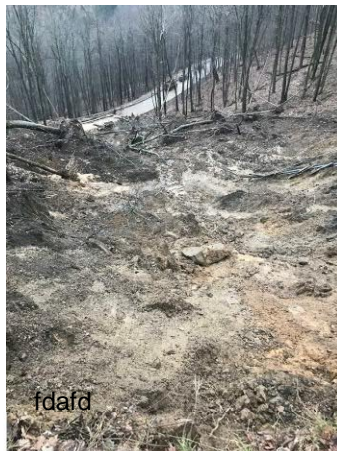
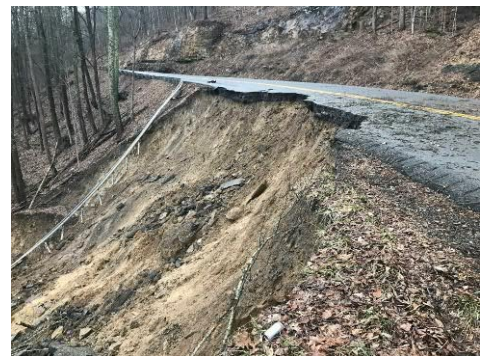
Pictures of Failure

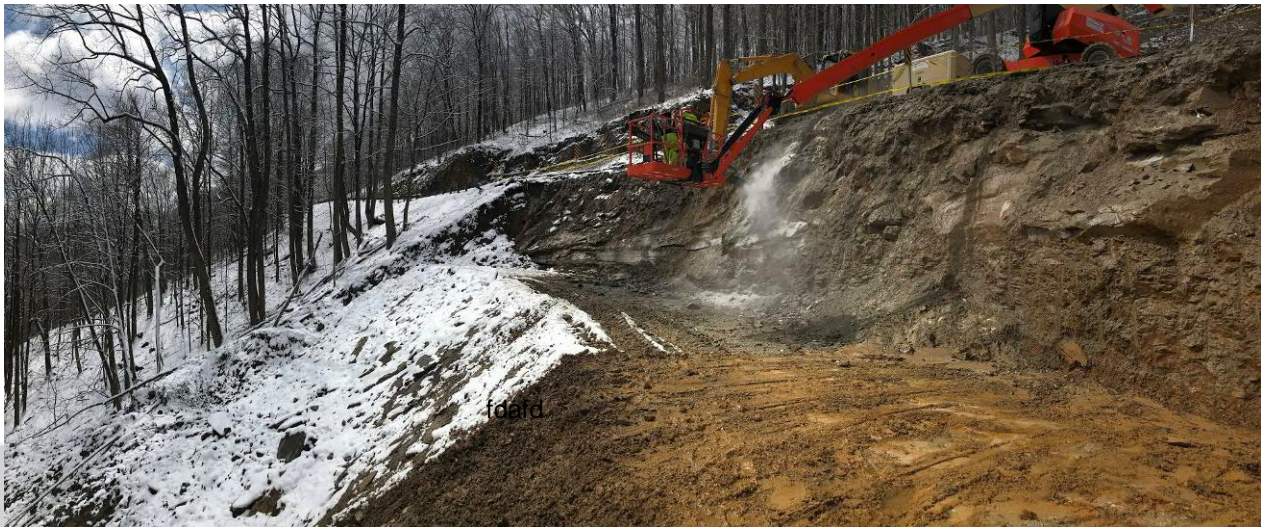
Construction Photos

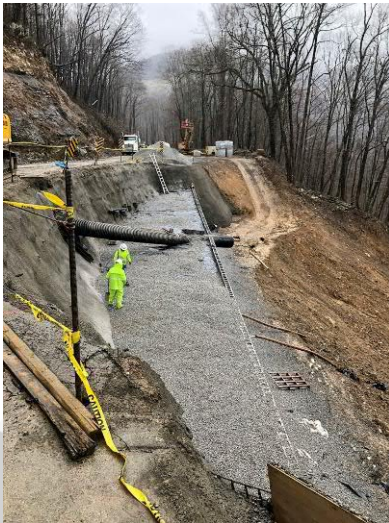
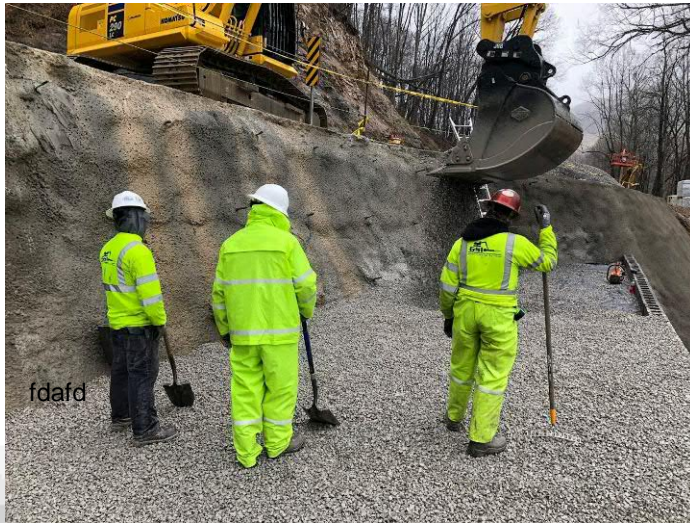
Construction Photos

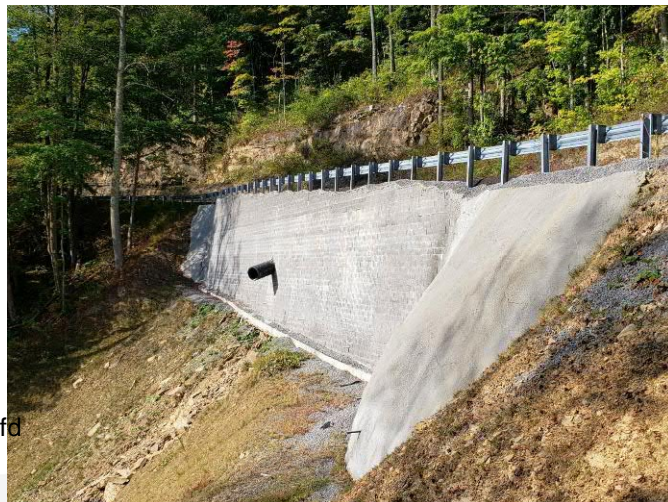
Completed Photos

- › Failure occurred on February 14, 2018
- › GSI was called and visited the site and conducted drone flight on February 24, 2018
- › Design and cost proposal submitted on March 2, 2018
- › Construction started on March 12, 2018
- › Construction Completed on May 3, 2018

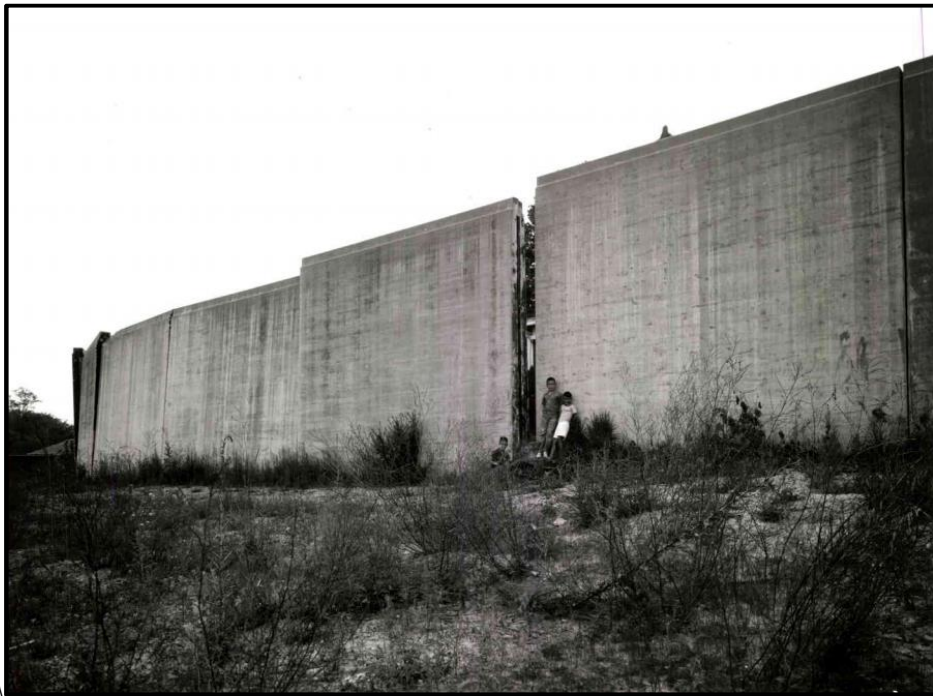
Figure 10: Floodwall Monoliths 43, 42, 41, 40, 39 and 38 (left to right)

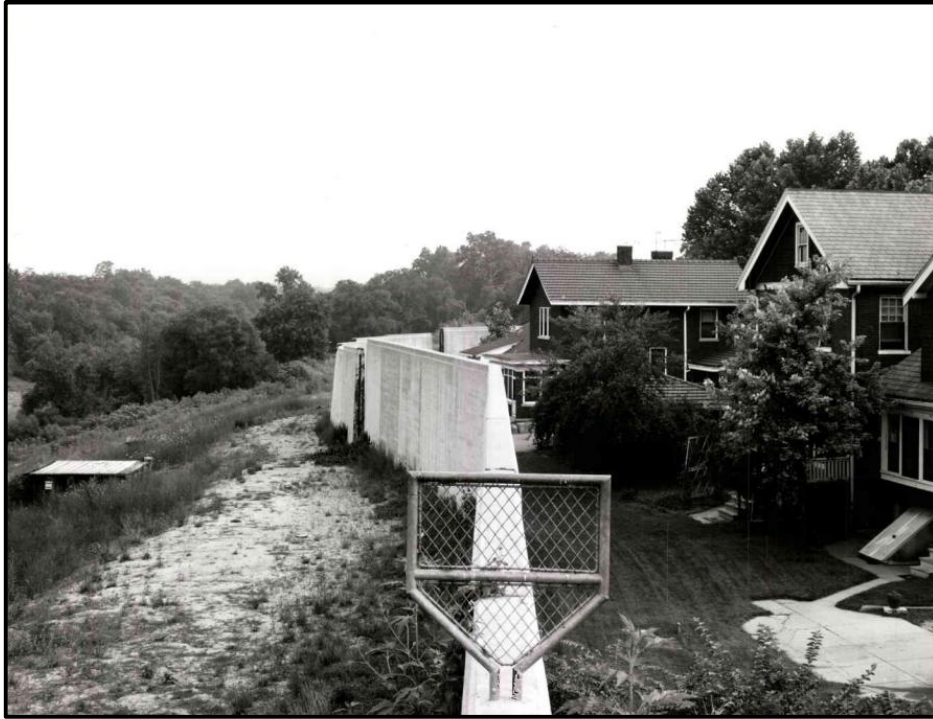
Figure 11: Looking south toward displaced monoliths (Drainage Pit No. 4 to the left)

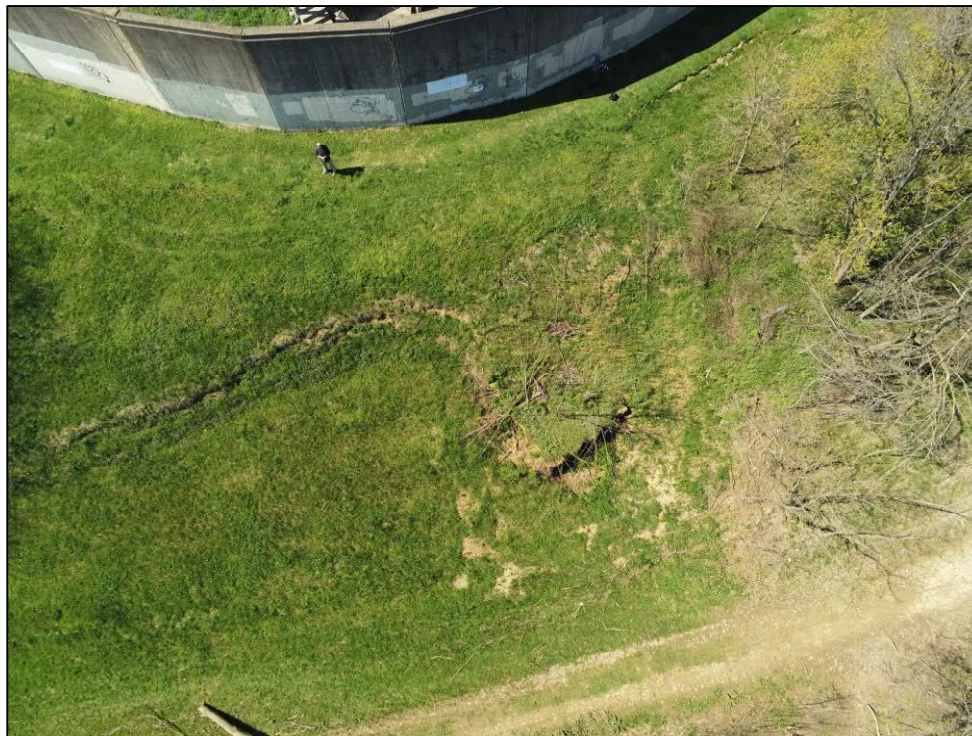
Figure 17: Slide scarp in January 2021 viewed from UAV over the riverside slope

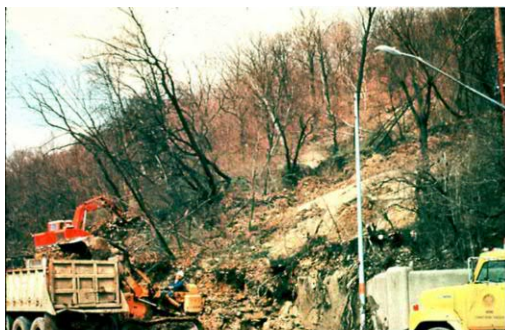
1975 Landslide
(Photograph Courtesy of City of Cincinnati)

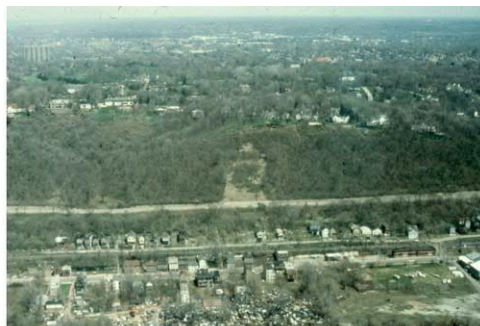
1975 Landslide
(Photograph Courtesy of City of Cincinnati)

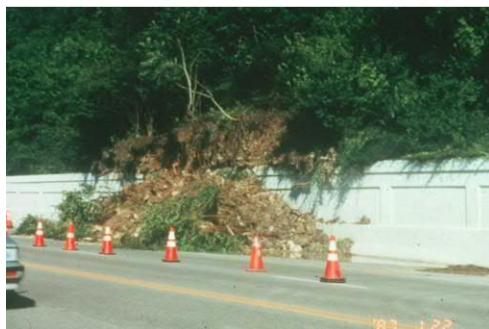
1996 Landslide
(Photograph Courtesy of City of Cincinnati)

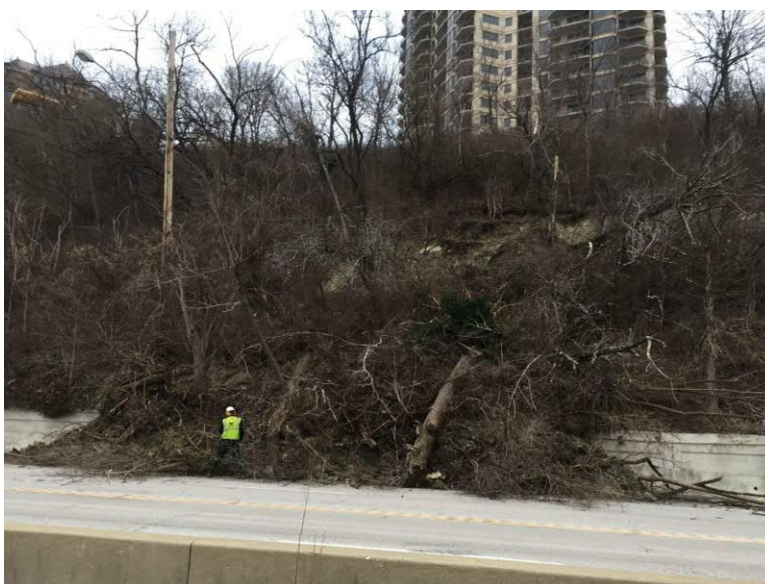
January 29, 2019
(Photograph Courtesy of City of Cincinnati)

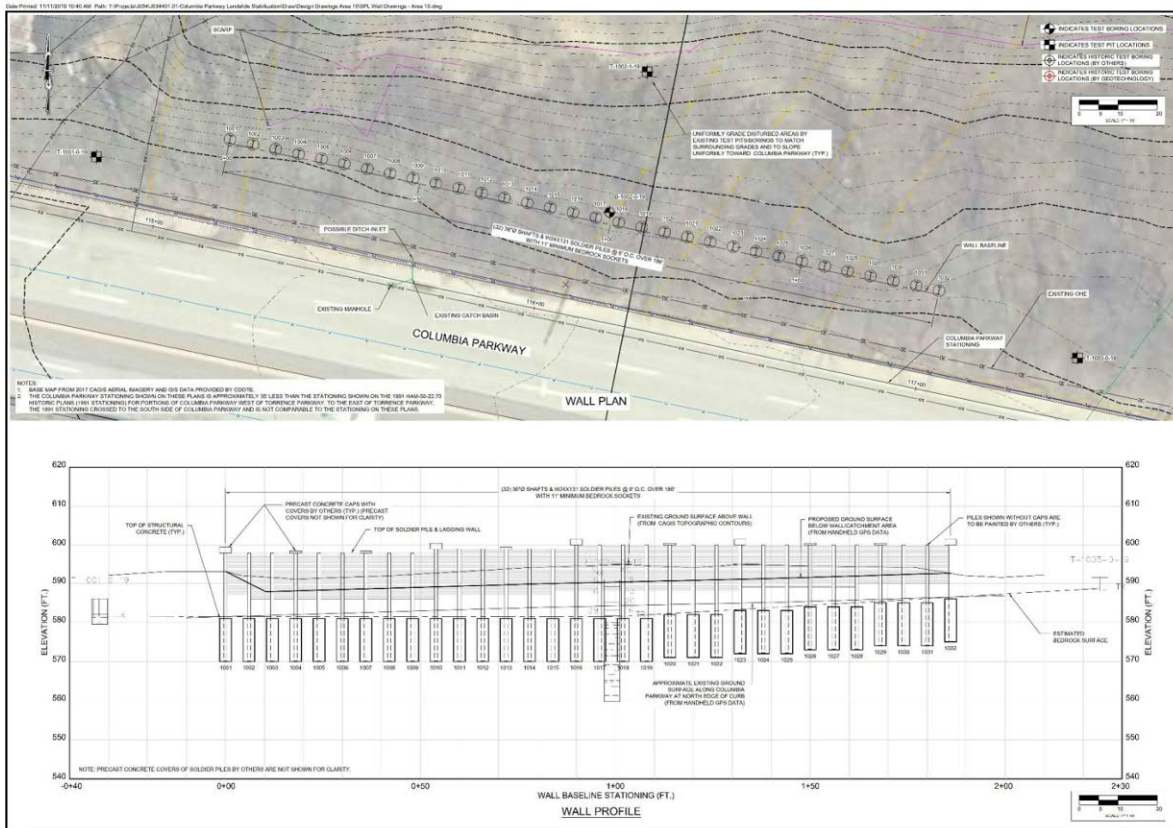
Columbia Parkway Landslide Stabilization: Area 10

Support Name	Color	Type	Force Application	Out-Of-Plane Spacing (ft)	Failure Mode	Pile Shear Strength (lbs)	Force Direction
Support 4	■	Pile/Micro Pile	Passive (Method B)	1	Shear	12000	Perpendicular to pile

Material Name	Color	Unit Weight (lbs/ft ³)	Strength Type	Allow Sliding	PC a	PC b	Water Surface
Colluvium	■	125	Power Curve		1.325	0.868	Piezometric Line 1
Basal Colluvium	■	125	Power Curve		0.949	0.866	Piezometric Line 1
Bedrock	■	140	Infinite strength	Yes			Piezometric Line 1

■ Wall Force from Slope Stability Analyses = 12 kips/linear

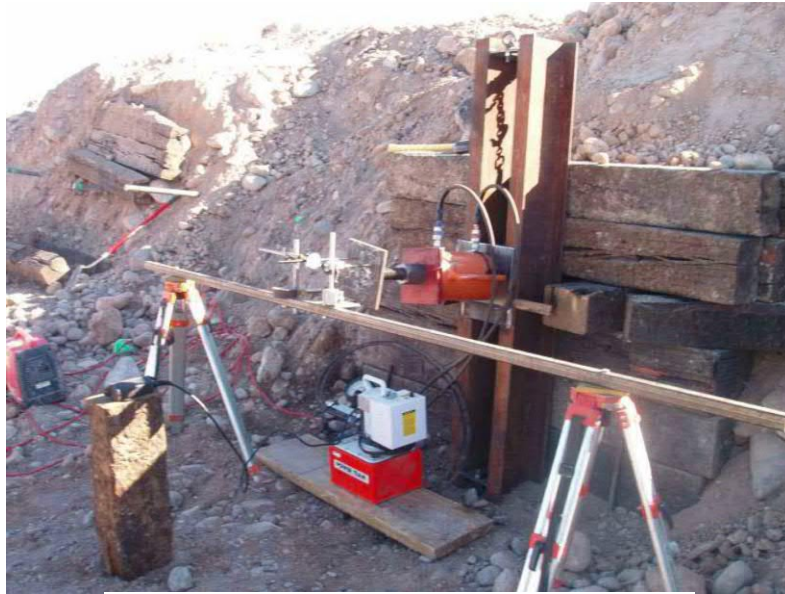
Verification Test Setup

(Photograph from FHWA GEC 007, Figure 9.1)

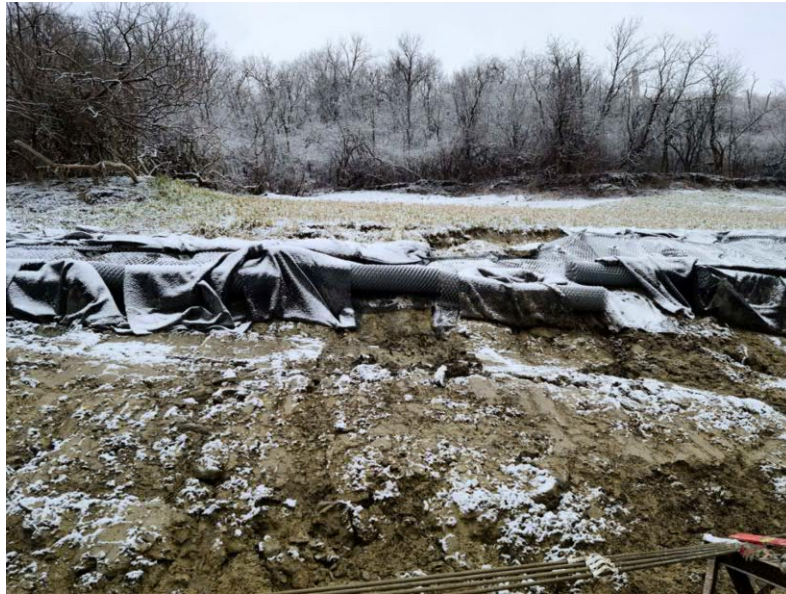
Construction Issues

February 1, 2021 – Slump Near Station 29+00 of Areas 1-3

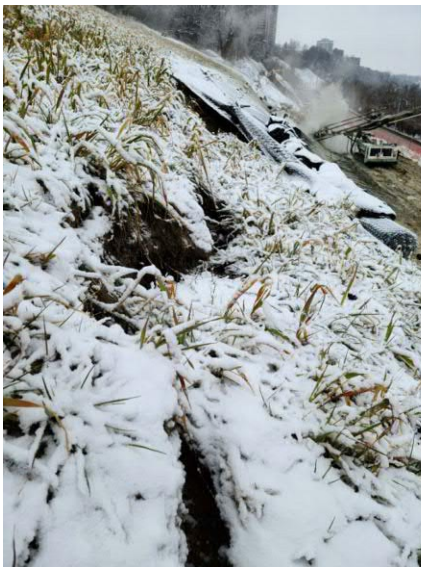
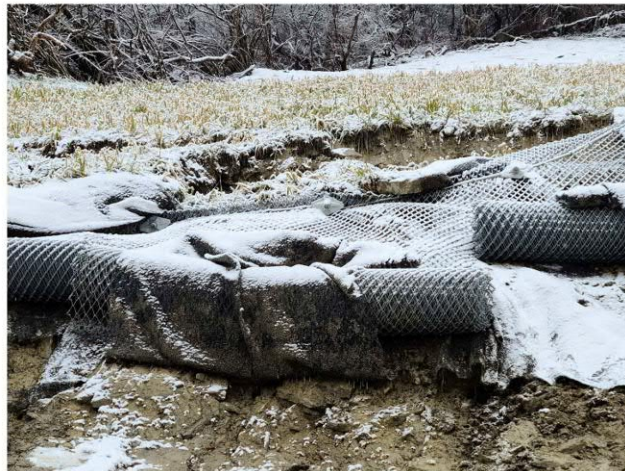
Construction Issues

February 1, 2021 – Slump Near Station 29+00 of Areas 1-3

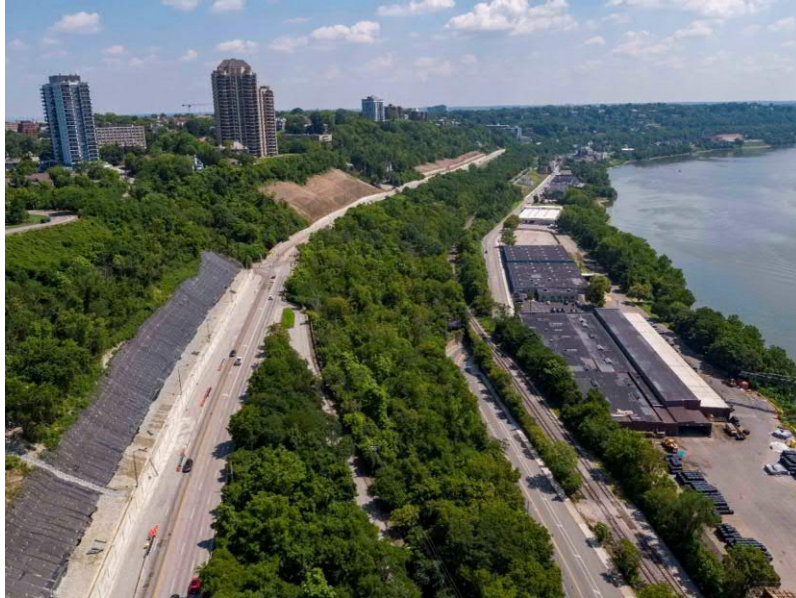
Columbia Parkway Landslide Stabilization: Nearing Completion

July 26, 2021

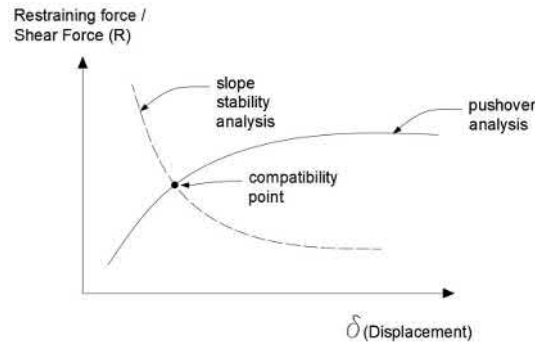
The intersection of the two plots represents the compatibility point where the force and displacement represent the design shear force on the pile.

Figure 8. Determination of compatible force-displacement state

The compatibility force-displacement that contributes to the stability of the slope and shear forces developed in the pile due to the slope deformation is determined by superposing the results from the pushover and the slope stability/deformation analysis in a single plot. Since the shear force calculated in the slope stability analysis represent a force per unit width, this force needs to be scaled to the effective width of the group of piles.
