OHIO RIVER VALLEY SOILS SEMINAR VI

SEMINAR PROCEEDINGS:
OCTOBER 17, 1975

SLOPE STABILITY & LANDSLIDES

S L O P E S T A B I L I T Y A N D L A N D S L I D E S

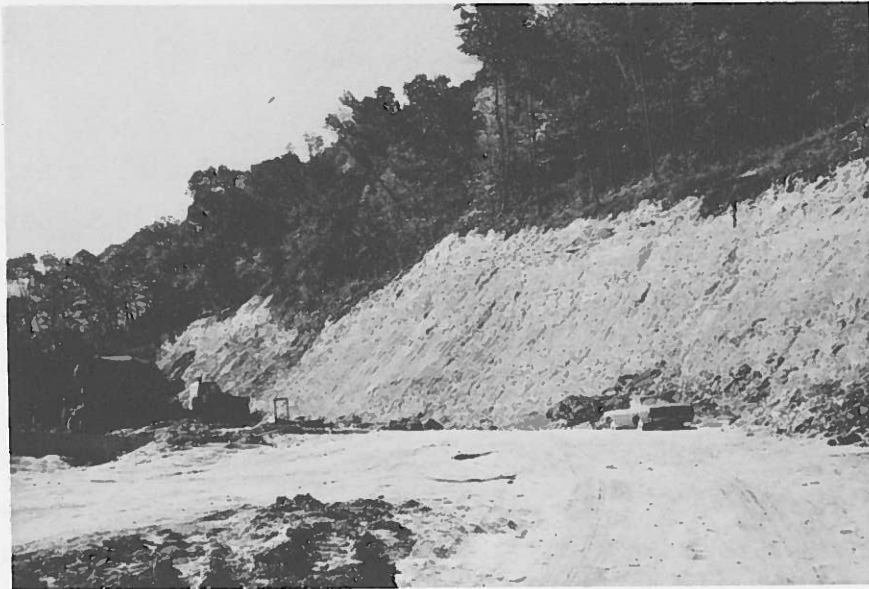
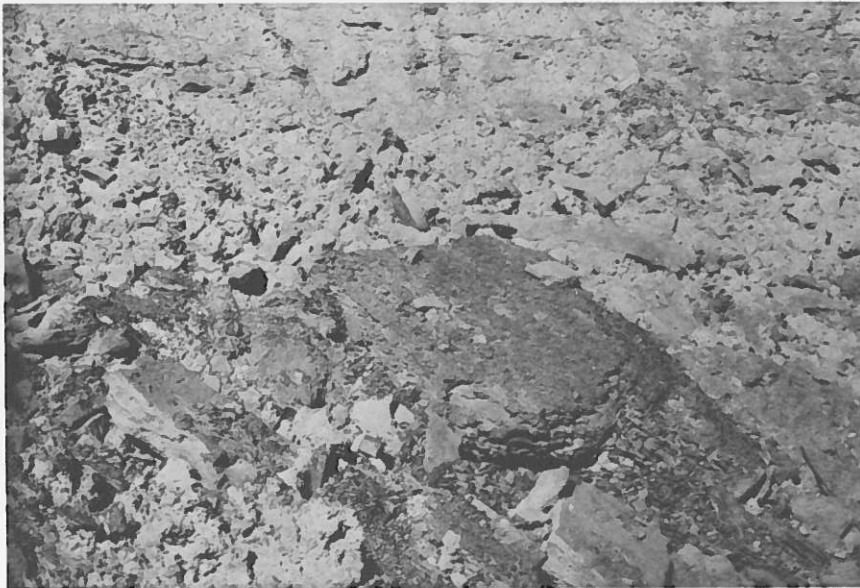
Figure 3.--Photographs of the Kope Formation along Hillside Avenue near Anderson's Ferry.

- a. Excavation into Kope Formation showing its rocklike character. Note accumulated debris at foot of excavation and slide in colluvial material uphill from ready-mixed concrete truck.**
- b. Closeup view of a block of shale that is slaking after short exposure. Largest dimension of shale block is about 2 feet (0.6 m) across.**

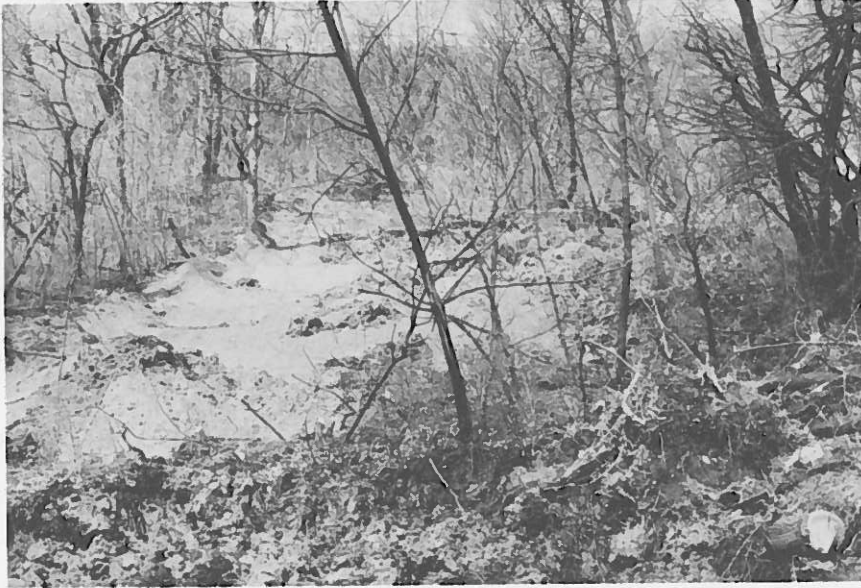
Figure 5.--Earthflow on Columbia Parkway, spring 1975. The semicircular channel on the left is part of the exposed failure surface.

Figure 5 illustrates a rapid earthflow that occurred in 1975 along Columbia Parkway. The earthflow moved over the retaining wall into the street, exposing layers of weathered bedrock below the surface of rupture.

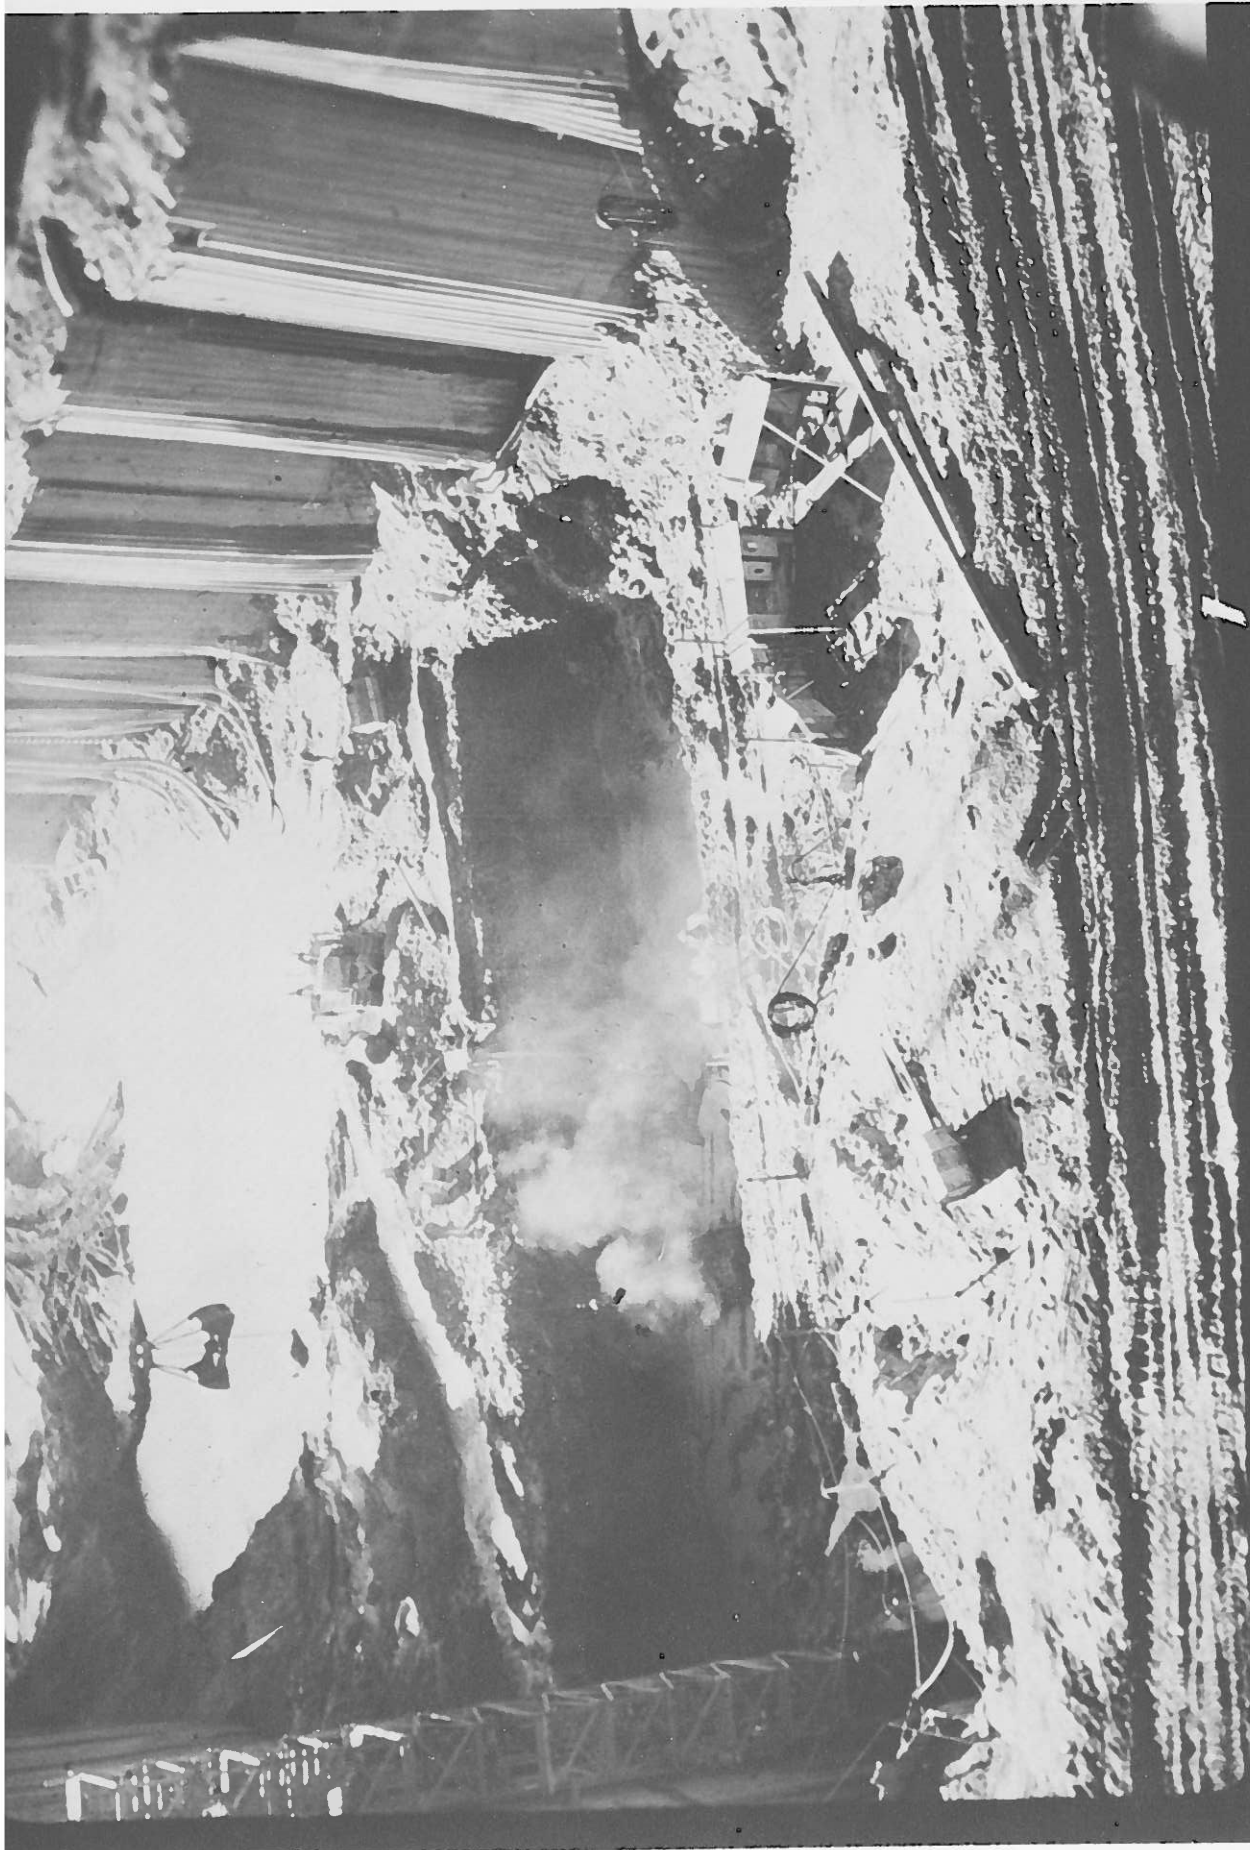
EXHIBIT 8

EXCAVATION PIER 8 19 OCT 67

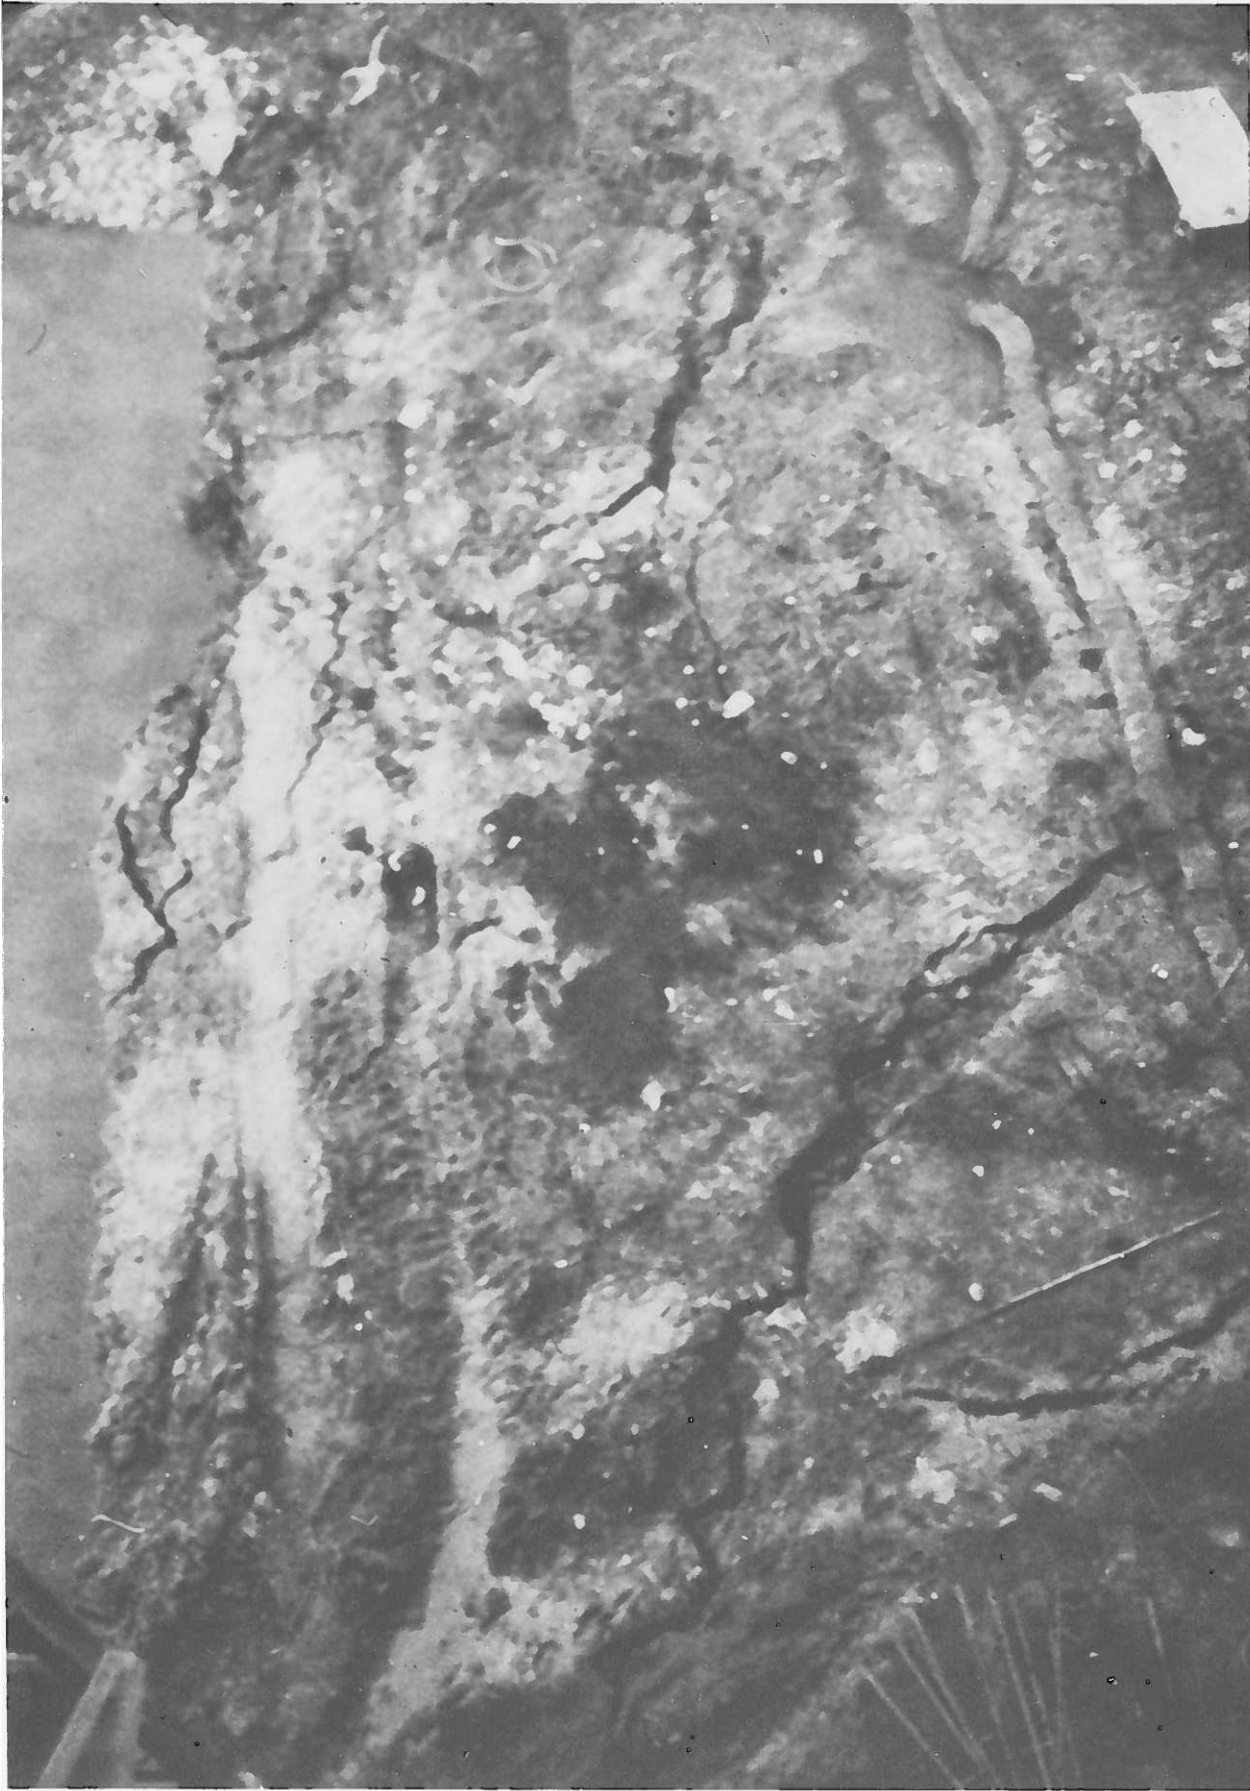
EXHIBIT 11

CRACKS IN GATEWAY 7 22 OCT 67

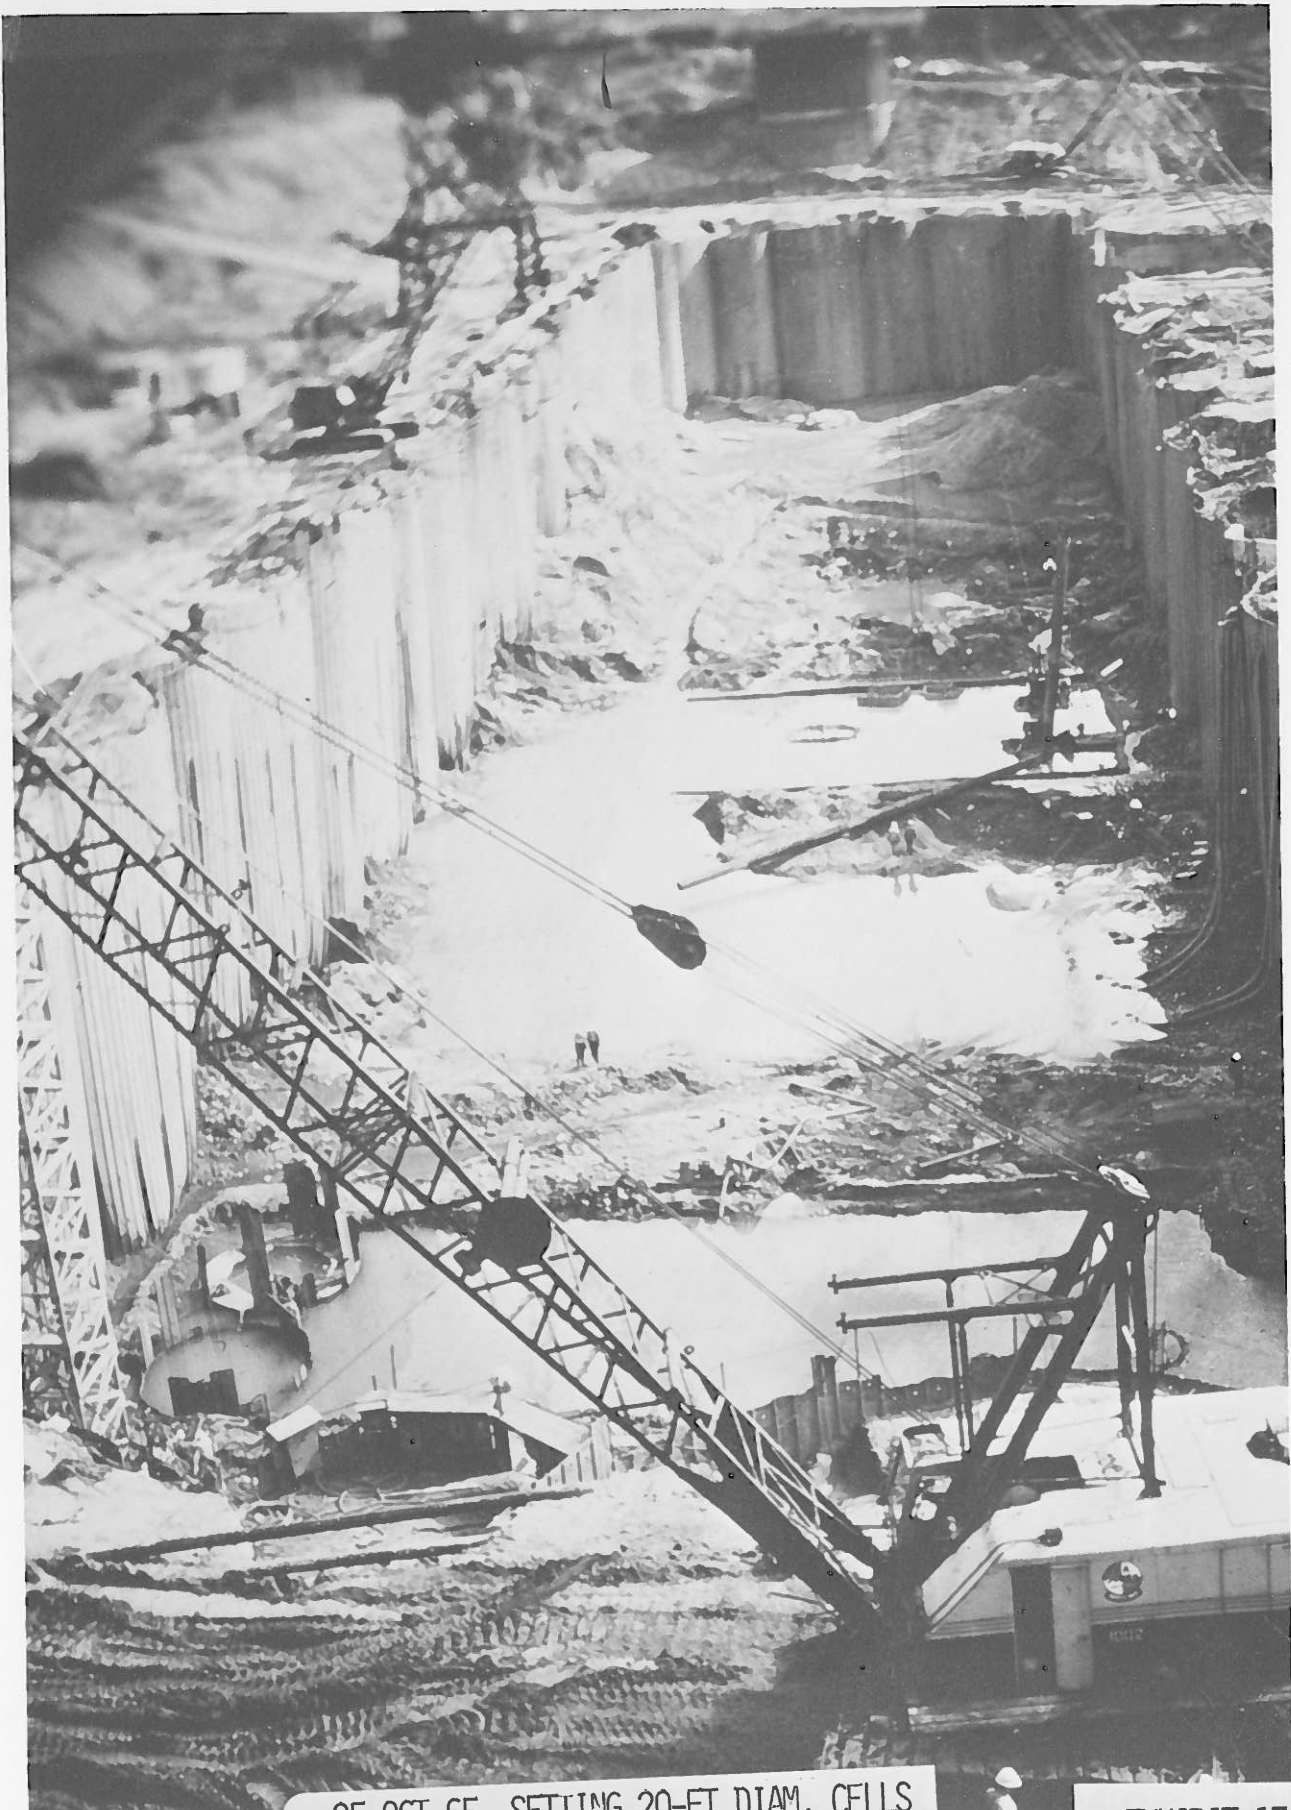
EXHIBIT 13

25 OCT 65 SETTING 20-FT DIAM. CELLS
IN PIER 3 EXCAVATION

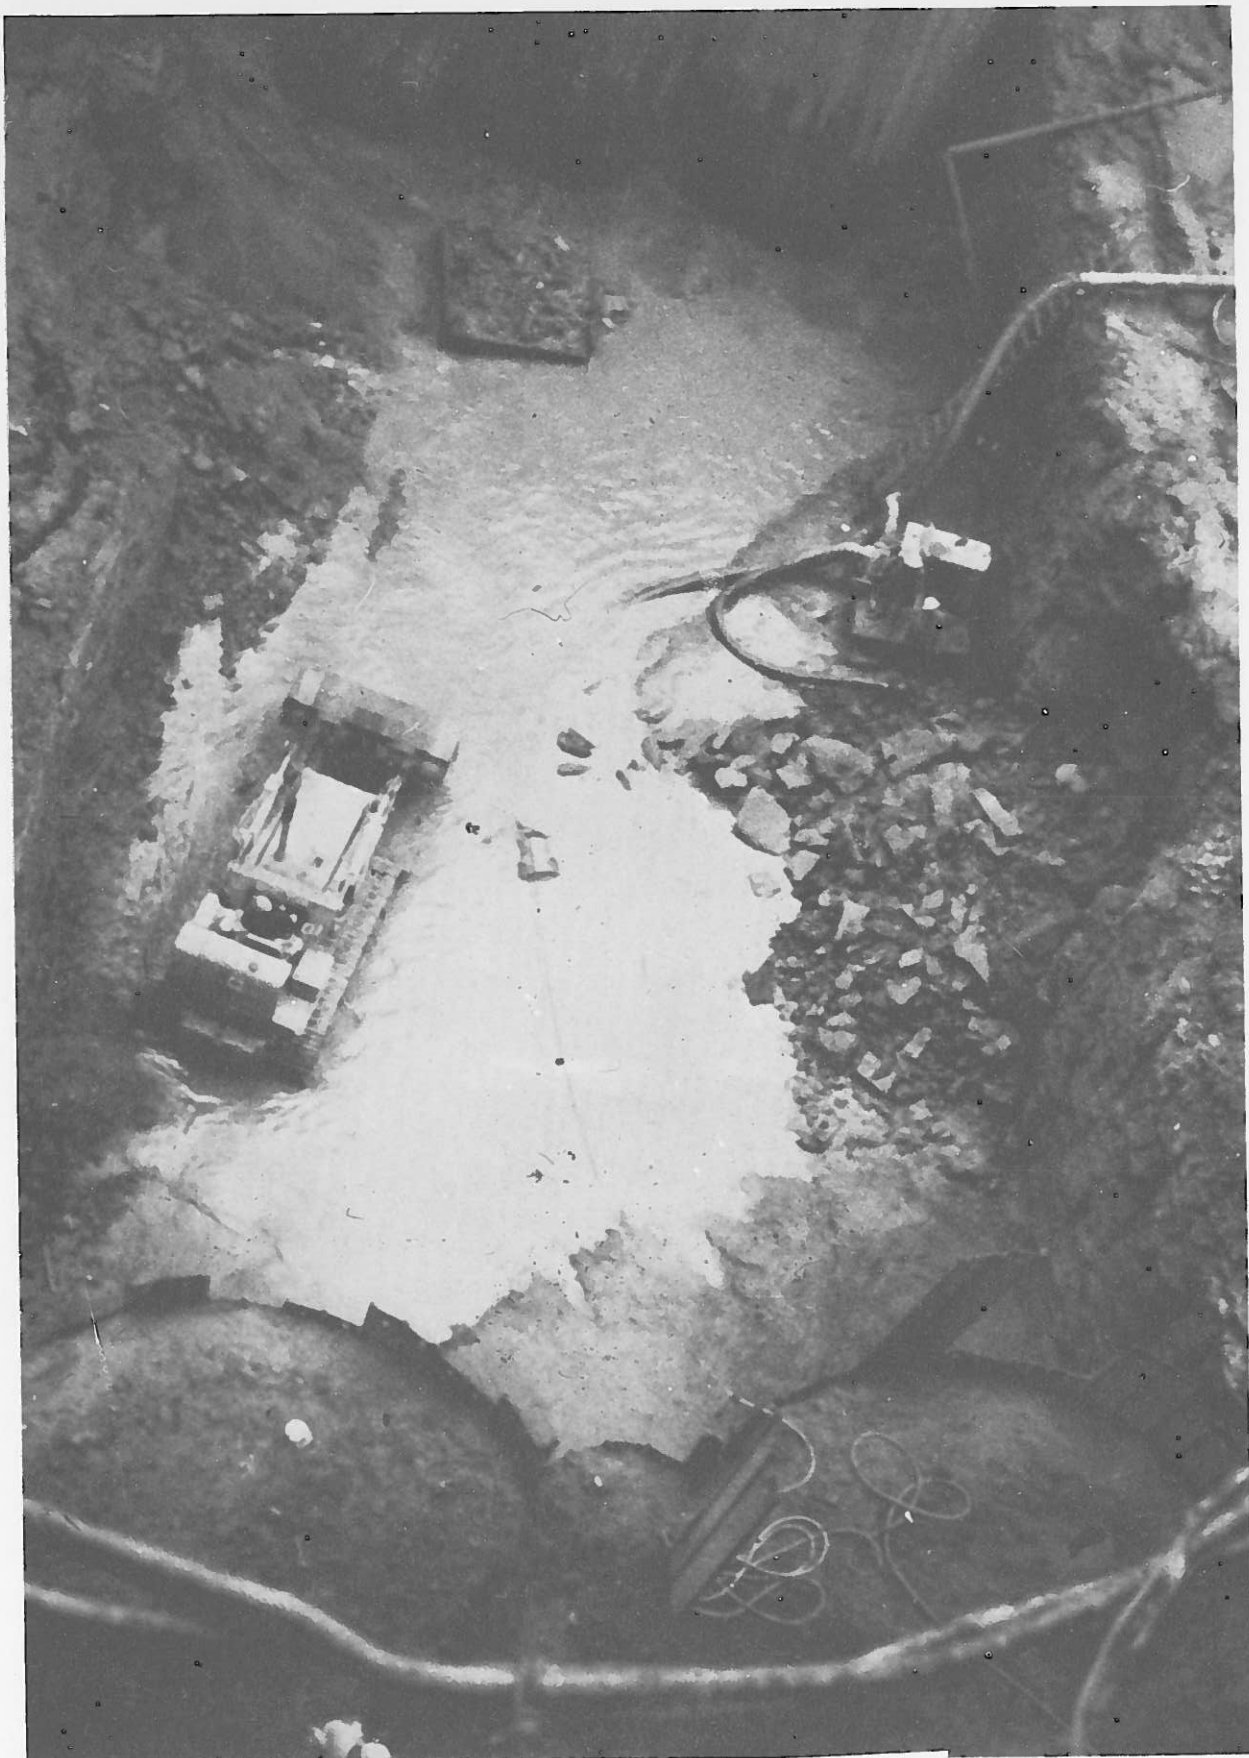
EXHIBIT 16

31 OCT 67 FALLOUT IN BOTH SIDES OF
PIER 3

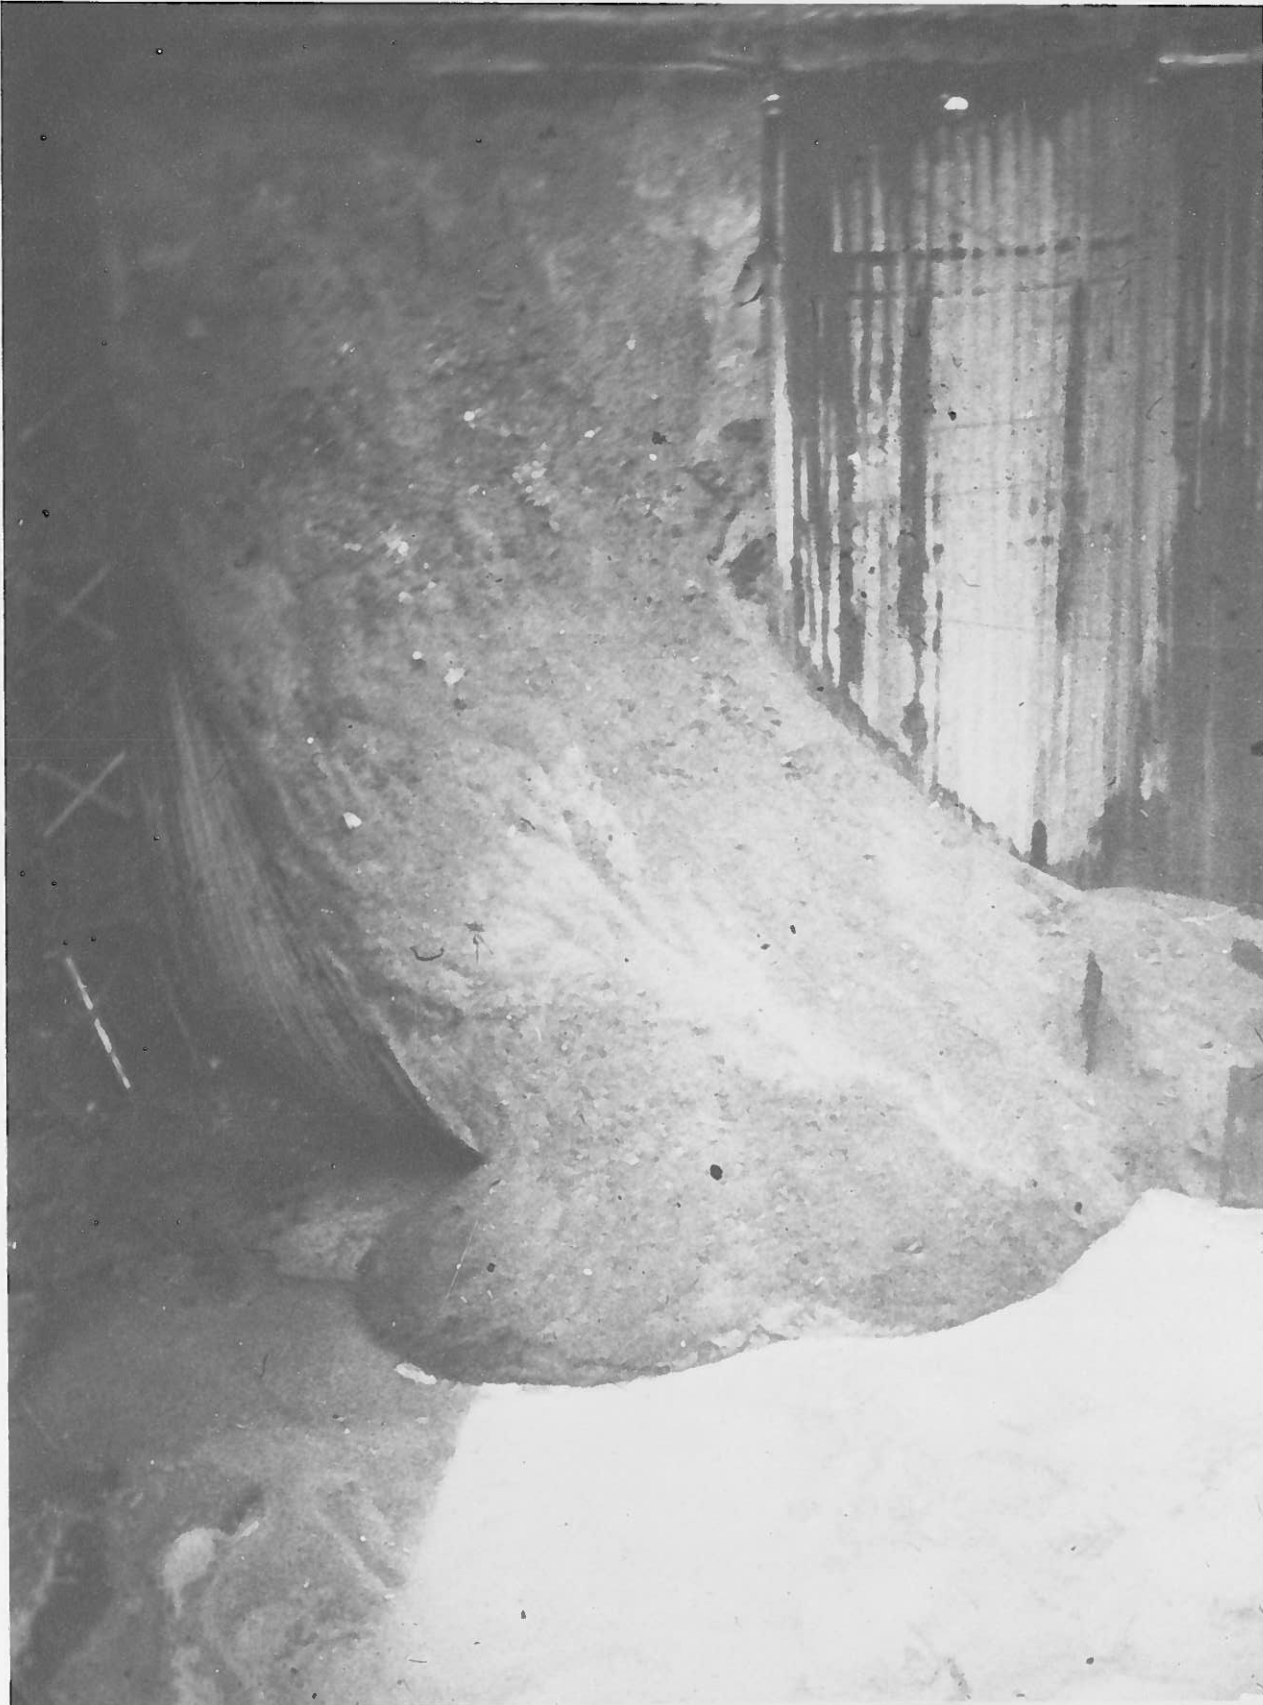
EXHIBIT 13

1 NOV 67 SAND SPILL FROM CELL 143

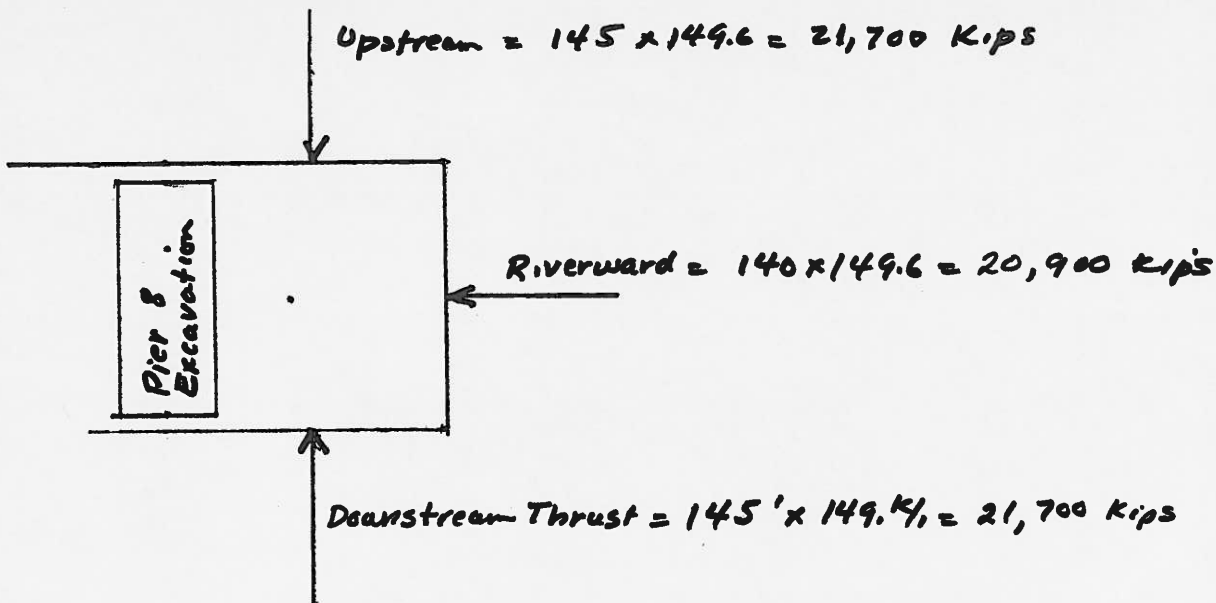
Compute thrust on Shale block riverward of Pier 8
