OHIO RIVER VALLEY SOILS SEMINAR

***EARTH DAMS AND EMBANKMENTS
DESIGN, CONSTRUCTION, PERFORMANCE***

**Proceedings of the Eighth
Ohio River Valley Soils Seminar on**

**EARTH DAMS AND EMBANKMENTS
DESIGN, CONSTRUCTION, PERFORMANCE**

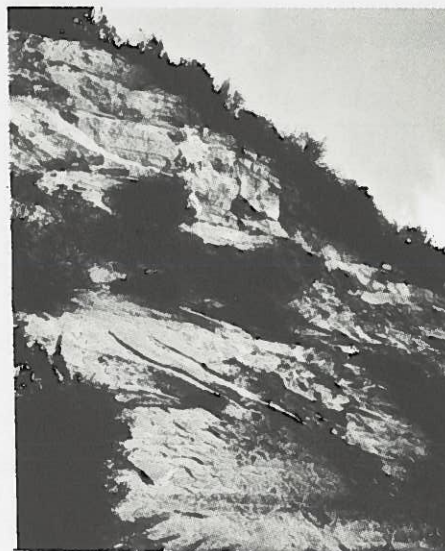
Fig. 3. Typical stress relief jointing in slope in layered rock.

Stress relief joints have been described by others (23, 24, 25) in valleys and man-made excavations of uniform lithology (massive limestones, sandstones, layered volcanics and intrusives). These joints are roughly parallel to the surface of the valley or excavation and can be observed to occur into the walls for distances that are small compared to the depths of the valley or excavation. These joints are believed to be extension fractures caused when the ratio of tangential stresses (both in the direction of the slope and in the horizontal direction) to normal stresses (normal to the valley or excavation wall) reaches a critical value. Only those stress relief joints closest to the surface show a tendency to open. Fig. 3 is a photograph of typical stress relief joints in a layered sequence.

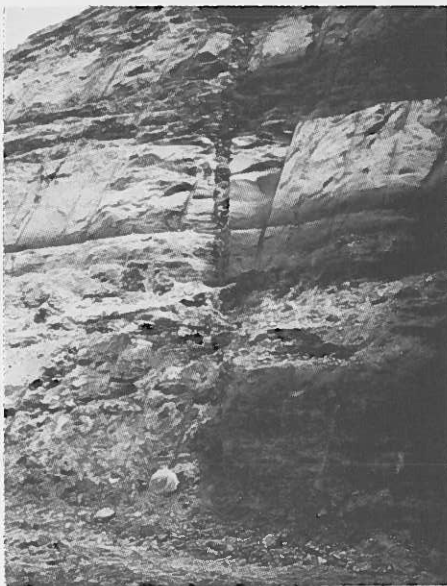
Fig. 4. Clay-filled joint, approximately 10 in. wide, in massive sandstone; abutment excavation for small dike in southern Indiana.

Fig. 4 shows a photograph of a vertical, clay-filled crack in very massive basal Pennsylvanian sandstone in southern Indiana. The sandstone is underlain by a limestone unit which in turn is underlain by a shale unit. The excavation is for the abutment key of a 35-ft.-high earth dike. Except for the clay-filled joint, the sandstone unit does not contain any discernible joints (the parallel, subvertical features in the photograph are drill casts of previous blasting holes) until the gully wall is reached. There, a few joints can be observed roughly parallel to and occurring some feet into the gully wall. The clay-filled joint is nearly 100 ft. from the gully wall measured horizontally along the

bottom of the excavation and has an average width of about 10 in. for most of its height.

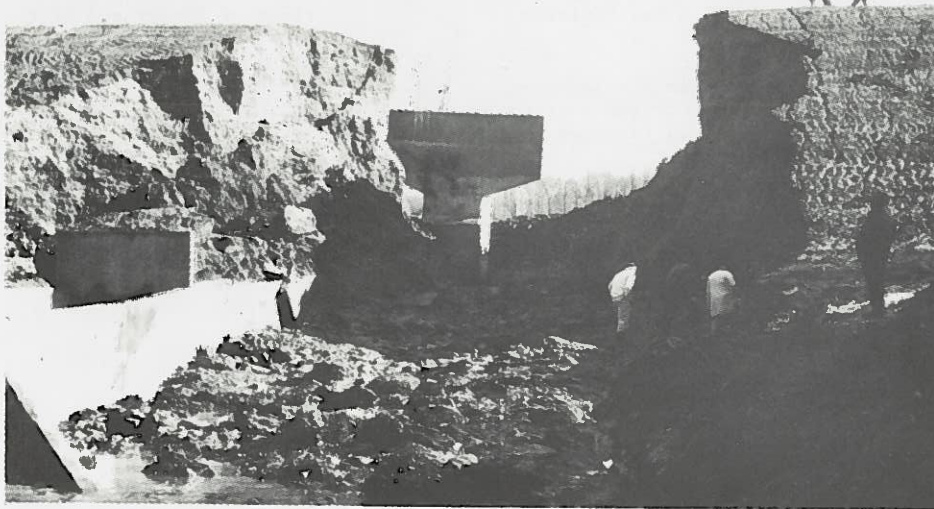
Figure 6. Typical riser-conduit spillway exposed in breach of small dam

Type of Primary Spillway. Various types of primary spillways are used for small dams. The most economical type of spillway for both dams in the Jubilee study appears to be a 3-sided weir on a riser structure of reinforced concrete connected to either a prestressed concrete pipe or a reinforced concrete conduit which passes through the bottom of the dam. The conduit would terminate in a reinforced concrete divergent chute and stilling basin. A typical spillway of this type is shown in Fig. 6 which also shows a failure of a small dam. The probable causes of the failure shown in the figure have been discussed in a previous paper (2).

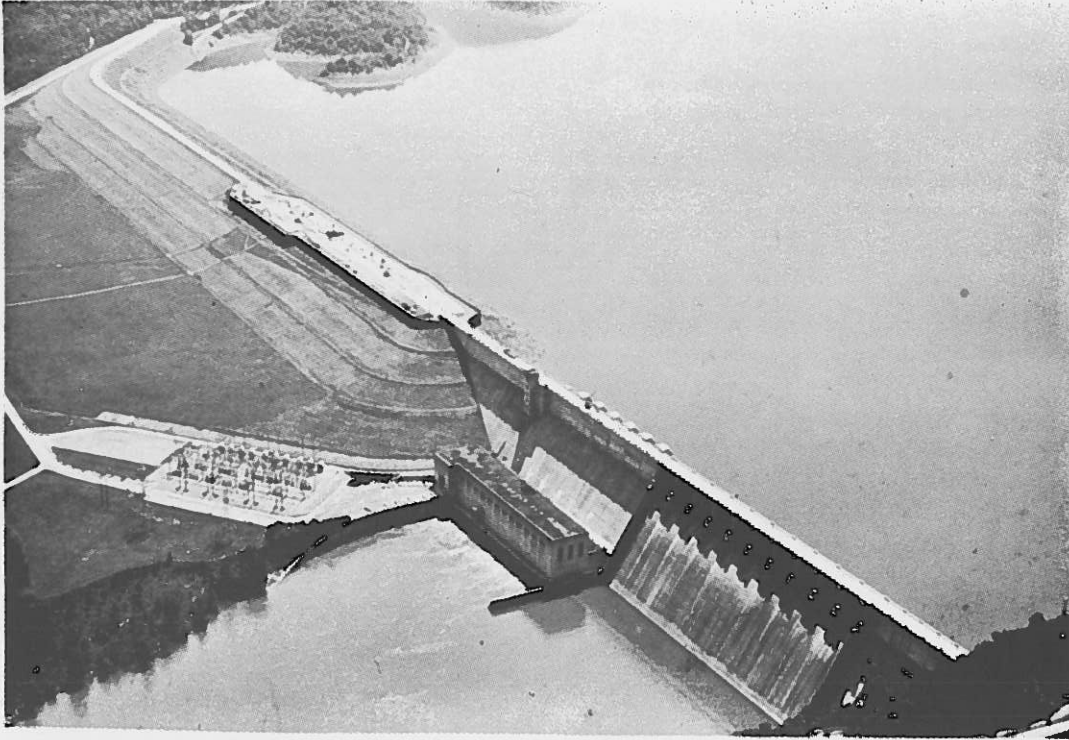
FIGURE 2 - GENERAL ARRANGEMENT OF PROJECT.

The general arrangement of the project is shown on the photograph in Figure 2. The main feature under consideration here is the 3940 foot long earth embankment that extends across the flood plain to connect the concrete section of the dam to the right abutment. This embankment is a homogenous rolled earth-fill structure constructed chiefly of clays, sandy clays, and clayey sands from the valley alluvium upstream and downstream of the damsite. The embankment, except for a small portion adjacent to the concrete structure, is underlain by up to 50 feet of alluvium and terrace materials which are, in turn, underlain by karstic Ordovician limestones. As seen in the dam cross section in Figure 3, the pre-World War II design and con-

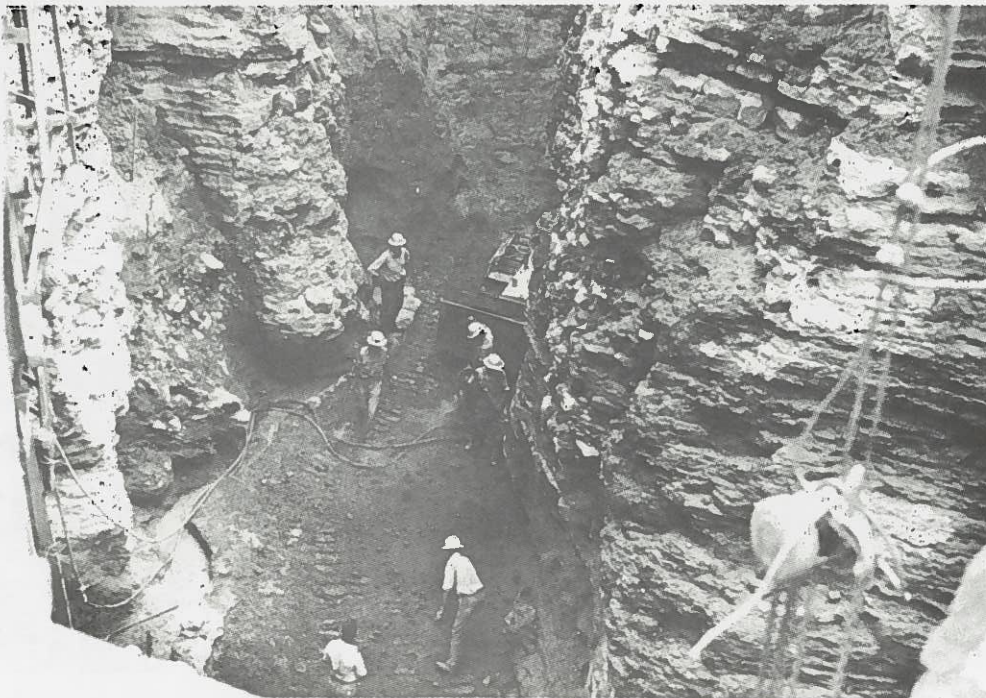
FIGURE 9. CUTOFF TRENCH AT CONCRETE STRUCTURE LOOKING LANDWARD.

cutoff trench at its riverward juncture with the concrete section of the dam. Figures 8 and 9 show the narrow, steep-sided configuration of the trench in this location. Another dubious feature is the single line of grout holes located mainly below the horizon of major karstic development.

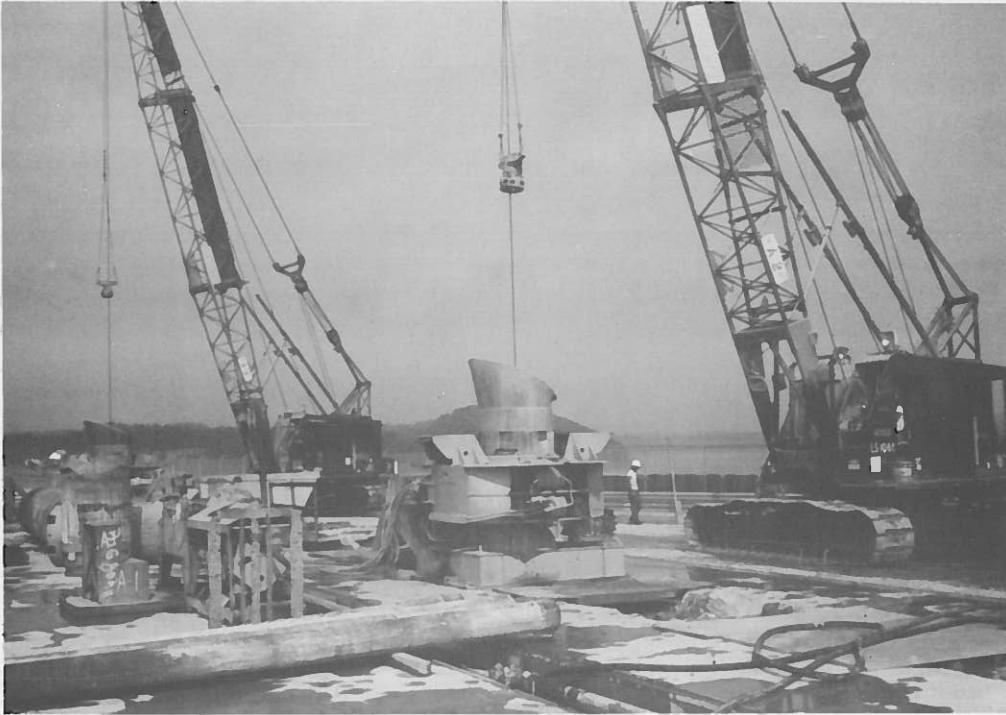
FIGURE 28. EXCAVATION WITH CLAMSHELL THROUGH TEMPORARY CASING. NOTE CASING DRIVER.

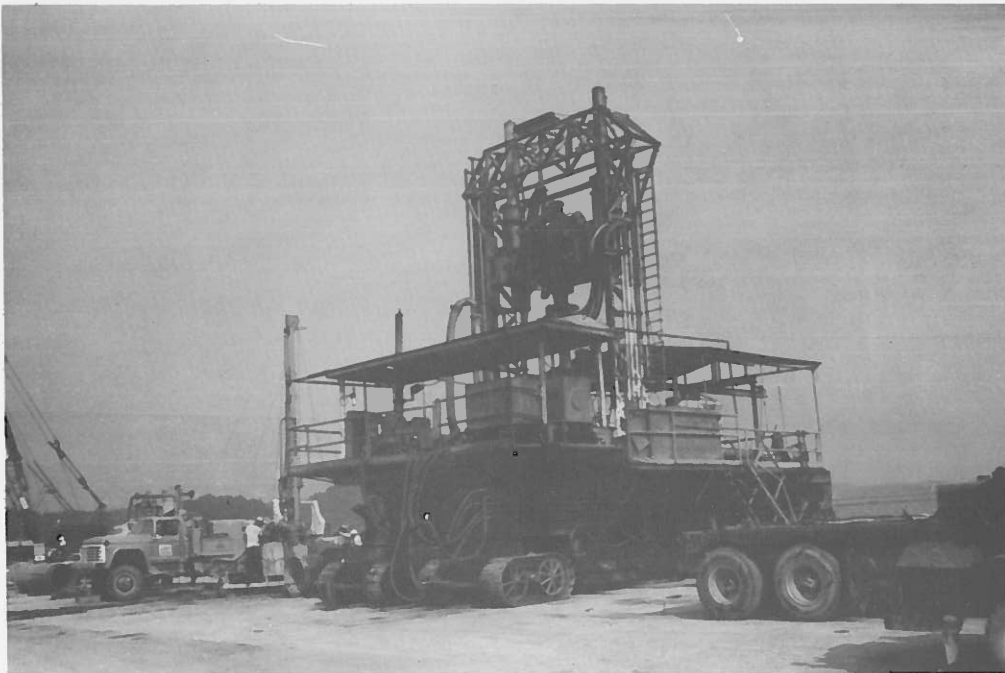
FIGURE 29. 36-INCH DIAMETER ROTARY DRILL WITH REVERSE CIRCULATION.

Next a rotary drill with reverse circulation excavates a 36 inch outside diameter hole through the rock. Meanwhile, to keep within the tolerance limits for the permanent casing, verticality is checked every 10 or 20 feet. When the bottom elevation of the wall is reached, exploratory drilling is carried out in order to test the underlying rock. Once the rock is determined sound and tight by pressure testing, the exploratory hole is grouted and the bottom of the hole is cleaned to remove grout and rock cuttings. The 47 inch casing is now withdrawn and the 41 1/4 inch casing freed. A 26 inch outside diameter permanent casing is weighted with

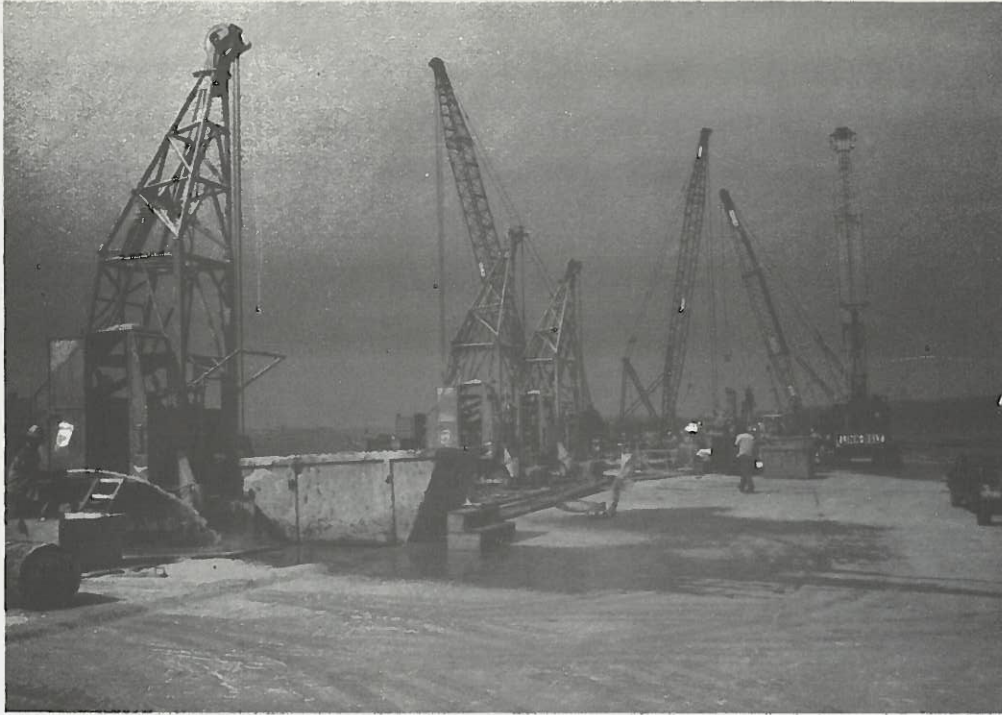
FIGURE 30. "WOLF CREEK" DRILL EXCAVATING SECONDARY ELEMENTS.

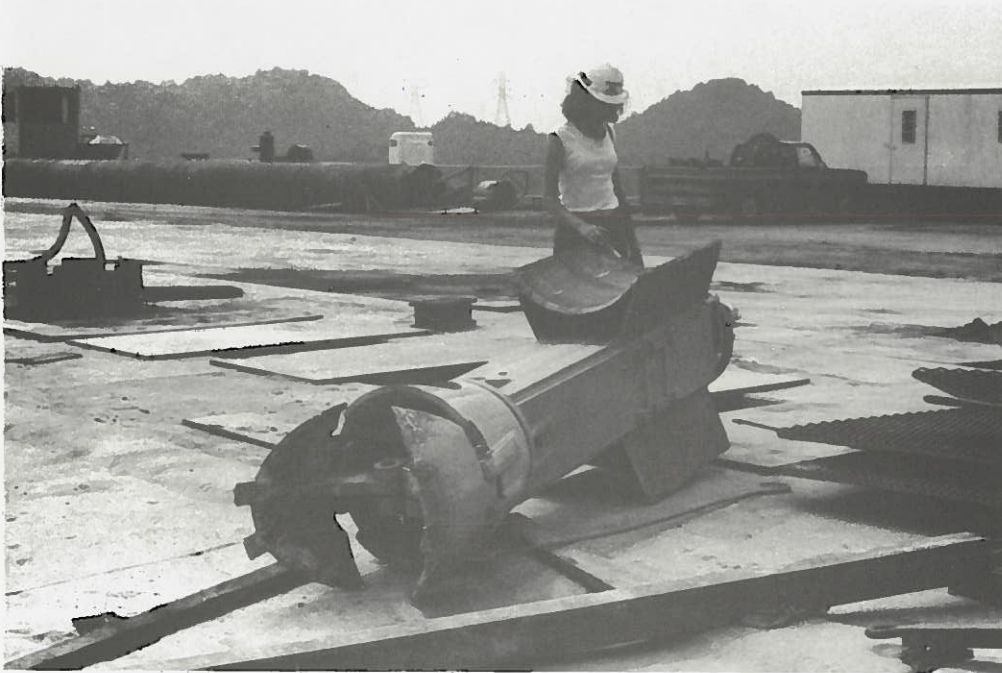
FIGURE 31. BI-CONCAVE CHISEL WITH SMALL CLAMSHELL FOR EXCAVATING SECONDARY ELEMENTS.
