OHIO RIVER VALLEY SOILS SEMINAR XXXIX

URBAN CONSTRUCTION

October 17, 2008
Cincinnati, Ohio - Northern Kentucky

EARTH RETENTION, UNDERPINNING AND DEEP FOUNDATIONS FOR AN ENTIRE CITY BLOCK IN SALT LAKE CITY, UTAH

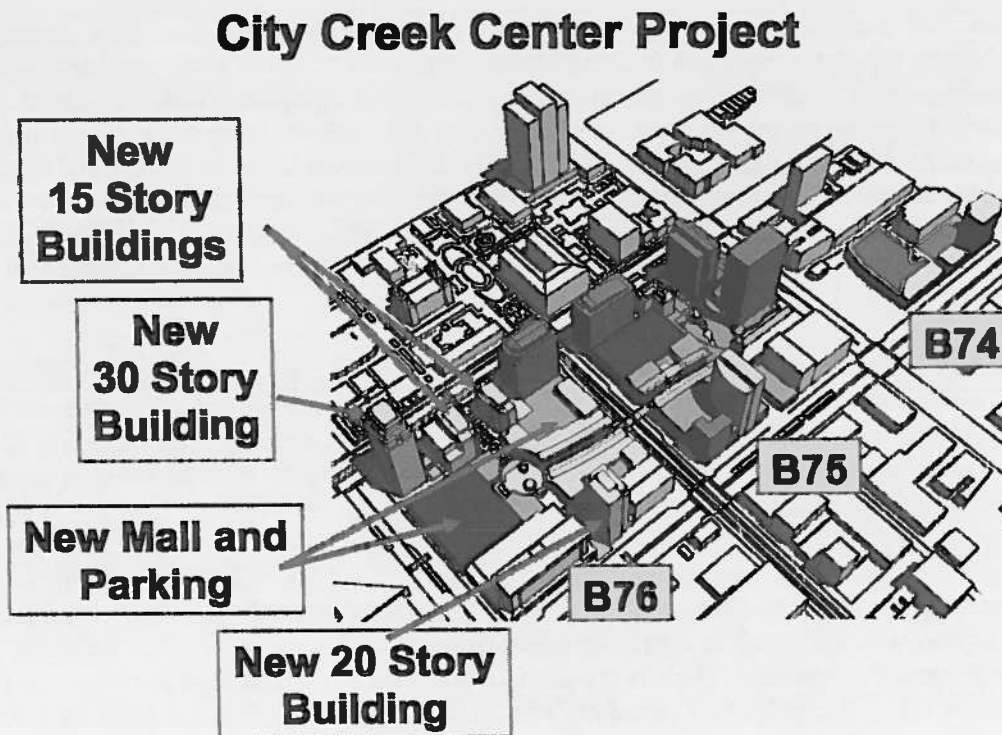
FIGURE 1 – City Creek Center Project

City Creek Center is a \$1 billion Project that will transform the downtown area of Salt Lake City, Utah. The project is spread over 3 city blocks encompassing 20 acres and involves the demolition and redevelopment for mixed use retail, office and residential properties directly adjacent to Historic Temple Square, (Figure 1).

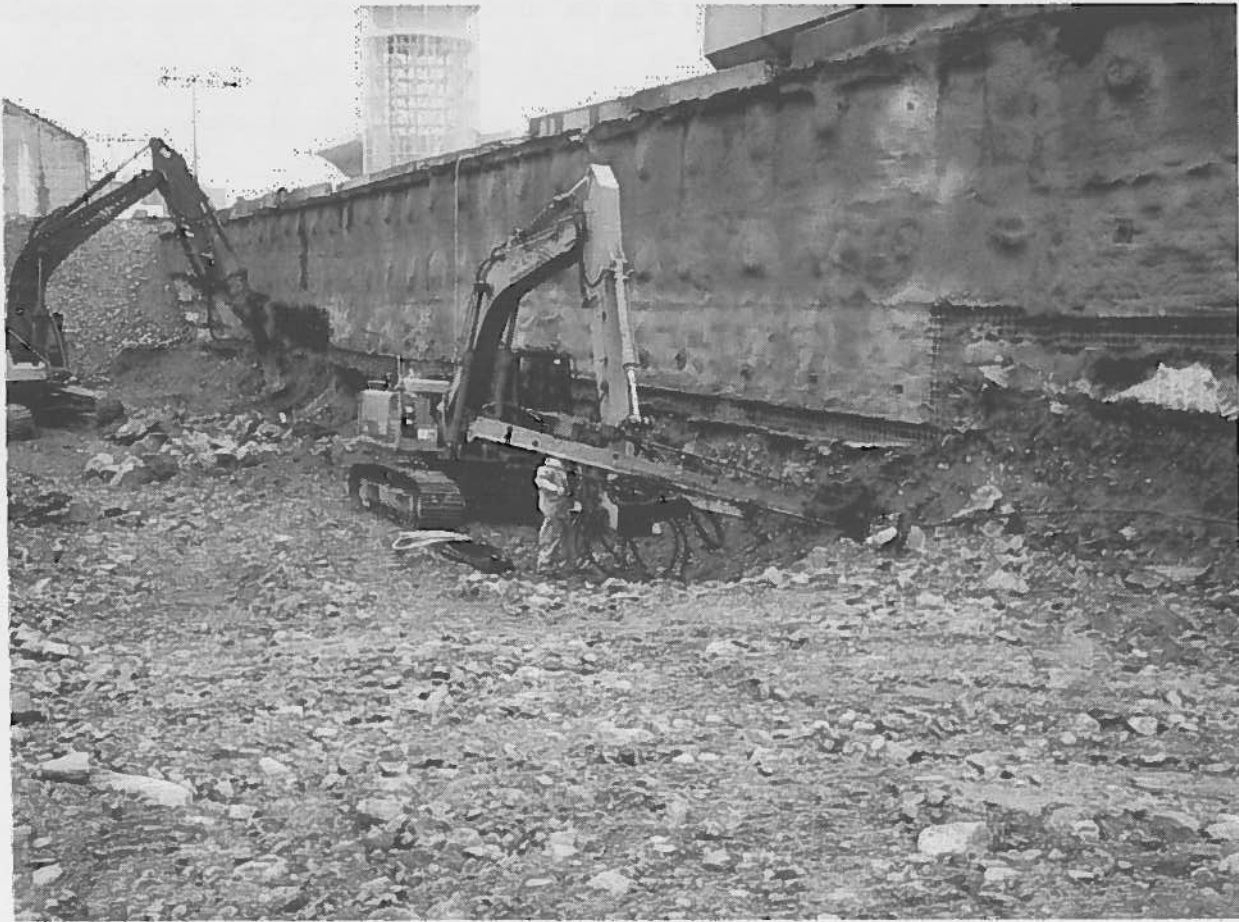
FIGURE 5 – Block 76 Concurrent Demolition and Soil Nail Wall Installation

Soil Nail Walls: The project began with a demolition phase that was supported by soil nail wall construction. As subsurface demolition occurred, the soil nail walls were sequentially installed as earth retention to support further demolition below grade. Figure 5 shows the concurrent demolition and soil nailing operations.

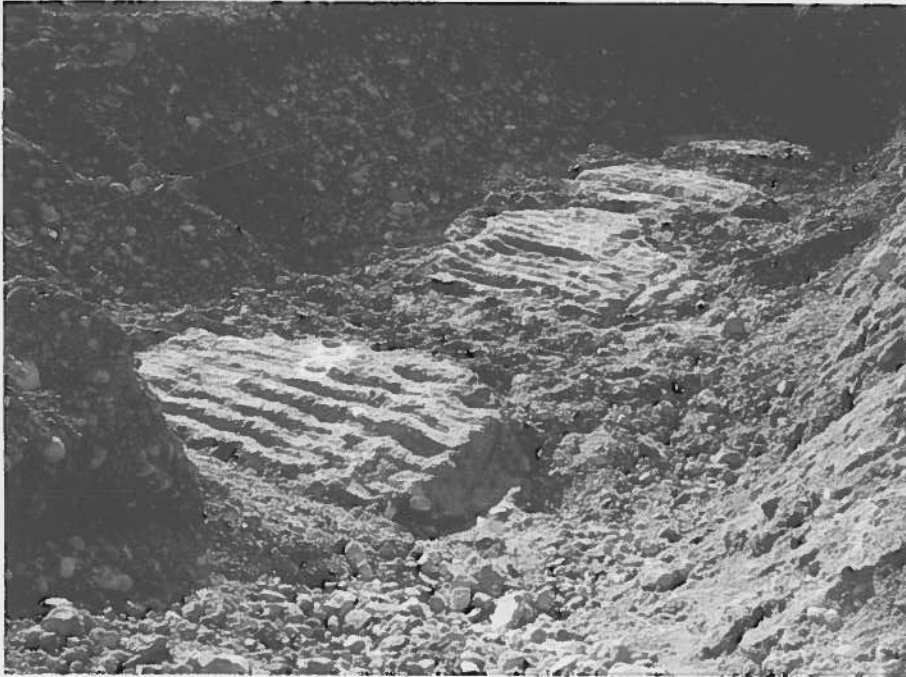
FIGURE 8 – Block 76 Jet Grout Test Columns – Initial Excavation

As discussed above, jet grouting was selected as an alternate to dewatering along South Temple and Main Streets. Prior to commencing production jet grouting, a jet grout field test program was instituted to optimize injection parameters and to confirm jet grout element geometric and mechanical properties. The test program involved the construction of 4 sets of 2 test columns followed by a 3 day cure time. The injection times were varied for each set of test columns, while all other parameters remained constant. The grout mix included a small amount of bentonite (2% by weight) to stabilize the grout mix and provide additional water control properties to the grout mix. The target column diameter was 4ft using the single fluid technique. The test columns were then exposed by excavation and geometric properties obtained by direct measurement (Figure 8 Test Columns). All test sets achieved 4ft column diameters or greater and production work commenced.

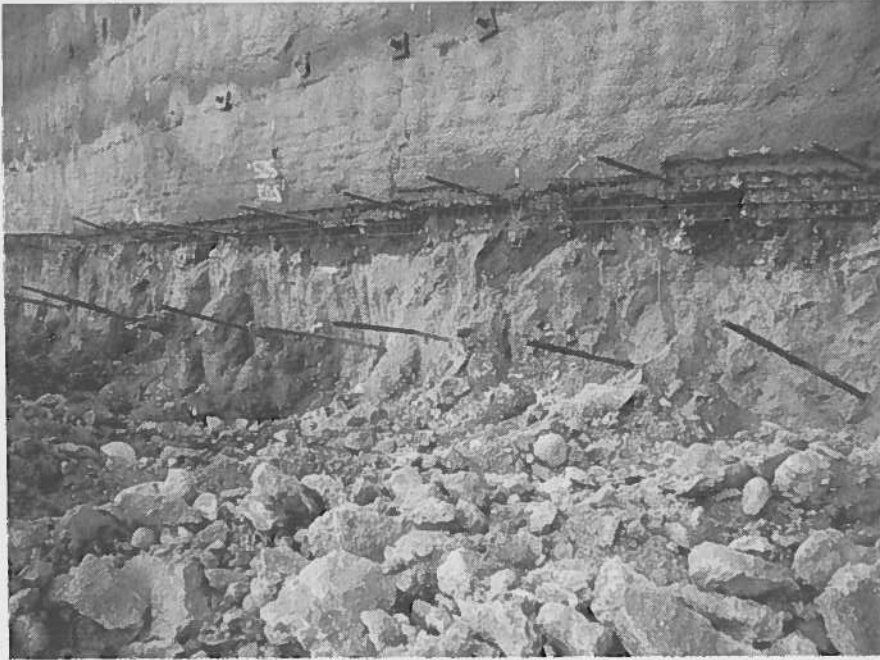
FIGURE 9 – Block 76 Jet Grout Wall South Temple Street

The jet grout columns were installed so the bottom of column was 5-10ft below the base of the excavation and the top of the column was installed to 5ft above the known high water elevation determined from the observation well readings. The average drill length for each column was approximately 50 ft and the jet length was 30 ft. 236 columns were installed in a 2 month time frame to complete the water control activities enabling completion of soil nail walls below the ground water table. Figure 9 shows the jet grout wall with soil nails being prepared for shotcrete facing.

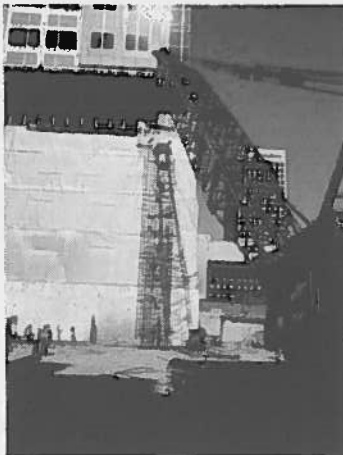
FIGURE 11 – Block 76 Diaphragm Wall at Gateway Tower Cage Placement

Along the Gateway Tower alignment, an existing building overhang was present approximately 86ft above our work platform elevation. This required careful consideration of crane requirements and rigging to ensure the reinforcing cages, when tripped would fit under the overhang without the added costs of cage splicing. The actual placement of cages required the crane boom tip to be within 3ft of the underside of the overhang (Figure 11). As a precautionary measure, the crane boom was fitted with a proximity sensor that warned the operator when he was too close to the building. On the plus side, the Gateway Tower was founded on an 8ft thick concrete mat, enabling us to construct the D-Wall with traditional 22ft long “three bite” panels.

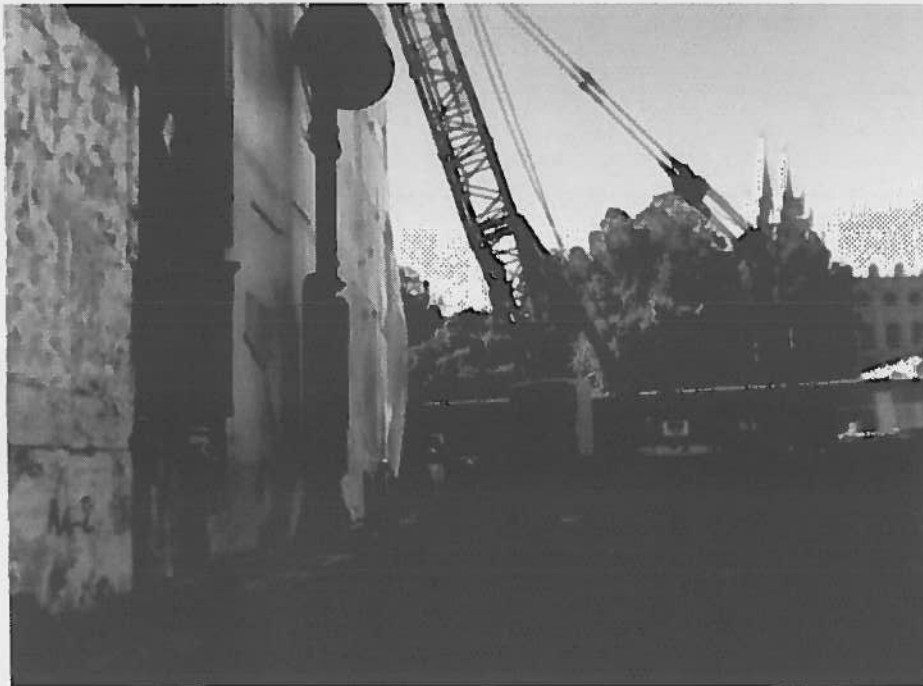
FIGURE 12 – Block 76 First Anchored Diaphragm Wall in Salt Lake City June 2007

In total 43 panels were installed to an average depth of 60ft. Over 45,000sf of D-Wall was installed in two months, beating the project schedule and eliminating a demobilization and remobilization because all D-Walls were complete prior to the implosion of the Key Bank Tower, a significant project milestone. Figure 12 below is believed to be the excavation for the first anchored diaphragm wall panel for earth retention in Salt Lake City, Utah.

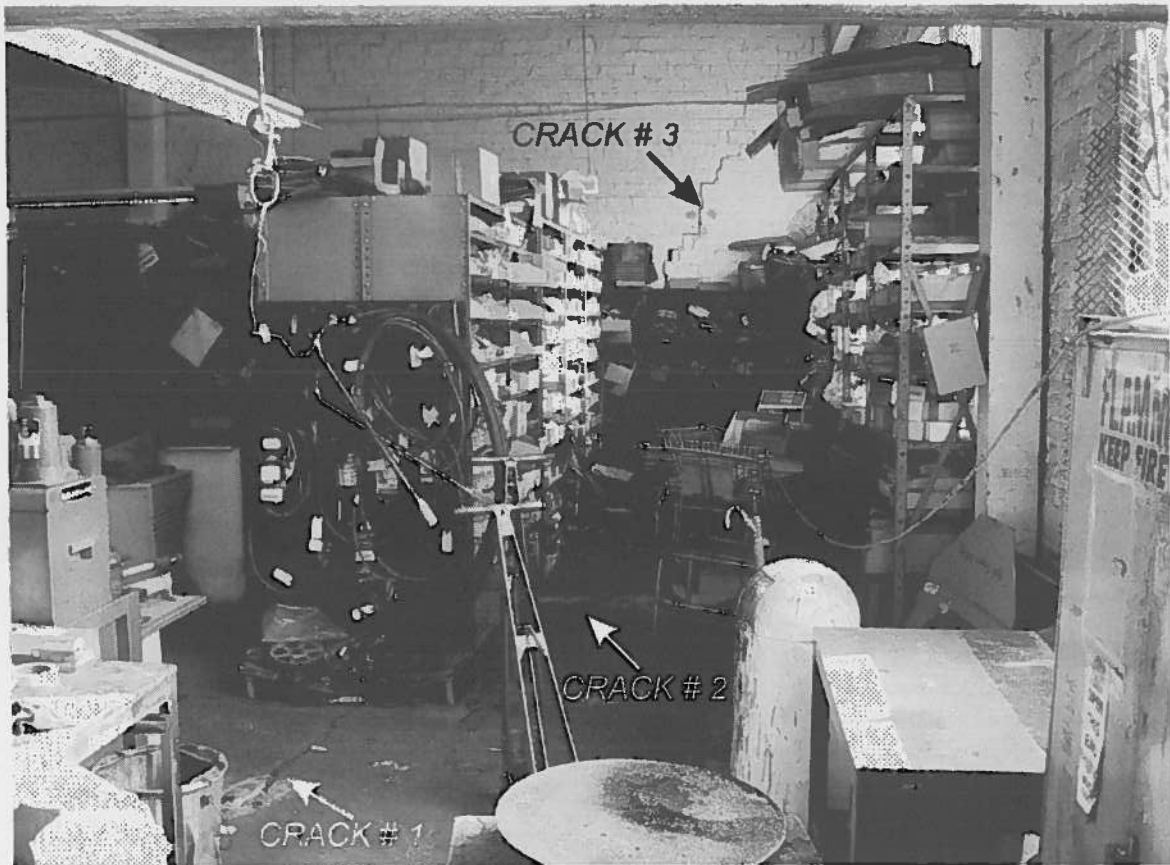
Figure 5: Locations Of Interior Cracks Monitored During The Press I Construction

Existing cracks were observed on the floor slab and one south wall inside one of the building, which was utilized as a repair shop at the time of construction. The locations of these three cracks (designated Crack 1, Crack 2, and Crack 3) are shown in Figure 5.

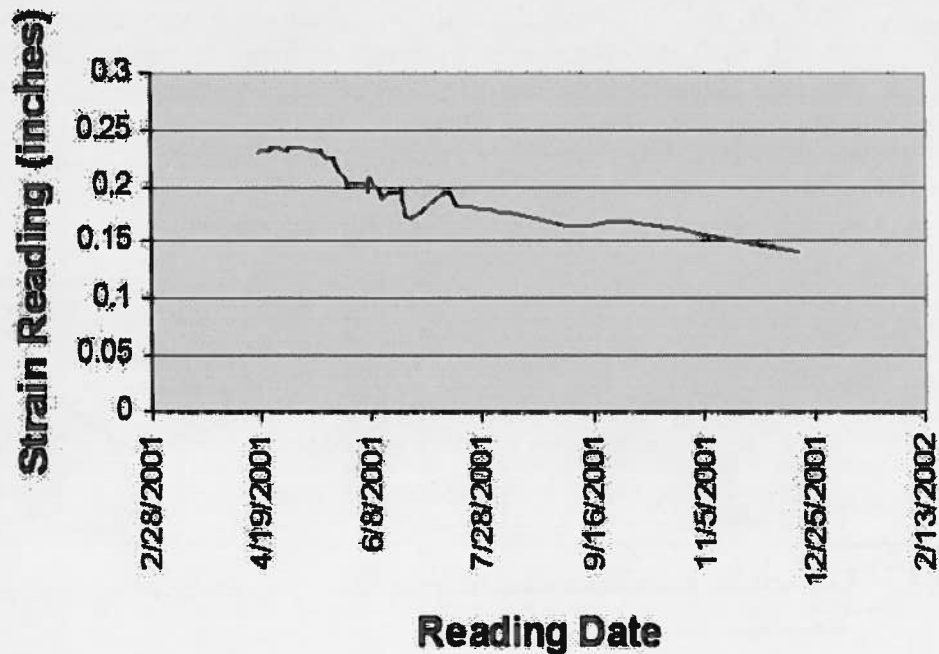
Figure 8: Crack Movement At The Location Of Crack 1

To verify that there would not be further movement of the existing cracks during the construction of the underground portions of Press I, a monitoring program was implemented in this building to observe displacement changes in the cracks. This monitoring was performed between April and December, 2006.

As illustrated in Figures 8 through 10 above, there was little displacement change observed at the three crack locations during or post construction of the underground portions of Press I.

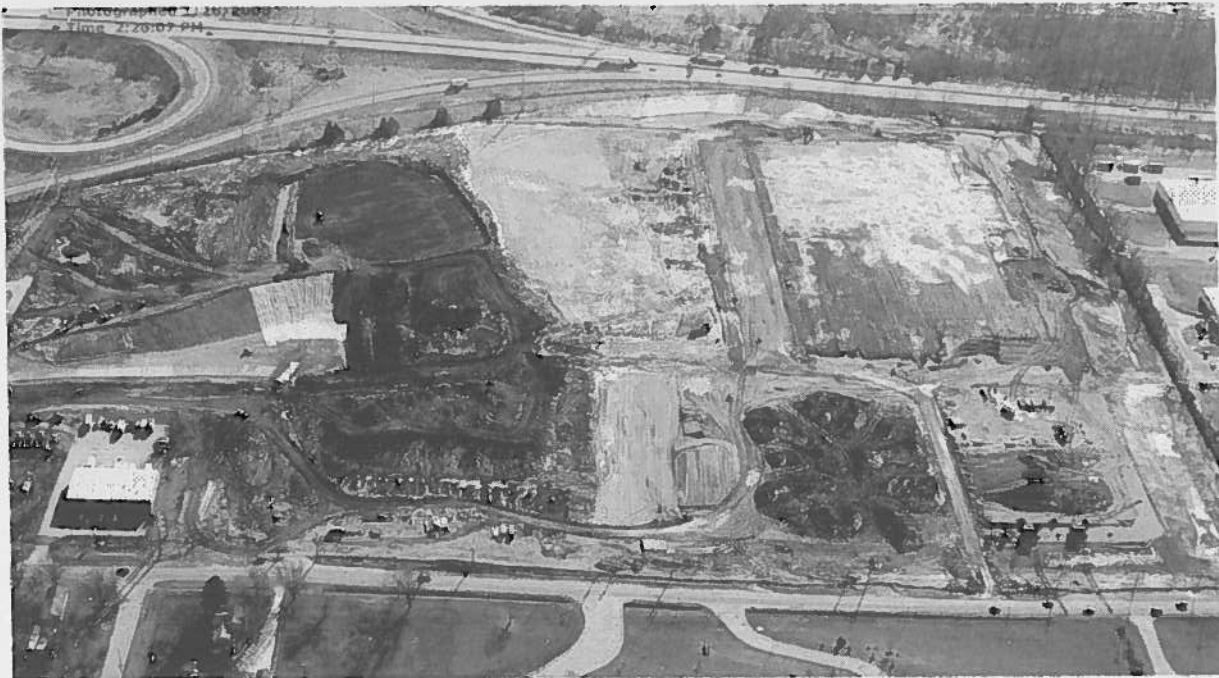
Figure 5. Site Development Activities About Mid-way through Project – looking south

- Landfill liner / leachate collection system design/installation. The need for structural fill to level the building pad areas of the site required that we consider obtaining soil borrow material from under the shallow areas of the old landfill. This created capacity to place waste material generated by undercuts in other areas of the site, including but not limited to the Lowe's building pad and detention basins. Since this was considered a vertical expansion of the landfill, IDEM required that these excavated areas be lined before waste materials were replaced in these areas. Due to the lack of clay material, a geosynthetic clay liner was used to line the excavated landfill cells. On-site sand was used as the leachate collection drainage layer. A leachate riser and submersible pump system was installed to remove leachate from the cell with discharge to the sanitary sewer system. Figure 5 shows a photograph about mid-way through the project development. The eastern extension of the partially-lined landfill cell is seen on the left-hand side of the photograph.

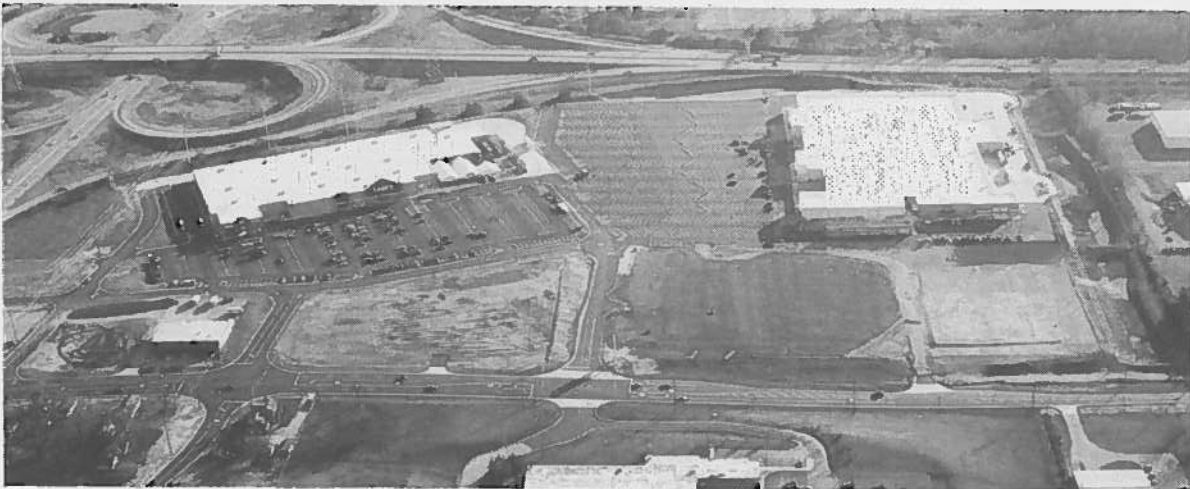
Figure 6. Site Development Activities Substantially Complete, looking south

Figure 6 shows the project at substantial completion with the two anchor stores completed and in operation. The detention ponds are apparent on the south and west ends of the site.

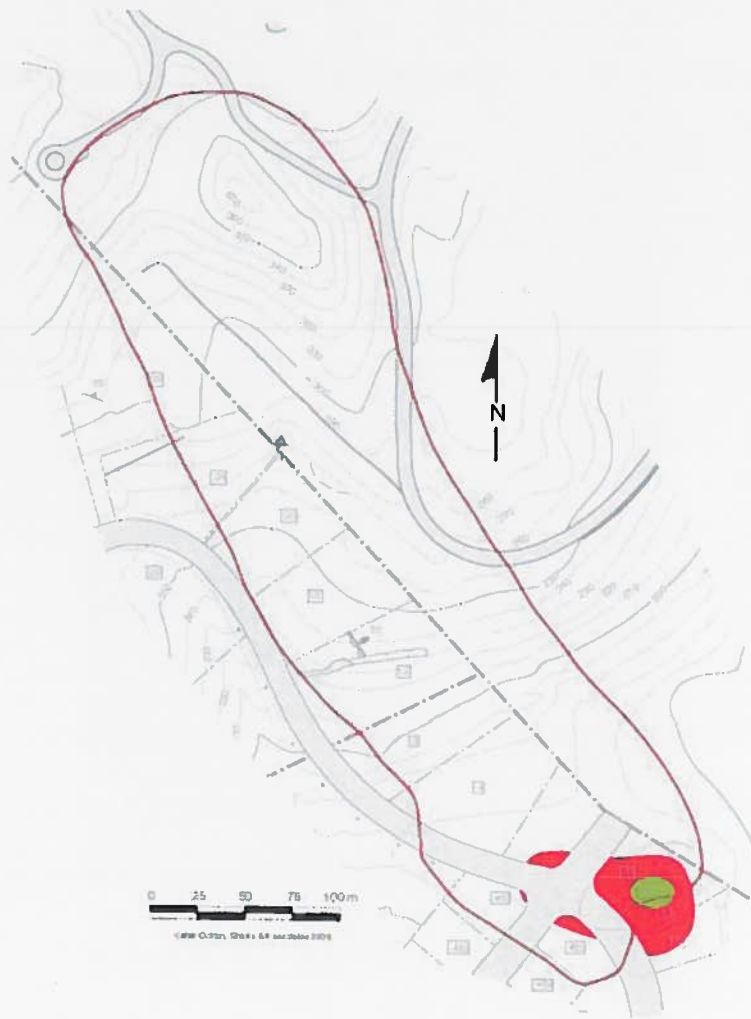
Fig. 4. Plan view illustrating the areas of greater than 3.5 m and 6.1 m (ellipsoidal area) of surface grading

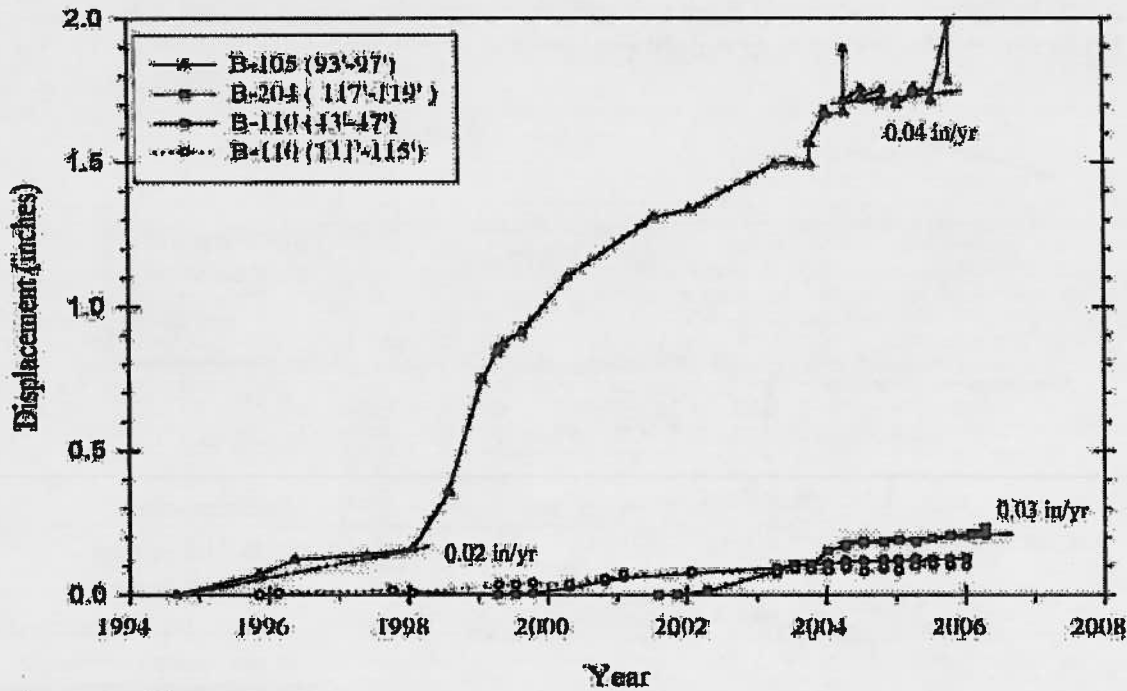
Figure 5. Measured displacement in inclinometers B-105, B-110 and B-204 (I-90 in Cleveland)

Figure 5 presents four inclinometer deflection history plots for inclinometers B-105, B-110, and B-204. Inclinometer B-204 was installed within the limits of the stabilization

structure after its completion in 1999. Construction of the stabilization structure, which included temporary toe unloading, increased the creep rate in the vicinity of pier 1, as is clearly indicated in the B-105 (93 ft to 97 ft) inclinometer tracing for the deep slip plane. Mitchell (1993) describes this onset of the dramatic increase in creep rate as the primary creep phase, which is characterized by a continuously decreasing creep rate. Data indicates that the creep rate began to level off to a nearly constant value around 2004. The soil is likely transitioning from primary to secondary creep phase, which is typically characterized by a nearly constant creep rate.

vicinity of the pier 1 stabilization structure. Creep still continues at nearly the same rate within the footprint of the stabilization structure along the deep slip plane, as is noted in inclinometer B-204 (117 ft to 119 ft), as outside of the stabilization structure. However, within the limits of the stabilization structure, creep along the shallow slip plane has essentially halted.

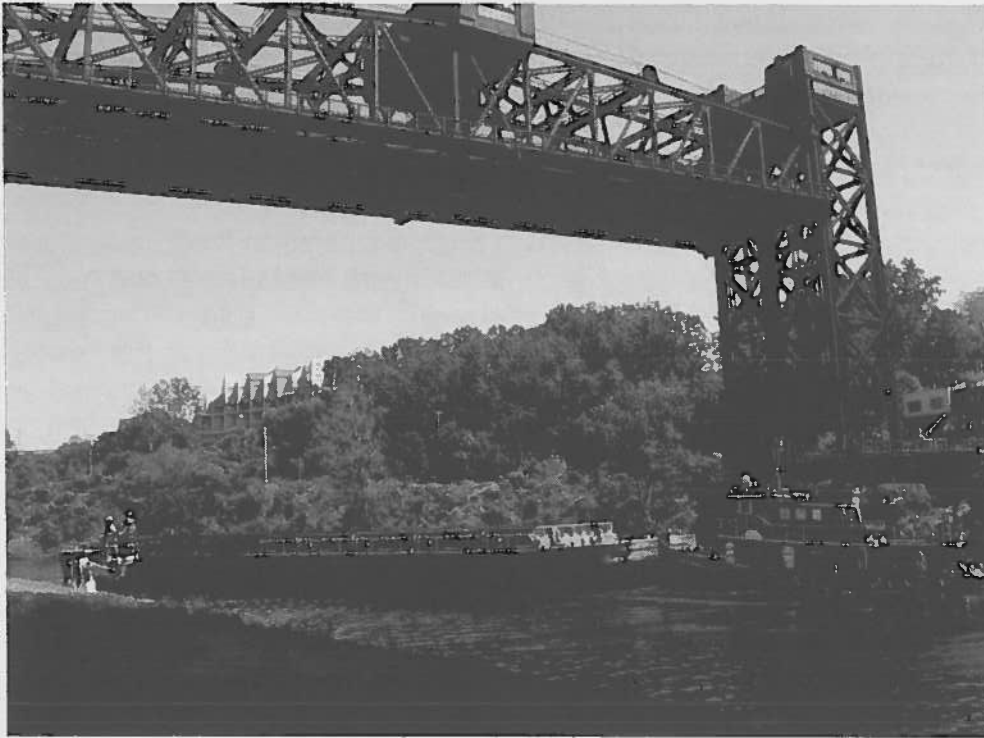
Figure 6. - Columbus Road Lift Bridge

The Columbus Road Bridge is a lift bridge (Figure 6) constructed in 1939, and is located immediately north of the Riverbed Street Landslide, as shown in Figure 2. The bridge is currently undergoing inspection for complete renovation, and preliminary information has revealed that the bridge has experienced approximately 3.5 inches of lateral movement based on old benchmarks, and that the bridge is “binding”.

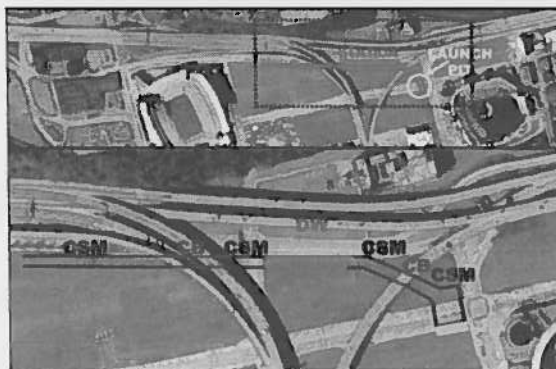
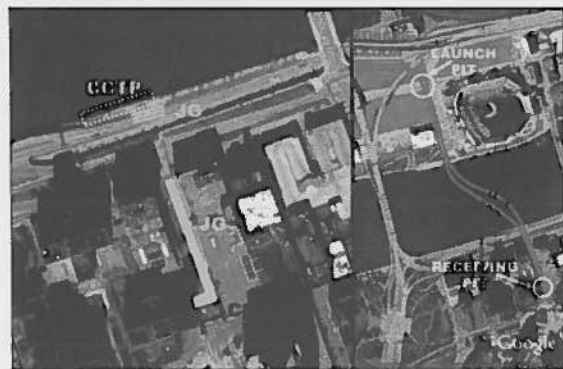
Nicholson's work at North Shore

Nicholson's work at South Shore

Figure 1. Nicholson's work at North Shore Connector

- Jet Grouting (JG): Column Confirmation Test Program (CCTP), 14 columns to select jet grout parameters. Total 32,700 cubic yard including CCTP.
- Cutter Soil Mixing (CSM): 110,000 SF (31.5-inch thick).
- Diaphragm Wall (DW): 37,000 SF (31.5-inch thick).
- Cement Bentonite Wall (CB): 22,000 SF (31.5-inch thick).

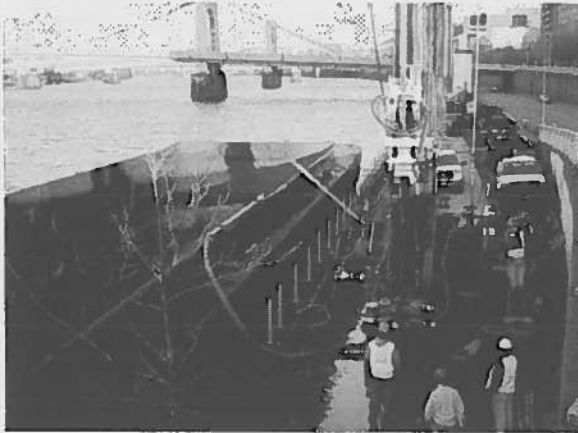
Figure 4. Spoil Management for CCTP

7-ft. diameter JG columns were used for production (Layout of JG Columns at the Launch Pit is shown in Figure 3). The JG spoils were directly deposited to the barges and truck mounted dumpsters during CCTP and production respectively (Figure 4 and 5). The following were considered to check the effectiveness of the jet grouting method.

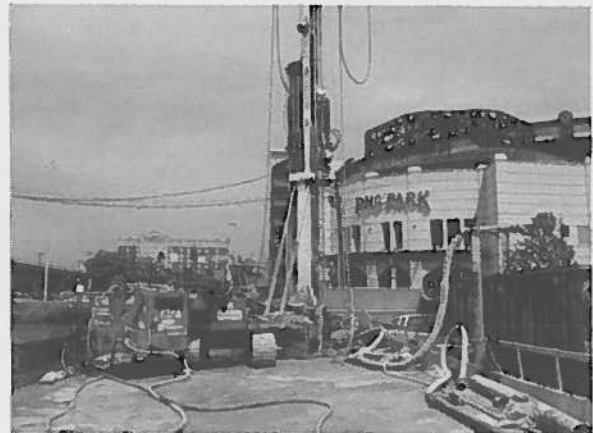
Figure 5. Spoil Management at Launch Pit

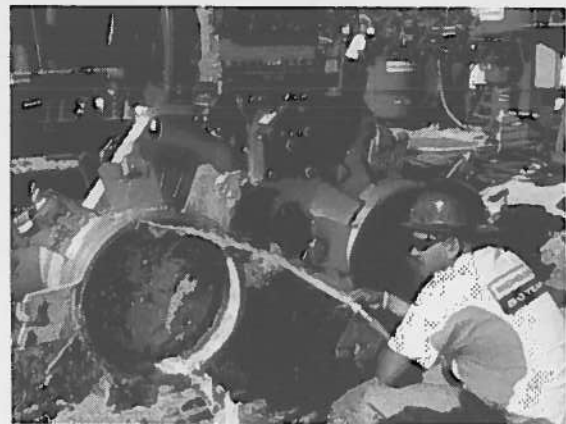
Figure 9. Cutting/Mixing Drums of CSM

The cutting and mixing drums are mounted on compact hydraulic motors. The drums are designed to combine high penetration rates and excellent soil/cement mixing. The cutting/mixing wheels are mounted on a Kelly bar supported by a hydraulic track rig (Figure 9 and 10). The Kelly bar allows accurate positioning and verticality of the soil mixed structure. The CSM machine is equipped with an onboard real time monitoring system.

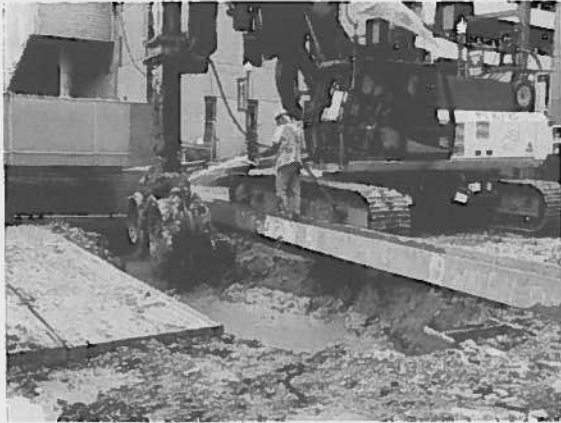
Figure 10. CSM Rig at North Shore

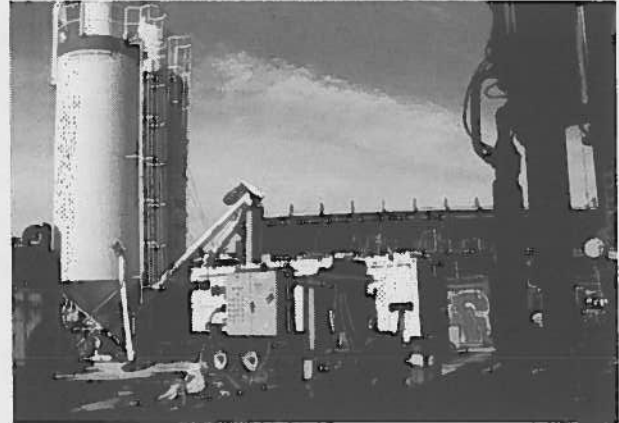
Figure 11. Grout Plant at North Shore

A compact automated grout mixer was used for preparation of grout for CSM wall system (Figure 11). A standard bentonite mixer and slurry tanks were used for preparing bentonite slurry. The soldier piles were installed after completion of a panel. Most of the soldier piles were embedded in the bedrock for structural purposes.

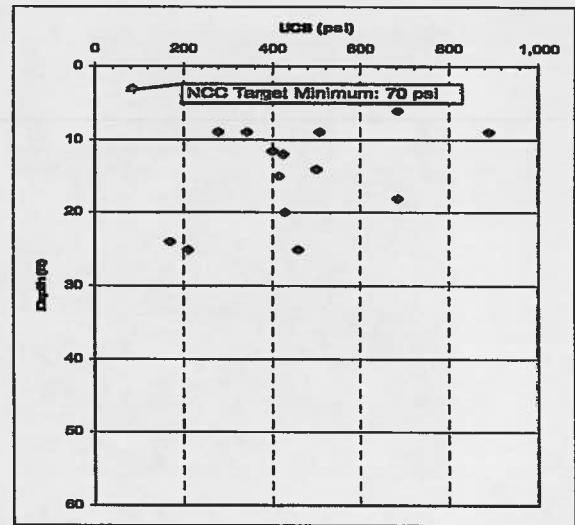
Figure 15. Cored UCS results of JG at Launch Pit

The specific gravity of grout was measured at the plant and jet grout parameters were monitored using a Lutz system. In addition, spoil samples were collected to measure specific gravity and strength testing. Cored samples from the JG columns were tested for strength requirement (results shown in Figure 15).

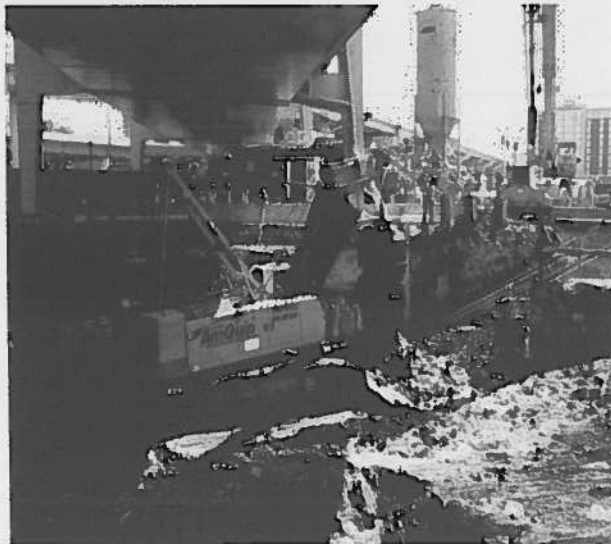
Figure 16. CB wall below I-279

The CB walls consist of overlapping primary and secondary panels excavated using conventional slurry wall technology. The trenches were excavated using a low head room grab with bentonite slurry as stabilizing agent (Figure 16).

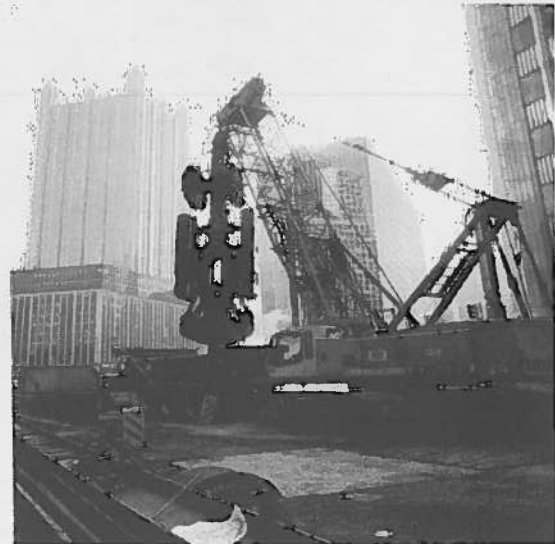
Figure 17. Soil disposal system for CB wall

Once the panels were excavated to full depth, steel beams were placed and the stabilizing agent was substituted with the designed cement-bentonite grout mix. Soil disposal system is shown in Figure 17.

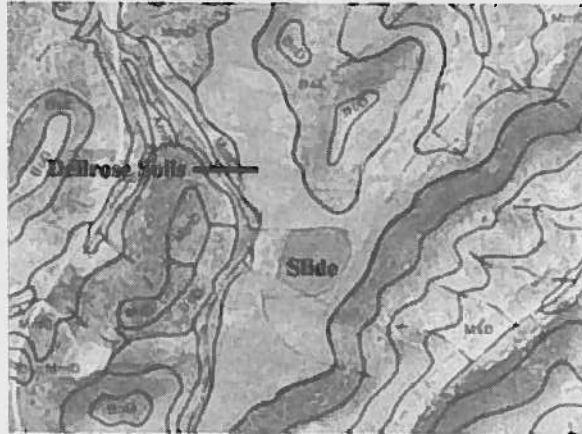
Figure 1. Geologic setting

Department of Agriculture are often a very reliable indicator of colluvial soils. In this case, the Dellrose soils contain many of the characteristics of colluvium produced by the geographically higher parent bedrocks. As can be seen in Figure 1, the landslide occurred well-within the boundaries of the mapped Dellrose soils.

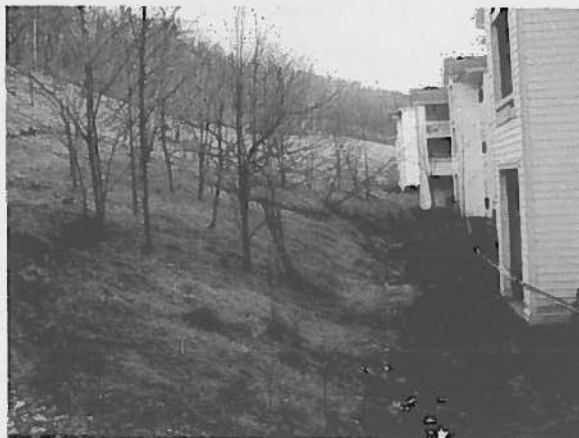
Figure 2. Early warning signs, small bulges in the slope.

Other early warning signs and historical evidence of previous slides were noted along the hillside. An older roadbed that transected the hillside and bounded on each end by very deep drainage swales was very likely a graben, or wedge shaped plunge into the subsurface at the upper end of a significant, historical slide. The character of the upper end of the current slide was nearly identical in its early stages to the nature of that feature. As the slope began to seep water and initiate small bulges, a 2 to 3 foot scarp became evident approximately 450 feet up the hillside.

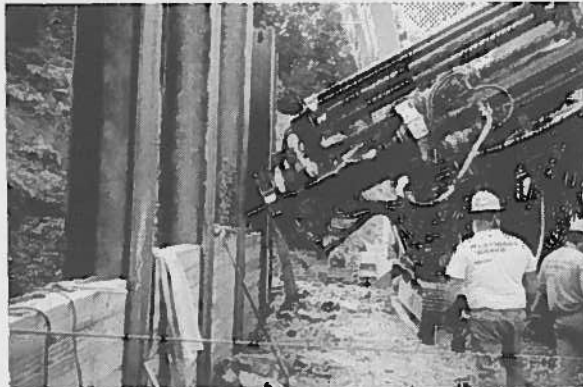
Figure 5. Permanent Wall

However, as the magnitude of the slide grew, it became necessary to make the wall a permanent feature and include tiebacks for added stability, as shown in Figure 5. The resulting final design is illustrated on Figure 6.

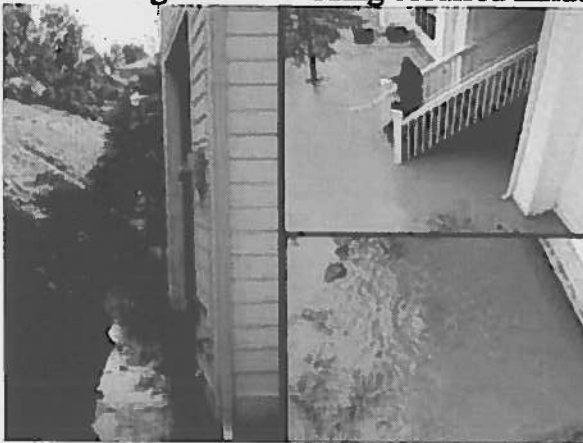
Figure 7. Flooding

As shown in Figures 7 & 8, the movement of the slope blocked surface drainage behind the units and significant flooding occurred inside several of the ground floor apartment units.

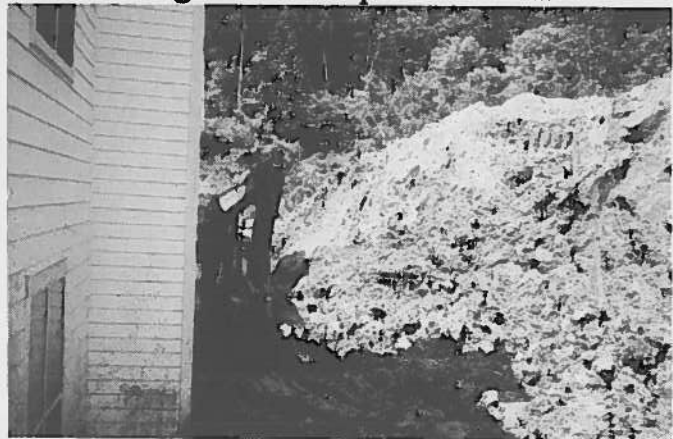
Figure 8. Emergency excavation of slide material

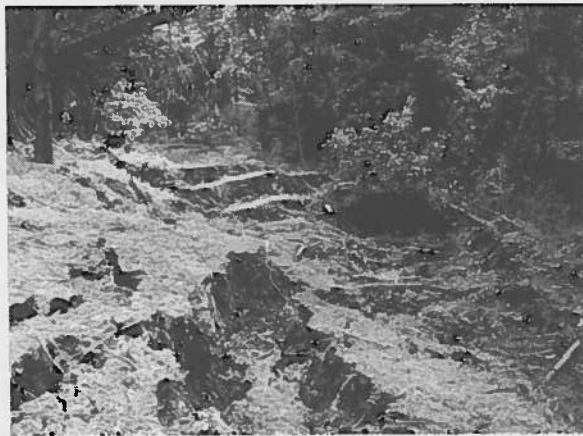
Figure 9. Surface expression of progressive failure

The design process required consideration of the progressive failure (Figure 9) that was occurring in the slope.

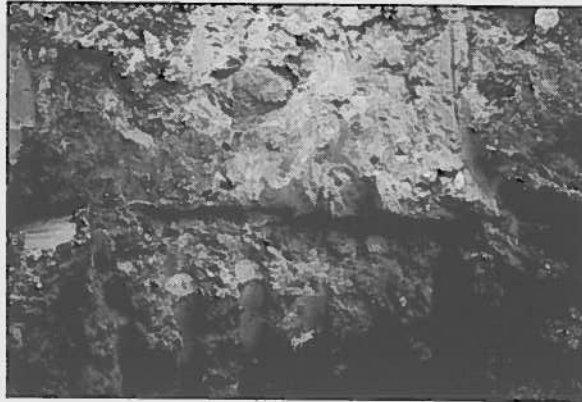
Figure 11. Exposed Slide Plane

The most effective parameters used for analysis were derived from back calculation using the location of the slide plane from the inclinometers and the slide surfaces exposed in the construction, such as the failure surface seen in Figure 11.

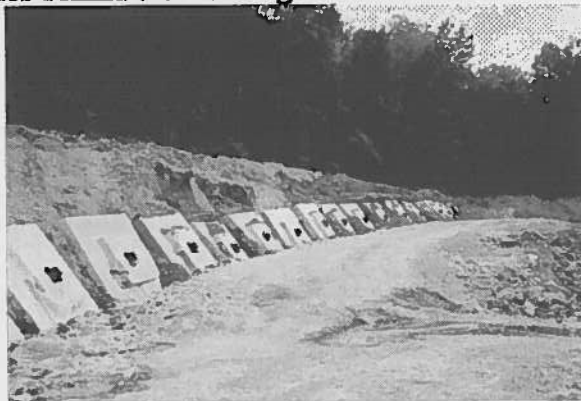
Figure 12. Finished Anchor Blocks

The parking lot provided a convenient staging area for the equipment and materials. An assembly line for construction of pre-cast anchor blocks (Figure 12) and lagging panels supported the field activities behind the buildings.
